Transport Accident
Investigation
Commission

Final report

Rail inquiry RO-2021-102
Freight Train 391
Collision with light truck
Saunders Road, Marton
13 May 2021

February 2023

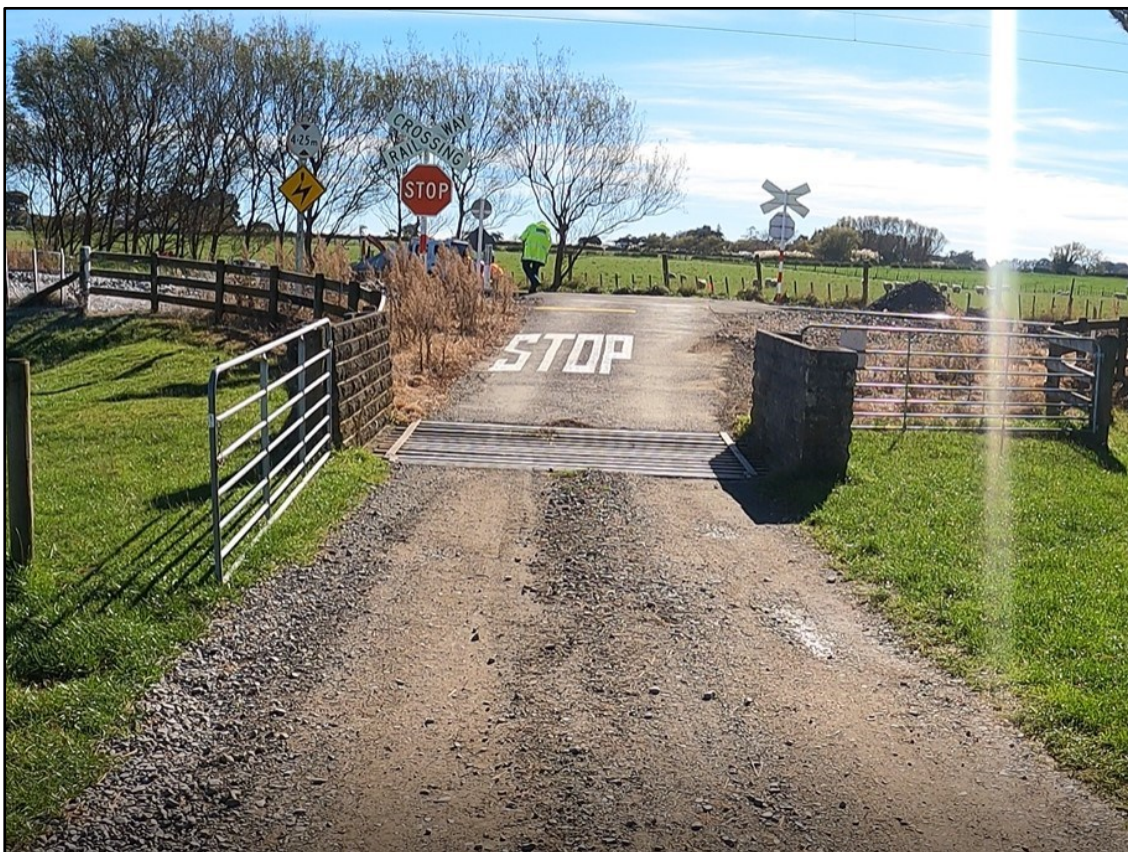
Figure 3: View towards worksite from southern side of crossing

- 1.1 At about 1520 on Thursday 13 May 2021, a two-person team was engaged in road-marking activities at Saunders Road level crossing, some 5 kilometres northeast of Marton.

- 1.2 The team consisted of a paint applicator operator (the operator), who was conducting work on the road next to a truck on the south side of the crossing. The operator was assisted by the truck's driver, who was sitting in the right-hand side of the truck cab in readiness to move when instructed by the operator.

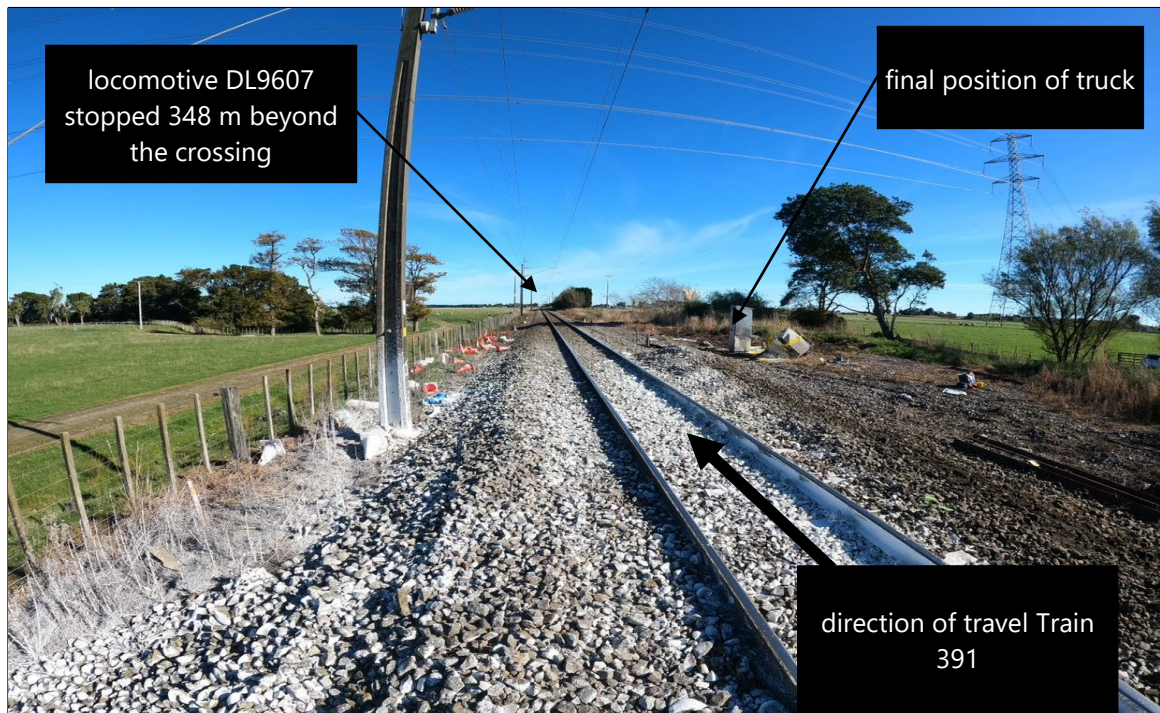
Figure 5: View to the southwest from the crossing

- 2.17 At 1526:06 the train driver applied the train's emergency brake.
- 2.18 At 1526:09 Train 391, travelling at 72.7 kilometres per hour, collided with the right-hand side of the stationary truck. The truck was shunted on impact about 30 metres southwest of the crossing and came to rest against a signal equipment box on the northern side of the track (see Figure 5).

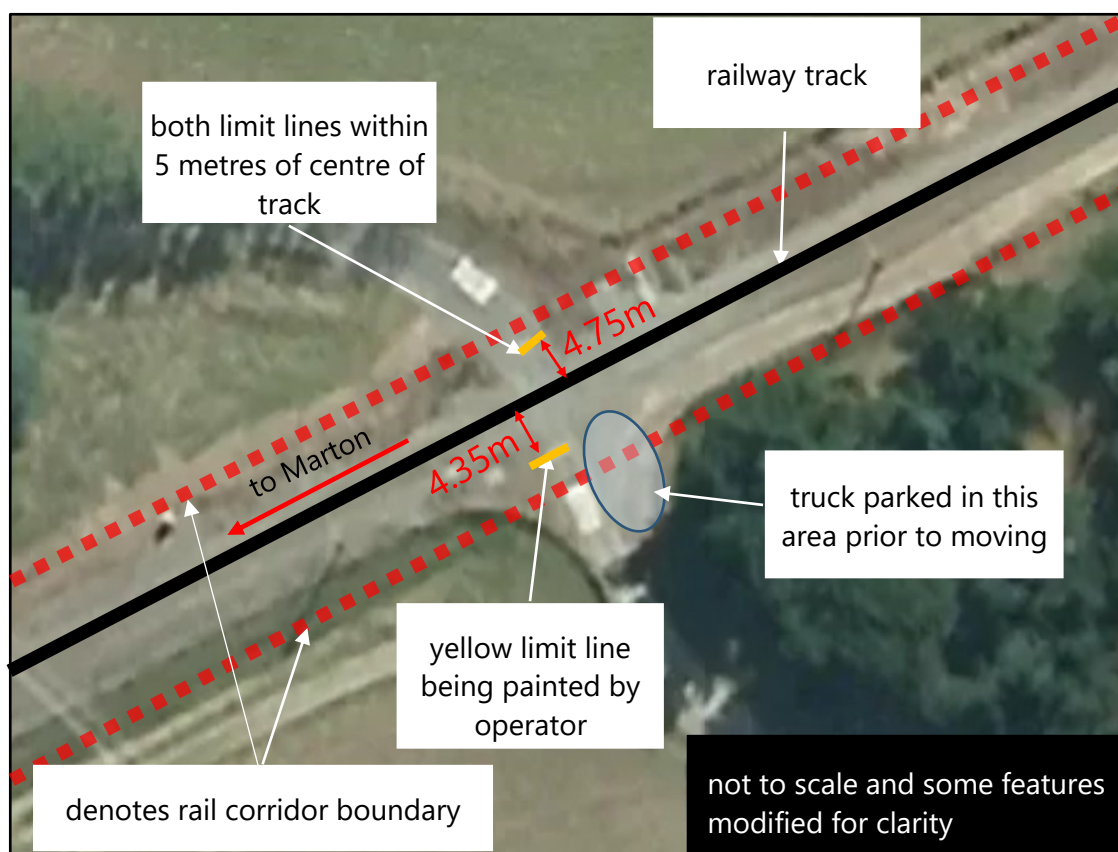
**Figure 6: Aerial view of Saunders Road level crossing
(Credit: Toitū Te Whenua Land Information New Zealand)**

- 3.10 The crew reported to an operations manager. The operations manager was responsible for, among other things, organising the work, training employees and advising employees of any instructions required for the work they were tasked to do.
- 3.11 Documentation provided to the Commission indicated that the contract on which the crew was working involved the marking of roads at 60 separate locations around the southern rural Rangitikei region. Of those 60 locations, 12 involved work near level crossings.
- 3.12 At Saunders Road the lines to be marked were measured at 4.75 metres from the centre of the track on the northern side, and 4.35 metres from the centre of the track on the southern side (see Figure 6).

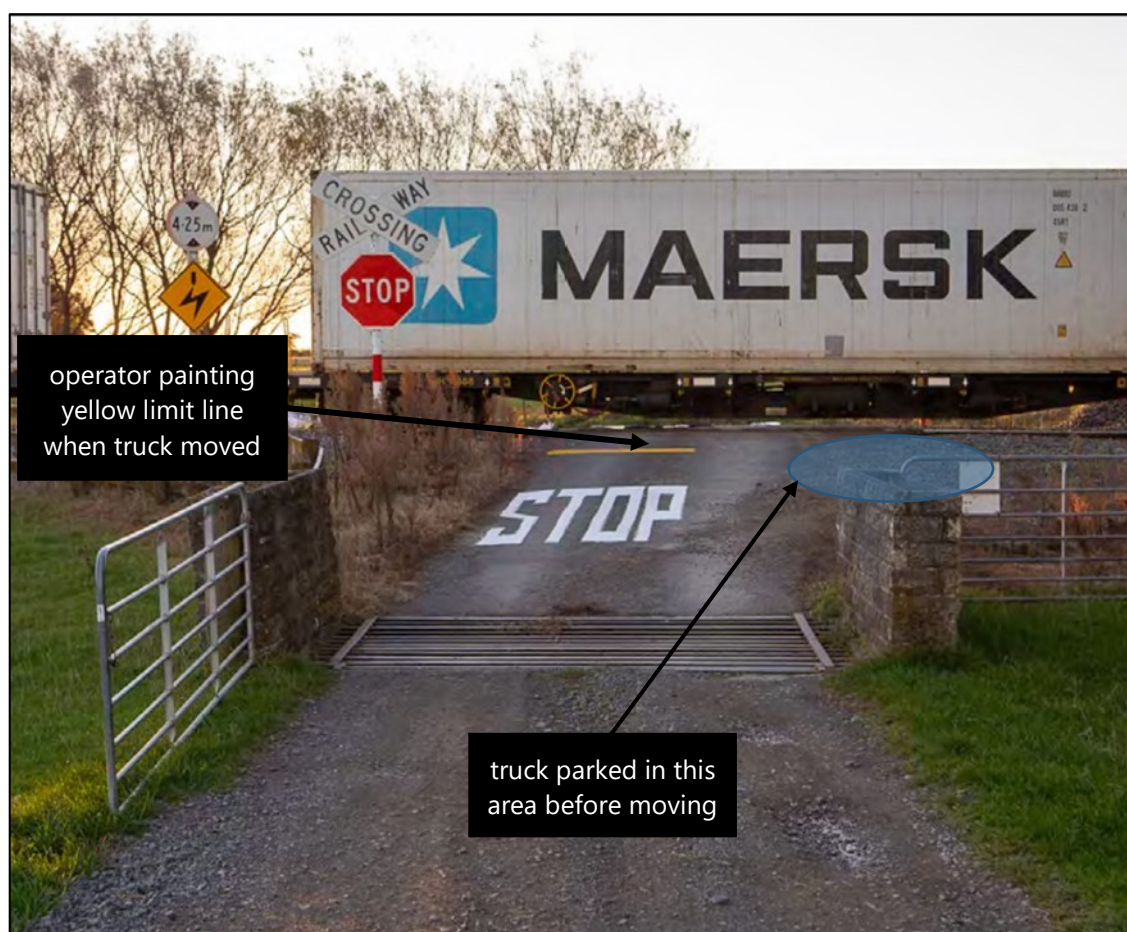
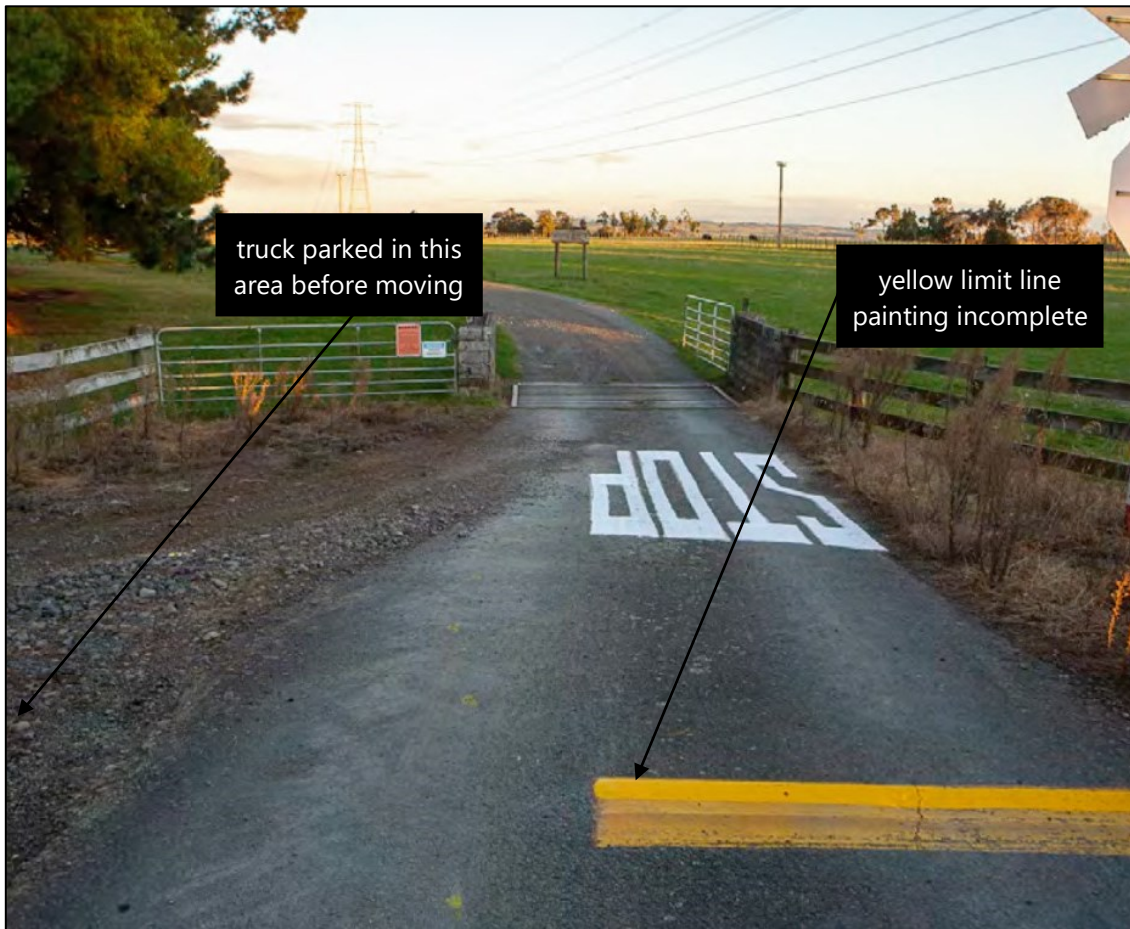
- 3.66 The set-up of the work area was outside the usual operating method, in that the truck was parked beside the location where the operator was painting, instead of the usual position of the truck being parked in front of the operator (see Figures 9 and 10).

Figure 9: View towards crossing from southern side
(Credit: New Zealand Police)

**Figure 10: View south towards cattle stop
(Credit: New Zealand Police)**

- 3.67 This position to the side was necessary due to the geographical constraints of the available area approaching the crossing.
- 3.68 Parking the truck to the side of the operator's work area avoided the truck blocking the entrance to the neighbouring farm or placing the paint hoses over the crossing. It further avoided the truck potentially driving over wet paint as it manoeuvred through the work area.

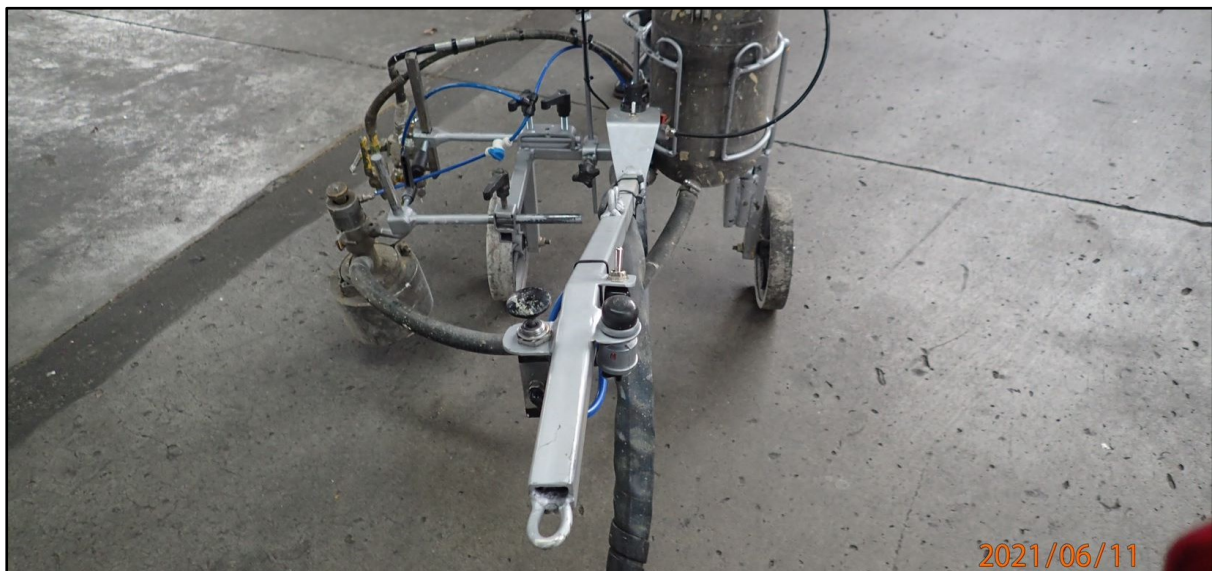
Figure 11: Paint applicator machine

- 3.76 Due to the nature of the work, the road-marking crew did not use hand-held radios to communicate. The working environment could at times be noisy due to road traffic, the paint compressor operating and the truck's diesel engine running. It was also impractical for the operator to use a hand-held radio while they were engaged with the paint applicator and hoses.
- 3.77 Instead, the paint applicator was fitted with a buzzer button (see Figures 11 and 12). When pressed the buzzer sounded in the cab of the truck.

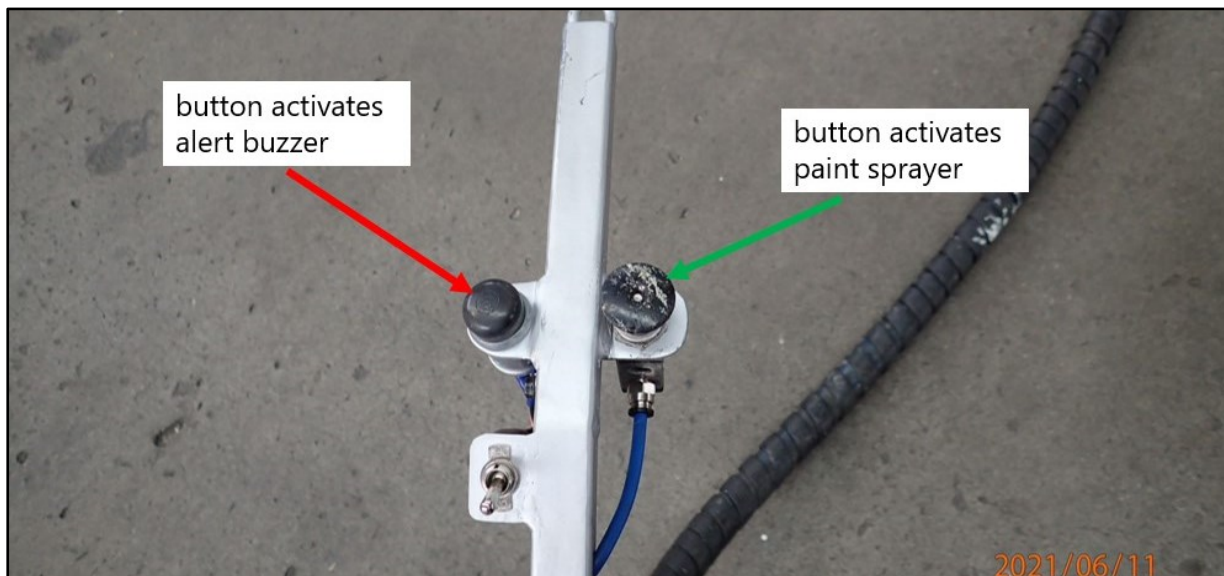
Figure 12: Button arrangement on applicator handle

Key lesson: Safety-critical communication equipment should be designed and operated in a manner that avoids the potential for misunderstanding.

- 3.78 The crew utilised a simple code for the buzzer: a short beep meant move forward, two beeps meant move back, and a sustained beep meant stop.
- 3.79 In an interview with Commission investigators and in statements taken by Police at the scene, the operator stated they had not pressed the buzzer.

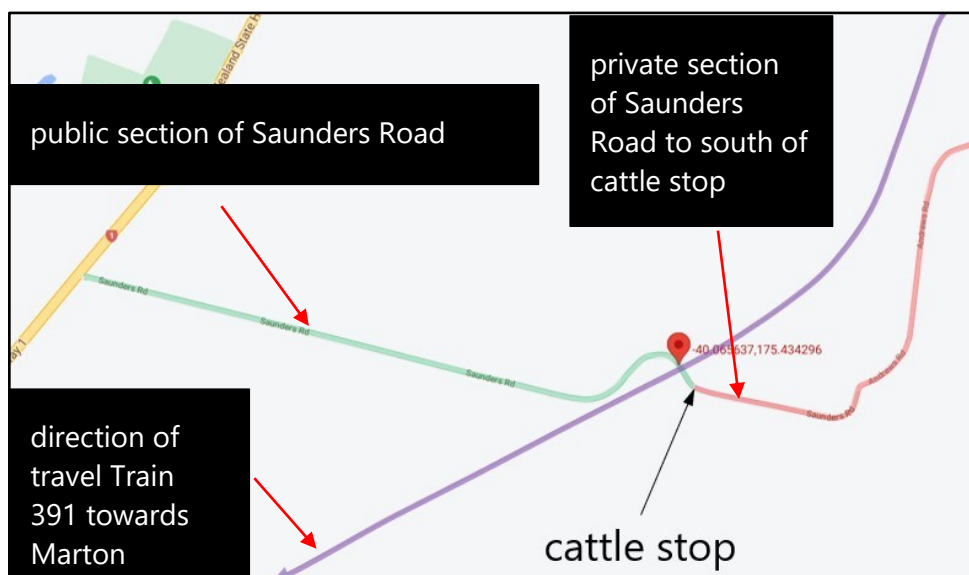
Figure 13: Layout of Saunders Road area

- 3.91 However, other factors, such as the frequency of traffic over the crossing, also formed part of the assessment equation.
- 3.92 Saunders Road had a low frequency of traffic, and the road terminated 20 metres south of the crossing at a cattle stop before a private roadway to farmland (see Figure 13).

- 3.93 Although the responsibility for the maintenance of the road markings was under the jurisdiction of the Rangitikei/Manawatū District Councils, the crossing essentially only existed to provide access to the neighbouring farm.
