Transport Accident
Investigation
Commission

Final report

Rail inquiry RO-2021-106
Derailment of Train 220
South of Hunterville
13 December 2021

May 2023

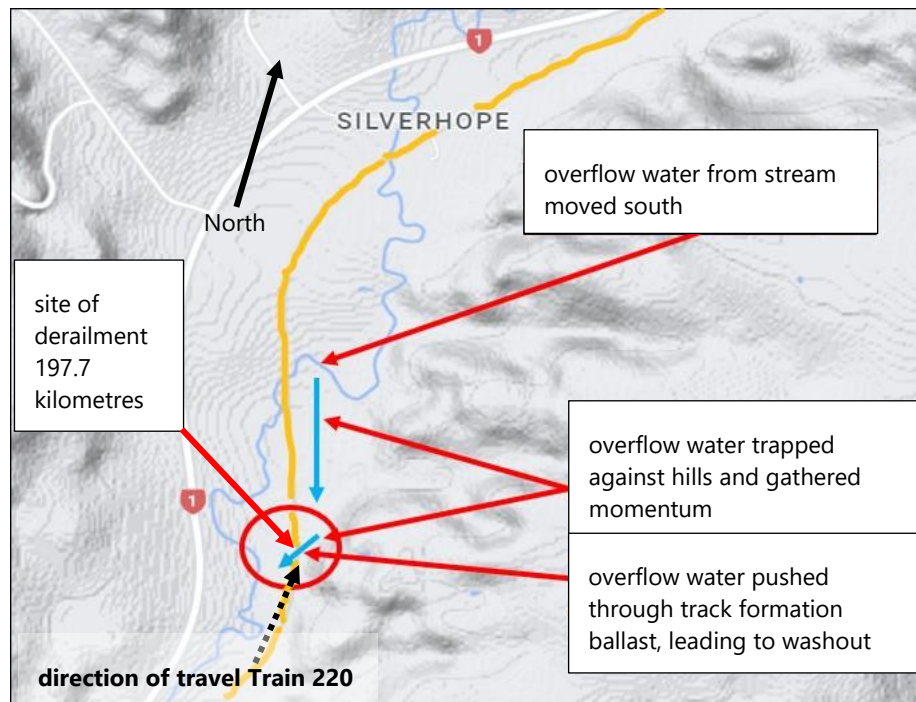
Figure 3: Waterflow leading to washout

- 2.9 At about 2259 Train 220 was travelling at 63 kilometres per hour when the driver noticed flooding in a paddock to the right of the track. As the track straightened out the driver noticed floodwater flowing across the track in front of the train (see Figures 3 and 4).

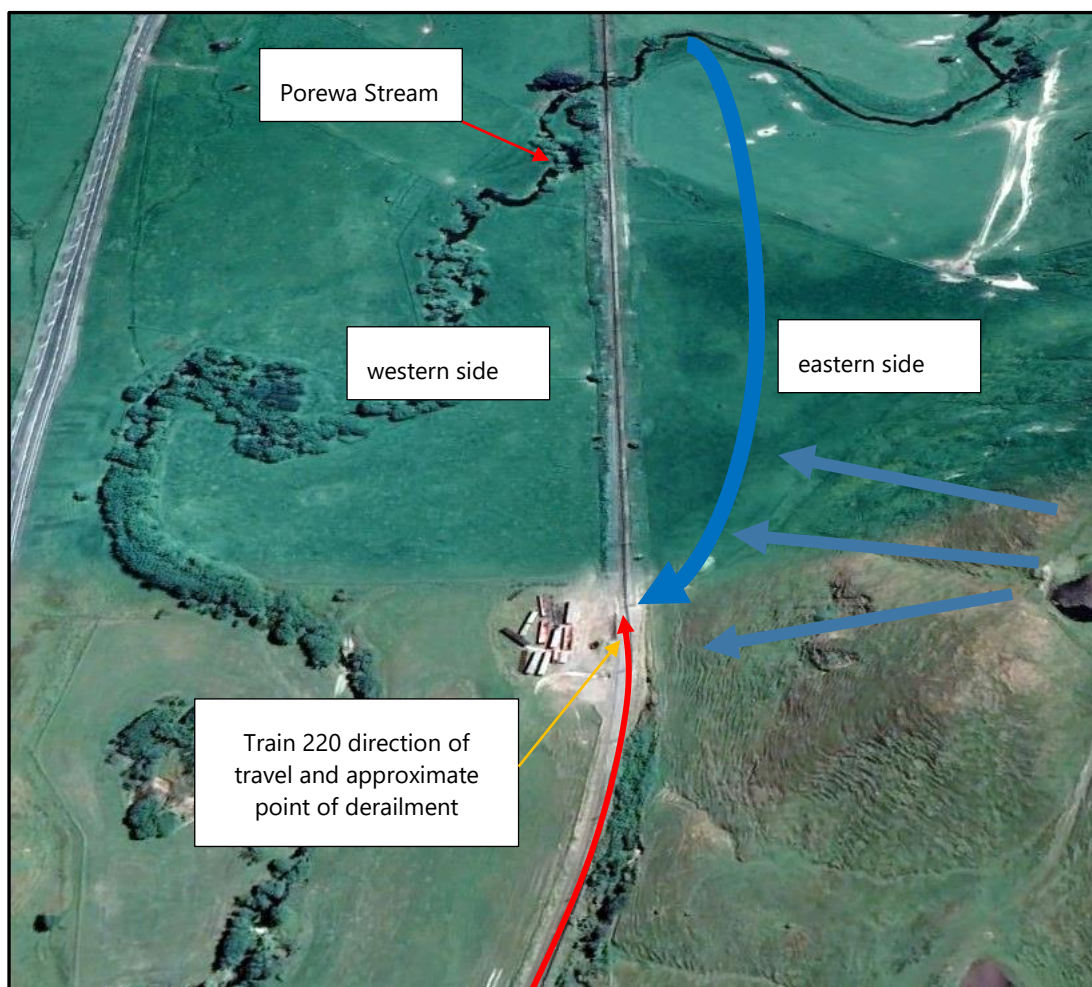
Figure 5: Direction of floodwater

- 2.22 Rainfall had collected in Porewa Stream and overflowed onto farmland on the eastern side of the railway. The floodwater had been channelled south into a small valley between hills on the eastern side of the rail formation.¹⁰ The floodwater from the Porewa Stream had gained momentum and the volume of water was further increased by floodwater travelling downhill from a pond situated at the top of the nearby hills (see Figure 5).

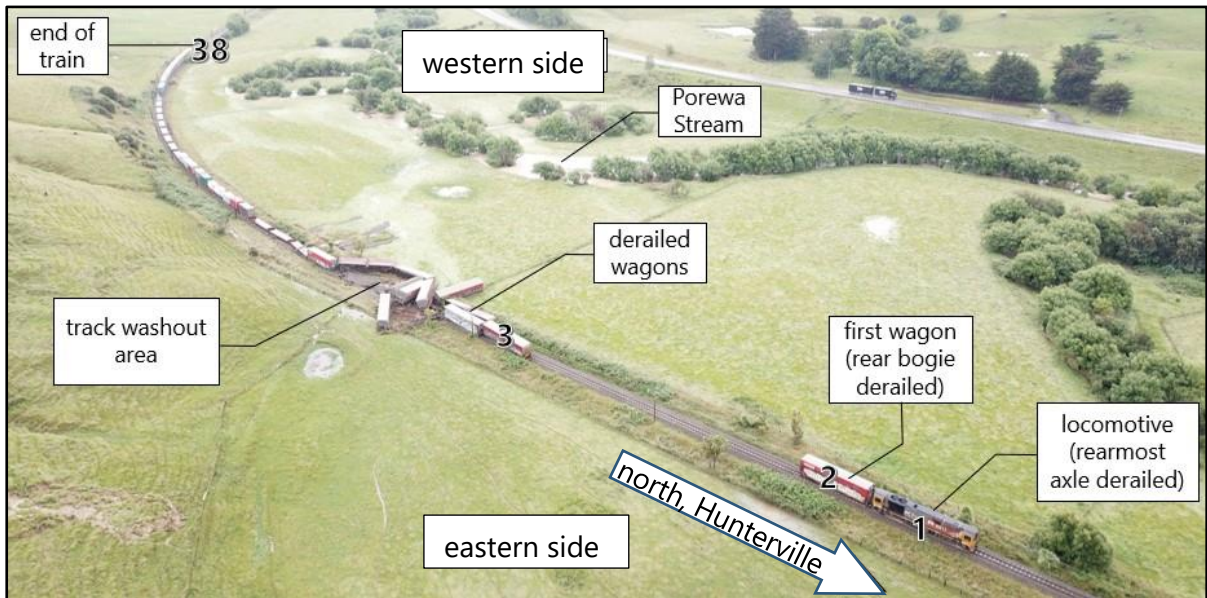
Figure 6: Derailment scene showing entire train
 (Credit: KiwiRail, modified by Transport Accident Investigation Commission)

2.25 The train consisted of 38 vehicles (one locomotive and 37 wagons). The locomotive and first wagon passed over the site of the washout; however, the second wagon derailed, causing a further 15 wagons to derail, of which some overturned (see Figures 6 and 7).

- 3.11 The momentum of the following wagons meant that a series of 'nose-to-tail' collisions occurred. The wagons were forced off the track to both sides and several wagons overturned as a result (see Figures 6 and 7).

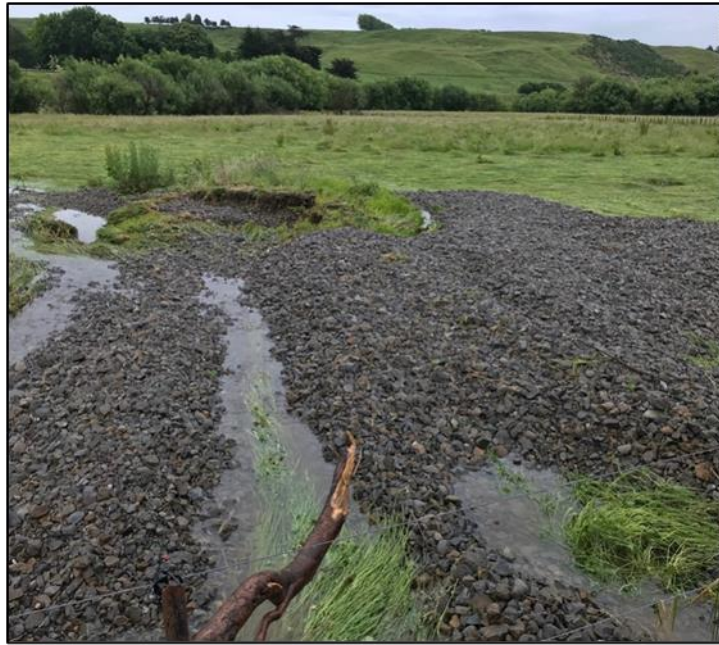
Figure 8: Ballast washed to western side of railway track
(Credit: KiwiRail)

- 3.5 The floodwater gathered at a natural depression and inundated the track ballast.¹¹ The ballast was forced from underneath the track by the weight and pressure of the floodwater from the eastern (hill) side to the western (stream) side (see Figure 8).

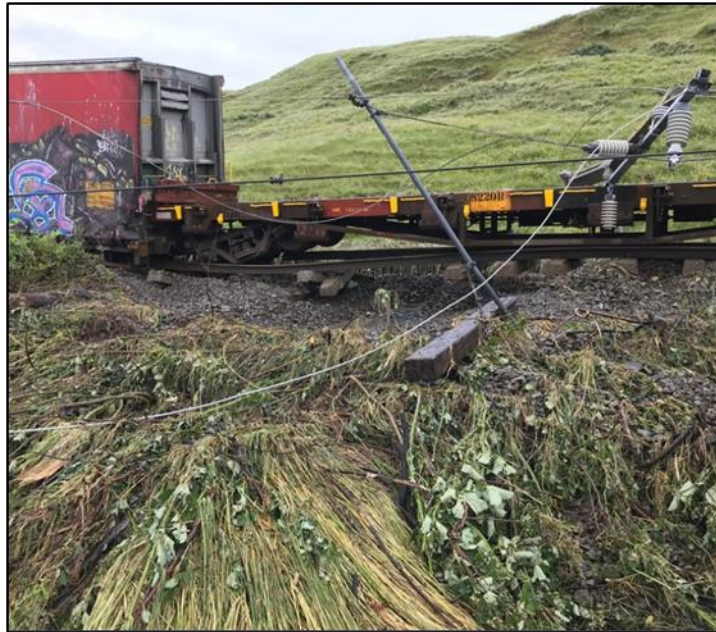
Figure 9: Washout showing unsupported rail
(Credit: KiwiRail)

- 3.7 The removal of the ballast from underneath the track seriously weakened the structural integrity of the formation and resulted in the rail track being unable to support the weight of the rail vehicles (see Figure 9).

- 3.8 As the train passed over the length of track that was now unsupported, the track moved and spread sideways under the weight. This caused the wheels of the rail vehicles to lose contact with the rail and they were forced off the railhead.¹³

- 4.7 It is **virtually certain** that the derailment was caused by floodwater inundating and washing out ballast from underneath the track. This led to the track being unable to support the weight of the train.

- 3.22 Since the accident KiwiRail has taken further safety actions by carrying out hydrology assessments and flood modelling of the area. It also intends to replace the existing culverts at the location with larger pipes and install a flood-monitoring gauge. The work is expected to be completed by mid-April 2023.

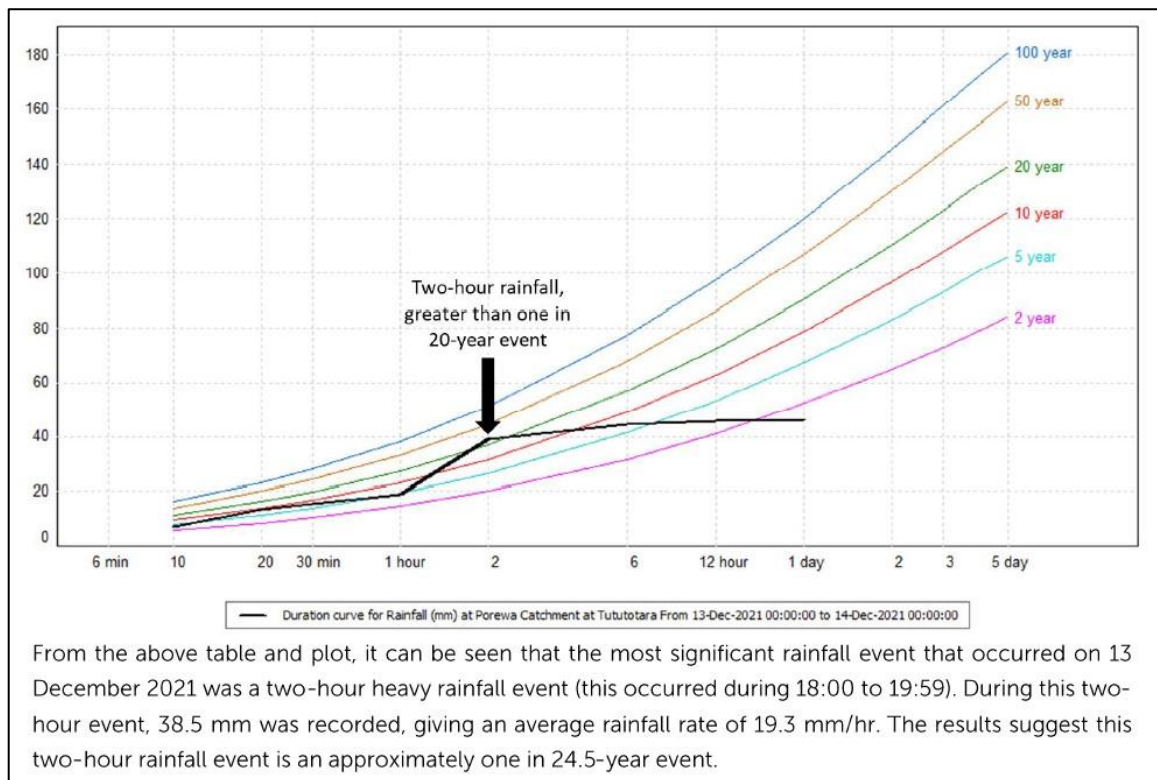
Figure 10: Porewa catchment area rainfall data for 13 December 2021

- 3.12 The weather conditions at the time of the accident were abnormal for the time of year¹⁴ (see Appendix 1). A total of 46 millimetres of rain was reported in the Porewa catchment area, 10 kilometres south of the derailment, between midnight on 13 December and midnight on 14 December. In a two-hour period between 1800 and 1959 that same day, 38.5 millimetres of rainfall were recorded, equating to an approximately one-in-24.5-year event (see Figure 10).
- 3.13 In comparison, there had been a total of 45.5 millimetres of rainfall during the 12 days preceding the accident, including zero rainfall in the three days immediately prior.
