Transport Accident  
Investigation  
Commission

# **Final report**

***Rail inquiry RO-2022-101***  
***Passenger train***  
***Fire in auxiliary generator wagon***  
***Palmerston North station***  
***11 May 2022***

**November 2023**

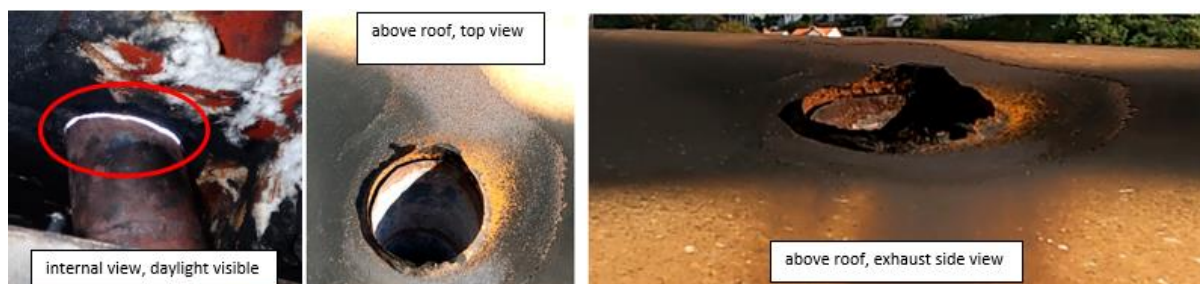
Figure 5: AG130 exhaust tail pipe inside, top and side views

- 2.37 The Commission inspected the exhaust systems of three AG wagons: AG130, AG176 and AG222. The AG130 and the AG176 were owned by KiwiRail, while the AG222 was occasionally leased by KiwiRail from Greater Wellington Regional Council. The AG130 exhaust system was the only one in which the exhaust tail pipe was missing, so that the auxiliary generator set's exhaust did not extend up through the top box and out through the roof (see Figure 5).

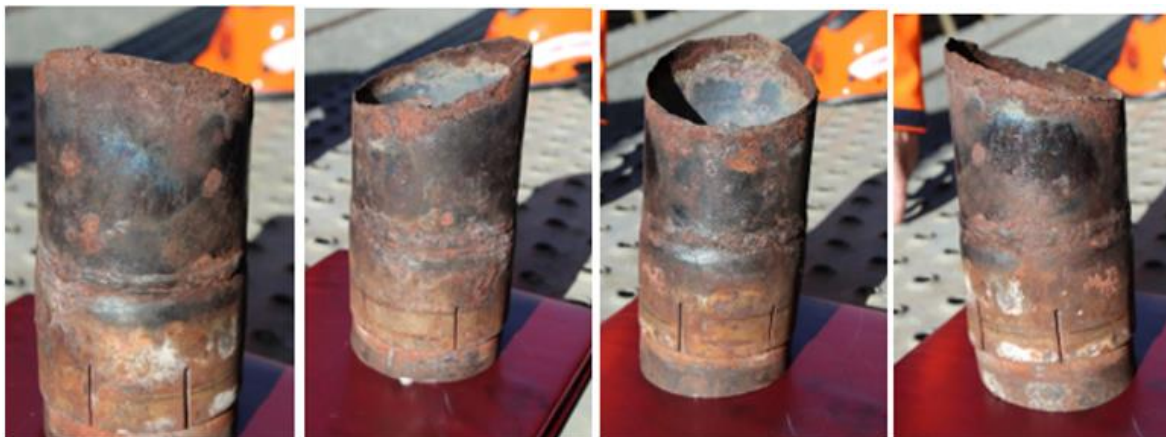
**Figure 6: Exhaust tail pipe from AG130 after removal**

2.38 The inspection also revealed significant surface rusting and thinning of the AG130 's exhaust tail pipe (see Figure 6).

- 3.3 The degree of surface rusting and thinning of the exhaust tail pipe wall thickness indicated it is **very likely** that the damage was age related.

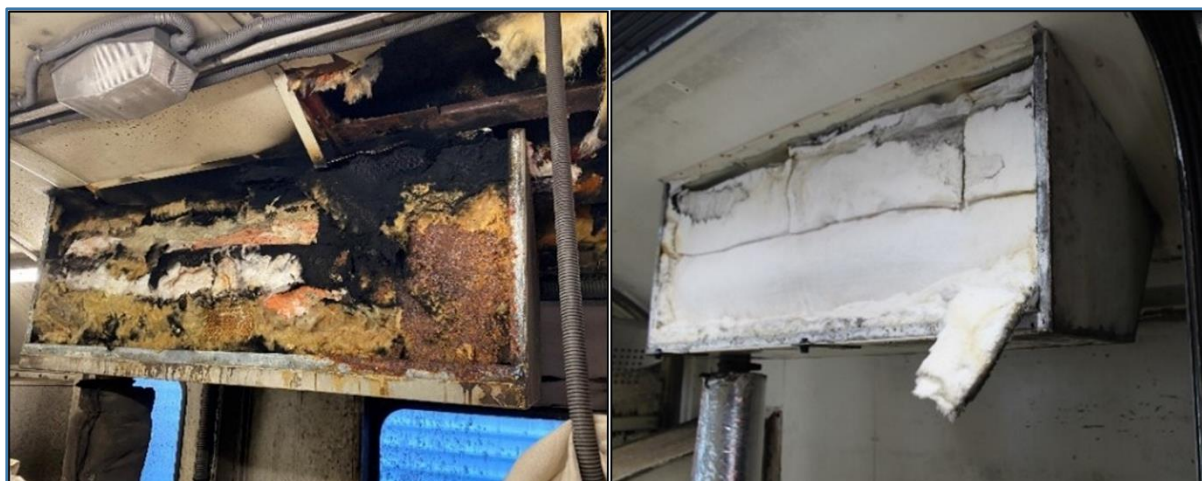
**Figure 7: Top boxes of AG130 (left) and AG176 (right) showing condition of insulation**  
(Credit: Fire and Emergency New Zealand)

2.39 When the top boxes of the three AG wagons were opened and inspected the soundproof material in AG130 showed signs of significant soot build-up between the layers (see Figure 7).

- 3.4 When the top box of AG130 was opened, investigators found the insulation material was in poor condition and contained a significant amount of soot. Although soot deposits in the top right of the top box may have been produced during the fire, it is **almost certain** that those in the centre and lower left of the top box were formed before the fire.

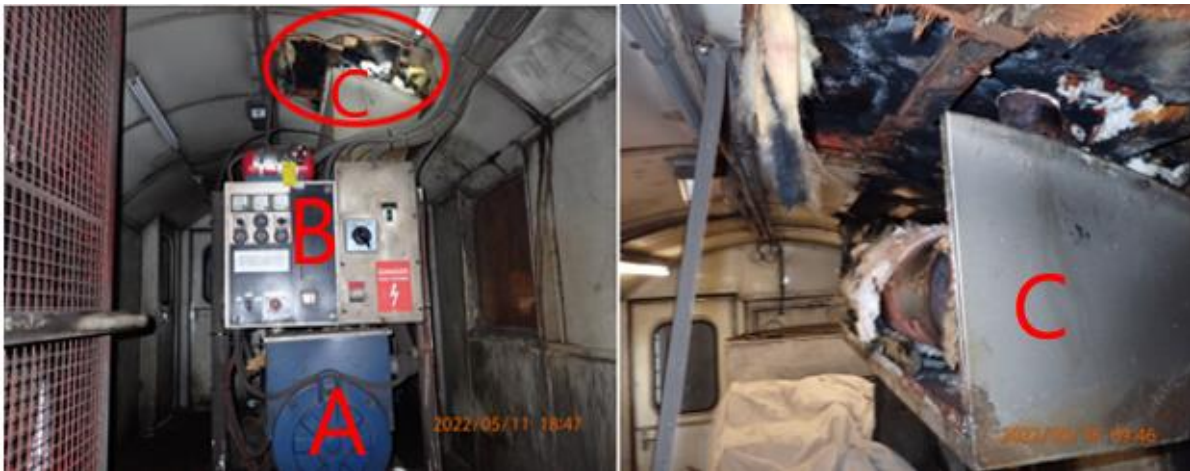
**Figure 8: The AG130 auxiliary generator set after the incident**

2.47 The fire was confined to the auxiliary generator set enclosure<sup>16</sup> of AG130, affecting the exhaust system and the ceiling of the wagon. There was smoke damage throughout AG130 (see Figure 8).

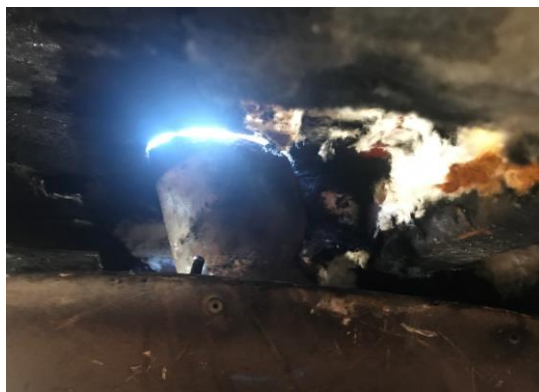
**Figure 9: Daylight visible where exhaust tail pipe met ceiling of AG130**

- 3.2 Commission investigators inspected the exhaust systems of three different AG wagons, including the AG130. Investigators found that the AG130 exhaust tail pipe no longer extended through the ceiling, and daylight was visible from inside the wagon (see Figure 9).

- 3.7 It is **virtually certain** that the likelihood of a fire on board AG130 increased because of a combination of the following factors:
- the insulation within the top box was in poor condition, containing soot build-up
  - the exhaust tail pipe had corroded and did not extend through and above the roof of AG130
  - the top box was sealed closed and could not be opened for maintenance or inspection.

- 5.3 In August 2022, KiwiRail informed the Commission that:
  - The 12 monthly maintenance check for the Capital Connection fleet including AG vans was updated in August 2022 to include the following:
    - Check motor generator exhaust extends above the roof
    - Check motor general exhaust rain flap is working
    - Open muffler compartment every year ending with 0 or 5 e.g. (2025 or 2030)
    - Inspect muffler, and exhaust pipe condition for damage, holes, corrosion, signs of exhaust leaks
  - The 1250 km maintenance check for the fleet was updated in October 2022 to include:
    - Check exhaust system and muffler box for signs of exhaust leakage, i.e. signs of soot.
    - Check for fuel, water and oil leaks.
- 5.4 The Commission considers these safety actions have addressed the safety issue identified, and therefore no recommendation has been made.

- 6.3 On 25 October 2023, the Commission recommended that KiwiRail install smoke and fire detection systems in all auxiliary generator wagons in service to alert train crew and passengers to a fire at the earliest opportunity. **(039/23)**
- 6.4 On 13 November 2023, KiwiRail replied:

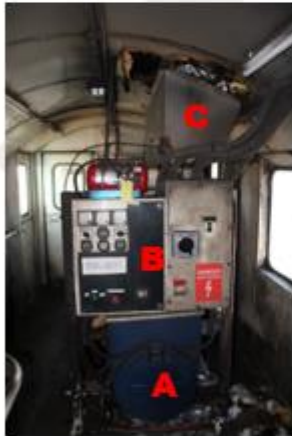
Photo 1.

Firefighters removed part of the ceiling to ensure that the fire had not extended to other parts of the ceiling, debris can be seen on the deck around the genset.

The fire extinguisher system installed on the genset with the extinguisher cylinder on top of the control panel did not activate as the activation sensors were on the genset, not the rest of the carriage.

View of genset from internal entry to compartment.

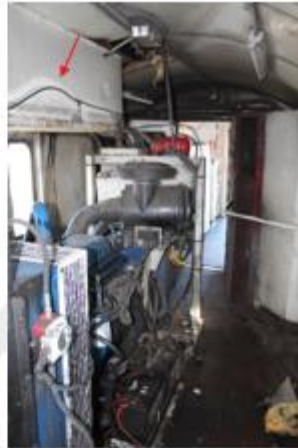
Opposite end of the genset shown in Photo 1.

Visible in Photo 2 is the tubing and one of the nozzles for discharging the extinguishing media. It is visible that the discharge tubing is remote from the fire area.

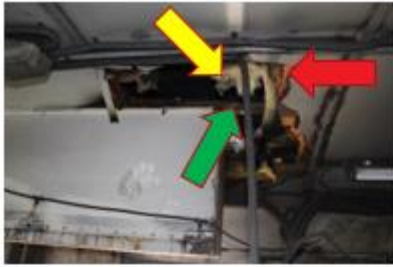
*Photo 3.*

*Red arrow indicates plywood type material.  
Yellow arrow indicates insulation material.  
Green arrow indicates steel frame of roof structure.*

It was also noted that the ceiling lining appeared to be a veneer and plywood combination.

It was not possible to identify how close this ceiling material and insulation were installed to the exhaust pipe where it penetrated through the outer roof prior to the fire.

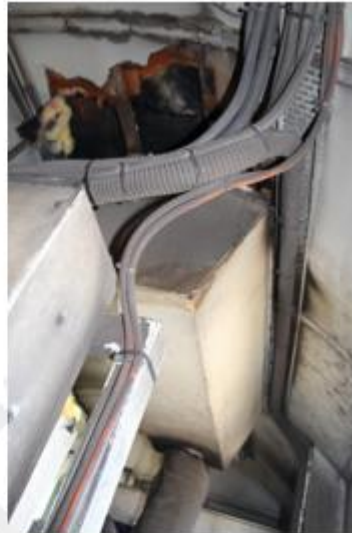
*Photo 4.*

*Cabling in vicinity of the fire area.*

The cabling that ran to/from the genset control panel and the genset appeared to have been unaffected by the fire, apart from sooting visible to the exterior of the cables.

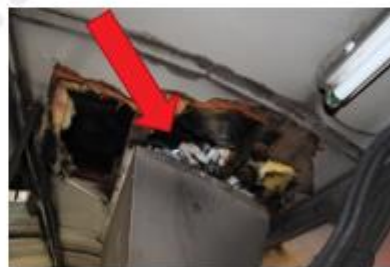
*Photo 5.*

*Arrow indicates daylight visible.*

*Note condition of electrical cables.*

During the initial examination daylight was observed through the space where the fire had occurred. This indicated that the

exhaust pipe was potentially missing above the outer roof level.

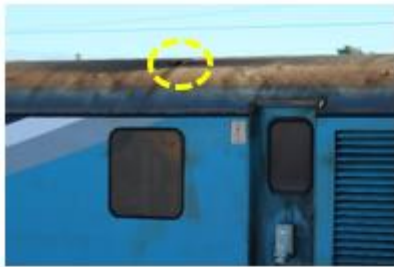
Photo 6.

Yellow circle indicates location where exhaust had previously passed through outer roof lining.

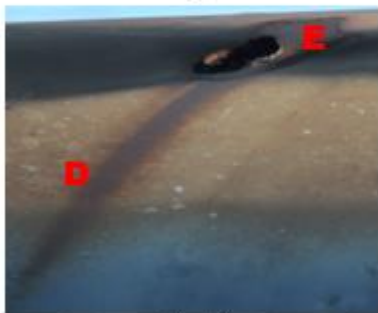
Photo 7.

Close up view of external exhaust and roof.

A closer examination of the roof of AG130, using a camera and telephoto lens, revealed that the exhaust pipe did not extend beyond the outer roof. Further, the photo shows an area where there appears potentially 'rusty water' has stained the roof below the exhaust pipe. Additionally, above the exhaust pipe there was an area of the roof which appeared to have been heated which had affected the surface. Following the relocation of AG130 to the Wellington Rail Yards, under impound,

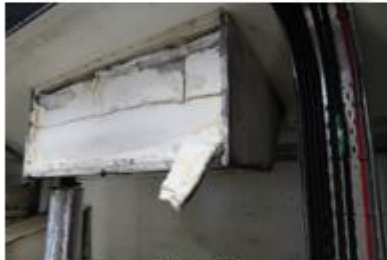
*Photo 12.*  
*External access cover of exhaust silencer enclosure removed from AG176.*  
IMG\_2114.jpg

Once the external access cover to the exhaust silencer enclosure was removed some sooting was visible on the insulation.

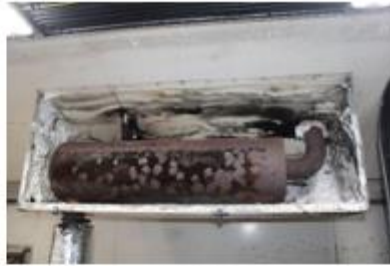
*Photo 13.*  
*Part of the insulation removed from the exhaust silencer enclosure removed from AG176.*  
IMG\_2117.jpg

With the removal of the insulation it was apparent that there had been sooting to the ceiling of the enclosure and to the insulation material. This sooting may indicate either a leak in the exhaust system or exhaust products re-entering the enclosure.

The general state of the silencer was noted with surface rusting which was also visible on the tail pipe.

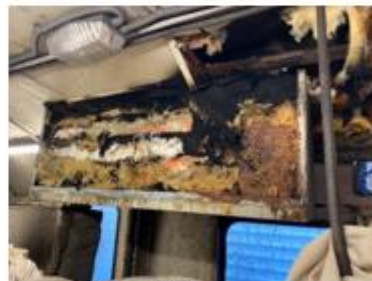
*Photo 14.*  
*Exhaust silencer enclosure AG130.*  
Part of IMG\_2939.jpg

the state of the insulation was apparent. The enclosure structure showed signs of rusting, potentially indicating prolonged water ingress.

The insulation material also showed signs of sooting throughout. The sooting in the upper right side may be as a result of the fire, however the sooting to the middle and left lower areas is less likely to be due to the fire and may be due to exhaust gas leakage over time.

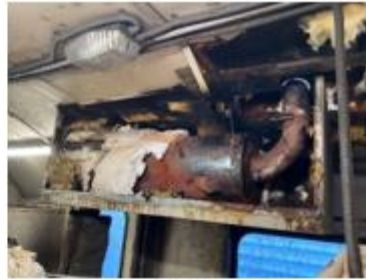
Photo 15.  
Exhaust silencer enclosure less insulation material AG130.  
IMG\_2951.jpg

Following the removal of insulation material, the exhaust end of the silencer became visible and the extent of damage to the external portion of the 'tail pipe' became visible.

Daylight was visible around the top of the 'tail pipe' as visible in Photo 15.

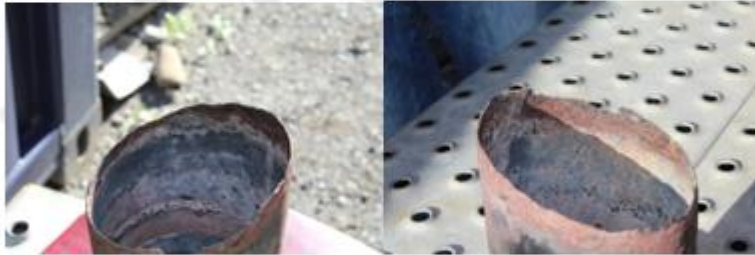
Photo 16.  
Exhaust 'tail pipe' from AG130.  
IMG\_2182.jpg

Photo 17.  
Exhaust 'tail pipe' from AG130.  
IMG\_2184.jpg

Once removed from the roof of AG130 the condition of the exhaust 'tail pipe' became visible. The above photos show the condition inside the 'tail pipe' and the external condition.

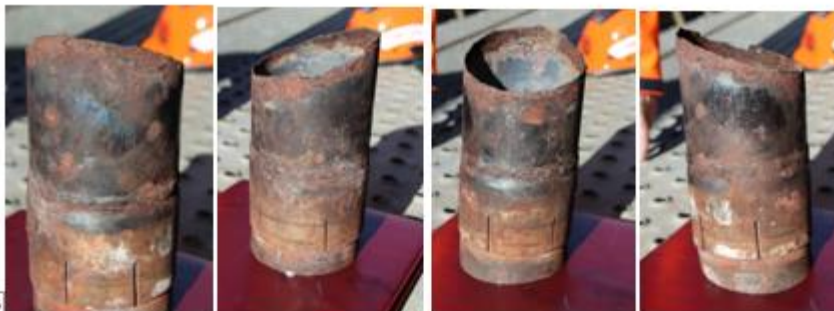
Photo 18 Exhaust 'tail pipe' from AG130. IMG\_2188.jpg  
 Photo 19. Exhaust 'tail pipe' from AG130. IMG\_2189.jpg  
 Photo 20. Exhaust 'tail pipe' from AG130. IMG\_2190.jpg  
 Photo 21. Exhaust 'tail pipe' from AG130. IMG\_2191.jpg

The irregular pattern of damage to the 'tail pipe' would appear to be potentially age related. There were no visible cut marks which would likely be linear. Additionally, the degree of surface rusting and thinning of the wall thickness most likely indicates that this is the effect of corrosion and is a time related event.

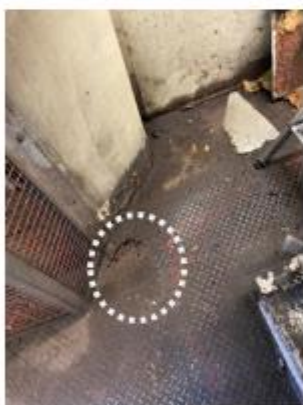
Photo 22  
 Floor of AG130 adjacent to the genset.  
 White circle indicates rust area.  
 IMG\_2970.jpg

It was noted that the floor of AG130 adjacent to the genset control panel had rusted through.
