Transport Accident  
Investigation  
Commission

# **Final report**

***Rail inquiry RO-2022-102***  
***L71 Mainline Shunt***  
***Derailment and subsequent rollover***  
***Tamaki***  
***1 June 2022***

**December 2023**

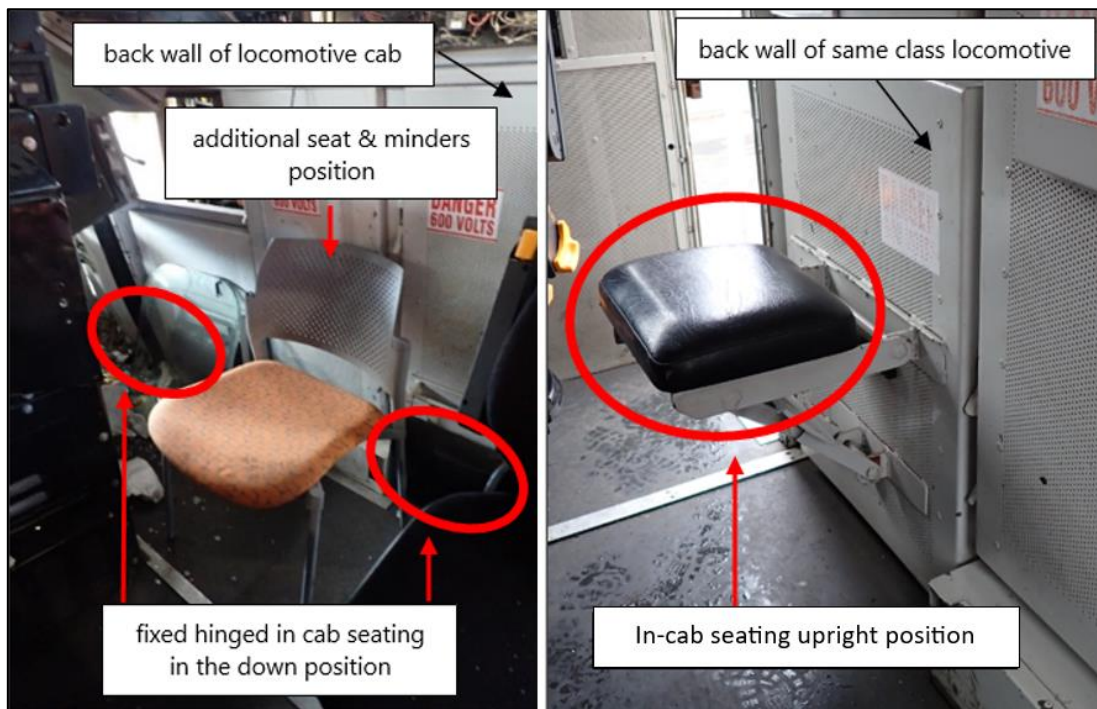
**Figure 6: Chair used as additional in-cab seating (left) and unused inbuilt hinged seating (right)**

- 3.38. Before departing Westfield, the LE placed a lunchroom chair in the locomotive cab for the minder to sit on during the shift. The Commission found that the use of removable chairs is common practice when more than two people are travelling in a locomotive cab. There is no policy on the use of additional seating in locomotive cabs.

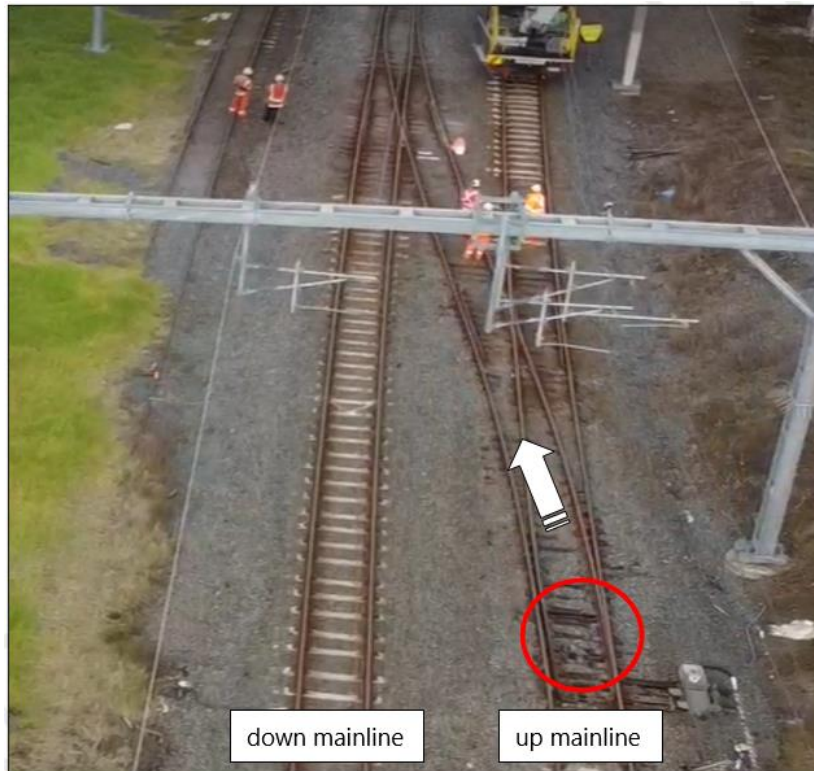
**Figure 14: Crossover points set to bring the locomotive from the up mainline onto the down mainline.**

- 2.22. At approximately 0103, the locomotive passed signal 507 at a speed of 76.8 km/h, rather than the required 25 km/h. The locomotive travelled a further 153m before entering a set of crossover points directing the locomotive from the up mainline across to the down mainline (see Figure 14).

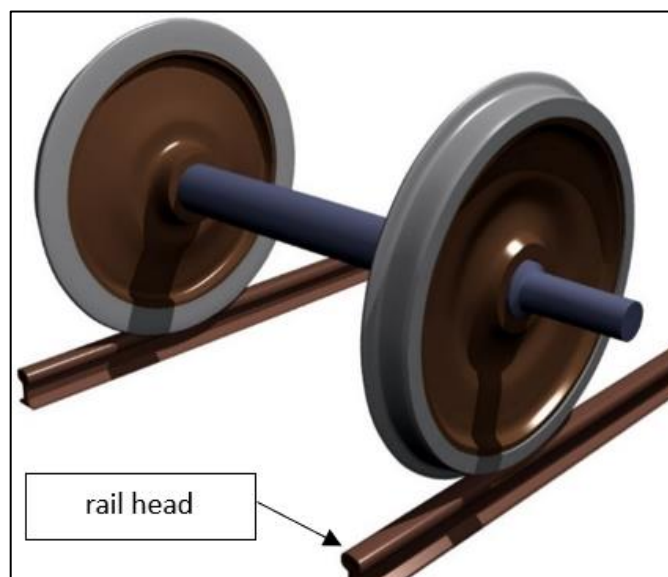
**Figure 15: Locomotive wheelset connection to the rail head**

- 2.23. As the locomotive entered the crossover points, it rolled heavily to the right, lifting the locomotive off the left-hand side of the rail head and disengaging the locomotive's wheel sets from the track (see Figure 15).

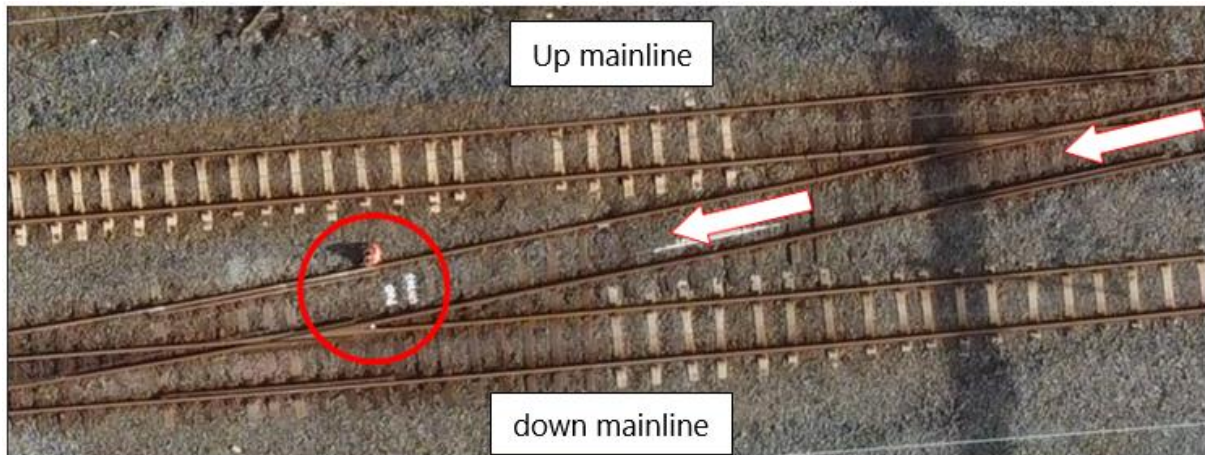
**Figure 16: Point of derailment**  
(Credit: KiwiRail)

2.24. The locomotive then fell back onto the rail head, immediately before the frog junction (circled in red in Figure 16).<sup>8</sup> The locomotive then fell further to the left and entirely off the track.

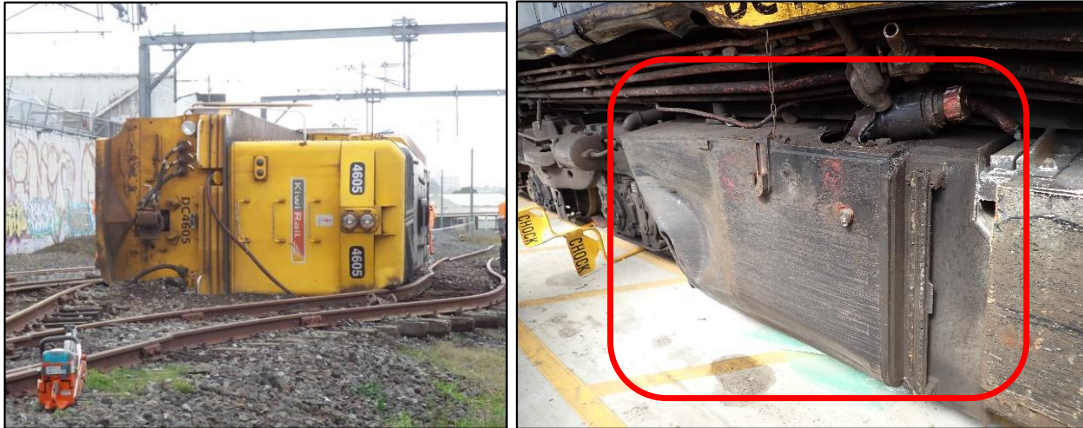
**Figure 18: Position of locomotive following derailment (left) and ruptured fuel tank (right)**

- 2.27. The locomotive slid a further 55 m on its side. The LE's side window shattered, allowing rail track ballast and spoil to enter the cab. The locomotive fuel tank ruptured, and the filling nozzle broke off, spilling diesel on to the ground (see Figure 18).
- 2.28. The locomotive came to a complete stop wedged between the down mainline and the adjacent track.

- 2.37. The locomotive's fuel tank ruptured when it rolled over, allowing approximately 1800 litres of diesel to be spilled under the overturned locomotive and surrounding area.

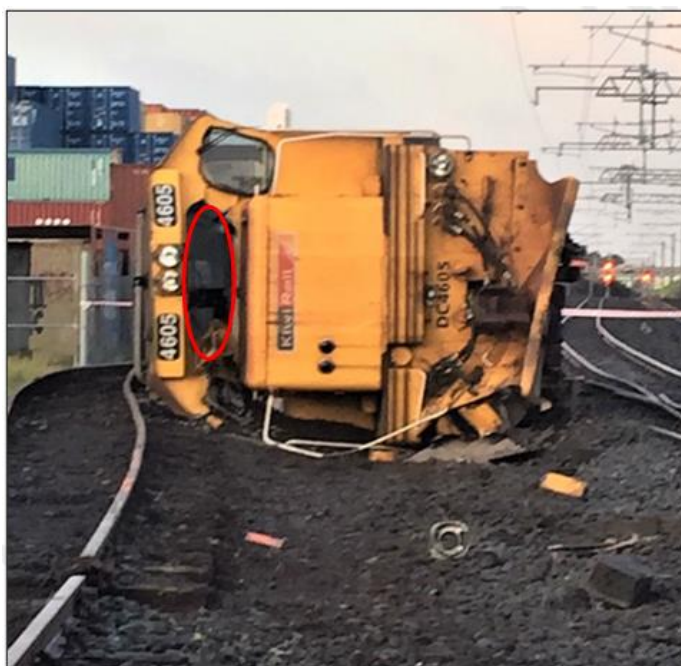
**Figure 20: Locomotive following derailment, showing window through which crew exited.**

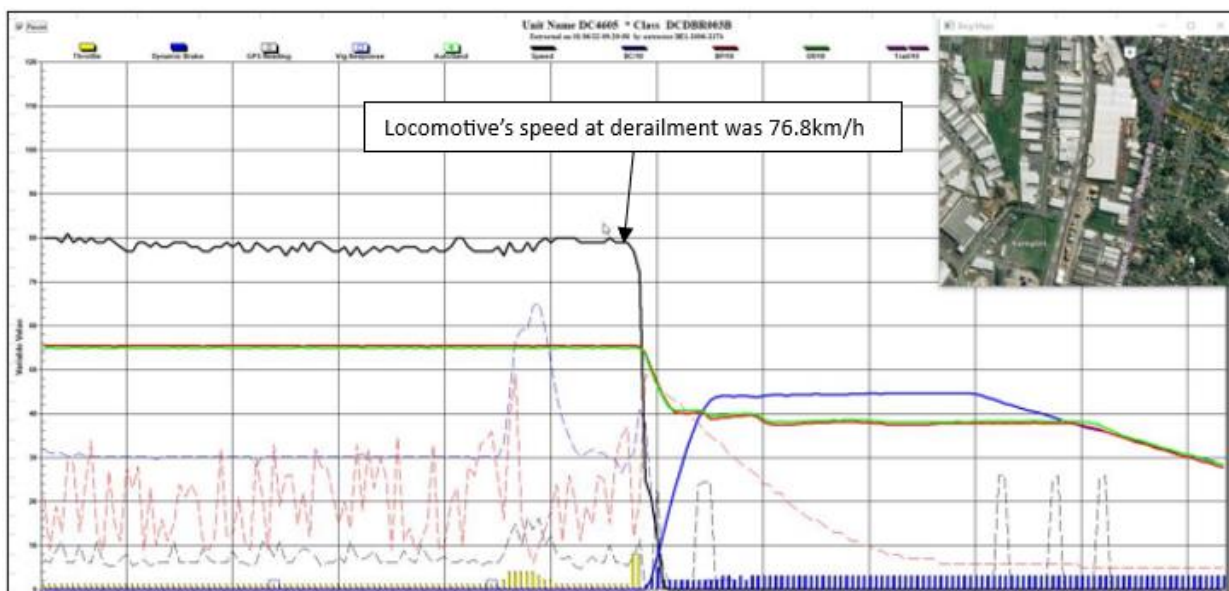
**Figure 22: Tranzlog data showing point of derailment**  
(Credit: KiwiRail)

2.48. The locomotive was fitted with a Tranzlog data recorder (see Figure 22).<sup>13</sup> This confirmed that the speed inputs and train handling control made by the LE were in accordance with the signal information given to them by the trainee.

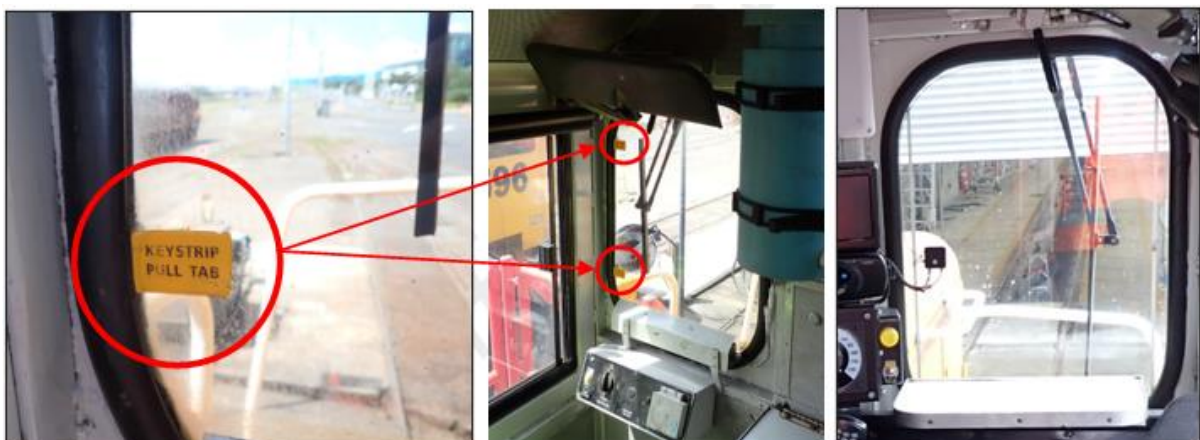
- 3.46. KiwiRail did not provide training to staff on how to escape from the cab of a locomotive that had derailed onto its side.
- 3.47. The Commission found that because of the size of the emergency escape windows in the locomotive cab, none of the train crew would be unable to escape if required to do so.
- 3.48. The emergency escape windows were operated by pulling on keystrip pull tabs to release the rubber tube and remove the glass panel. The keystrip pull tab stickers, located on the inside of the cab window, were ambiguous and could cause confusion in an emergency, as the actual location of the tab was outside of the window (see Figure 24). This requires a crew member to extend their arm outside of the side window and reach around to the front of the locomotive in order to pull the tab to release the rubber tube and remove the glass panel (see Figure 25).

Figure 24: Keystrip pull tab locations (left/centre), window with no tabs (right).

- 6.6. On 25 October 2023, the Commission recommended that KiwiRail provides first aid training and evacuation training to all rail personnel that work in rail vehicles. **(037/23)**
