Transport Accident
Investigation
Commission

Final report

Rail inquiry RO-2022-103
KiwiRail W6 shunt and Metro (Go Bus) Route 60
bus
Near miss at Selwyn Street level crossing
Christchurch
08 August 2022

October 2023

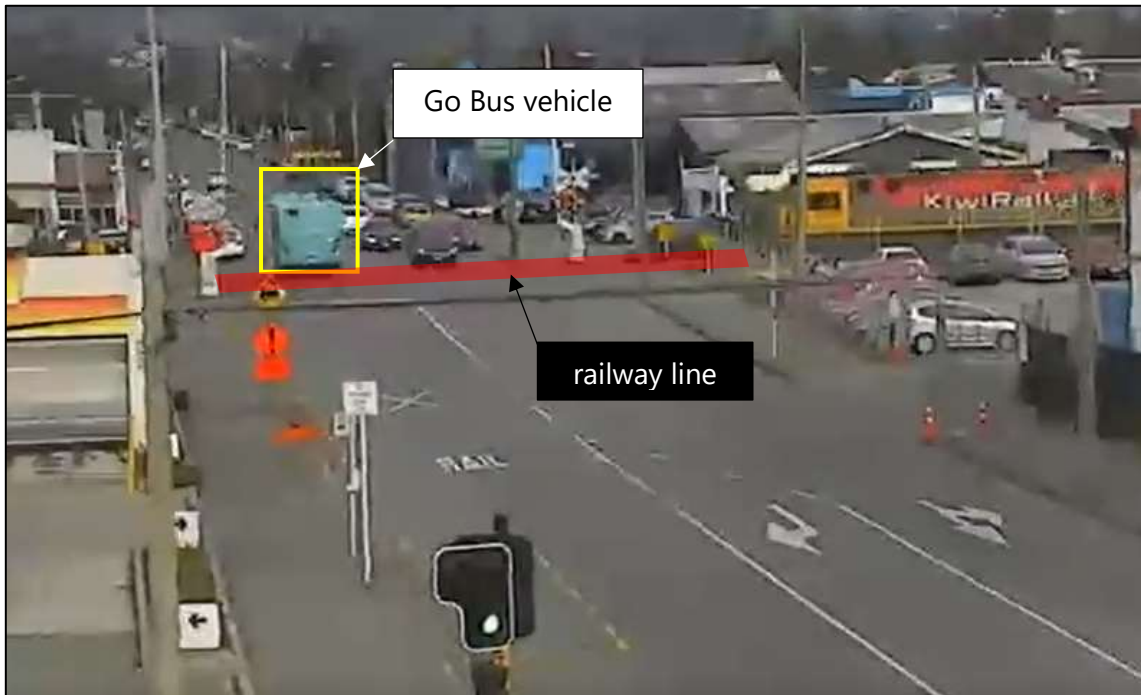
Figure 1: Locomotive DXB 5137 approaching Selwyn Street level crossing as Route 60 Go Bus vehicle exits the crossing

- 1.4. On Monday 8 August 2022, while the level crossing remained disconnected, a 'Go Bus'-operated Christchurch Metro passenger bus drove across the Selwyn Street level crossing as a KiwiRail locomotive approached. The bus passed approximately 12 metres in front of the locomotive, creating a 'near-miss' situation. There was no collision, no damage and no injuries.

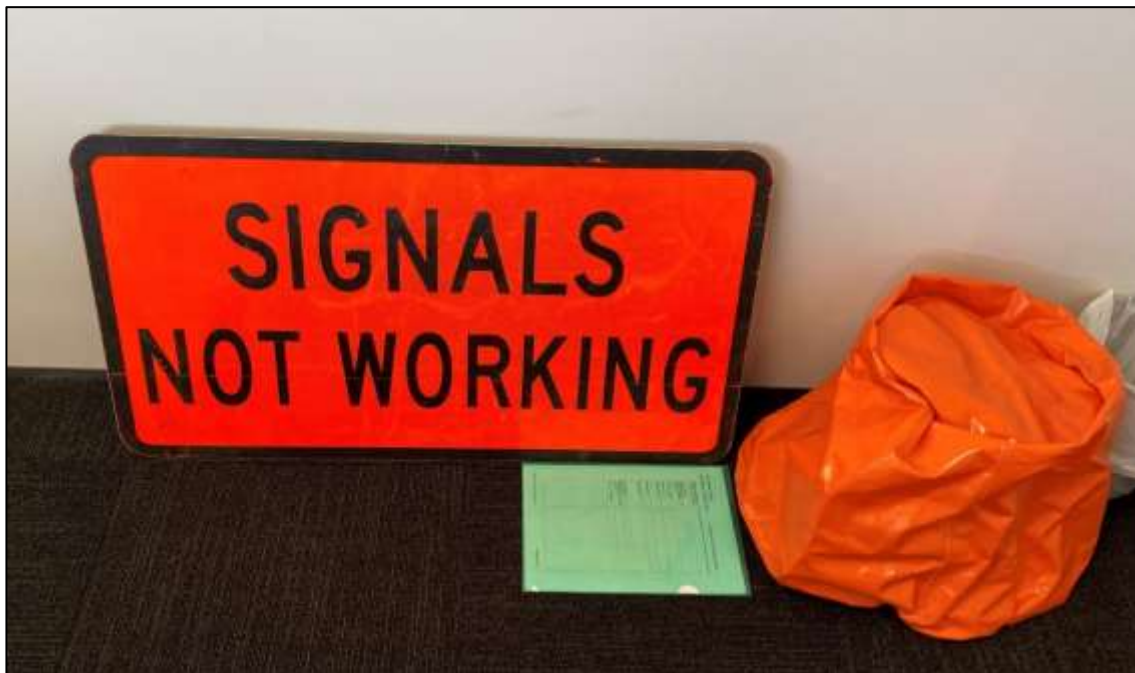
KiwiRail's Signals and Telecommunications task instructions (see Appendix 1). The procedure involved imposing a 10 km/h speed restriction for rail traffic (which had already been done), pulling the fuses that power the bells, lights and barriers, tying up the barrier arms, placing high-visibility orange bags over the warning lights, and placing 'signals not working' signage (see Figure 3).

Figure 3: Sign and bag used when level crossing is disconnected

- 3.22. However, when the level crossing alarms and barrier were disconnected, the signs and covers required by KiwiRail's Task Instructions were inadequate to alter the habits of road users accustomed to the normal day-to-day conditions at the Selwyn Street level

- 6.3. On 27 September 2023, the Commission recommended that KiwiRail adequately address the risk posed by disconnecting level crossing protections, whether planned or unplanned. **(031/23)**
- 6.4. On 27 September 2023, the Commission recommended that KiwiRail work with road controlling authorities to develop processes for notification, risk assessment and traffic management measures for unplanned level crossing disconnections. **(032/23)**
- 6.5. On 16 October 2023, KiwiRail replied:

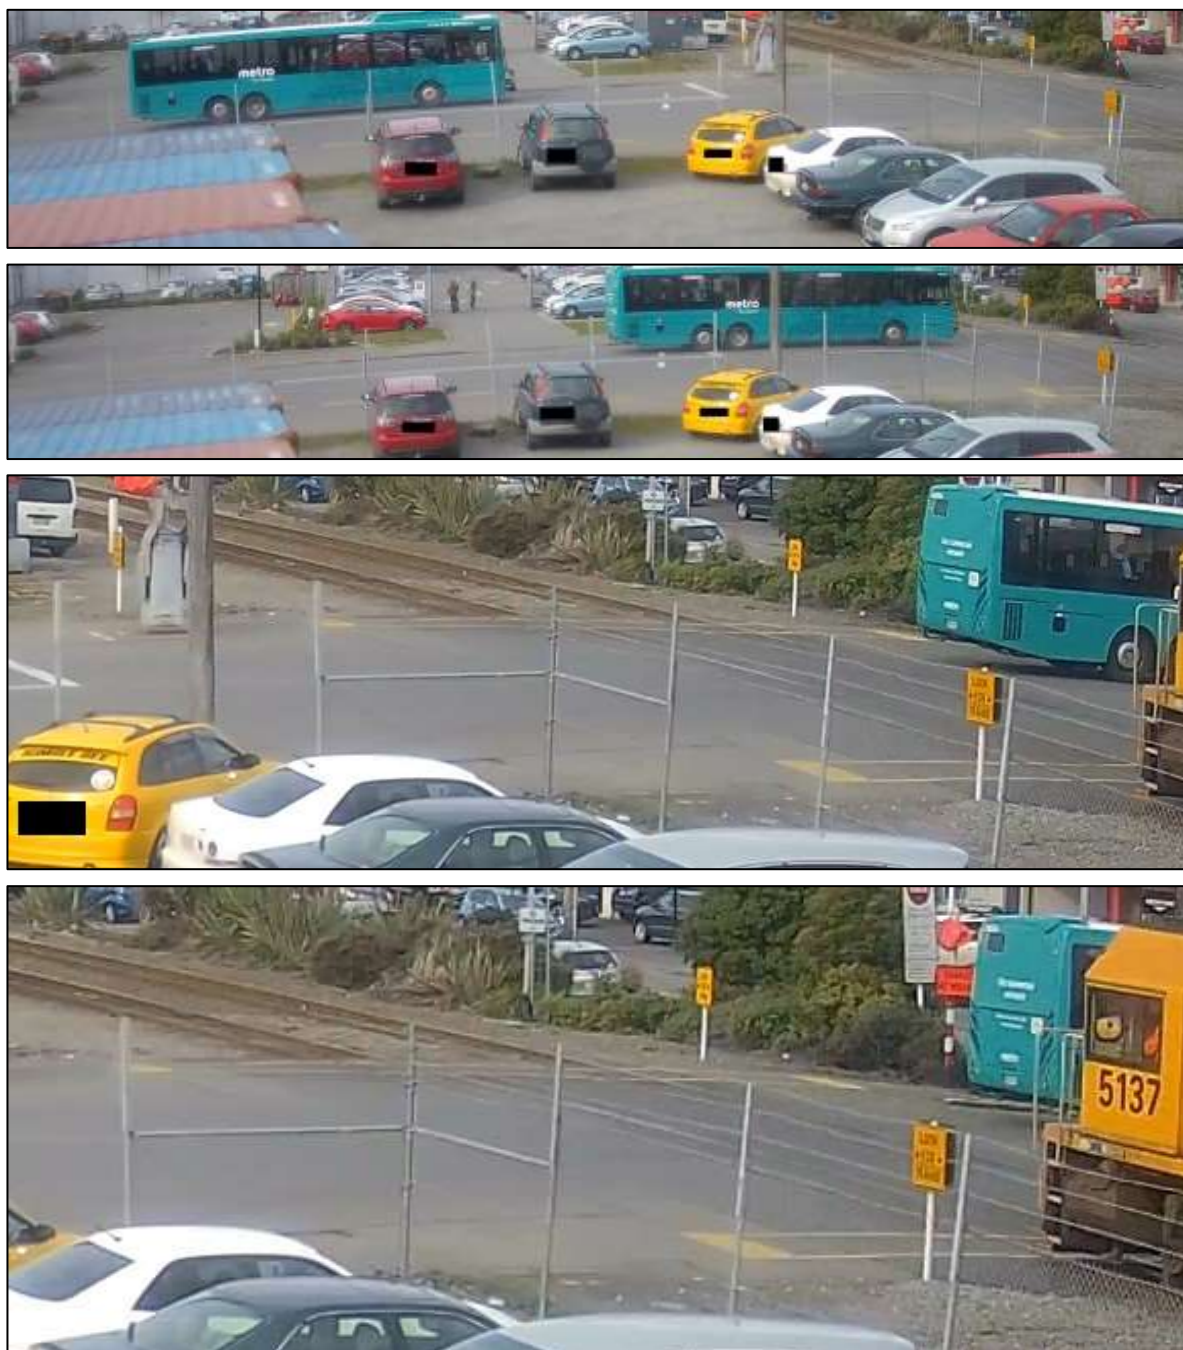
- 2.21. At 1435 on Monday 8 August, with the Selwyn Street level crossing still disconnected, the driver of W6 Shunt, consisting of DXB class locomotive 5137 and DXR class locomotive 8022, contacted train control to inform them that a bus had just driven across the front of the train at the Selwyn Street crossing. The train driver reported that the bus did not appear to slow down at all.
- 2.22. Figure 4 shows still images of the near miss from CCTV¹² footage captured by a security camera located at a neighbouring business.

Figure 4: Sequence of images of the bus approaching, crossing and clearing Selwyn Street level crossing

- 3.3. When a passenger bus traversed the Selwyn Street level crossing in front of an approaching locomotive, a potentially tragic accident was avoided by a matter of metres and by seconds. The bus driver did not realise that there was any danger, nor did they realise that a near miss had occurred. This analysis describes the measures taken to make level crossings safer, and the factors that led to unsafe conditions at the level crossing when the near miss occurred.

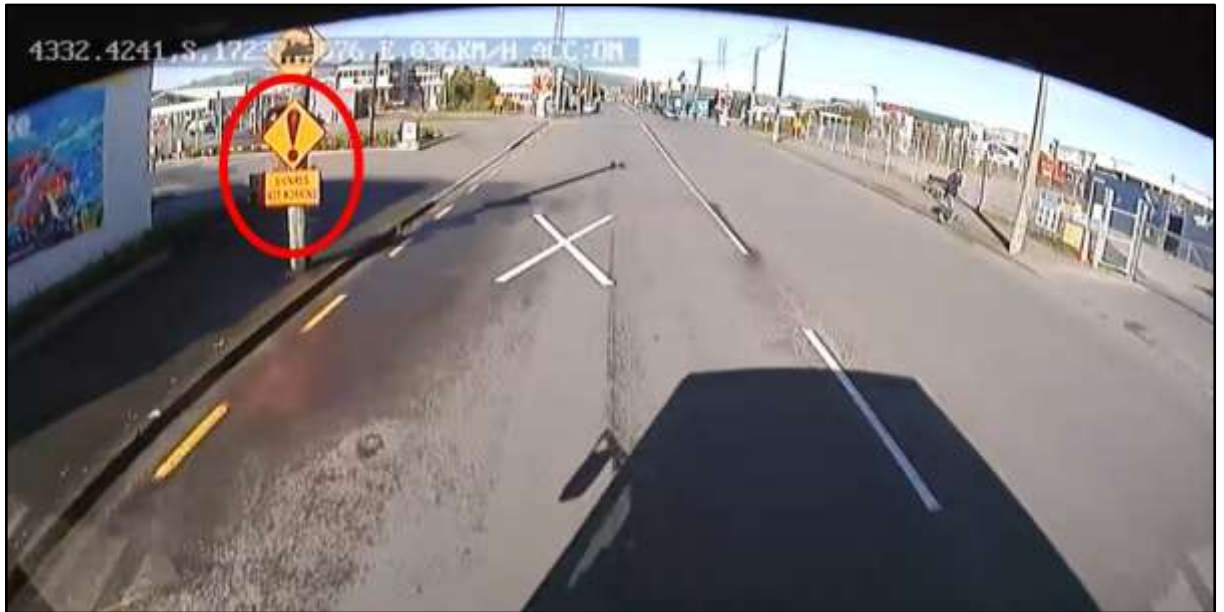
- 2.31. CCTV footage of the incident was obtained from Waka Kotahi NZ Transport Agency (Waka Kotahi) and a local business. The bus involved in the incident had a CCTV camera installed. On the day of the incident, the CCTV camera was not working. Go Bus provided footage from another bus on the same route so that the investigation team could determine the positions and visibility of signage at the Selwyn Street level crossing (see Figures 5 and 6).

Figure 5: Bus driver's view approaching level crossing – 'signals not working' signage

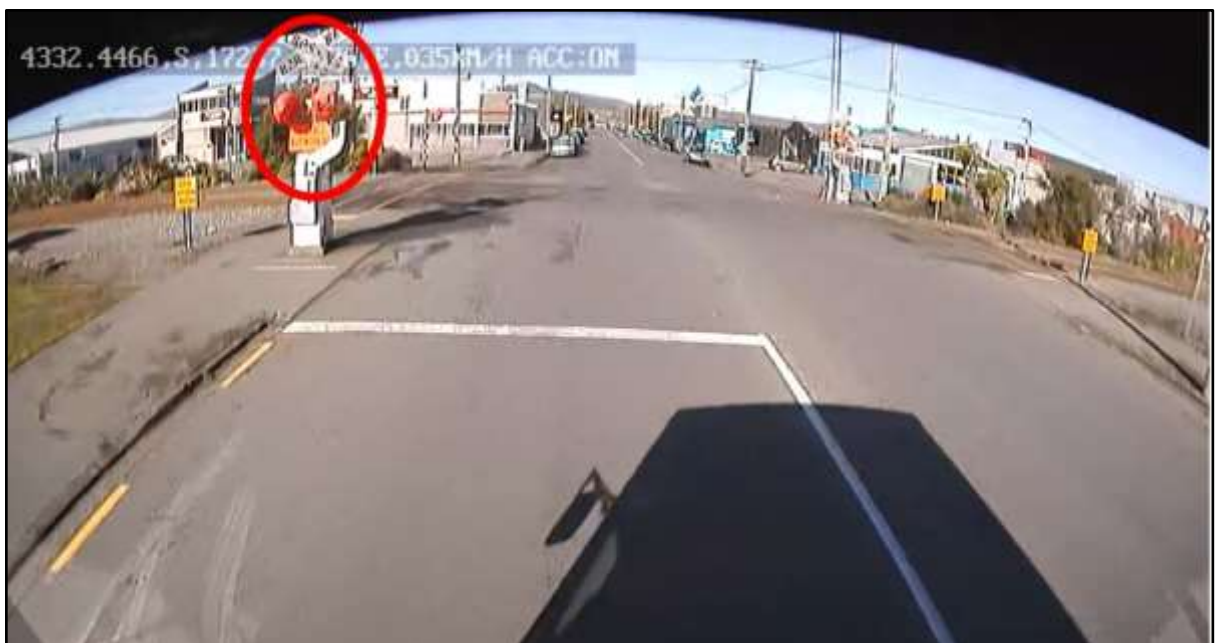
Figure 6: Bus driver's view approaching level crossing – warning lights bagged

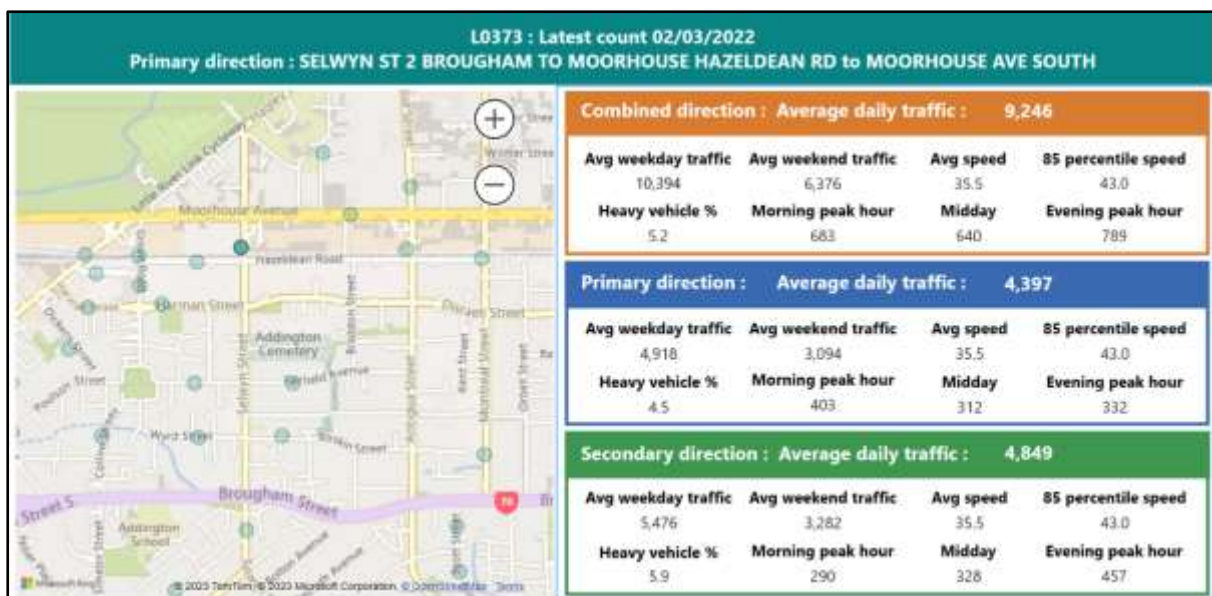
- 3.28. Figures 7–9 show traffic counts in the vicinity of the Selwyn Street level crossing up to March 2022. At the time of the incident this was the latest count available on CCC’s traffic count data website²⁷. Figure 7 shows the traffic count, while Figures 8 and 9 show the recorded north and southbound speeds of that traffic.

Figure 7: Traffic link counts database
 (Credit: Christchurch City Council)
