Transport Accident
Investigation
Commission

Final report

Rail inquiry RO-2023-101
Hi-Rail vehicle collision near Te Puna
86.43 km East Coast Main Trunk line
10 January 2023

April 2024

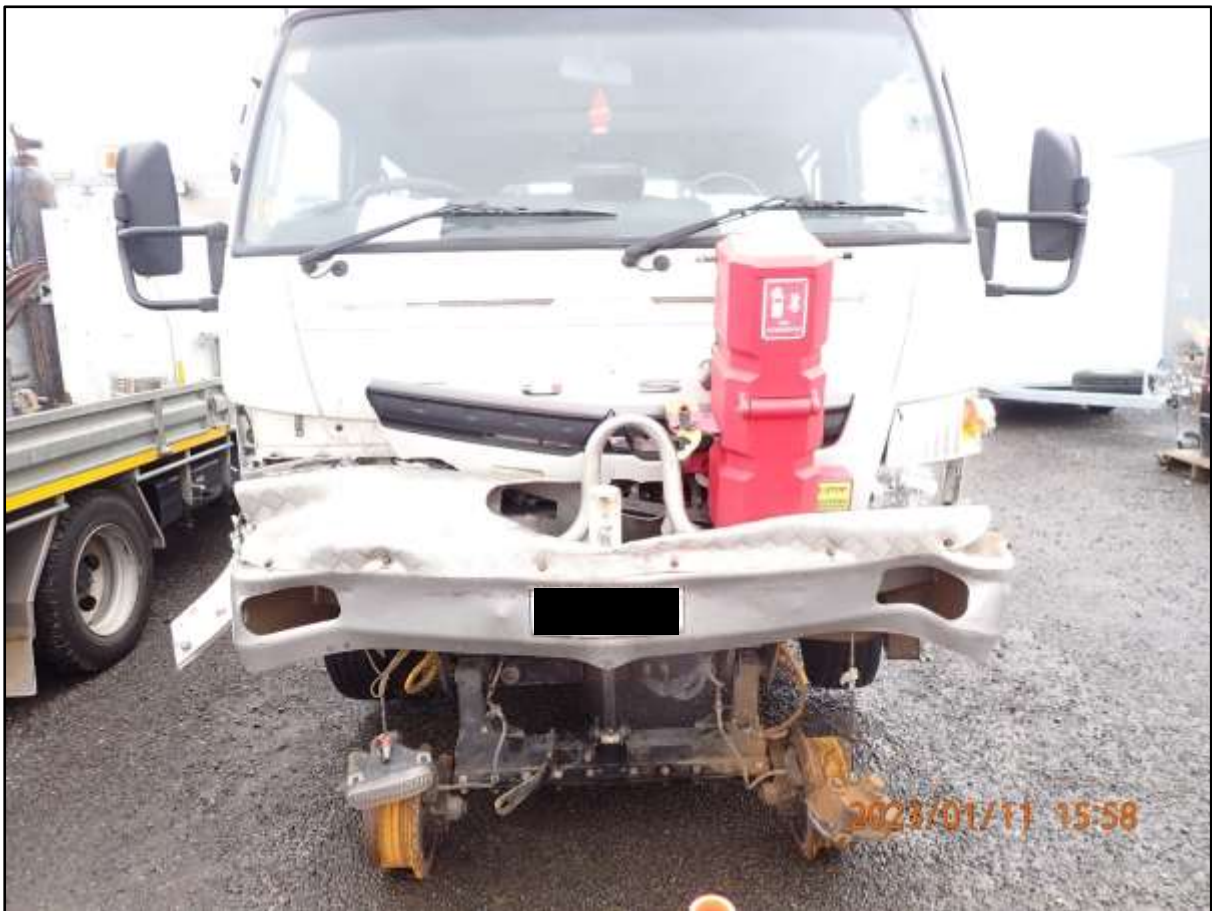
Figure 2: Hi-Rail vehicle 2 (HRV2) showing collision damage

2.28. HRV2 received substantial damage to the front of the vehicle and to the retractable Hi-Rail equipment.

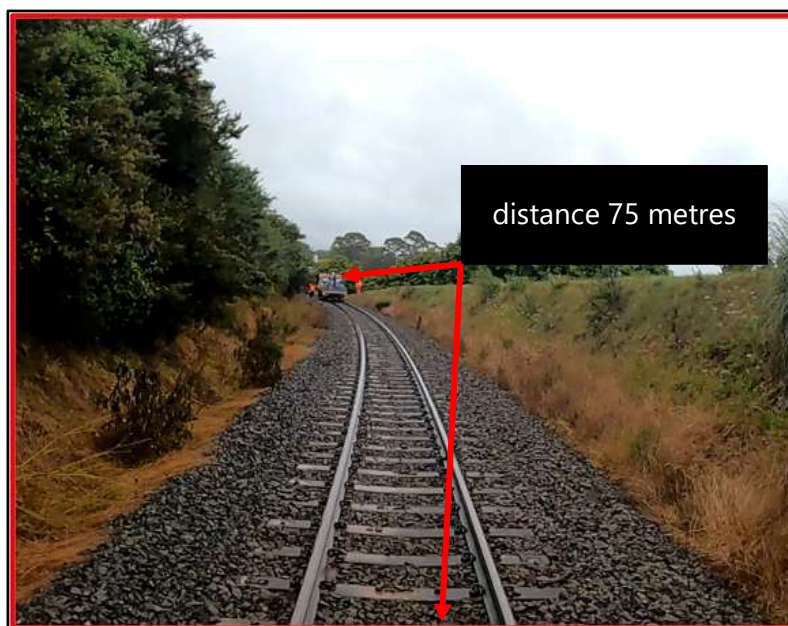
- 2.11. At about 0711 the Ganger stopped HRV1 to mark a section of the track with spray paint. The Ganger and TW1 left the cab of HRV1 and were standing on the ballast¹² in front of the vehicle.
- 2.12. The Ganger stated that on stopping they made a call on the radio to inform HRV2 that HRV1 had stopped. No response or acknowledgement was received for this radio call from HRV2 and the occupants of HRV2 both stated that they did not hear a call on the radio.
- 2.13. At 0712 TW2, the driver of HRV2, which was travelling at approximately 38 km/h, was not aware that HRV1 had stopped. On seeing the vehicle after rounding a bend and realising that HRV1 was not moving, TW2 attempted to stop HRV2 but was unable to do so before it collided with the rear of HRV1 (see Figures 6 and 7).

Figure 6: First clear sight line between HRV1 and HRV2 (re-enactment)

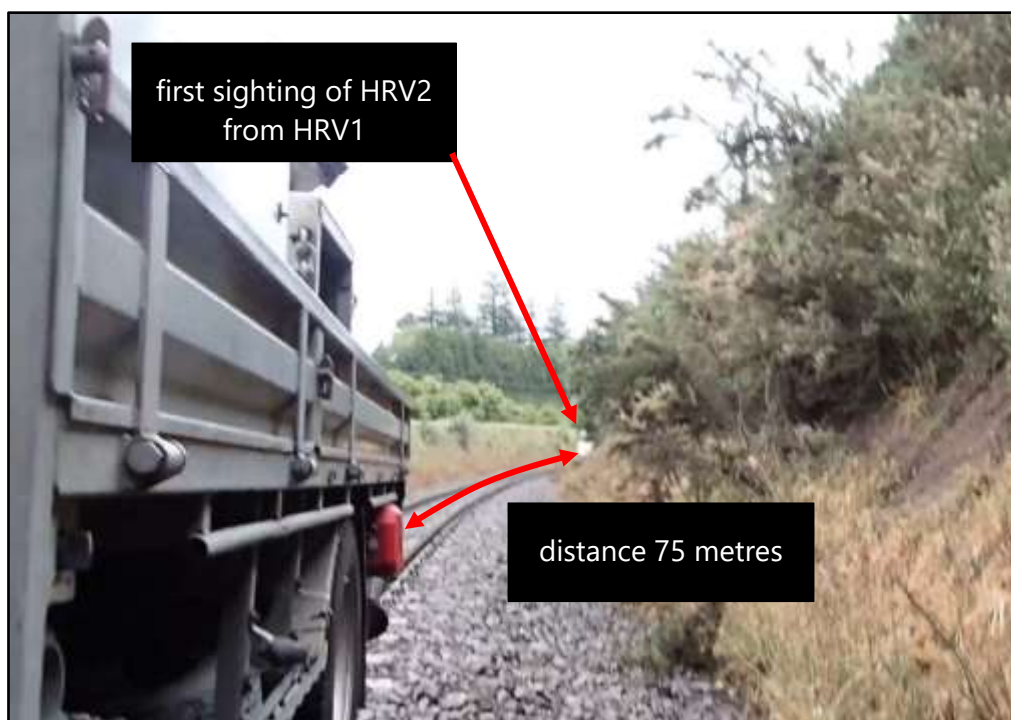
Figure 7: Reverse view from HRV1 (re-enactment)

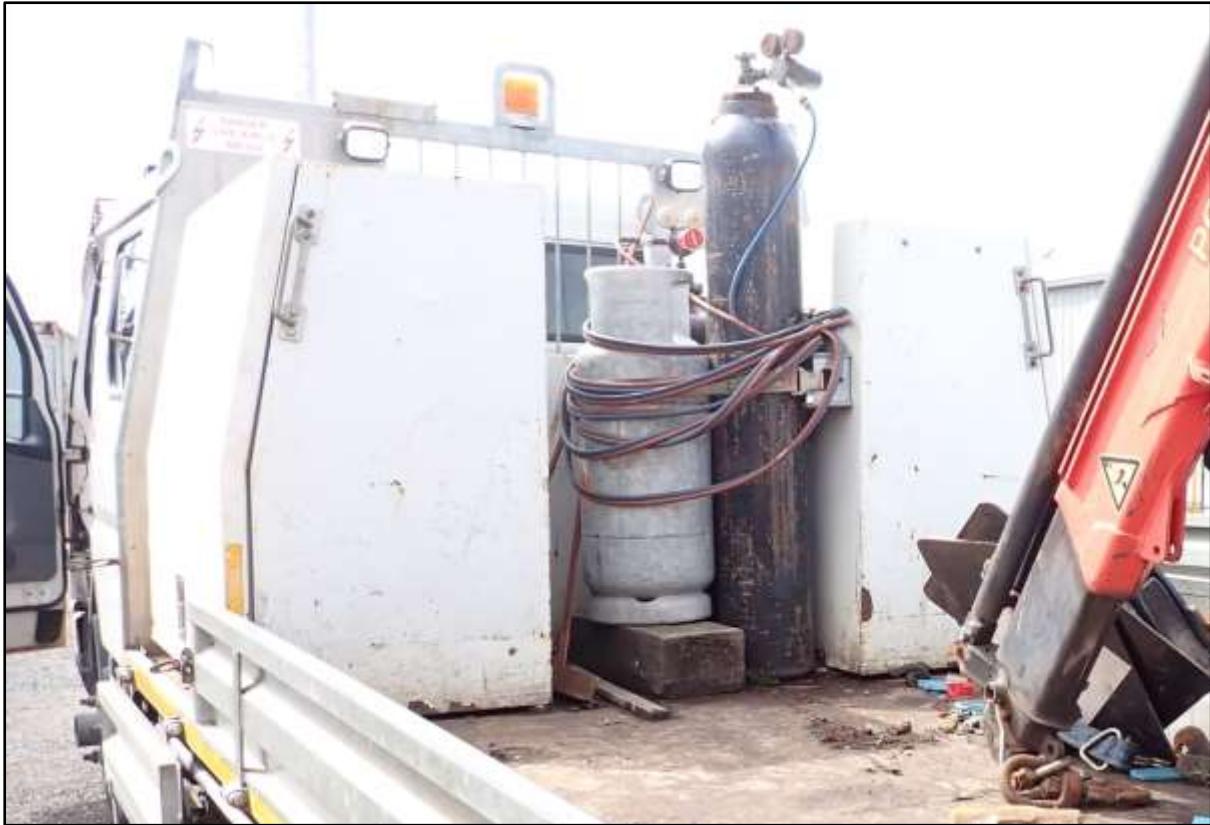
- 3.55. The Commission found that on impact the four 8mm steel bolts that secured two metal cabinets containing heavy equipment were shorn from their mountings on the deck of HRV1.
- 3.56. The Commission also found that tanks containing flammable welding gas were not secured sufficiently on the deck of HRV1 and were attached to the metal cabinets that became unsecured when the bolts were shorn off during the collision (see Figure 10).

Figure 10: Gas bottles secured to metal cabinets on deck of HRV1

- 3.57. This collision between the two HRVs occurred at a relatively low speed, and with little resistance when HRV1 began moving on impact.
- 3.58. The Commission is concerned that had one of the HRVs, which can travel on both rail and road, been involved in a rail incident at a higher impact speed the consequences of the load being unsecured could have been serious.
- 3.59. Although the unsecured load was not contributory to this accident, there is a **key lesson** for personnel involved with the loading of rail vehicles, including HRVs, that they should ensure the security of loads before travel to mitigate the consequences of a collision.
