Transport Accident  
Investigation  
Commission

# **Final report**

***Rail inquiry RO-2023-102***  
***Freight train 360***  
***Derailment***  
***Te Puke***  
***29 January 2023***

**June 2024**

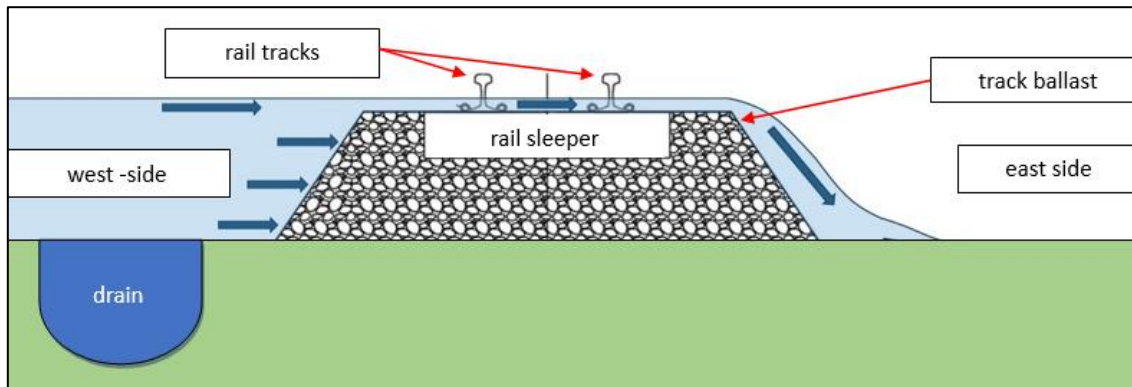
- 2.29. The crew disembarked from the locomotive and began walking towards the rear of the train. When they arrived at the fifth wagon, they realised that they could not see the remaining 34 wagons. From their location, they could see that the track's formation<sup>27</sup> had washed down the embankment (see Figure 6).

**Figure 6: Diagram of track formation and water loading**

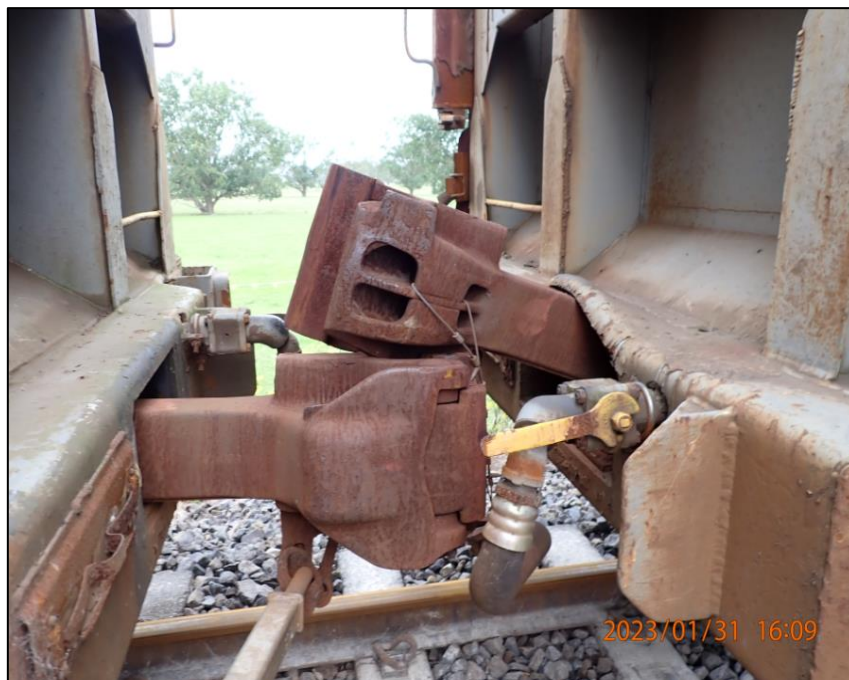
- 2.30. On inspection, the crew found that four of the five wagons remaining with the locomotive had decoupled (see Figure 7), leaving only one wagon still connected to the locomotive. The crew then returned to the cab of the locomotive.

**Figure 7: One of the four decoupled wagon connections.**

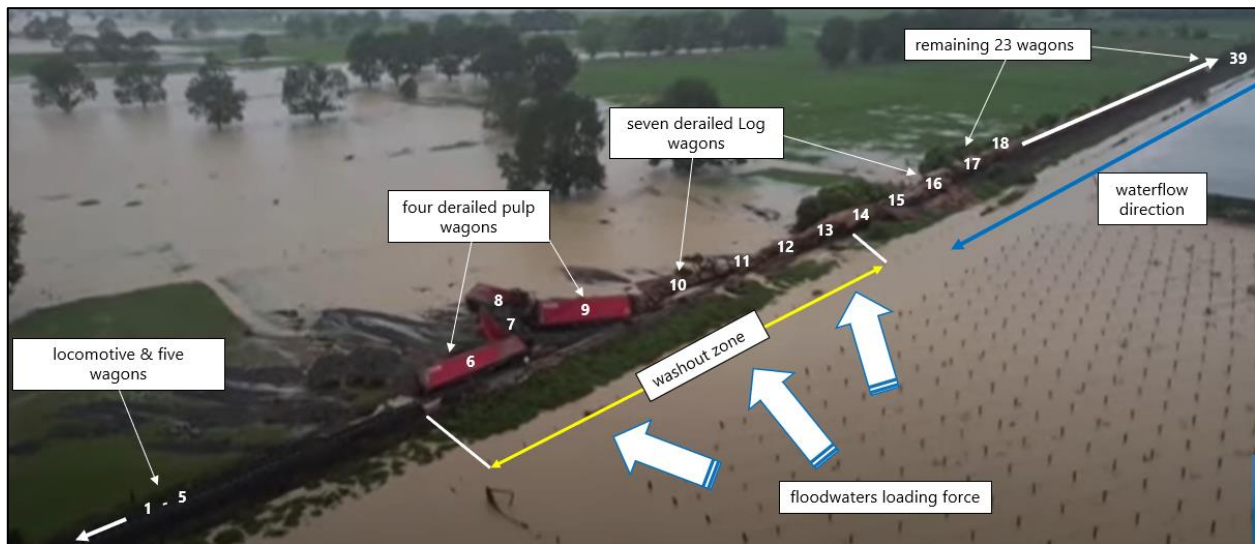
2.42. The accident site was at 115.715 km on the ECMT north of Te Puke. The track and infrastructure were maintained and inspected by KiwiRail. The derailment occurred on an elevated embankment that was between 2.4-3.5 m in height<sup>30</sup> with farmland on either side (see Figures 10 and 11).

**Figure 10: Derailed site from west side (drone footage taken at 0800 on 29 January 2023)**  
(Credit: NZ Herald. Labels added by Transport Accident Investigation Commission)

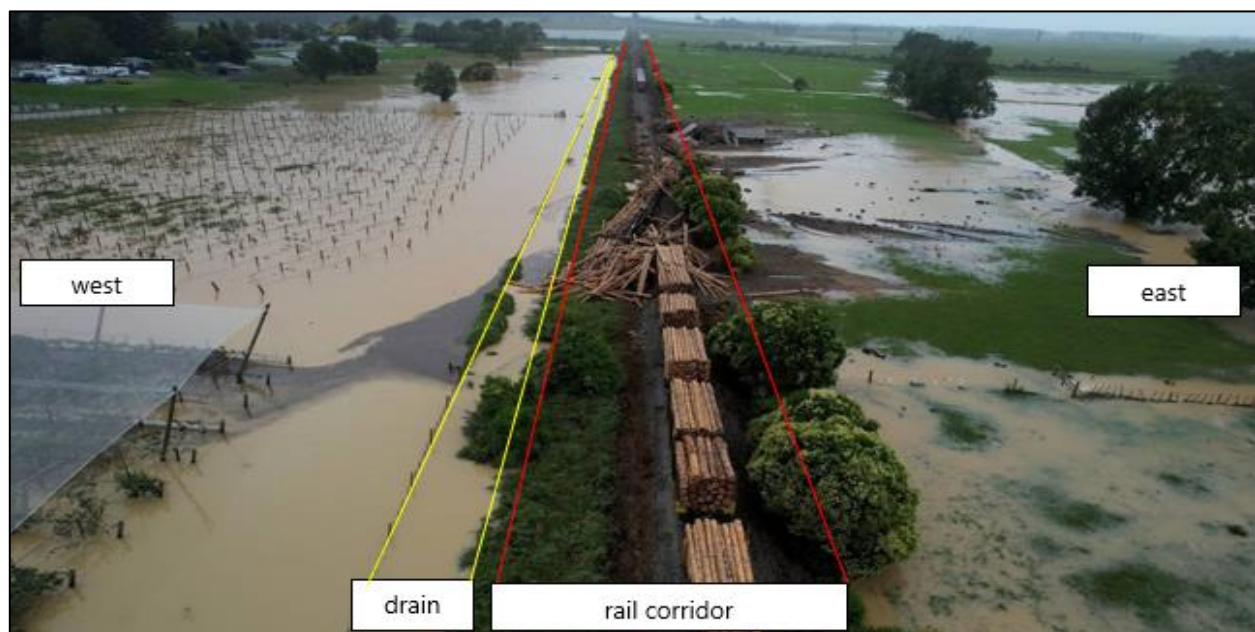
**Figure 11: Derailed site from rear of the train (drone footage taken at 0800 on 29 January 2023)**  
(Credit: NZ Herald. Labels added by Transport Accident Investigation Commission)

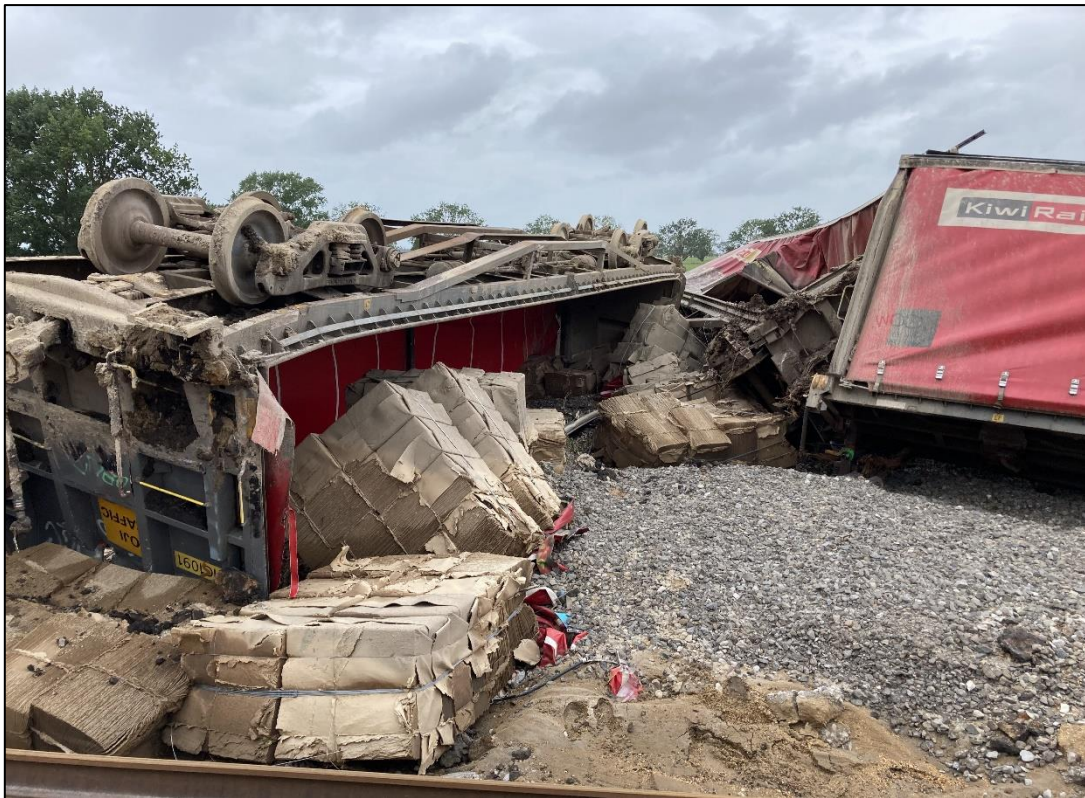
**Figure 12: Derailed wagons and ballast debris on the eastern side of the rail corridor**

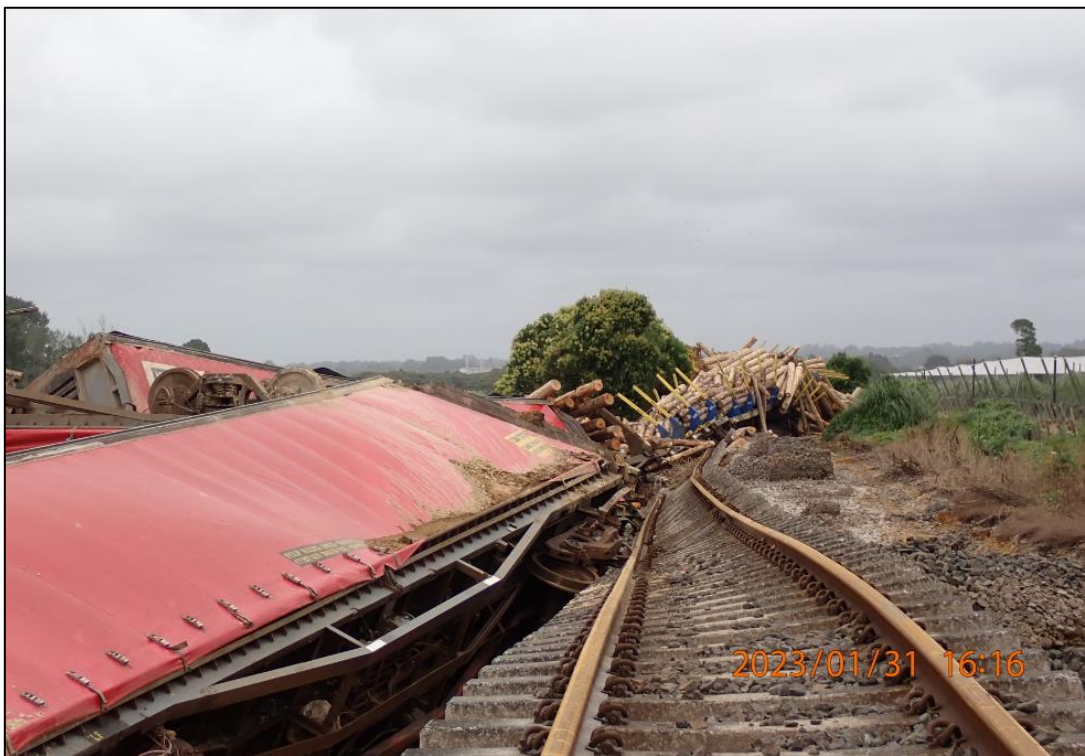
**Figure 13: Derailed wagons and washed-out track formation**

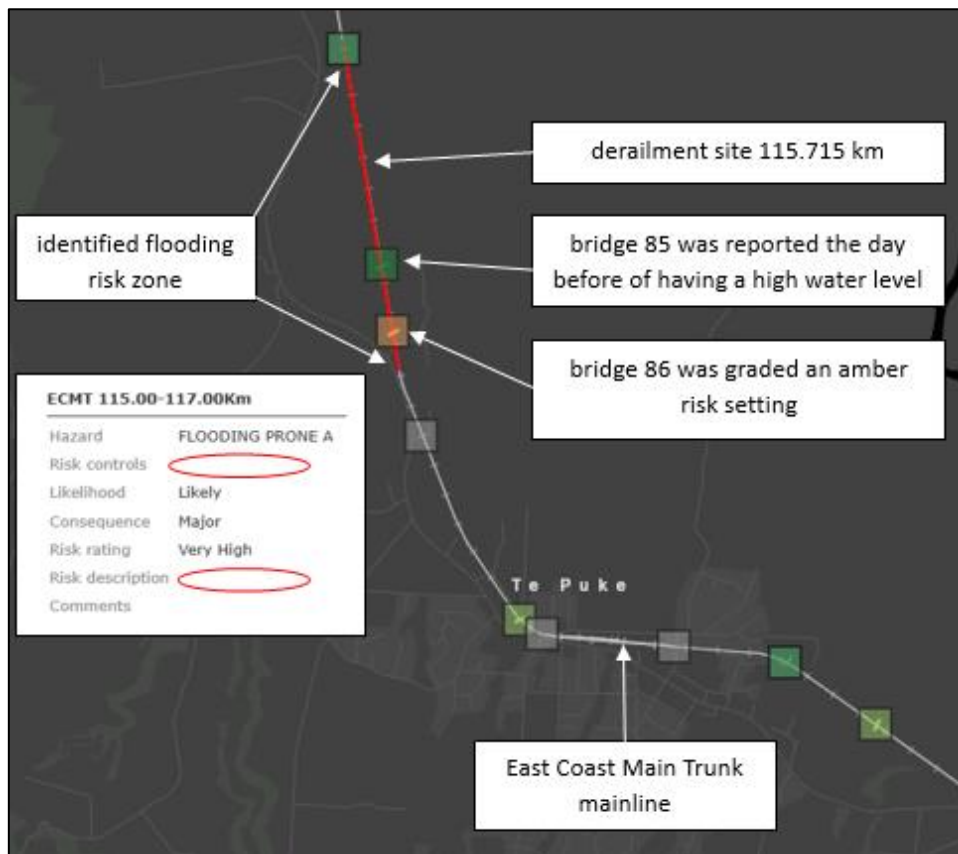
- 3.12. The rail resilience map was designed to help with hazard assessments for civil works and the management of severe weather events (see Figure 17). The map colour-coded and ranked areas of the rail network that were subject to flooding, slope instability and scouring of bridge supports.

**Figure 17: The rail resilience map at the accident site**

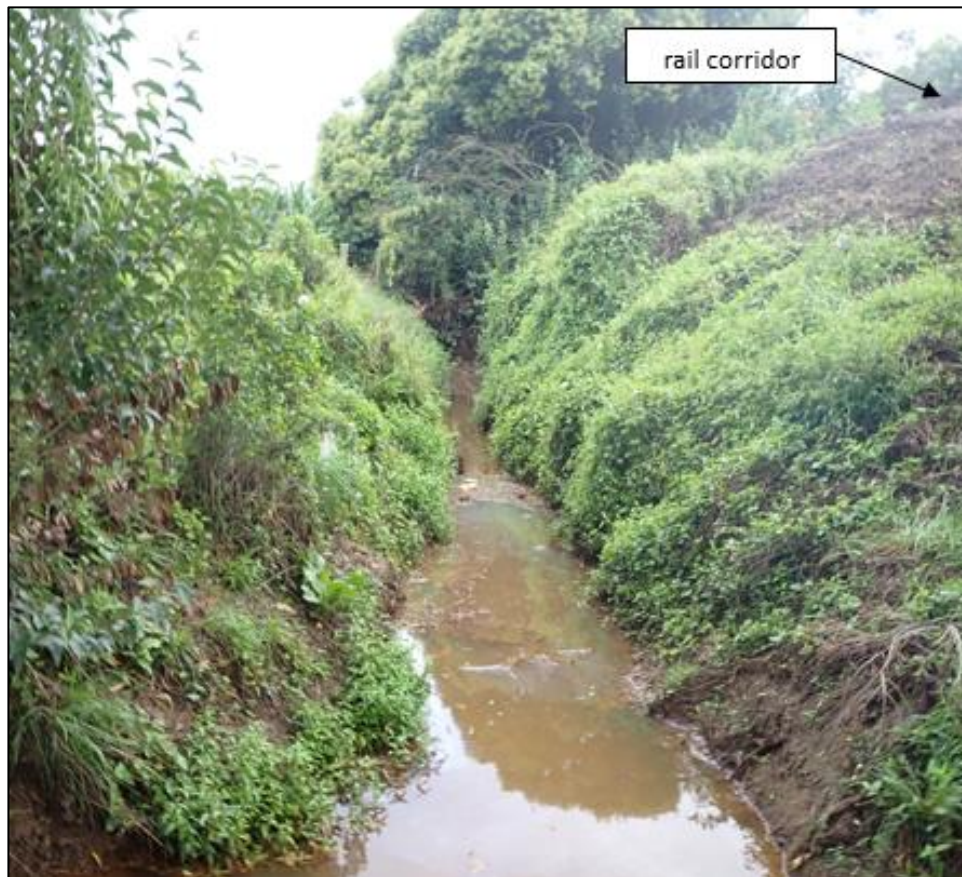
- 3.37. Where the Flaxton drain and Collins drain intersected, the vegetation on both sides had grown down to the water level (see Figure 21).

**Figure 21: Vegetation at junction of Flaxton drain and Collins drain**

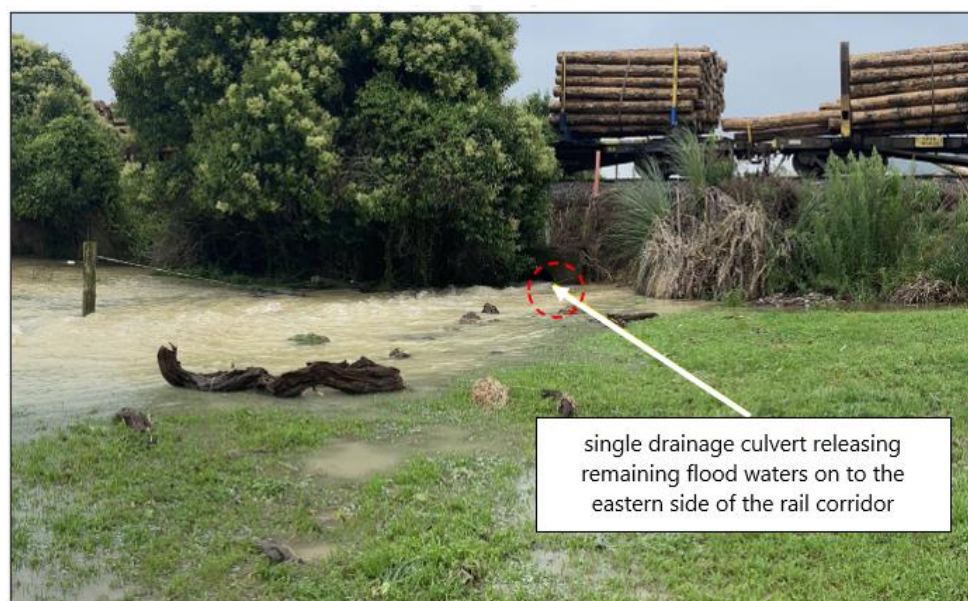
- 3.38. Located approximately 60 m south of the accident site was a single, 750 mm diameter concrete culvert, owned and maintained by KiwiRail. The culvert allowed water to flow beneath the rail corridor and was approximately 0.5 m above the Flaxton drain. The purpose of the culvert was to move excess water from the farmland in the east to the Flaxton drain in the west. It was not designed for flood mitigation.
- 3.39. However, when floodwaters breached the top of the Flaxton drain, the culvert allowed water to move from the drain east onto farmland (see Figure 22). Eventually the culvert was also overwhelmed by the volume of floodwater, resulting in the water crossing over the track, undermining the track formation and washing out the ballast.

**Figure 22: Culvert allowing floodwater to move east onto farmland**  
(Credit: KiwiRail – photograph taken at approximately 10:00 on 29 January)

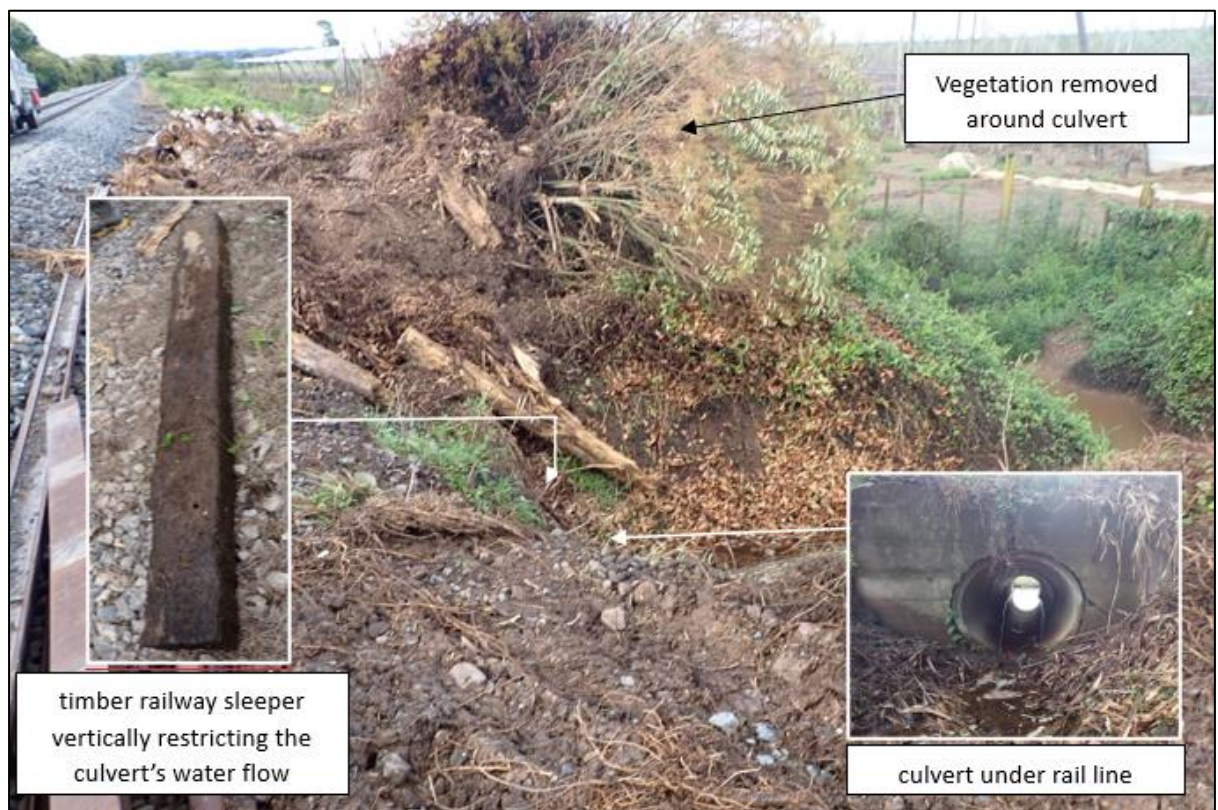
- 3.41. When attending the accident site after the floodwater had subsided, the Commission investigators found the culvert was partially blocked on the western side by a vertically positioned wooden railway sleeper and that vegetation had grown into the area where the Flaxton drain met the culvert (see Figure 23).

**Figure 23: Western entrance of culvert**

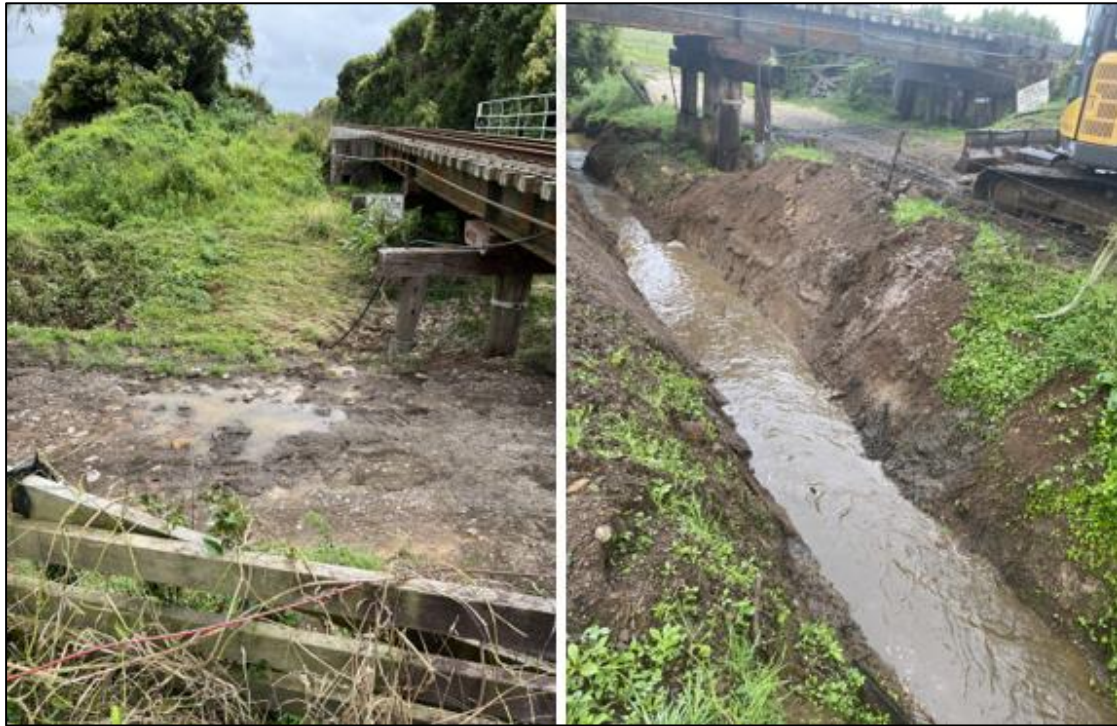
**Figure 24: Remedial work at Bridge 85 after the accident**  
(Credit: Bay of Plenty Regional Council)

- 3.45. Remedial works post the accident were completed by the Bay of Plenty Regional Council. This work included the removal of a culvert within Collins drain located near bridge 85, which was removed due to its being blocked with compacted soil. Upon its removal, a smaller pipe was found within the culvert. The culvert removal created an open drainage system up to and under bridge 85 (see Figure 24).
