Transport Accident
Investigation
Commission

Final report

Rail inquiry RO-2023-106
Passenger train 804 TranzAlpine
Train parting
Arthur's Pass
17 December 2023

May 2025

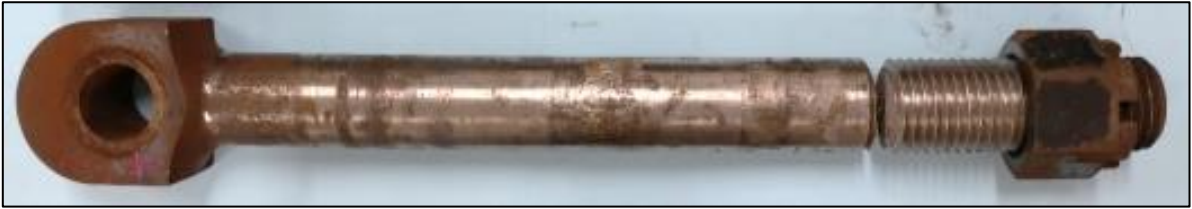
Figure 8: Broken tailpin from carriage one

- 4.1. As the TranzAlpine passenger train approached Arthur's Pass station, carriage one and carriage two of the train parted when the coupler tailpin between the carriages failed.

- 4.2. It is **virtually certain** that at the time of the incident, the tailpin was in a weakened condition because of a pre-existing fatigue crack.
- 4.3. It is **virtually certain** that the operation of the train's four locomotives in throttle position three while applying the train's brakes fully caused the brittle fracture of the weakened tailpin.

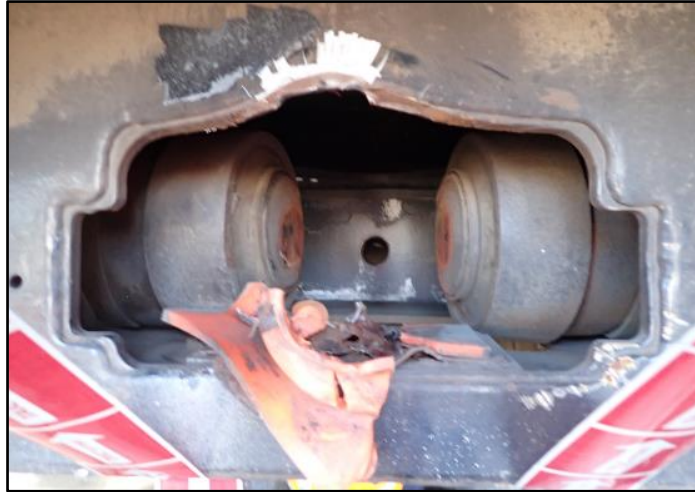
- 2.20. This caused the front portion of the carriage's spring-pack shock absorber system (that dampens in-train coupler forces) to fall out from the chassis housing onto the track below (see Figure 9).

Figure 9: Rear of carriage one showing coupler drawgear location and damaged chassis

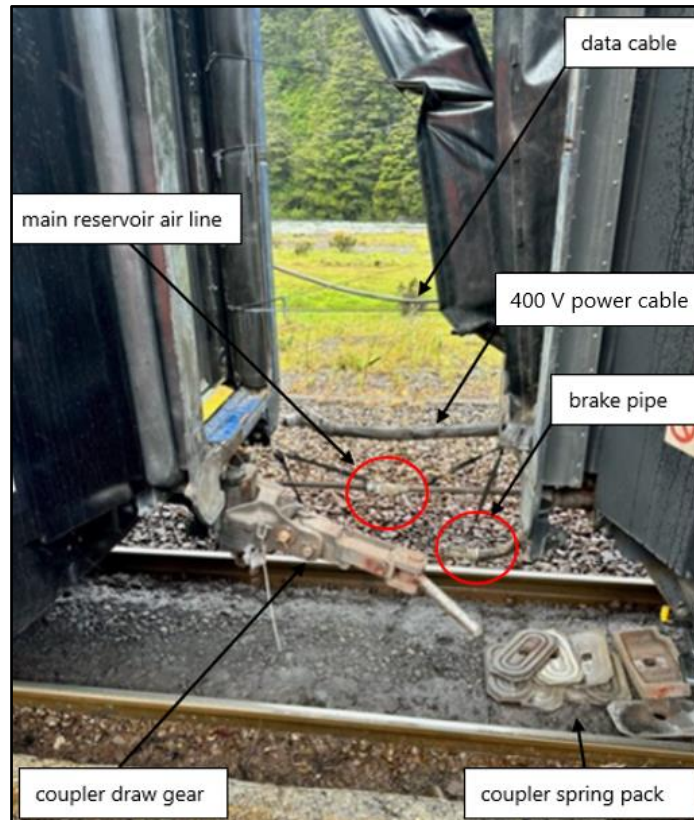
- 2.21. As a result of the parting, the carriage's brake pipe¹⁹ uncoupled and the 400 volt (V) power-connection lead²⁰ broke from its housing, causing carriage one to lose its power supply (see Figure 10).

Figure 10: Parted carriages

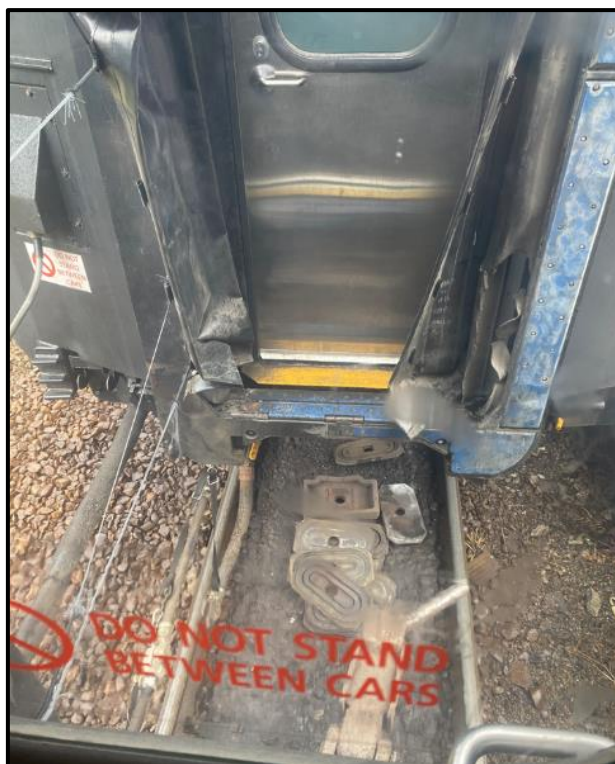
- 2.28. A crew member then moved through carriage two (the AKF kitchen carriage) to enter carriage one (the AKS luggage storage carriage) and in doing so, discovered that the carriages had parted (see Figure 11).

Figure 11: Parted gap between first and second carriages
(Credit KiwiRail)

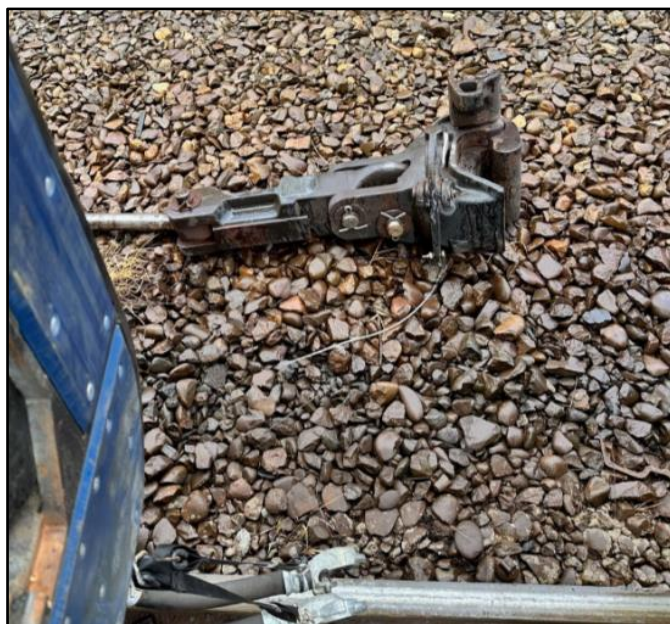
- 2.32. In preparation to travel back to Christchurch, the Otira train crew removed the broken coupler connected to carriage two and secured the carriage's loose power and data cables, which could not be removed (see Figure 12). The crew completed a brake test for carriage one before the oncoming LE (6) departed Arthur's Pass station with carriage one and two locomotives.

Figure 12: Removed drawgear and coupler
(Credit KiwiRail)

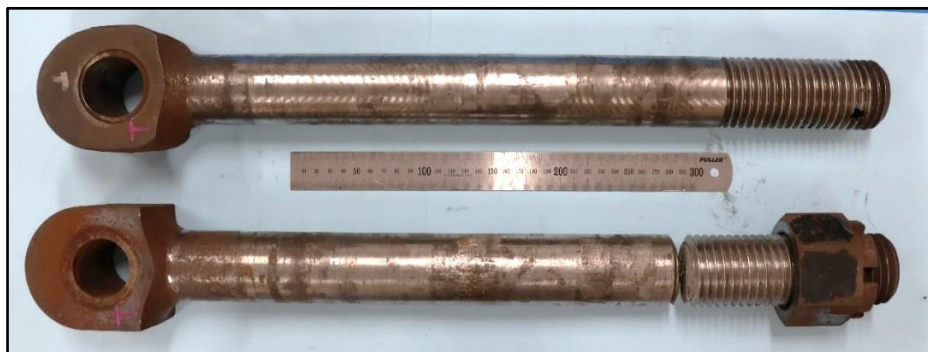
- 3.20. Quest Integrity NZL Limited carried out testing for KiwiRail on the material composition and cause of failure of the tailpin from carriage one.
- 3.21. The tailpin (see Figure 19: Tailpins from each end of carriage one) transmits draft tensile forces and buff compression forces from the drawbar to the spring pack and therefore the carriage chassis.

Figure 19: Tailpins from each end of carriage one

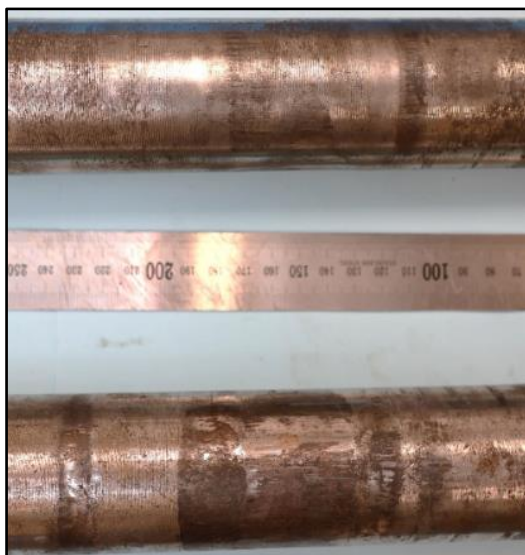
- 3.22. The approximate length of the tailpin was 538 mm from the centre of the eye to the end of the thread. There was moderate and irregular surface wear and corrosion on the tailpin (see Figure 20).

Figure 20: Surface wear on the tailpin

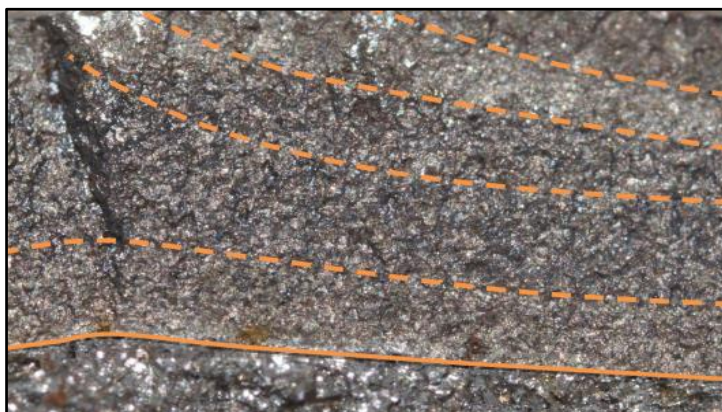
- 3.23. The material grade was identified as medium carbon steel, having low fracture-toughness properties³⁴ at operating temperature. The carbon content was slightly above the maximum allowed by EN 8³⁵ specification; however, all other material aspects were consistent with specification EN 8.
- 3.24. The tailpin was slightly bent in the horizontal plane. While the Commission was unable to determine the cause of the bend, examination of the fatigue crack indicates that the bend was **very likely** present before the fracture occurred (see Figure 21).

Figure 21: Fatigue crack changes over a period of time

- 4.6. While the Commission was unable to determine the cause of the bend in the tailpin, examination of the fatigue crack indicates that the bend was **very likely** present before the fracture occurred.

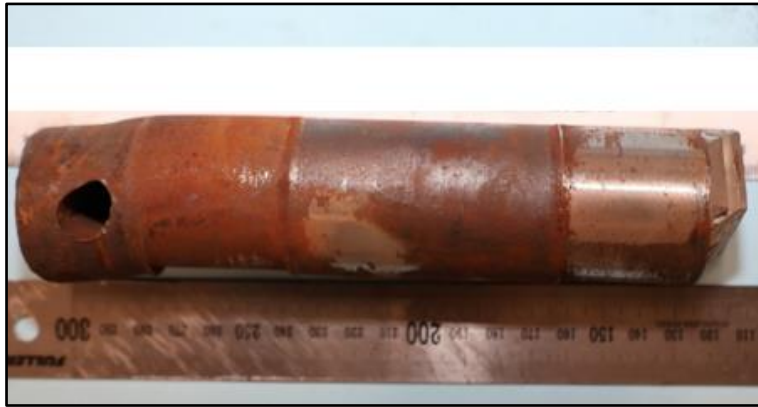
- 3.25. The drawbar pin, which connects the drawbar to the tailpin, was deformed and worn with surface rust (see Figure 22).

Figure 22: Drawbar pin from AKS coupler that parted

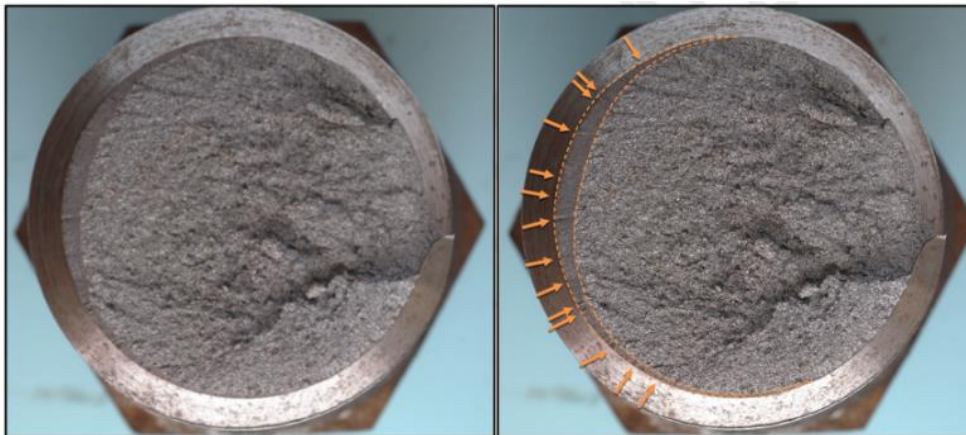
- 3.26. The testing indicated that it was **virtually certain** that the failure of the tailpin was caused by a brittle fracture³⁶, initiated by a pre-existing fatigue crack. The fatigue crack originated from the thread root³⁷ (see Figure 23), on the inner curve of the bent tailpin.

Figure 23: Tailpin fracture surface with fatigue crack shown on right hand photo

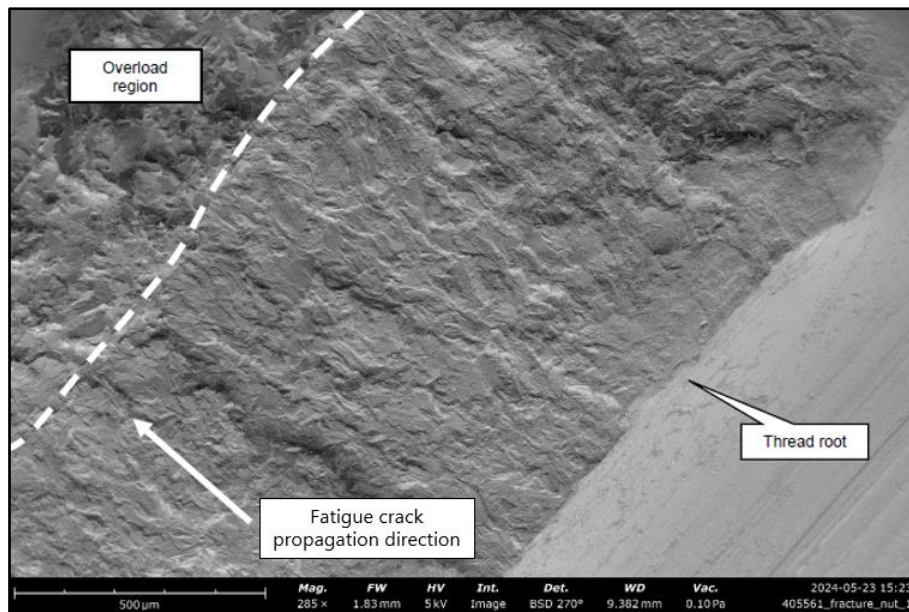
- 3.27. The draft tensile force put on the tailpin during operations acted to straighten it. This additional force on the inner curve of the tailpin led to the initiation of a fatigue crack (see Figure 24). The characteristic of the fracture suggests a load of between 406 and 465 kN was applied during the failure.

Figure 24: Magnified picture of thread root and overload region
 (Credit: Quest integrity NZL Limited)

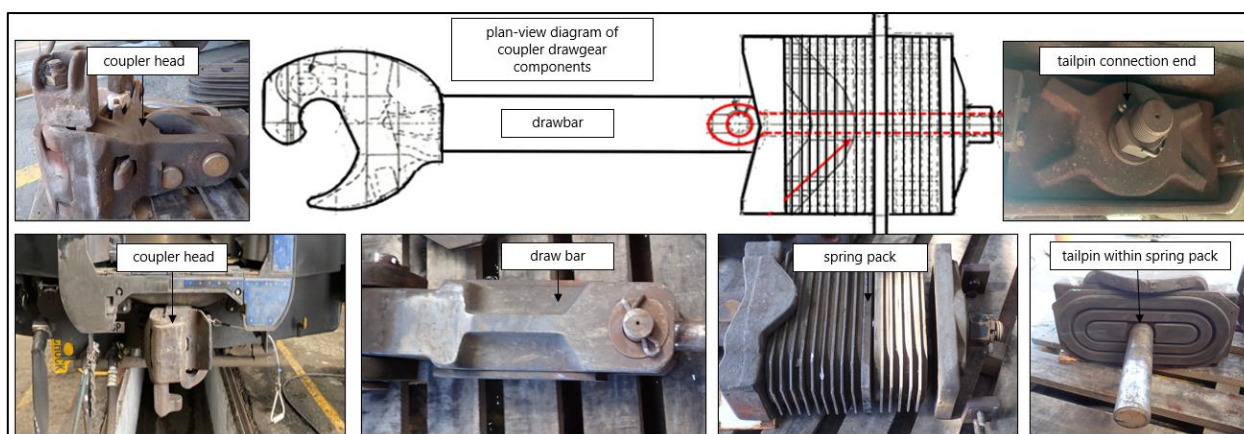
Figure 29: AKS carriage-coupler parts

- 3.45. The internal parts of the carriage coupler were not inspected at any stage of the maintenance inspection programme (see Figure 29).

- 3.46. Independent testing found the tailpin of carriage one had a pre-existing fatigue crack, reducing its integrity and increasing the likelihood of failure. The maintenance inspection programme did not require the removal of the tailpin from the spring pack or removal of the drawbar pin, so not allowing the condition of the tailpin and drawbar pin to be fully inspected.
- 3.47. Had KiwiRail’s maintenance inspection programme included removing, inspecting and testing of the entire tailpin it is **very likely** that the pre-existing fatigue crack would have been identified and the tailpin and drawbar pin replaced.

- 4.5. Had KiwiRail's maintenance inspection programme included removing, inspecting and testing the entire tailpin it is **very likely** that the pre-existing fatigue crack would have been identified and the tailpin replaced.

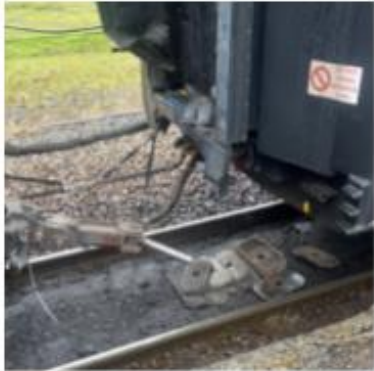
Train Parting – Broken buffer	Broken Buffer	Other End of Broken Buffer
