Transport Accident
Investigation
Commission

Final report

Rail inquiry R0-2024-101
Loaded coal train 850
Signal passed at danger
Cora Lynn, Midland line
27 February 2024

January 2025

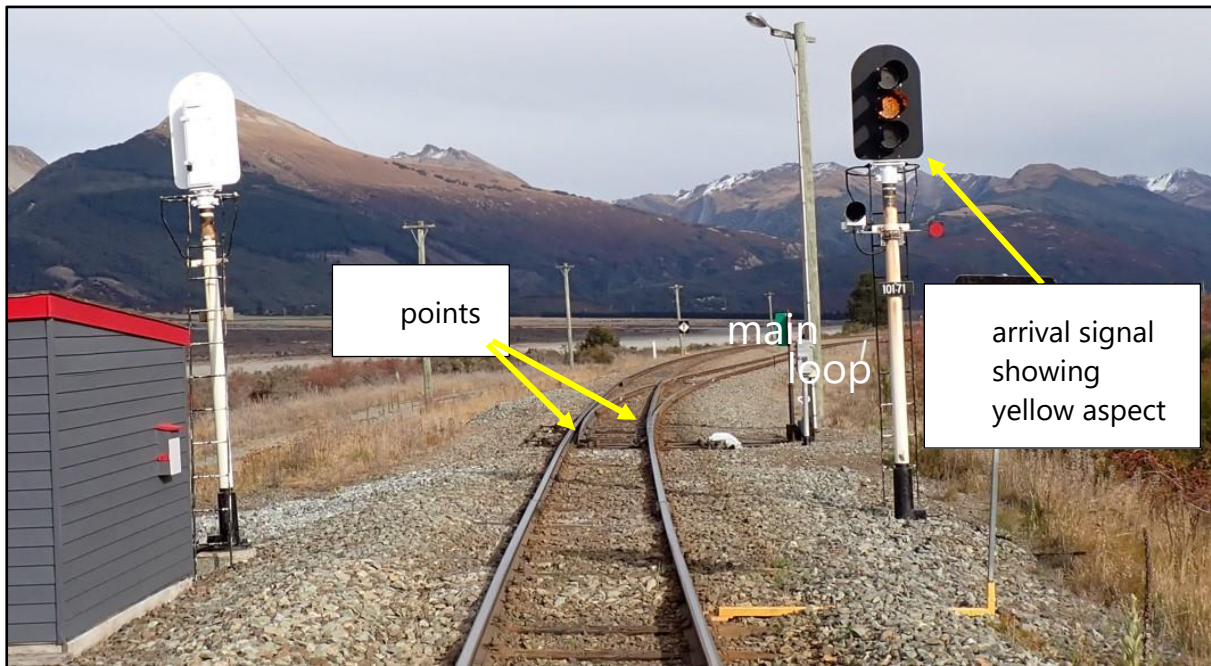
- 2.4. The signals that govern entry to and exit from a crossing loop operate in isolation on simple closed-circuit logic. This means that if the points at both ends of the crossing loop are set for the main line, then the circuit is closed. With a closed circuit the arrival signal will display either a green or yellow aspect⁶ if the section ahead is clear (see Figure 4).

Figure 4: Signals and points locations at Cora Lynn east end

- 2.6. On the incident journey, the west end arrival signal had a red aspect at Cora Lynn because the opposing train had entered the loop from the east end. This meant that the points at the east end were still set for the loop and the circuit was open.

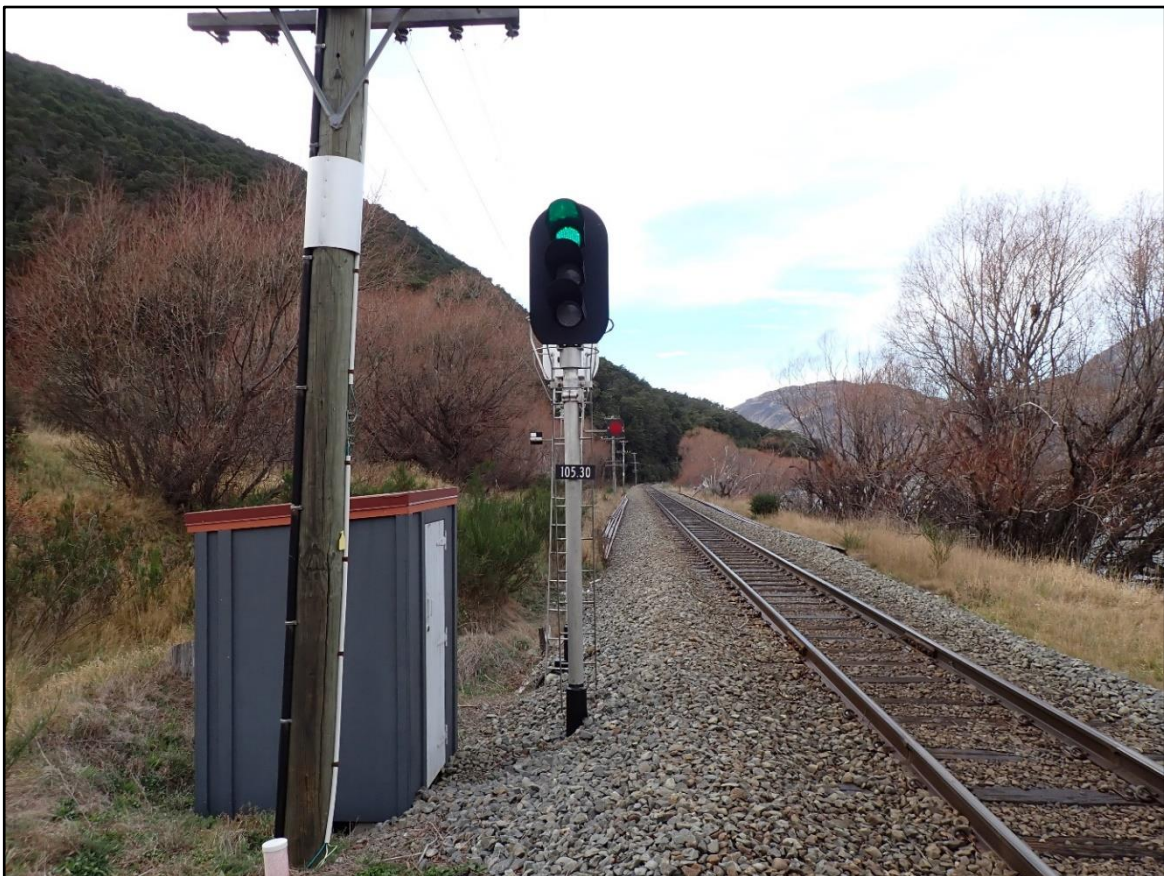
- 2.18. At 0800:10, Train 850 passed intermediate signal 10530, approximately 3 km west of Cora Lynn (see Figure 5). This signal was indicating a yellow aspect, meaning that the next signal was at red (stop), informing the LE to take the necessary action to stop at the next signal.

Figure 5: Intermediate signal 10530 (displayed yellow, not green, at the time of the incident)

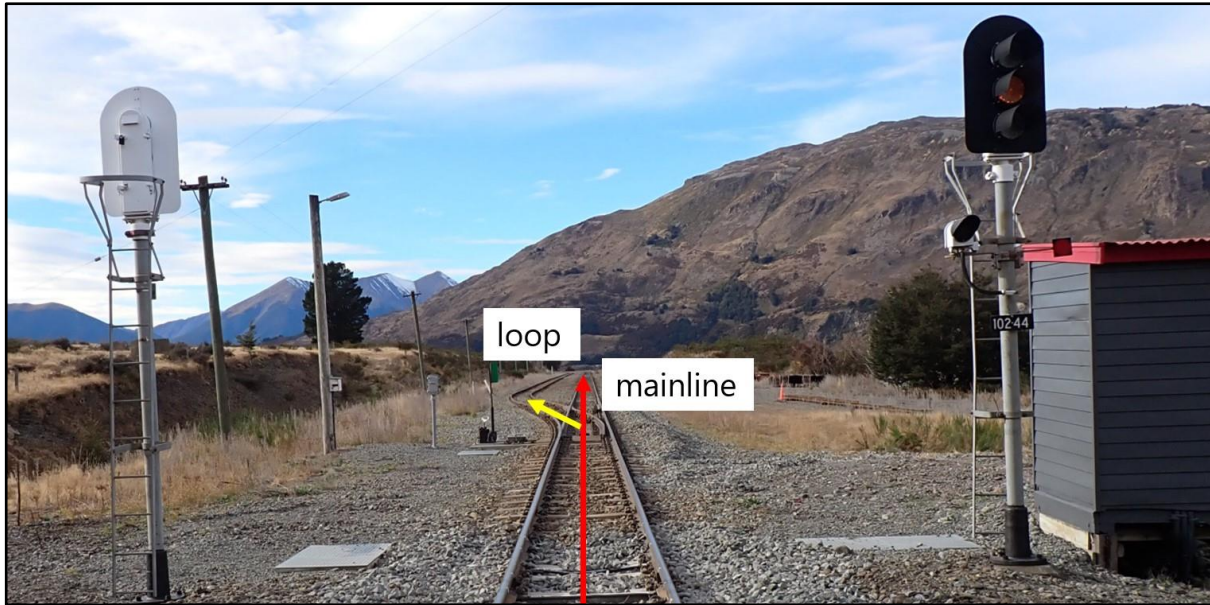
- 2.19. At 0802:13, as Train 850 approached Cora Lynn, the LE made a radio call to ascertain the location of Train 833. The Mis 51 recorded that the two trains were to cross at Cora Lynn.
- 2.20. During this radio conversation, the LE of Train 833 confirmed that Train 833 was in the loop at Cora Lynn.
- 2.21. Train 850 approached Cora Lynn at speeds between 50 and 56 km/h before slowing as it reached the Cora Lynn arrival signal.
- 2.22. At 0803:25 Train 850 passed the Cora Lynn arrival signal 10244 (see Figure 6), which was indicating a red (stop) aspect, at a speed of 44 km/h.

Figure 6: West end of Cora Lynn showing the main line, the loop and signal 10244 (displayed red, not yellow, at the time of the incident)

- 2.24. Train 850 should have stopped before signal 10244 for a minimum of 10 seconds to allow the LE to visually confirm that the points were set in the correct position for the main line before passing the signal.

- 2.25. Instead, Train 850 continued past signal 10244 at stop, reducing speed before coming to a complete stop at the east end of Cora Lynn at 0805:38. The LE had to set the east end points for the main line as they were still set at reverse after Train 833 had entered the loop.

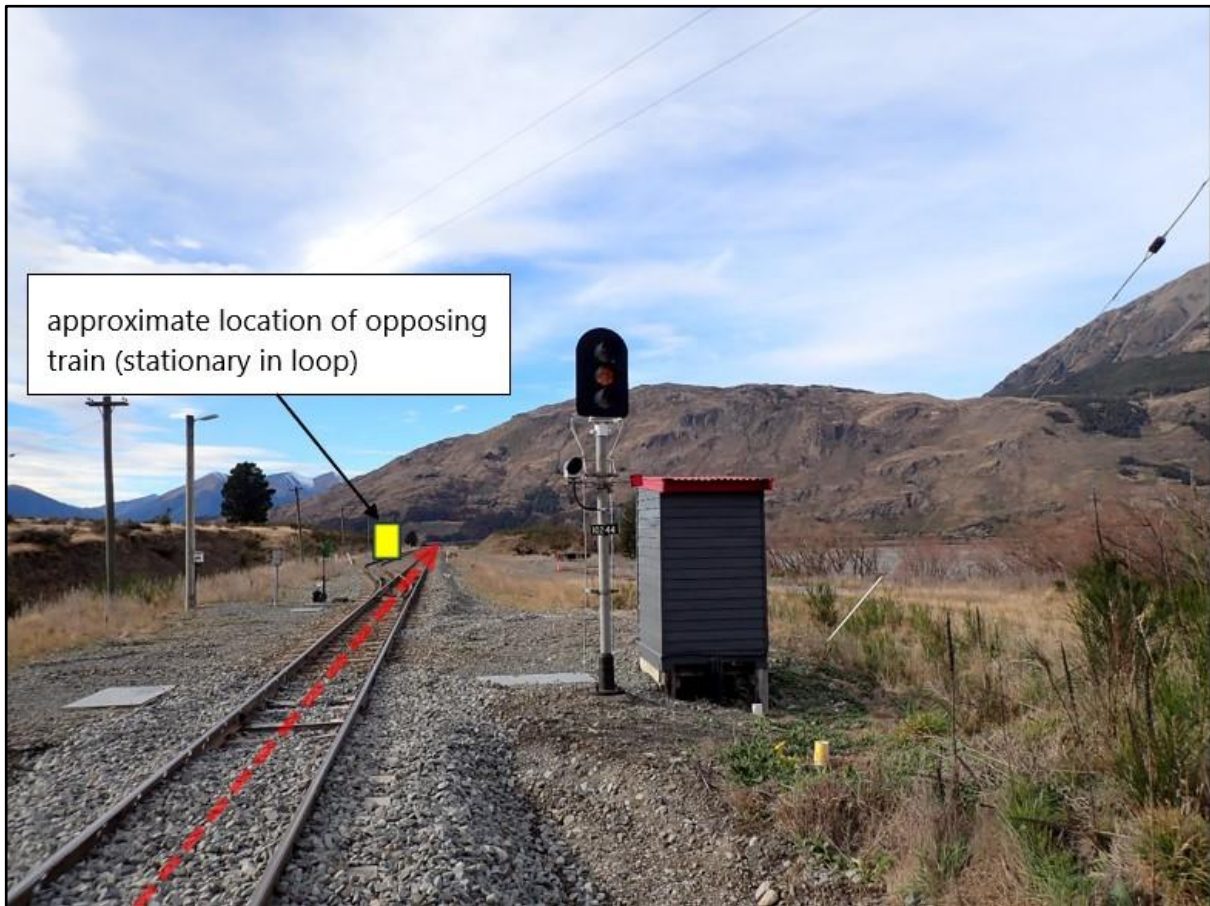
Figure 7: Approximate location of opposing train at Cora Lynn

- 2.23. Train 833 was positioned stationary in the loop (see Figure 7). The LE of Train 833 had disembarked and was walking towards the west end of Cora Lynn to set the points for departure from the loop when Train 850 went past on the main line.

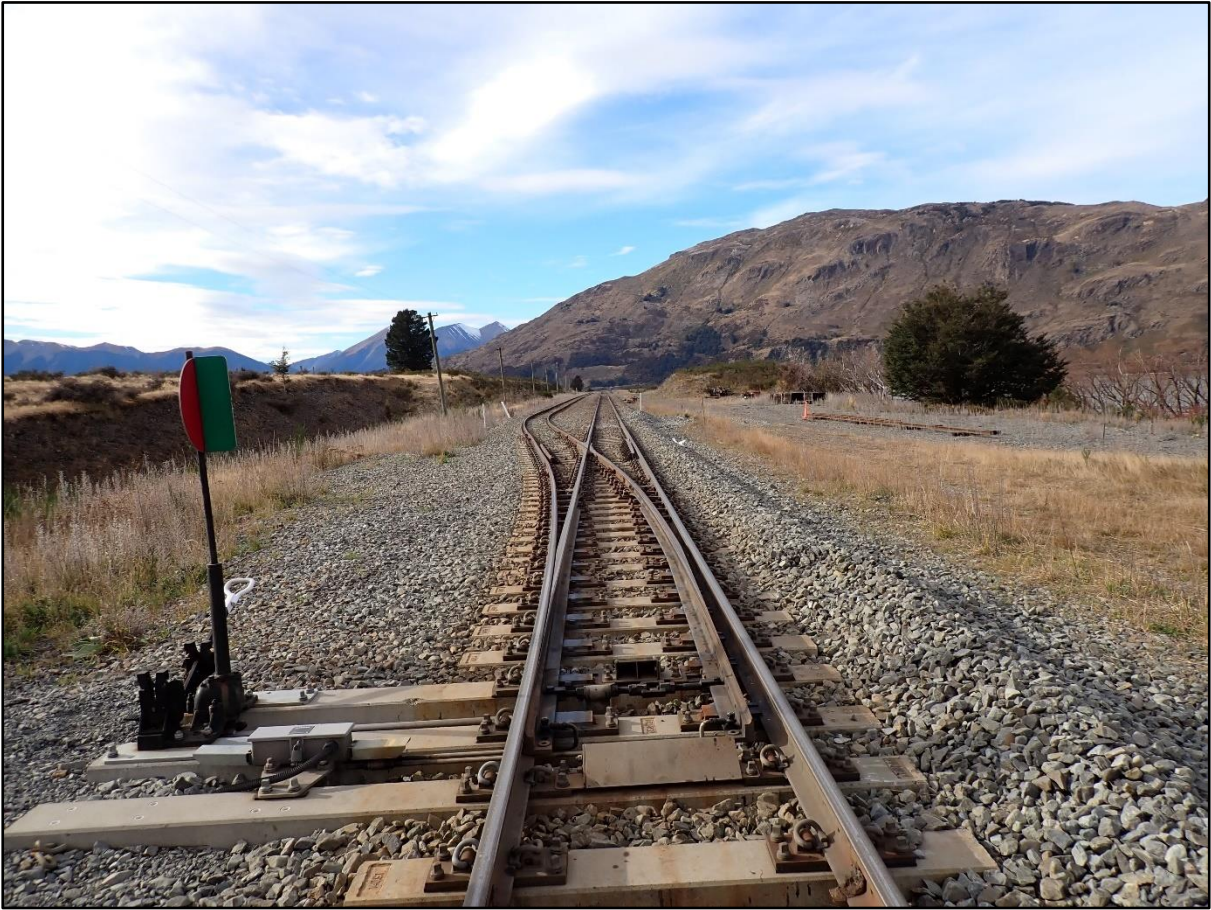
Figure 10: Points equipment at west end of Cora Lynn set for main line
