**Report 06-005, Gippsland Aeronautics GA8 Airvan, ZK-KLC, partial engine failure,
Cook Strait, 27 November 2006**

Report 06-005

Gippsland Aeronautics GA8 Airvan

partial engine failure

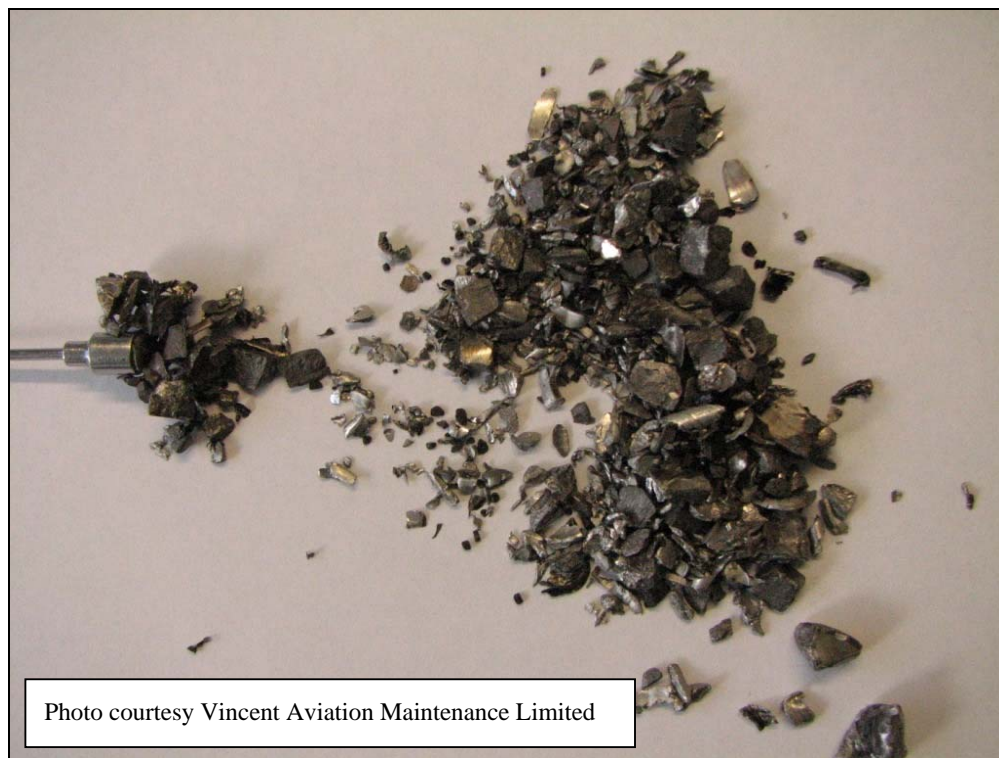
- 1.1.6 The engineers had difficulty restarting the engine and abnormal resistance was encountered when turning the propeller by hand. The engine was eventually started and the oil pressure checked with a test line and found to be steady at 60 psi when at idle power. The engine oil suction screen was removed and found to be clogged with metal debris that was recognised as being from the tappets (see Figure 2). The pressure filter was also contaminated with fine metal particles. The oil sump was drained and more metal was found.

Figure 2
Debris from oil suction screen, with small test magnet at left

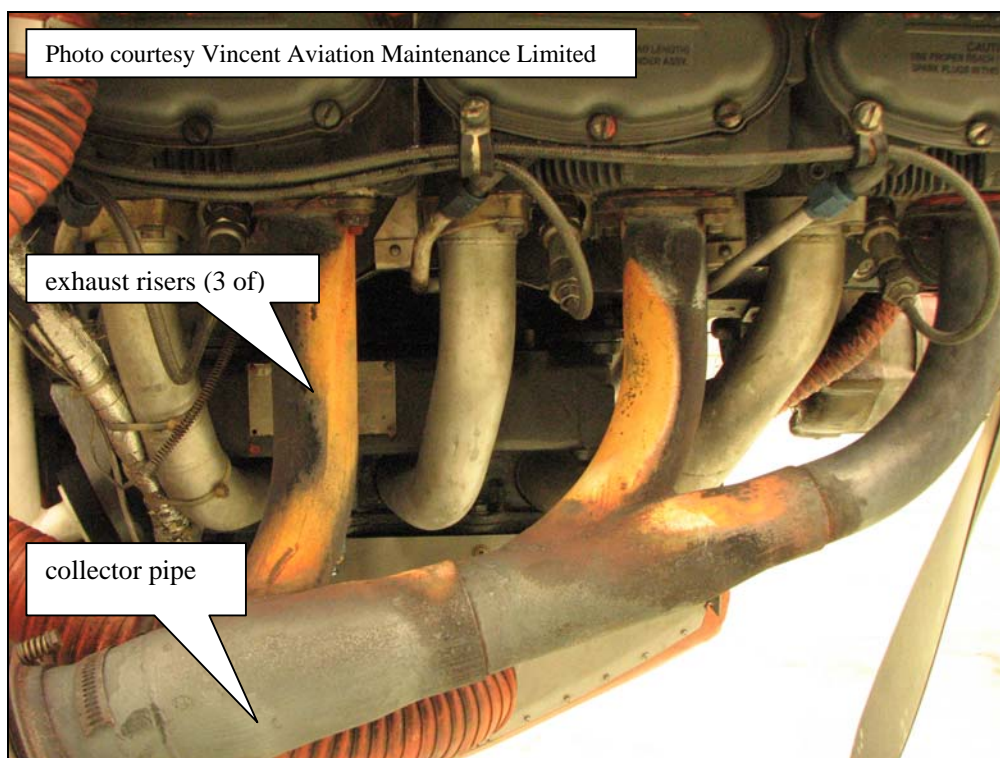
Figure 3
Right-hand exhaust pipes, ZK-KLC

- 1.3.9 Welded stainless steel exhaust manifolds were fitted to each side of the engine. The exhaust from the 3 cylinders on each side passed through "risers" into a collector pipe that went to a muffler (see Figure 3).

- 1.4.22 A specialist exhaust pipe repairer said that the pipes were almost in a dangerous condition and the need for rectification could have been apparent for 200 or more flight hours. He said that the exhaust systems of most general aviation aircraft required high maintenance, and few aircraft had exhaust pipes that lasted as long as the nominal time until engine overhaul. In his opinion, the similar damage on each riser indicated the engine had been operated too lean, too often.

- 2.23 The poor condition of the exhaust pipes was probably not a consequence of the rapid tappet break-up. The pilot did not recall the engine and oil temperatures, but even if they were higher than normal, they were unlikely to have been high enough in the remaining short flight time at reduced power to have caused the distortion seen, especially as the cowls and baffles were considered to be effective at cooling the engine.

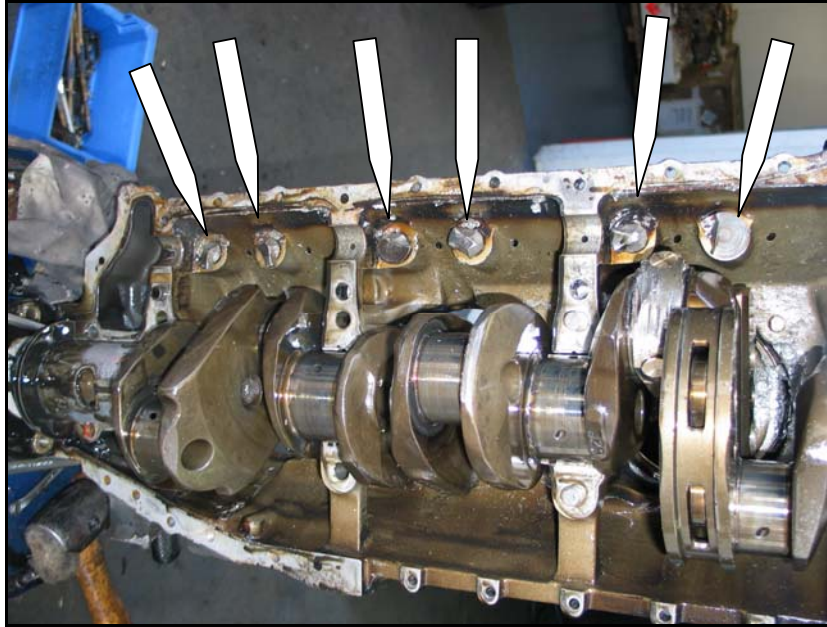
- 1.4.6 The bulk of the debris in the engine was broken tappets (see Figure 6). Only the 2 tappets in the #6 cylinder had not been broken; their faces retained the slightly convex profile. There was evidence on the crankcase counter bore surfaces at all tappet positions that debris had been trapped between the underside of the tappet heads and the crankcase.

Figure 6
One crankcase half, showing broken tappets

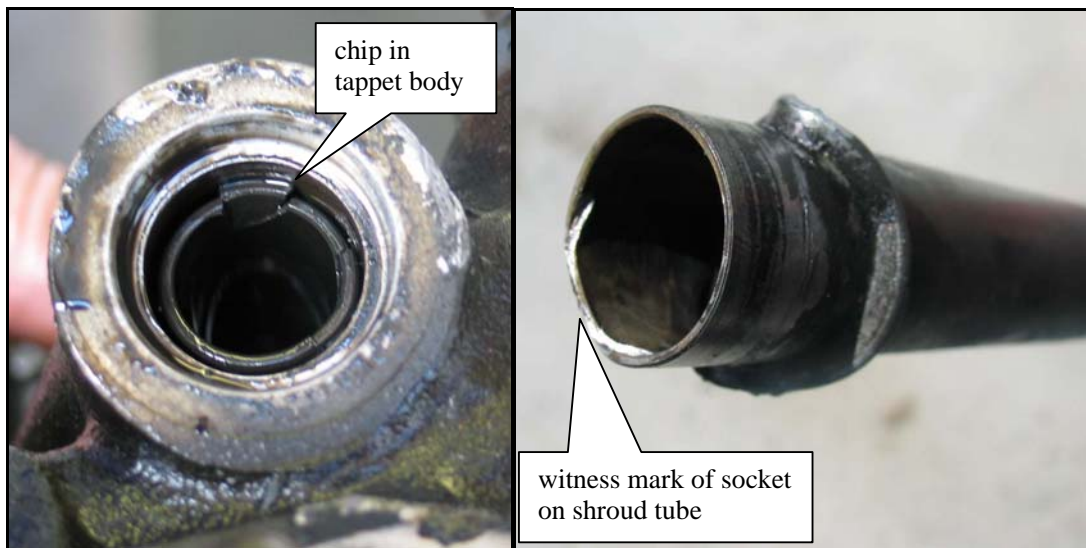
- 1.4.7 The tappet for the #4 cylinder exhaust valve was the most damaged, with the head worn away and the body chipped in 2 places at the push rod end. The chips were retained in the tappet within the crankcase, as was the push rod socket (see Figure 7). Because of the head damage,

the #4 exhaust valve tappet was 9.75 millimetres (mm) shorter overall than a serviceable IO-540 tappet.

- 1.4.8 There was a witness mark on the end of the #4 exhaust valve push rod shroud tube that matched the push rod socket edge (see Figure 7). Wear marks on the socket showed that during normal operation nearly half of the socket's 17.56 mm length extended out of the tappet body.

Figure 7
#4 exhaust valve tappet body (left), and push rod shroud tube (right)

- 2.10 It was probable that the #4 exhaust valve tappet was the first to break, because it was the most eroded and its push rod socket had been displaced between the shroud tube and the tappet body. There was no evidence that the #4 exhaust valve tappet had failed because of a design, material or manufacturing deficiency. The subsequent tappet failures were due to the increasing amount of debris that became trapped between the tappet heads and the crank case.
