**Report 06-007, Kawasaki-Hughes 369HS, ZK-HDJ, collision with terrain,
Mount Ruapehu, 11 December 2006**

Report 06-007

**Kawasaki-Hughes 369HS
ZK-HDJ**

collision with terrain

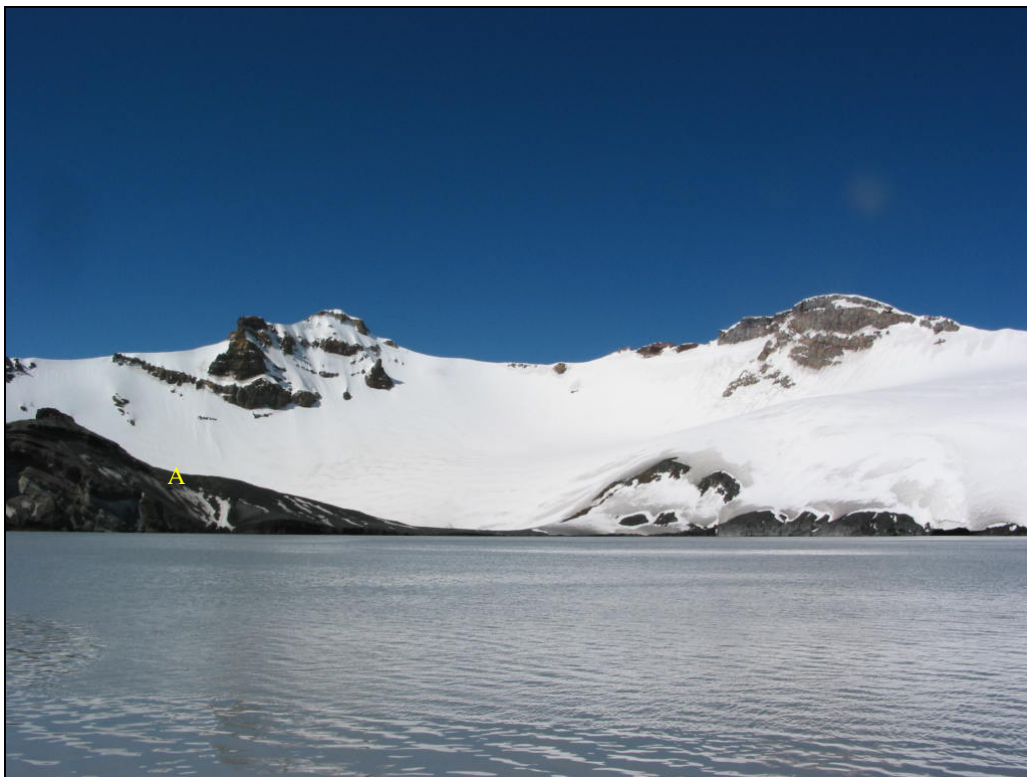
Figure 2
Crater Lake, looking south
A = landing and take-off site

- 1.1.10 The landing site was east of, and nearly 30 ft above, the lowest point of the lake edge, at an elevation of about 8330 ft (see Figure 2). The pilot said he needed very little power to land in “nice and steady” conditions.

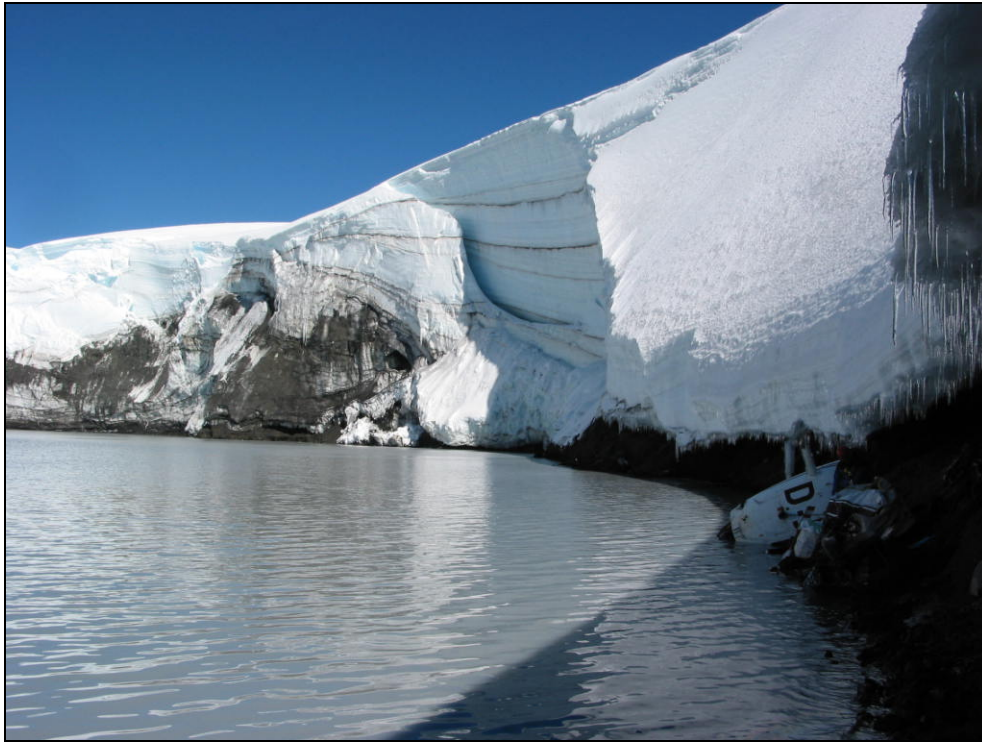
Figure 3
ZK-HDJ beneath ice cliffs

- 1.2.2 The helicopter came to rest on the steep, narrow shore of the lake below an overhanging ice cliff approximately 30 m high. The fuselage faced the approximate direction of take-off with the left side submerged, but the tail boom was turned forward nearly 180° and lay to the right of the fuselage. The forward windscreen and surrounding structure, including both front cabin doors, were torn off. The rear cabin retained its shape. The main rotor blades had damage consistent with having impacted while under power.
