**Report 07-011, Cessna A152 Aerobat, ZK-KID, impact with terrain,
Te Urewera National Park, 23 kilometres south-east of Murupara, 26 October 2007**

Report 07-011

**Cessna A152 Aerobat
ZK-KID**

impact with terrain

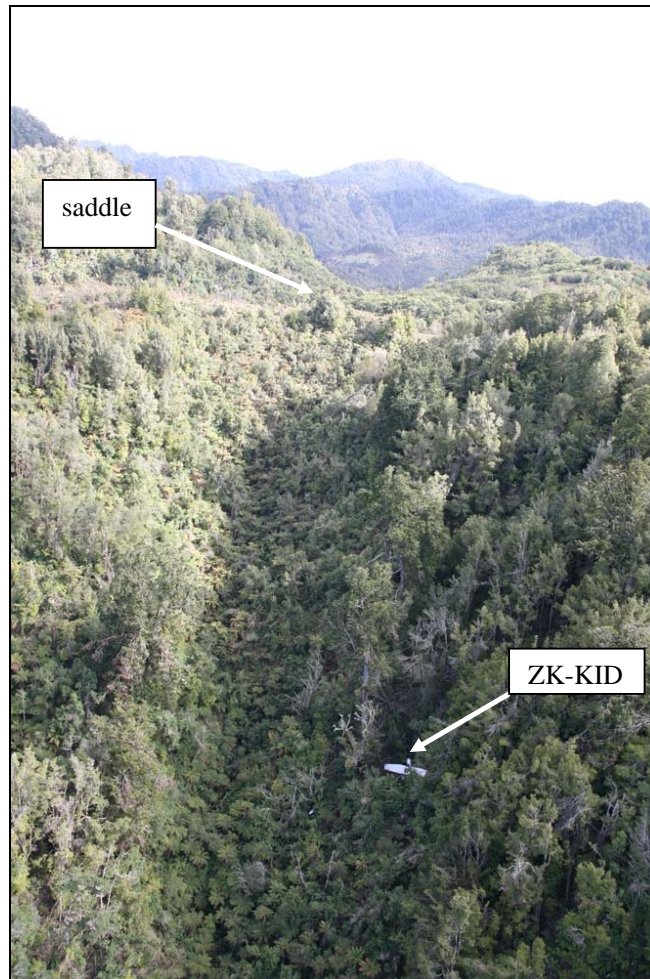
Figure 3
Accident site

- 1.2.1 The area around the accident site was not in a designated low-flying area. The accident site itself was on the eastern side of a steeply rising valley that was aligned about north-south; at an elevation of about 2200 feet above mean sea level (see Figures 3 and 4). The tree canopy was estimated to be from 80 to 100 feet high.

- 1.2.2 The top section of a tree had been broken off about 60 feet above the ground. The diameter of the tree where it had been broken was about 40 cm. Impact marks on the trees indicated that the aircraft had struck the trees while in a steep right turn. The aircraft then fell down to strike the ground in a steep nose-down attitude. Several branches and sections of a tree trunk had entered the aircraft cabin, mainly through the right side.

- 1.2.3 ZK-KID had incurred significant structural damage as it struck the trees and fell to the ground. All aircraft components were accounted for at the site. Both wings and the horizontal stabiliser displayed severe indentations along their leading edges. The empennage had separated forward of the fin and the left wing had nearly separated at the root. The engine had been forced upwards and backwards into the cabin area. The propeller had separated from the engine.

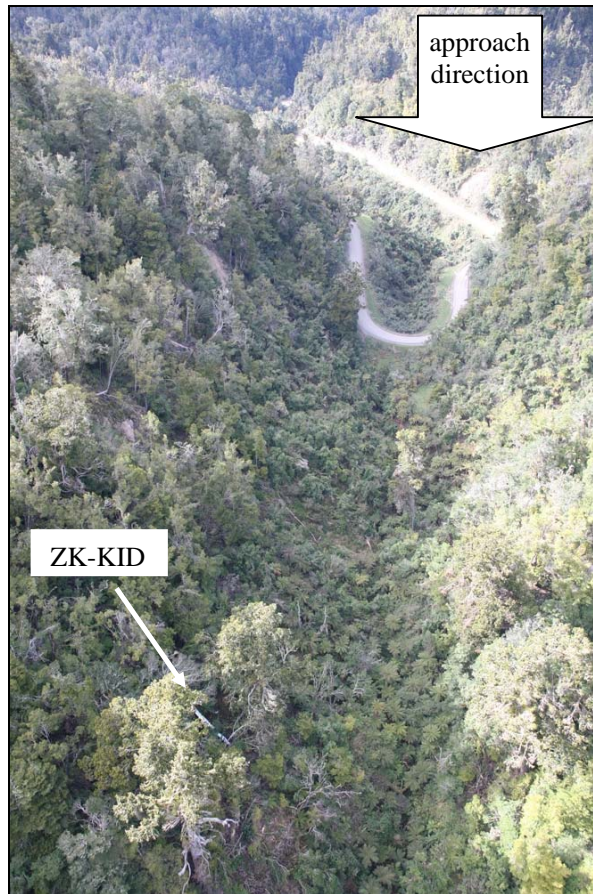
Figure 4
Approach to valley

- 1.1.10 The student reported that after leaving Ruatahuna the terrain rose steadily, so the aircraft was slowly climbed to maintain the same height above the road (see Figure 2). It also became increasingly windy and turbulent, and after several minutes the instructor took control of the aircraft, estimated by the student to be about 2 or 3 minutes before the accident. No explanation was given for taking control, but the student thought it was because of the turbulence, including localised downdraughts, and to give him a break from flying.

- 1.1.11 Shortly after passing the village of Papueru and when following a left-hand bend in the road, the student saw that the road ahead turned sharply right and would cross underneath the path of the aircraft. The road climbed up the side of a hill to the right of the aircraft, but the instructor continued flying straight ahead up a valley towards a saddle. The student recalled that the engine was at full power and that he became increasingly concerned that they did not have enough height to get over the saddle. He later estimated they needed another 400 feet to get over the hill.

- 1.1.12 With the aircraft on the left side of the valley, the instructor started a turn to the right as the aircraft approached the saddle. No words were spoken at this time. The student said that the aircraft remained at a constant altitude during the turn before it struck trees on the eastern side of the valley and fell to the ground nose first. He recalled no indication of the aircraft stalling before it struck the trees,⁷ or any change in engine noise or power.
