Report 07-102 (incorporating inquiry 07-111):  
freight train mainline derailments, various locations on the national network,  
from 6 March 2007 to 1 October 2009

# Final Report

Rail inquiry number 07-102  
(incorporating inquiry 07-111)

Approved for publication: May 2012

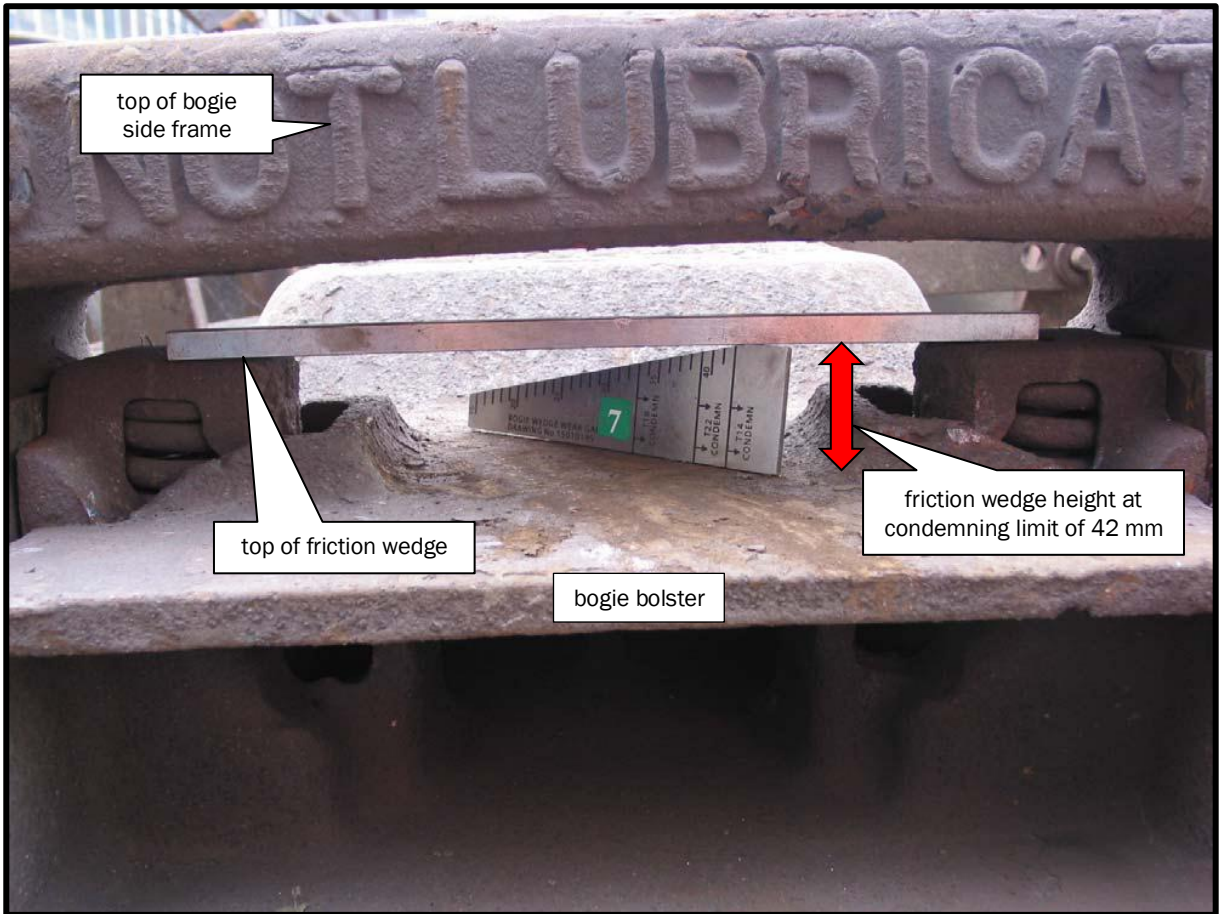
**Figure 1**  
**Measuring friction wedge height**

15. The friction wedge height on the leading bogie was 27 mm for both the A and B sides of the wagon. On the trailing bogie the friction wedge height was 37 mm on the A side and 41 mm on the B side. The A4 and B3 spring inners were broken on the trailing bogie.

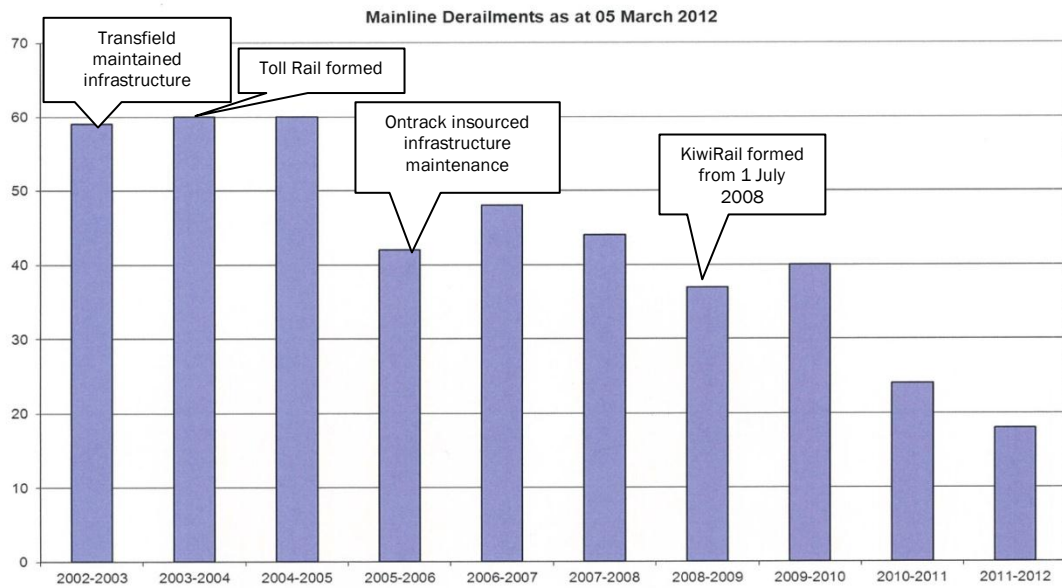
**Figure 2**  
Mainline derailments

- 3.2.21. Figure 2 has been annotated with key milestones in the ownership of rail freight operations and rail infrastructure. It shows a noticeable drop in mainline derailments from about 2005, which was when investment in the rail infrastructure increased. This could also be partly attributed to the programmes introduced by Toll Rail to track critical components of freight wagons and carry out more detailed inspections of bogie side frames and roller bearings. A further noticeable drop is post 2009-2010, when the standards for track and rolling stock were reviewed and the wear limits for some rolling stock components were reduced in line with the manufacturers' recommended limits.

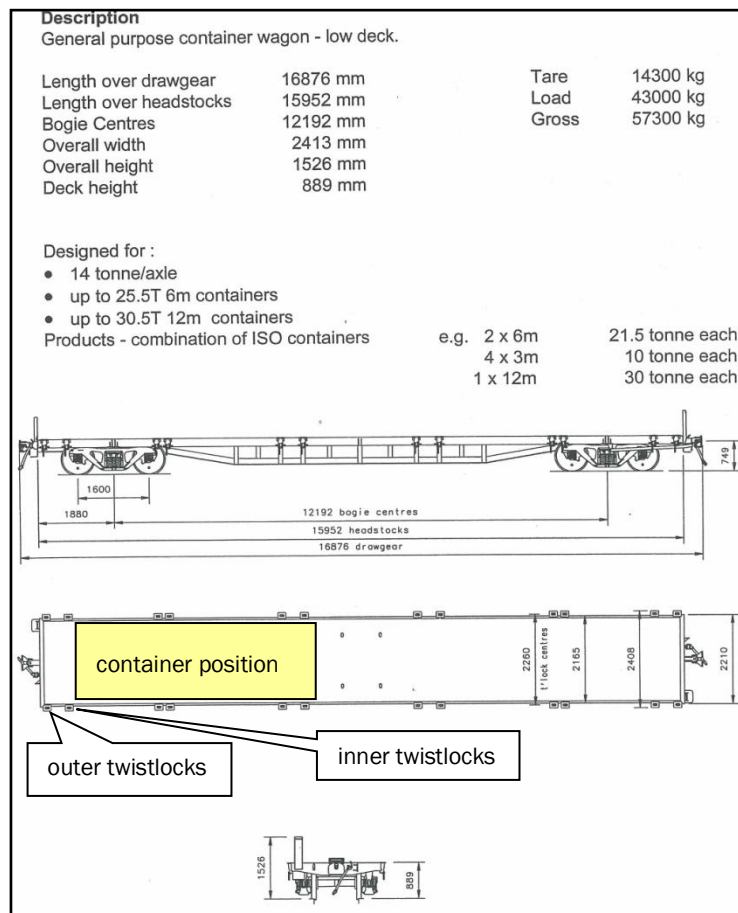
**Figure 3**  
Loading position of container on UK class wagon

- The UK class container flat-deck wagons were the mainstay of the general-purpose container-carrying fleet, with about 1400 of these wagons in service. Each wagon had a serviceable deck length of 15.952 m and a tare weight of 14.3 tonnes (t). The wagons were designed to carry a maximum payload of 43 t, giving a maximum gross wagon weight of 57.3 t or 14.3 t per axle. The wagon class typically carried one 12 m or two 6 m or five 3 m containers or combinations of these sizes. KiwiRail's freight handling code restricted the maximum load of a single 6 m long container carried on a UK class wagon to 25 t, and then only when secured by the inner twistlock pins. The maximum load was reduced to 23.9 t when a single 6 m container was secured by the outer twistlock pins (see Figure 3).

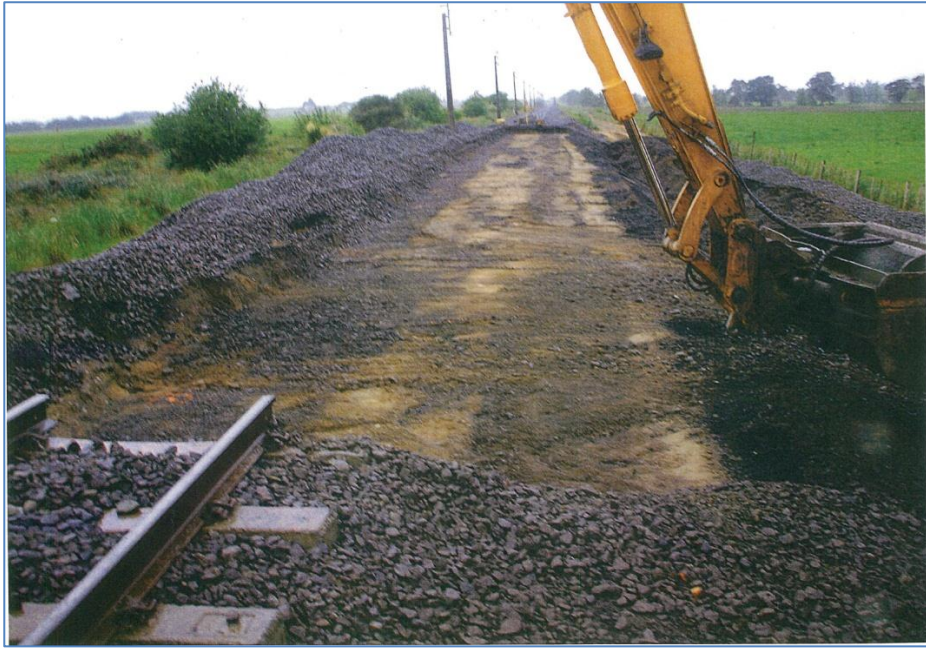
**Figure 6**  
**Excavated track formation**

15. Despite the track geometry survey findings, a 30 m length of track covering the 5 derailment sites was lifted and the formation below was excavated to a depth of about 500 mm (see Figure 6). During the excavation it became apparent that the sub-grade supporting formation included soft material predominantly made up of organic fills. The soft material was excavated and taken to a dump site. A filter material was laid and the formation was replaced with a graded structural fill.

16. There have been no recorded derailments at this location since the formation improvements were completed.
