**Report 09-005: Cessna 182N ZK-FGZ and Bombardier DHC-8 Q311 ZK-NEF,
loss of separation and near collision, Mercer, 40 km south of Auckland, 9 August 2009**

Report 09-005

**Cessna 182N ZK-FGZ
and
Bombardier DHC-8 Q311 ZK-NEF**

loss of separation and near collision

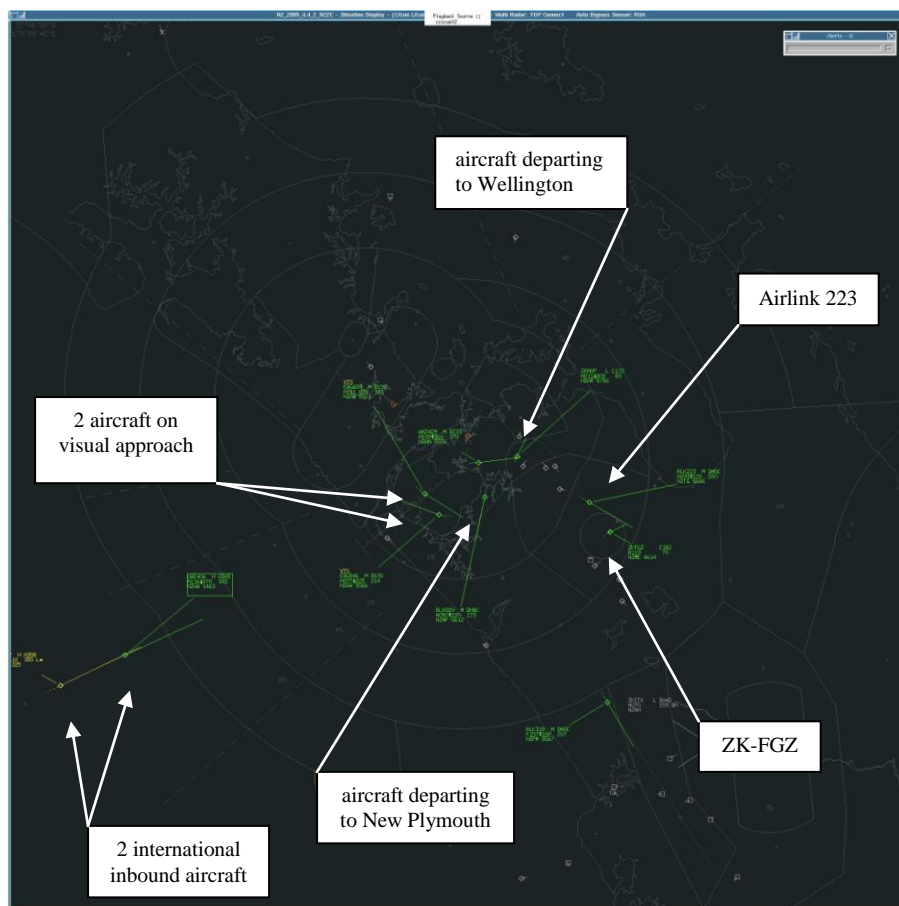
Figure 3
Radar recording- area
(Courtesy of Airways)

climbing through 9300 feet and heading south-east, with the velocity projections for the 2 aeroplanes crossing each other (see Figures 3 and 4). During this time the controller's computer cursor was on one of the inbound international flights, then moved to an aeroplane departing from Auckland, and the controller was talking to both of these aeroplanes. There was no cursor movement or audible recording to indicate that the controller reacted to the *conflict alert* between Airlink 223 and ZK-FGZ.

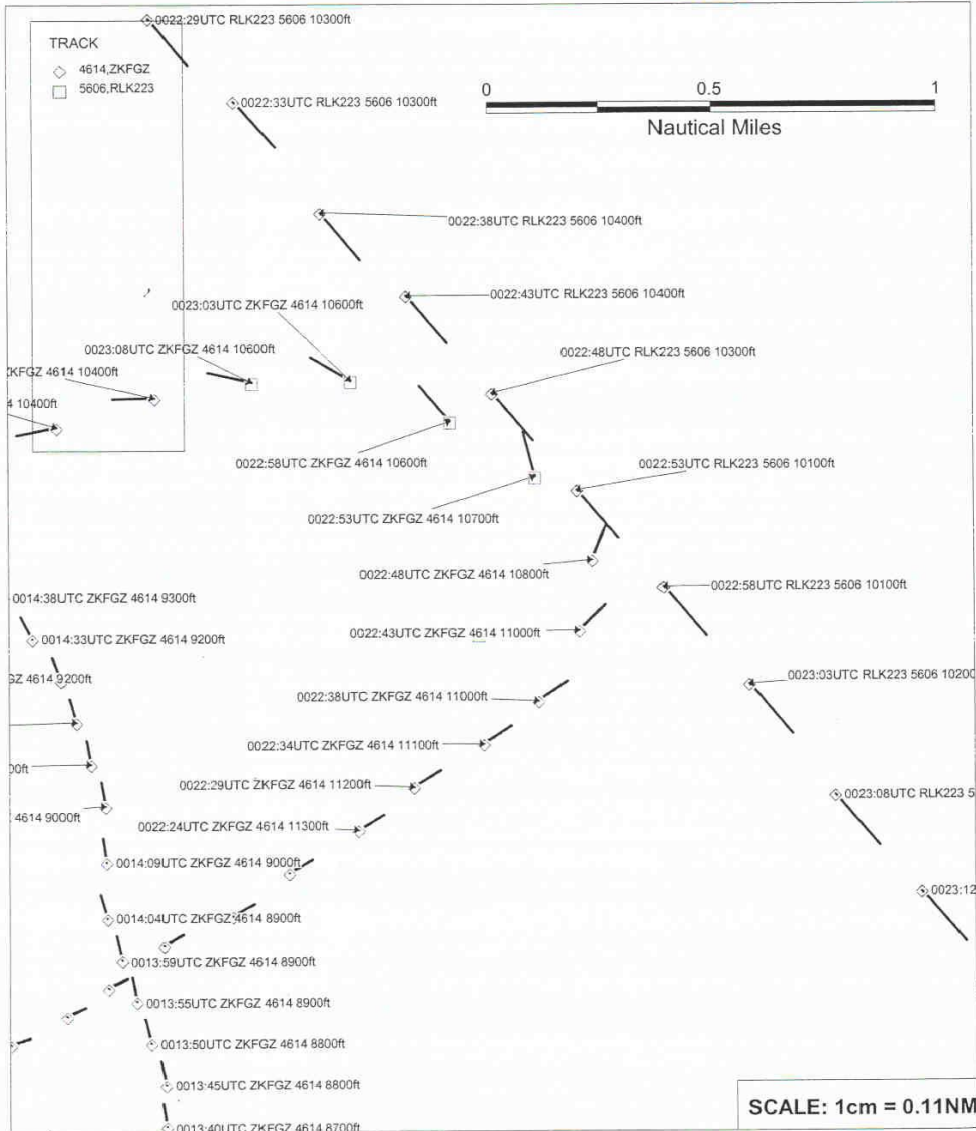
Figure 6
Radar recording of incident
(Courtesy of Airways)

- 2.13 The loss of required separation occurred when the controller re-cleared Airlink 223 "direct TULMI". Prior to issuing this clearance the controller should have checked the proposed route for any possible conflicts. That neither the controller nor the planner identified ZK-FGZ as being a likely hazard was concerning, especially since the controller had only 2 minutes previously cleared ZK-FGZ to operate in the Mercer PDA. What may have influenced the controller at this time was earlier seeing the radar target representing ZK-FGZ positioned west of Mercer and heading further west as it was climbing and before he cleared it to operate within the PDA.
