Transport Accident
Investigation
Commission

Final report

Marine inquiry MO-2021-205
Container vessel Moana Chief
Serious injury to crew member
Port of Auckland, New Zealand
10 December 2021

April 2023

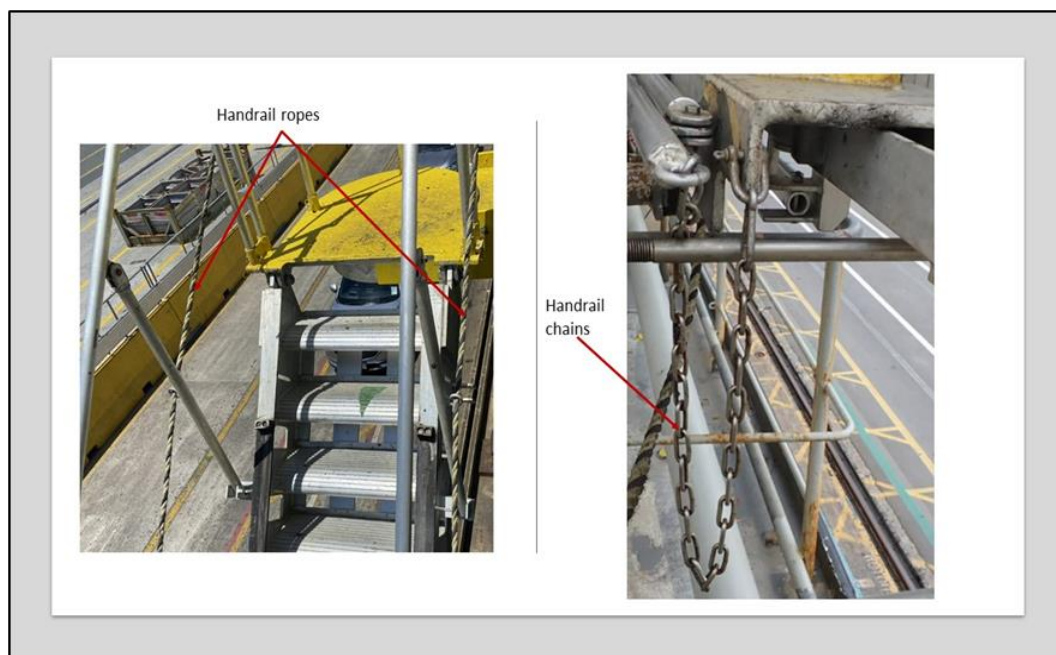
Figure 6: Handrail ropes and chains

- 2.14 The EWR walked down to the bottom platform and the IR walked down to the top of the lower ladder. They untied the handrail ropes but left the handrail chains in place, which was the normal procedure (see Figure 6).

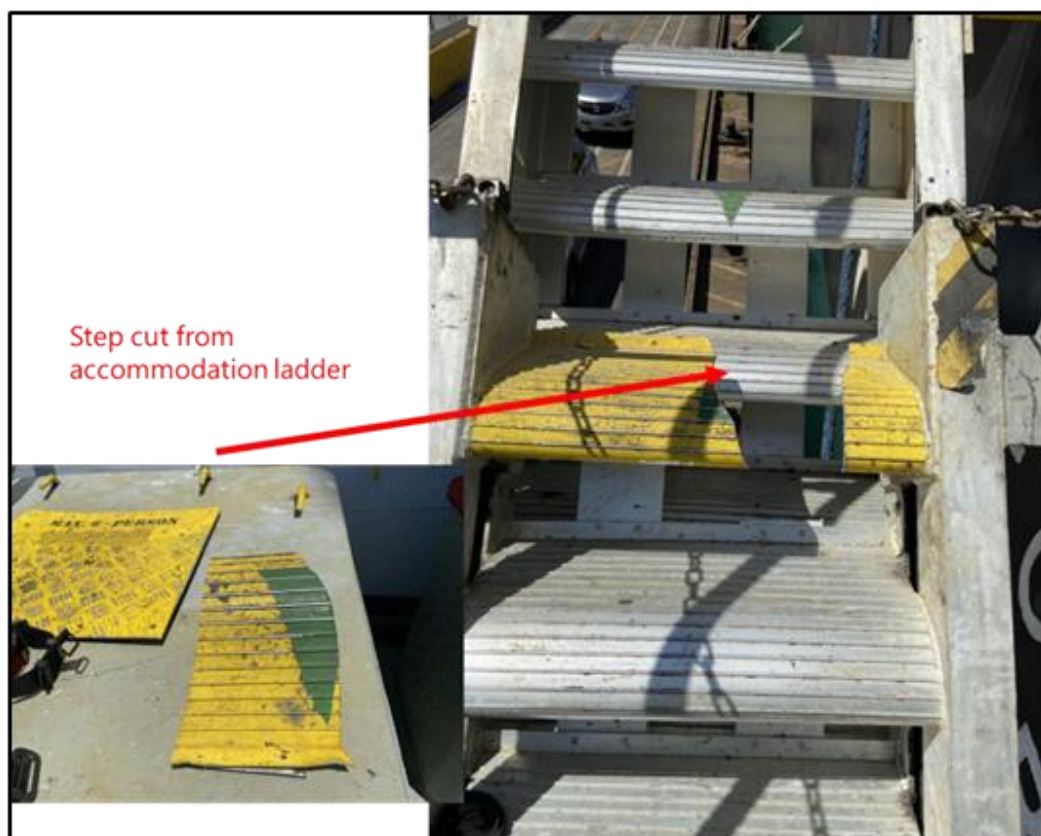
Figure 7: Step cut from the lower section of the ladder

- 2.24 The Master saw that the EWR was sitting on the ladder with their left leg trapped between the steps and immediately advised the Pilot that there had been an accident and asked them to inform Harbour Control.
- 2.25 The crew wedged timber between the steps to ease the weight on the EWR's leg and prevent further injury. The crew assured the EWR that they were doing everything possible to free them from the ladder. At approximately 0736 an ambulance was requested.
- 2.26 The vessel's crew considered various options before deciding that the safest option to free the ERW's leg was to cut the step. At approximately 0752 the ladder step was cut away (see Figure 7) and the EWR's leg was freed. At about the same time the first responders boarded the vessel.

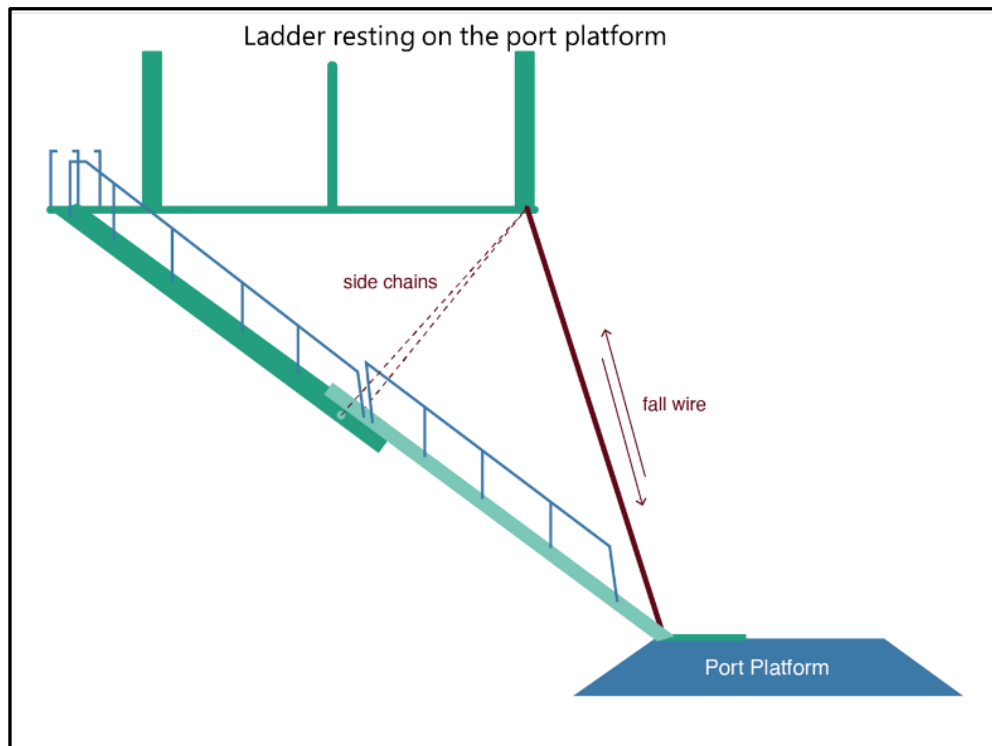
Figure 11: Ladder resting on the Port platform

- 2.50 When the weight of the upper ladder was supported by the side chains, further slackening of the wire allowed the lower ladder to slide out (see Figure 11). The operation was complete when the lower ladder reached the desired target area (the Port platform) on the wharf.

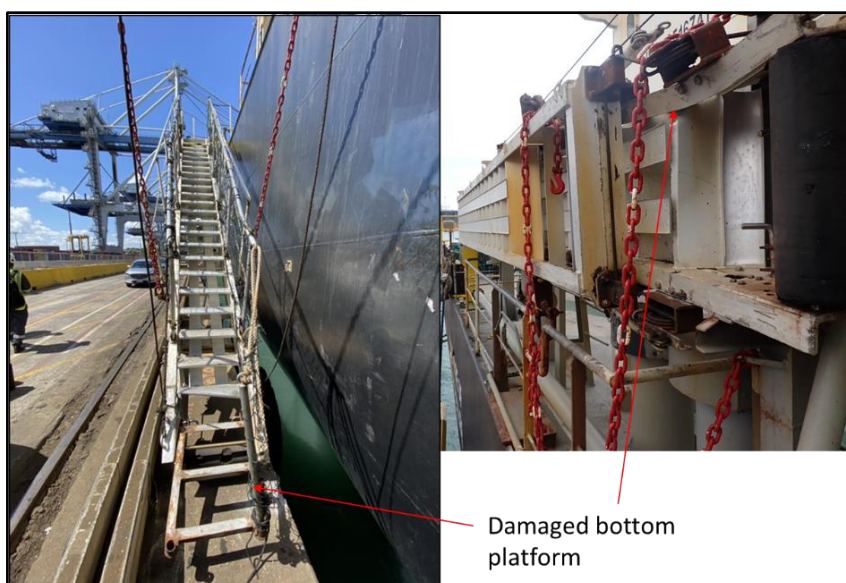
Figure 13: Photos showing damaged bottom platform of accommodation ladder

2.68 Before the injured EWR was safely moved to the poop deck, the bottom platform of the ladder was crushed between the wharf and the vessel's side, when the mooring line was tightened. A Ports of Auckland CCTV camera recorded the occurrence (see Figure 13).

2.69 The ladder was retrieved and stowed after the incident. The bottom platform was badly damaged, which made the ladder unsafe for any further use.

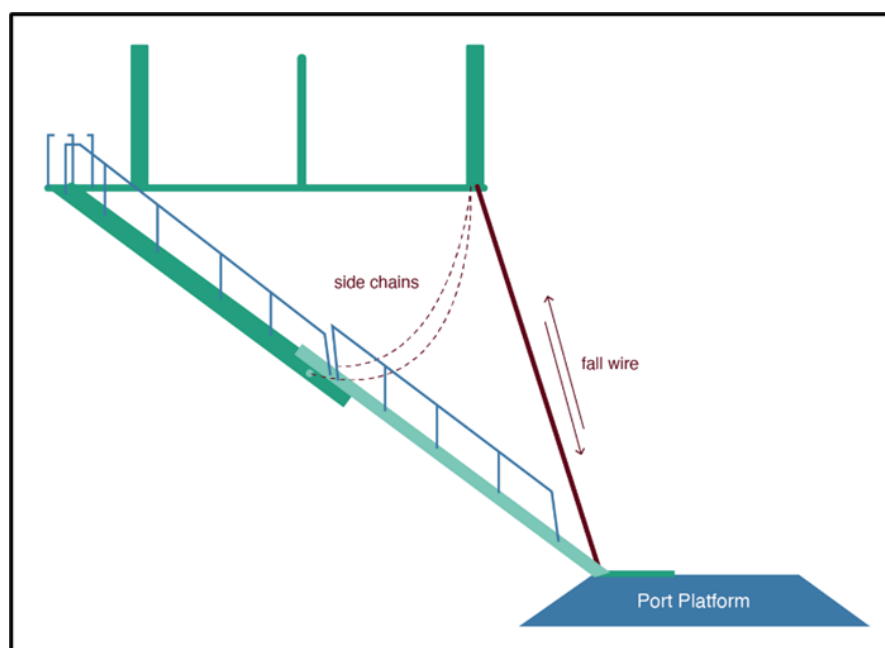
Figure 14: Accommodation ladder before the accident

- 3.4 Once the EWR had cleared the inboard handrail chain they picked up the outboard handrail chain and held onto both to prevent them from getting caught again. While holding the handrail chains the EWR stood on a ladder step close to the top of the fixed ladder.

- 3.5 As the CIR resumed heaving on the fall wire to retract the lower section of accommodation ladder, the ladder dropped off the Port platform. Because the side chains were slack and not supporting the fixed upper ladder (see Figure 14) the weight was transferred from the Port platform and onto the fall wire. It resulted in an unexpected and uncontrolled upward movement of the lower ladder.

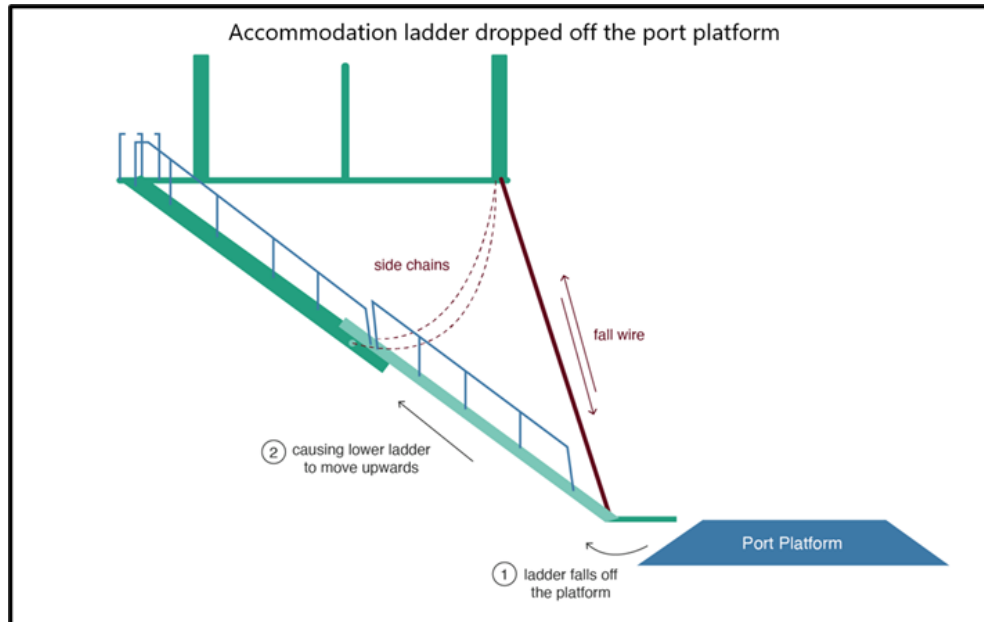
Figure 15: Accommodation ladder dropped off the Port platform

- 3.6 The lower ladder slid upwards in its interlocking guides and before it reached the end point trapped the EWR's leg between the top step of the lower ladder and the third step of the fixed upper ladder (see Figure 15).

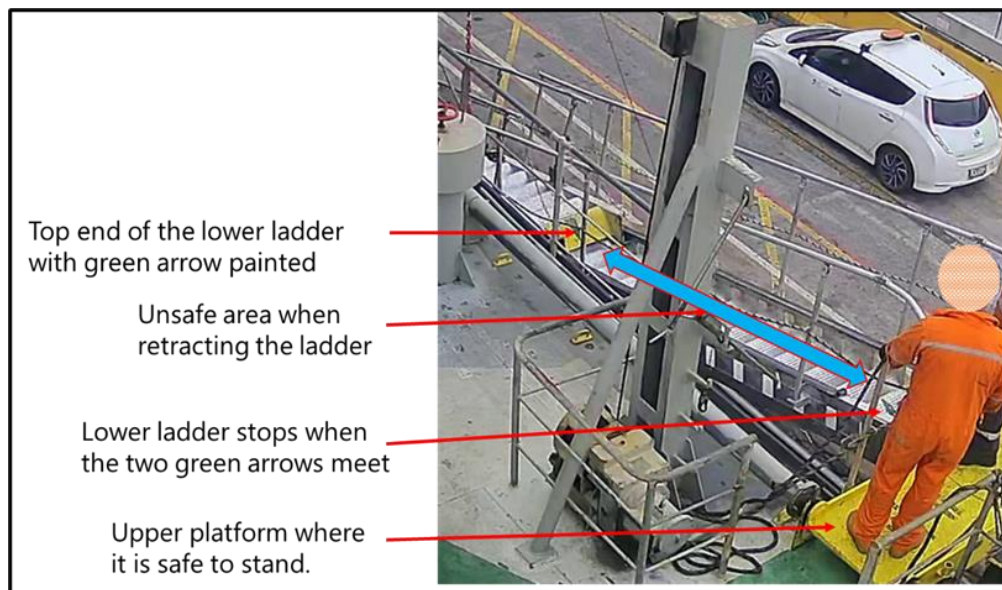
Figure 16: Yellow steps and green arrows marked on the accommodation ladder

- 3.7 The EWR had stood between the two green arrows marked on the steps of the upper ladder. As a result they were positioned, and working, in an area that had been identified as unsafe (see Figure 16). The arrows were a preventative safety action taken in response to a previous accident on another vessel.
