Interim report AO-2017-009: Boeing 787-9, registration ZK-NZE, Trent 1000-J2 engine failure near Auckland, 5 December 2017; and AO-2017-010: Boeing 787-9, registration ZK-NZF, Trent 1000-J2 engine failure, near Auckland, 6 December 2017

Aviation Interim Report Combining:

Boeing 787-9, registration ZK-NZE
Trent 1000-J2 engine failure
near Auckland, New Zealand
5 December 2017, and

Boeing 787-9, registration ZK-NZF
Trent 1000-J2 engine failure
near Auckland, New Zealand
6 December 2017

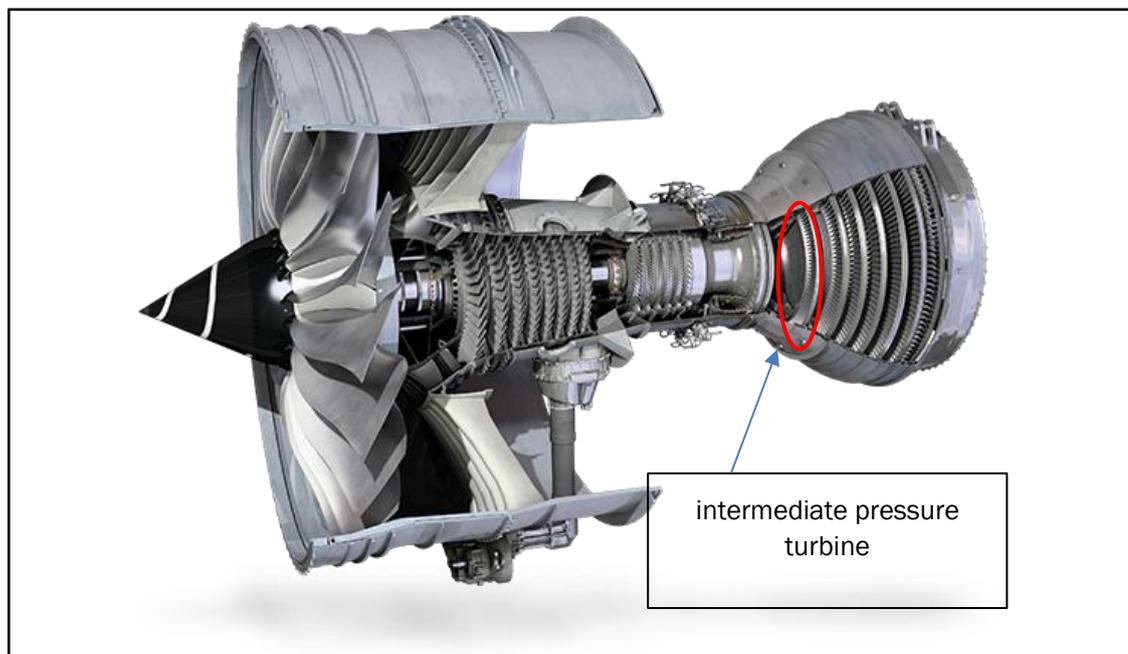
Figure 1
Cut-away of Trent 1000 engine
(courtesy of Rolls-Royce PLC)

- 2.1.4. In both cases an initial borescope inspection found that a turbine blade in the intermediate-pressure turbine (IPT) module had fractured and separated from the IPT disc (see Figure 1). Features were identified that indicated corrosion fatigue cracking had occurred. In the first occurrence the released blade caused significant damage to the IPT and low-pressure turbine modules. Small pieces of the turbine and stator blades were ejected through the exhaust nozzle and struck the leading edge of the right horizontal stabiliser. Some pieces also chipped the underside of the wing and the side of the fuselage towards the rear, but these did not cause significant damage. The damage in the second occurrence was mainly confined to the IPT module.

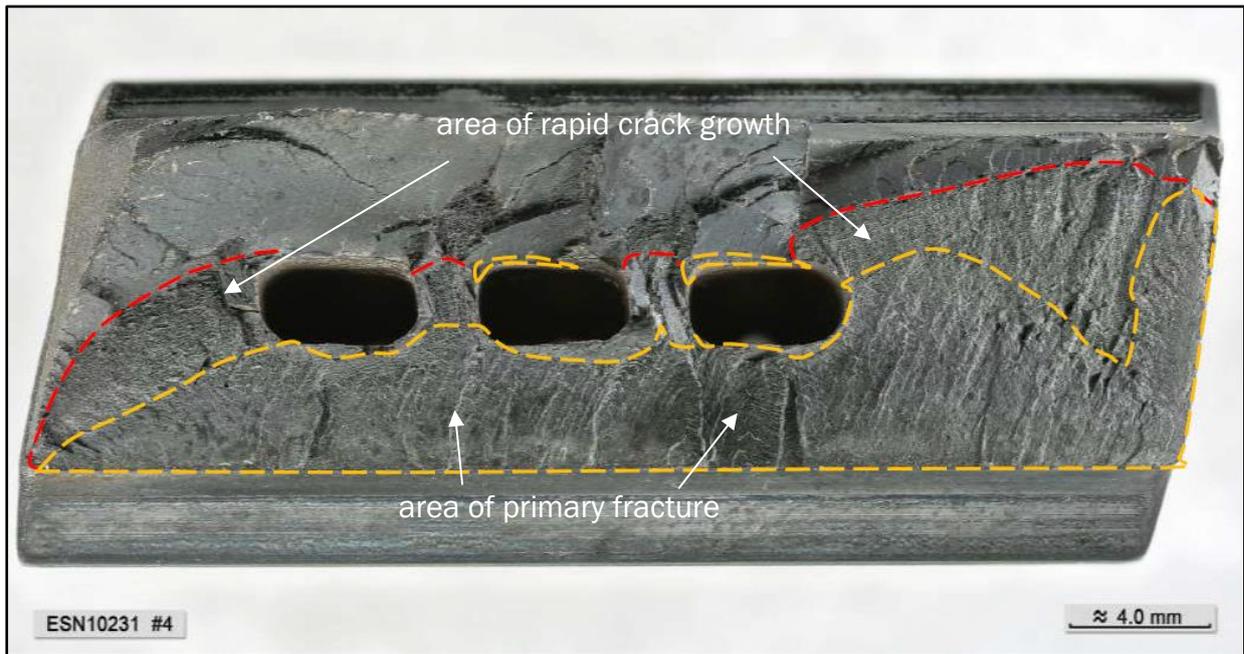
Figure 2
Shank of fractured IPT blade from engine serial number 10231

- 2.4.5. The teardown examination of engine 10231 found that the corrosion fatigue crack in the failed blade was deeper than the model predicted for a critical crack (see Figure 2). Therefore the assumed crack progression rate may have been understated for that engine. Rolls-Royce said that similar crack depths had been seen on some other failed blades, but with a higher number of cycles. If a CFL offset of minus 400 cycles¹⁵ had been in place for the operator’s fleet before the incidents, both engines would have been removed from service before the blades failed (see Section 4, Safety actions).

- 4.4. The engine manufacturer advised the Commission that the maximum depth of cracks on the failed IPT blades was 6.2 millimetres for engine 10231 and 5.9 millimetres for engine 10227. It advised that as these crack depths were in keeping with the CFL model predictions, it saw no need to again amend the baseline CFL model.
