Transport Accident  
Investigation  
Commission

# **Final Report**

***Rail inquiry RO-2019-108  
Level crossing collision  
Piako Road, Morrinsville  
7 December 2019***

**November 2021**

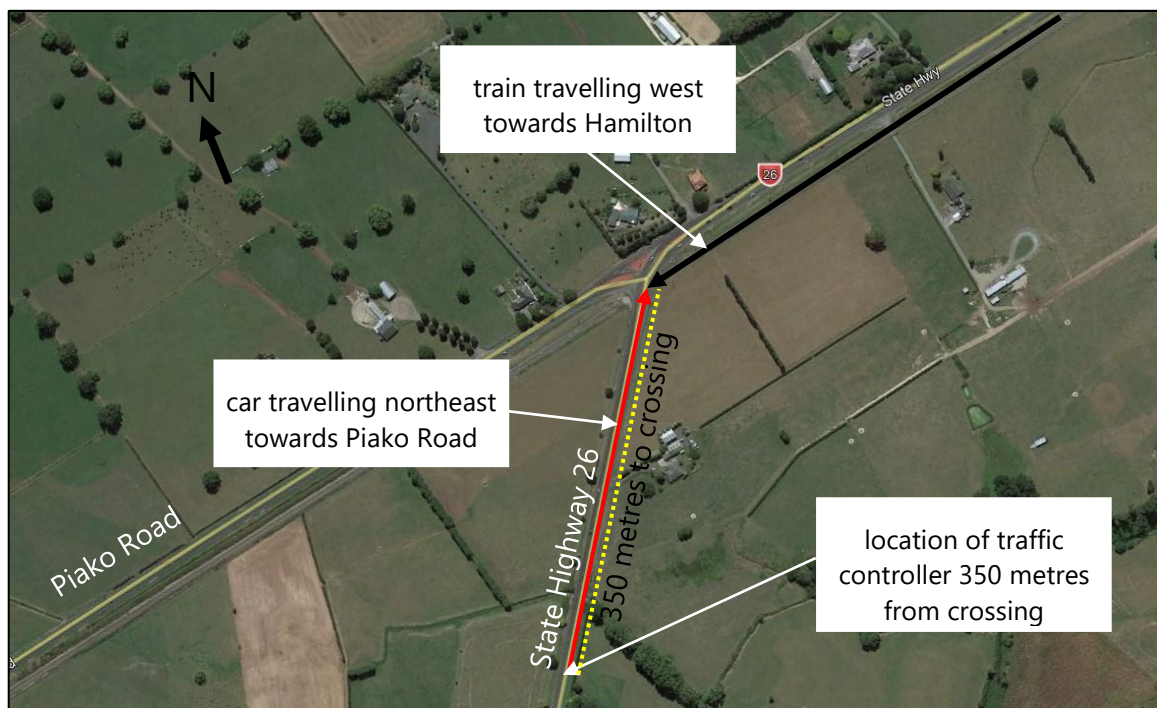
**Figure 3: Satellite view of accident site**  
(Credit: Google Maps modified by Transport Accident Investigation Commission)

- 2.18 At 0407 the car entered the crossing directly in front of Train 320. The car was struck in the middle of the driver's side by the locomotive (see Figure 3).

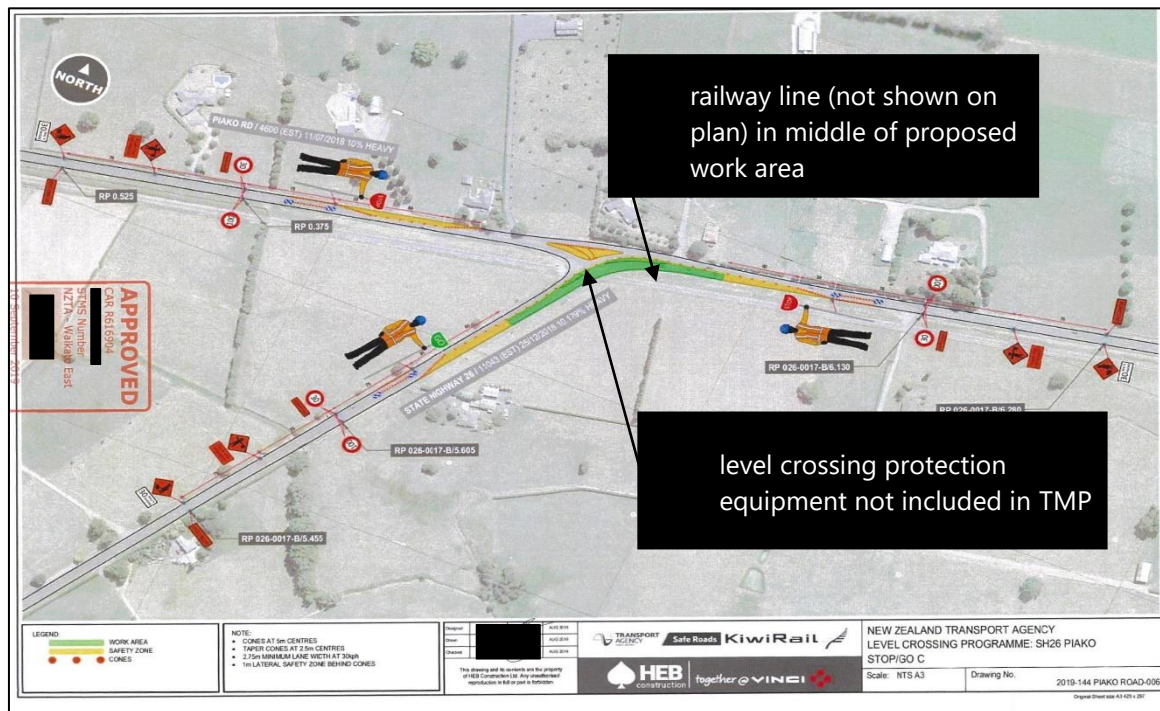
**Figure 4: Approved TMP**  
(Credit: Higgins, modified by Transport Accident Investigation Commission)

- 3.7 The work had been approved by means of a TMP, which had been signed off by Higgins on behalf of Waka Kotahi in September 2019 (see Figure 4).
- 3.8 The TMP included information regarding the positioning of warning signs, road cones and traffic controllers in relation to the proposed work.

- 3.9 The TMP approved by the contractor under delegated authority from Waka Kotahi did not identify the rail corridor and crossing within the work area. This was contrary to the advice in Waka Kotahi's own publication, Traffic Control Devices Manual Part 9 (NZ Transport Agency, 2012), which stated in part:

- 3.10 Although required by the TMP approving authority, the absence of any reference to the rail corridor meant that the planning of the proposed work did not consider the danger to road and rail vehicles approaching the crossing, and subsequently no added protection was required to be put in place while the work was being carried out.
- 3.11 Vehicles were signalled through the roadworks area towards the crossing. Specific protection had not been put in place to ensure that road users would comply with crossing alarm warning devices as they normally would in the absence of any roadwork activity.
- 3.12 A lack of specific protection for the crossing within the work area increased the risk to road and rail vehicles.
- 3.13 The Commission has made a recommendation to address this issue in section 6.

- 6.5 **On 27 October 2021 the Commission recommended that Waka Kotahi review its current auditing of agencies delegated to approve traffic management plans, to ensure that applicants developing traffic management plans identify any rail crossings within the vicinity of proposed work and that the rail access providers have been consulted to ensure that any additional safety requirements in relation to the road/rail interface are met. (006/21)**

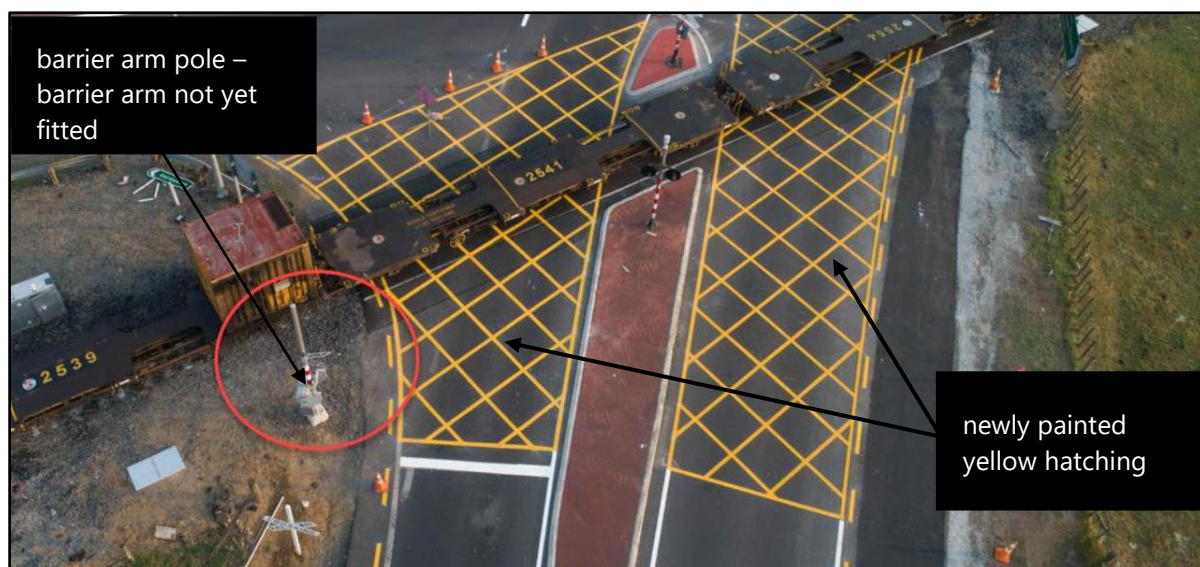
**Figure 5: Painted hatching at the crossing**  
(Credit: KiwiRail, modified by Transport Accident Investigation Commission)

- 3.15 Before a PTE was granted, a series of checks was to be made to ensure there was no unacceptable risk to KiwiRail assets and users of the rail corridor.
- 3.16 On this occasion, the contractor requested that an existing PTE granted for a different location be extended to cover the State Highway 26/Piako Road crossing.
- 3.17 The National Corridor Permit Manager questioned the request, as it did not follow the correct protocol. After a period of correspondence on the matter, communication ceased. The request was not followed through and a PTE was not issued for the crossing.
- 3.18 The work requiring a PTE was the painting of yellow road markings (hatching) that denoted the danger area for road users close to the crossing. This work went ahead despite a PTE not having been issued (see Figure 5).

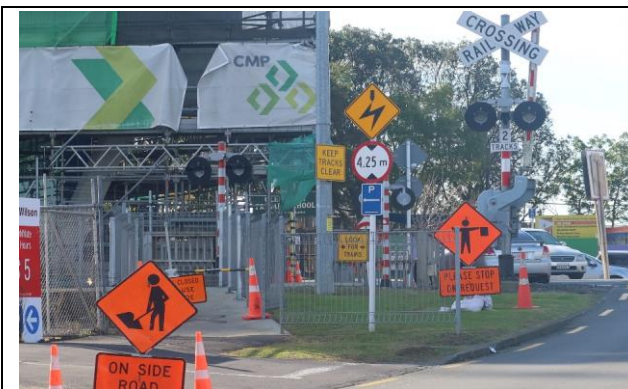
Example of confusing signage as approaching a level crossing.

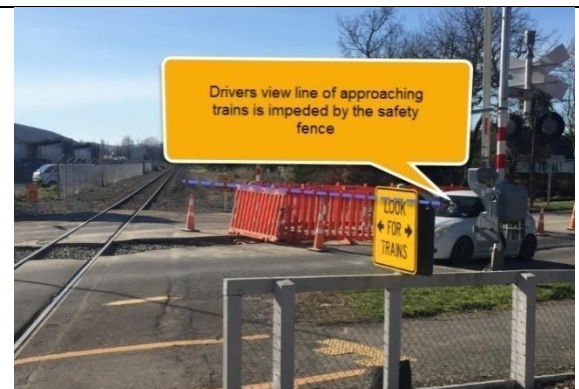
Example of driver view lines where fencing is used in proximity to the rail corridor

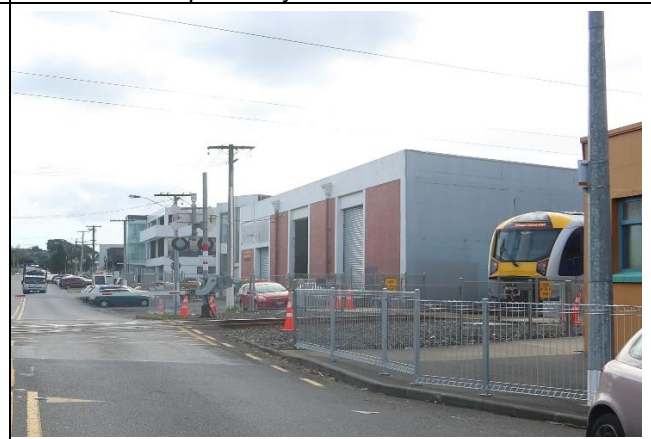
View of signalling when crossing is activated on the wrong side of the road (half-arm barrier has very low visibility and flashing lights are not observable)

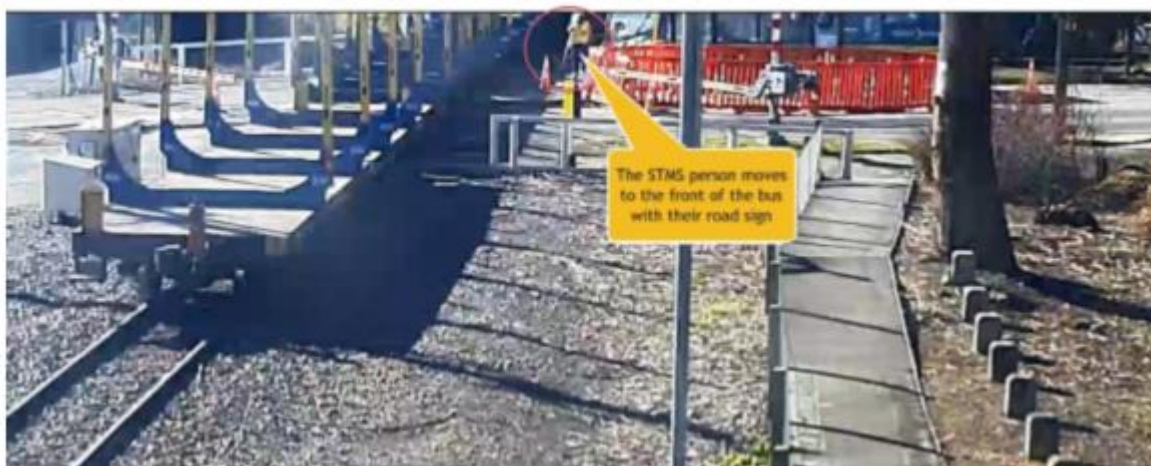
Figure 10: STMS person positioned near the front of the bus.

A temporary traffic management system had been established for excavation work being undertaken on Renall Street. The system diverted road users through side roads away from the crossing. A passenger bus service was granted special permission supported by the local council to travel through the worksite and over the wrong side of the crossing. A passenger bus approached the crossing as the half-arm barrier activated blocking the bus from exiting the crossing. The driver stopped the bus and reversed clear of the tracks. Less than 10 seconds later a freight train proceeded over the crossing. As the train is proceeding over the crossing the STMS placed themselves between the front of the bus and the passing train wagons shown in figure 10 below.

Rail protection and bulletins are required to protect people from rail movements where activity is underway within 5m of the track centre line.
