Watchlist

Safety for pedestrians and vehicles using level crossings

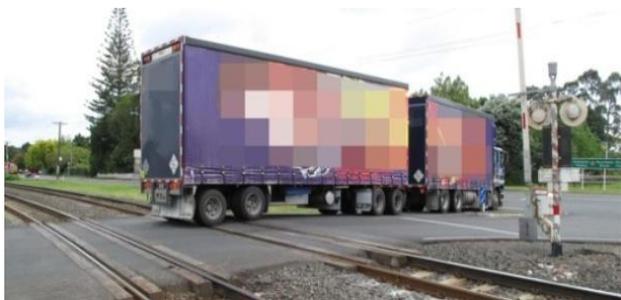
A total of 362 level crossings with short stacking distances are rated as high risk.² At level crossings with a short stacking distance, a long vehicle, even though it complies with road regulations, is unable to clear the level crossing when stopping at an adjacent road intersection. Similarly, the profile (the rate of change in gradient) of level crossings may not be compatible with vehicles that have low, albeit legal, ground clearance. A train colliding with a heavy vehicle is a serious safety issue.
