Transport Accident
Investigation
Commission

Watchlist

Safety for pedestrians and vehicles using level crossings

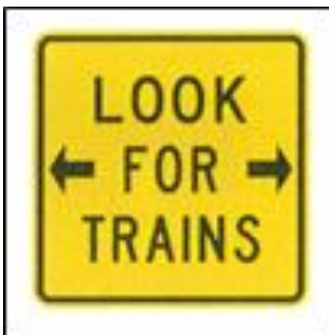
In early 2015, the Commission opened an inquiry into a pedestrian fatality at Morningside, a metropolitan railway station in Auckland.¹ The investigation highlighted how changes to the rail infrastructure can inadvertently compromise safety. For example, at Morningside, the design of the existing pedestrian 'maze' at the station was constructed to force pedestrians to face in the direction of approaching trains before they turn and cross the tracks. But with increasing rail traffic at Morningside, signalling changes were made to allow trains to run in both directions along the tracks. The change meant trains could approach from behind pedestrians, so defeating the maze design.

The Commission found the process for assessing risk at pedestrian crossings is not keeping pace with the infrastructure changes and increasing patronage on metropolitan passenger trains.

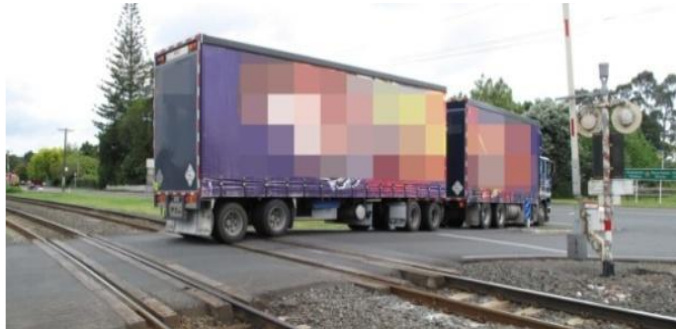
In 2016, the Commission closed an inquiry into a train and truck collision at a level crossing near Rangiriri in 2014.³ Because of the permitted train speed and available sight lines at the crossing, it was possible that a truck would be unable to safely cross after stopping and confirming it was clear.

We recommended that Waka Kotahi NZ Transport Agency work with KiwiRail and all road controlling authorities to ensure assessments of rail level crossings include a measure of the road profile and compatibility with the allowable dimensions for long and low road vehicles. The recommendation was implemented. We have made similar recommendations in earlier reports.⁴ An urgent recommendation made in relation to a crossing (at Beach Road in Paekakariki) has also been implemented.³
