# RAILWAY OCCURRENCE REPORT

02-101 derailments due to washouts and slips, various trains and locations

between 3 January 2002 and 19 January 2002

## express freight Train 841, Buller Gorge, 3 January 2002 express freight Train 929, Rangitata, 4 January 2002 express freight Train 720, Mina, 19 January 2002

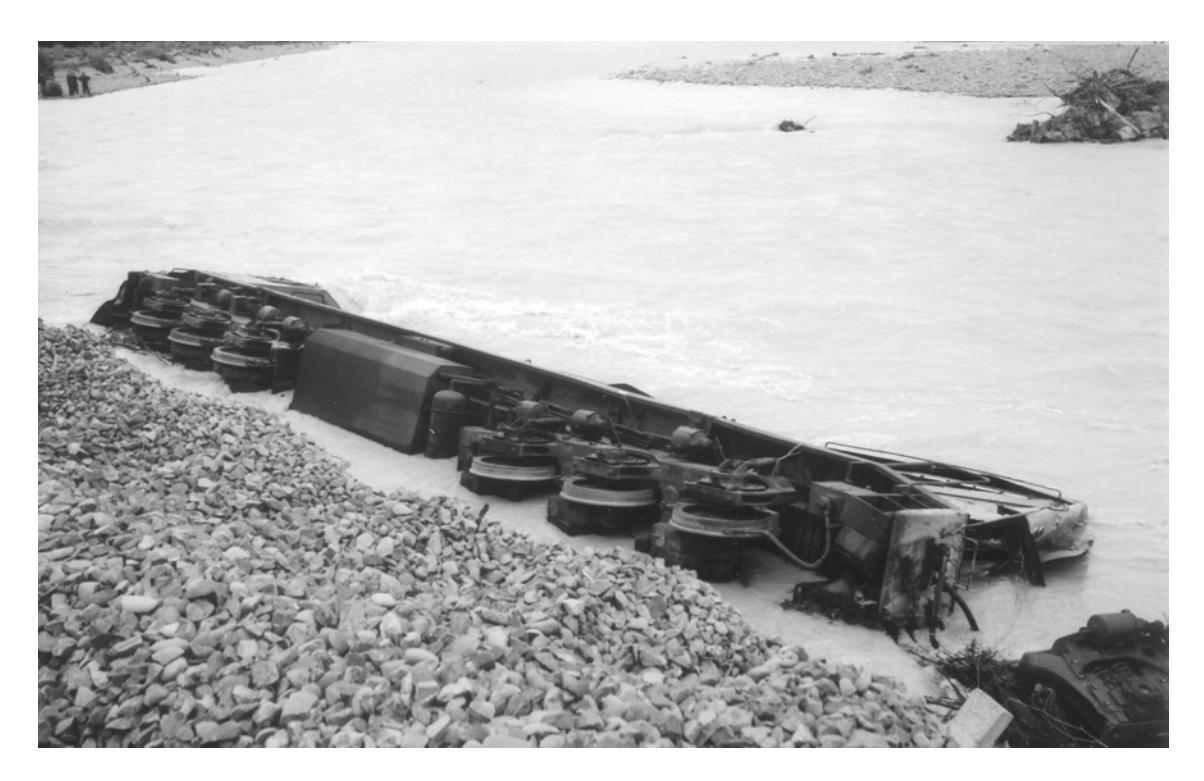
- 2.1.5 As the locomotive traversed the washout, it toppled from the track formation and crashed into the river below. It came to rest on its side with the cab quickly filling with water. The locomotive engineer, who had been thrown back to his original side of the cab as the locomotive tipped, eventually located a broken window and was able to escape from the cab and climb on to the side of the locomotive above the water level.

Figure 1 The leading locomotive, DX5195, after the water level had subsided

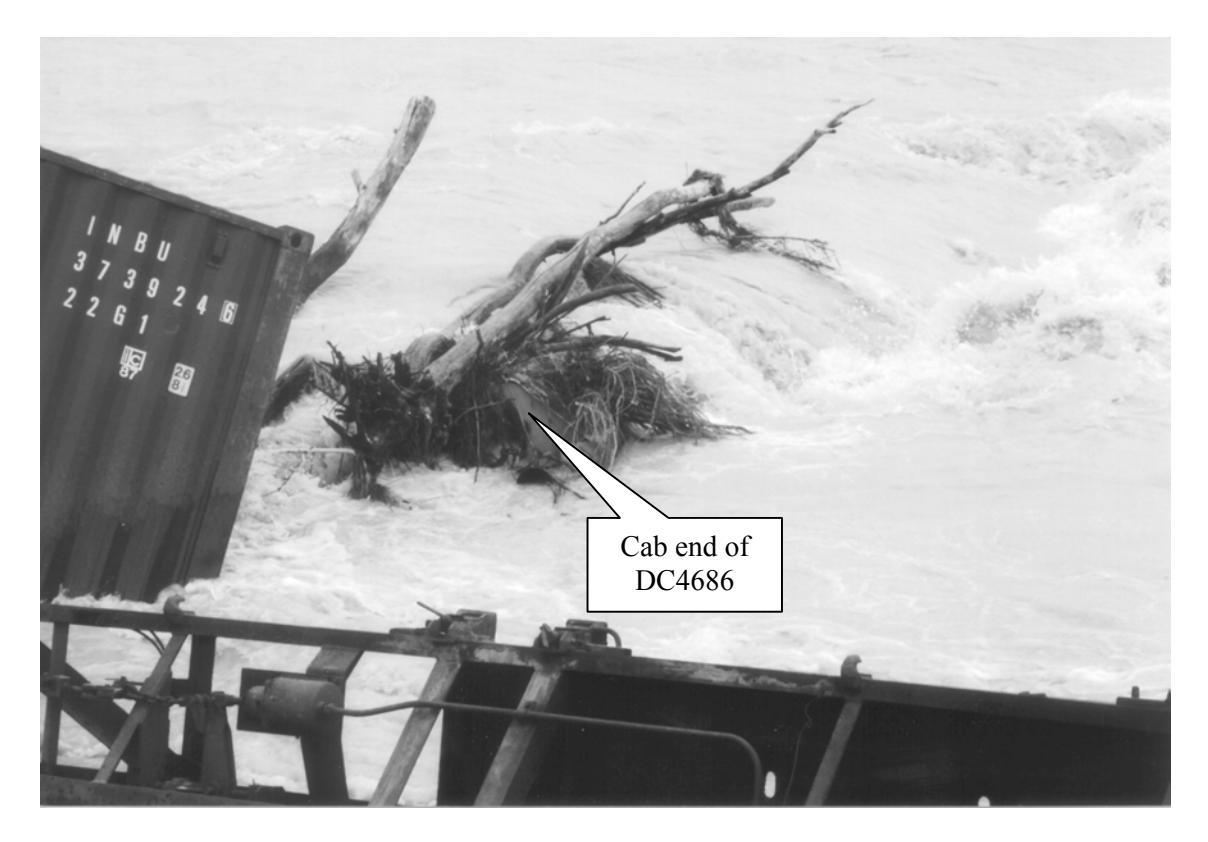
Figure 2 The second locomotive, DC4686, lying at right-angles to the track formation

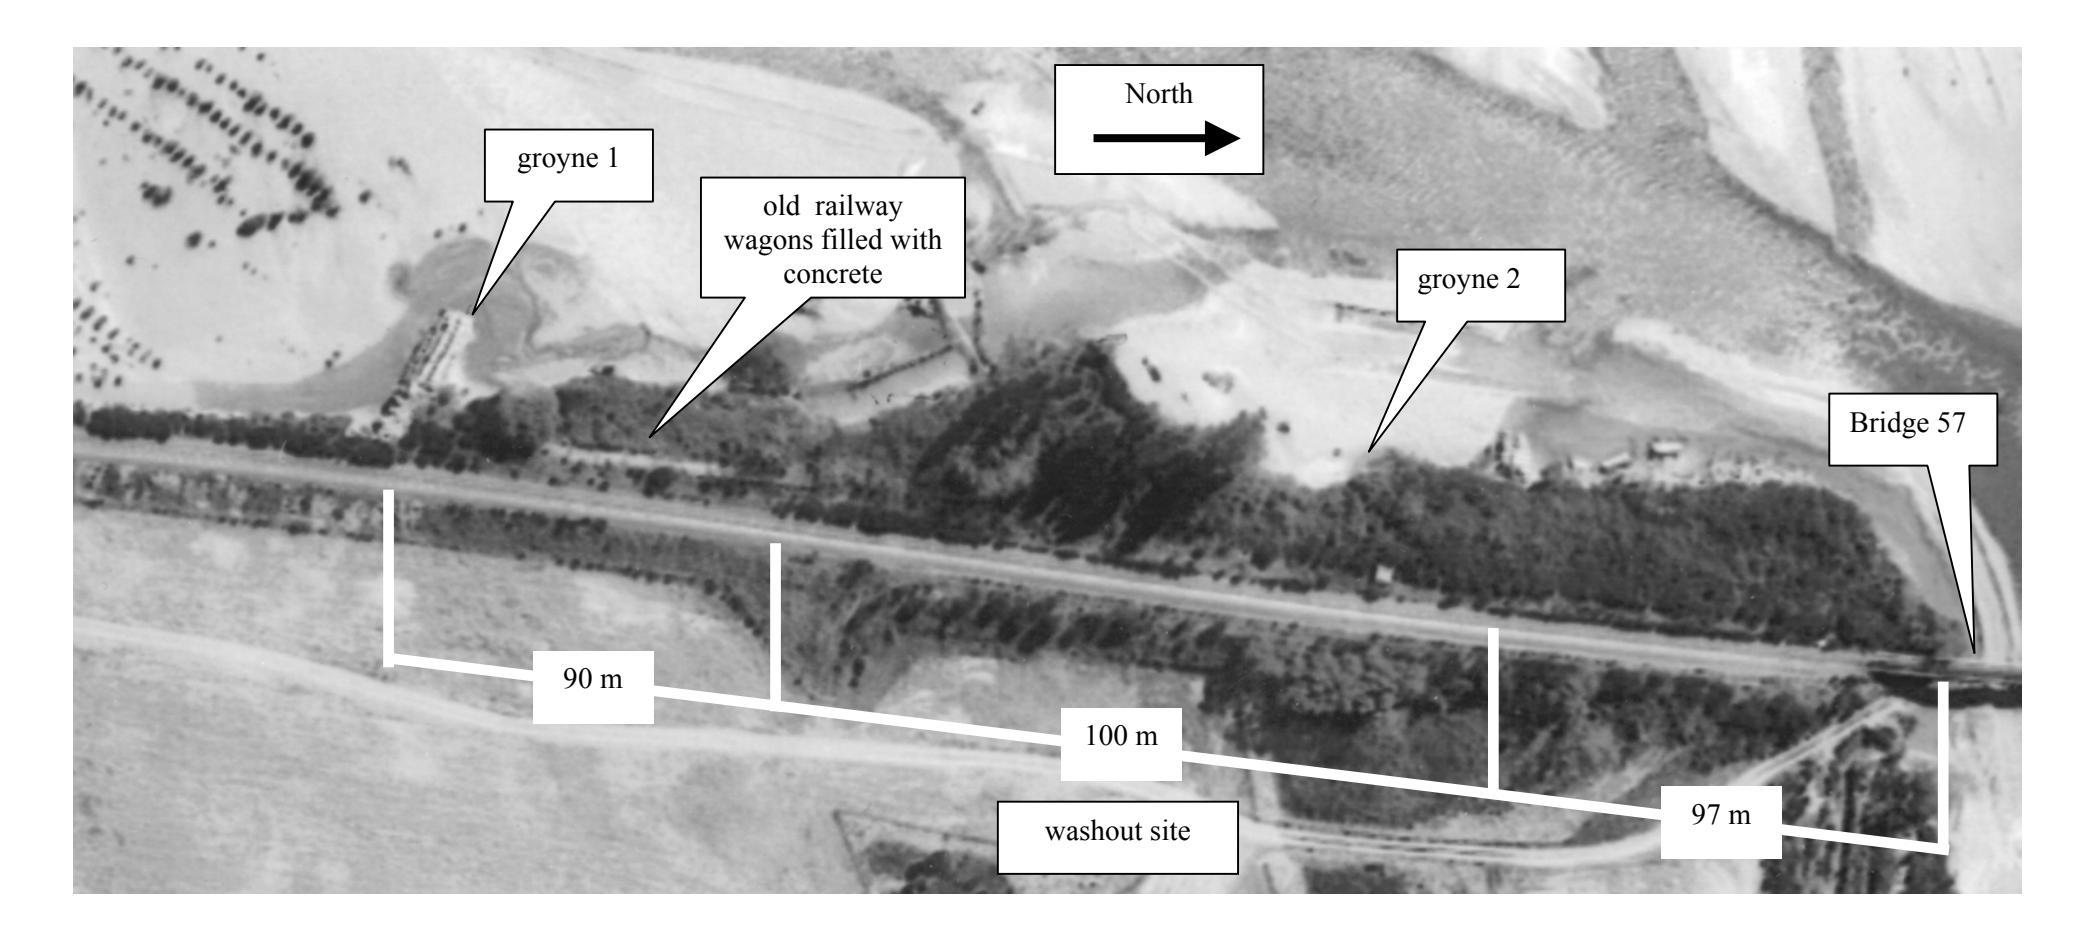
Figure 3 Aerial view of the washout site taken in March 2001 (reproduced from a photograph courtesy of Transit New Zealand)

- 2.5.1 Groyne 1 was designed to protect the land mass by deflecting flood waters back into the river. However, over a period of time the land mass had been eroded by the flood water flowing around the end and back behind the groyne (see Figure 3).
- 2.5.2 The water then scoured out the land beneath the concrete-filled wagons and reached the track formation (see Figure 6). Once it reached the formation the water ran against it in a northerly direction towards the rail bridge, about 300 m away. As the water level rose the track formation became saturated and piping or seepage occurred. As the land mass was eroded the track formation became further exposed and accessible to the force of the river.
- 2.5.3 Following the flood, groyne 2 was left isolated in the river (see Figure 7) as the landmass which had earlier reached it from the track formation (see Figure 3) had disappeared.

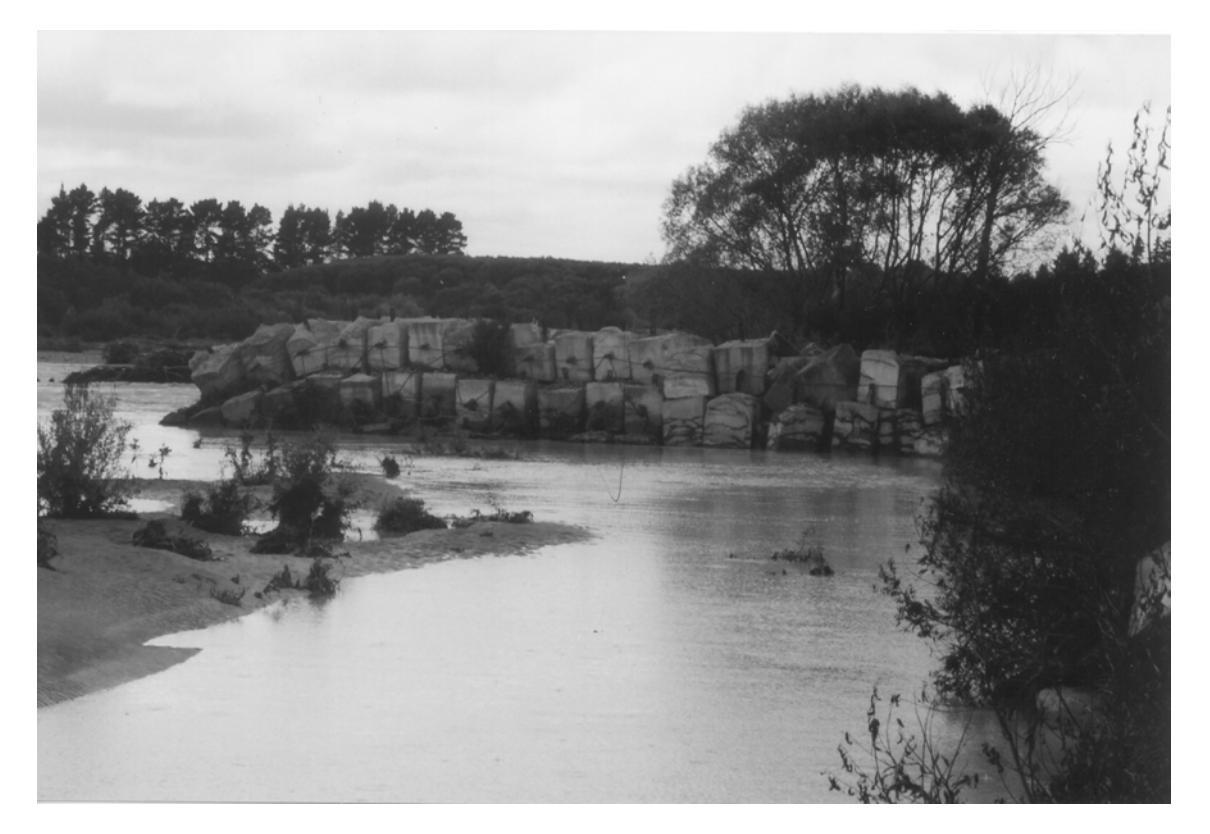
Figure 5 Looking downstream at groyne 1

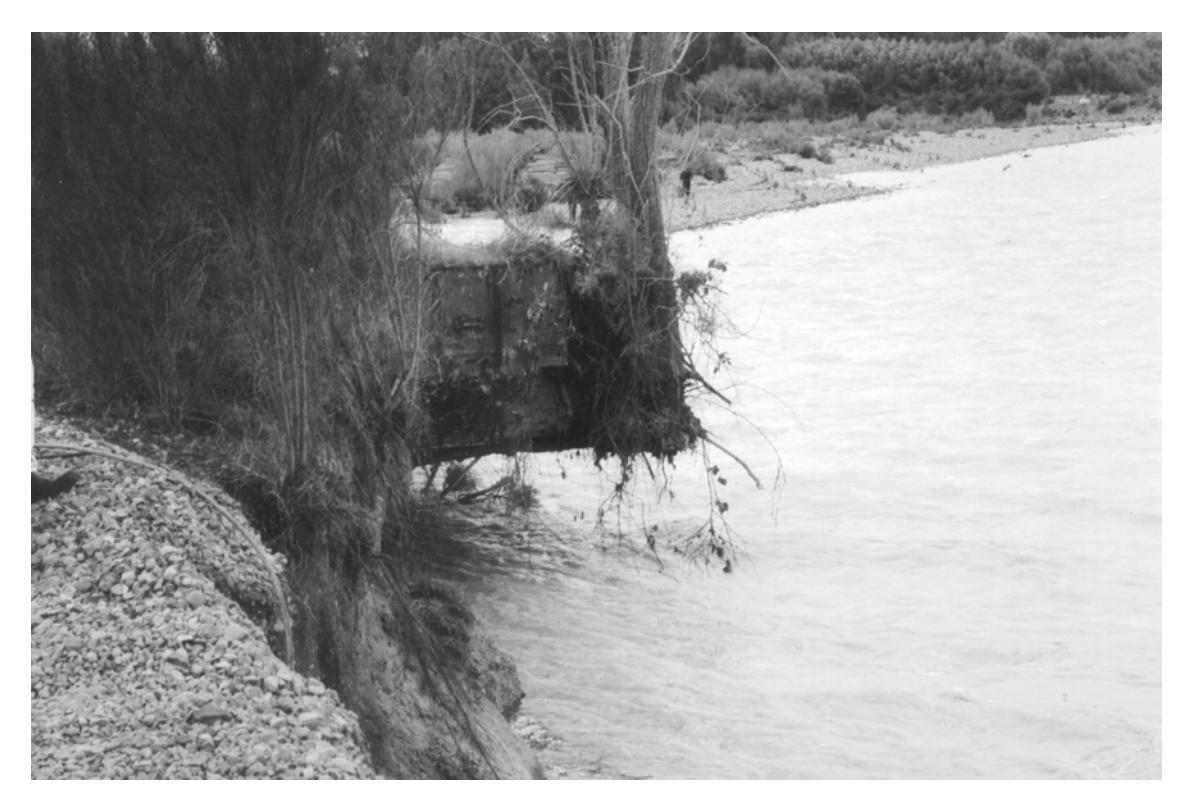
Figure 6 Looking upstream at the northernmost concrete filled railway wagon with the track formation to the left (photograph taken the day after the flood)

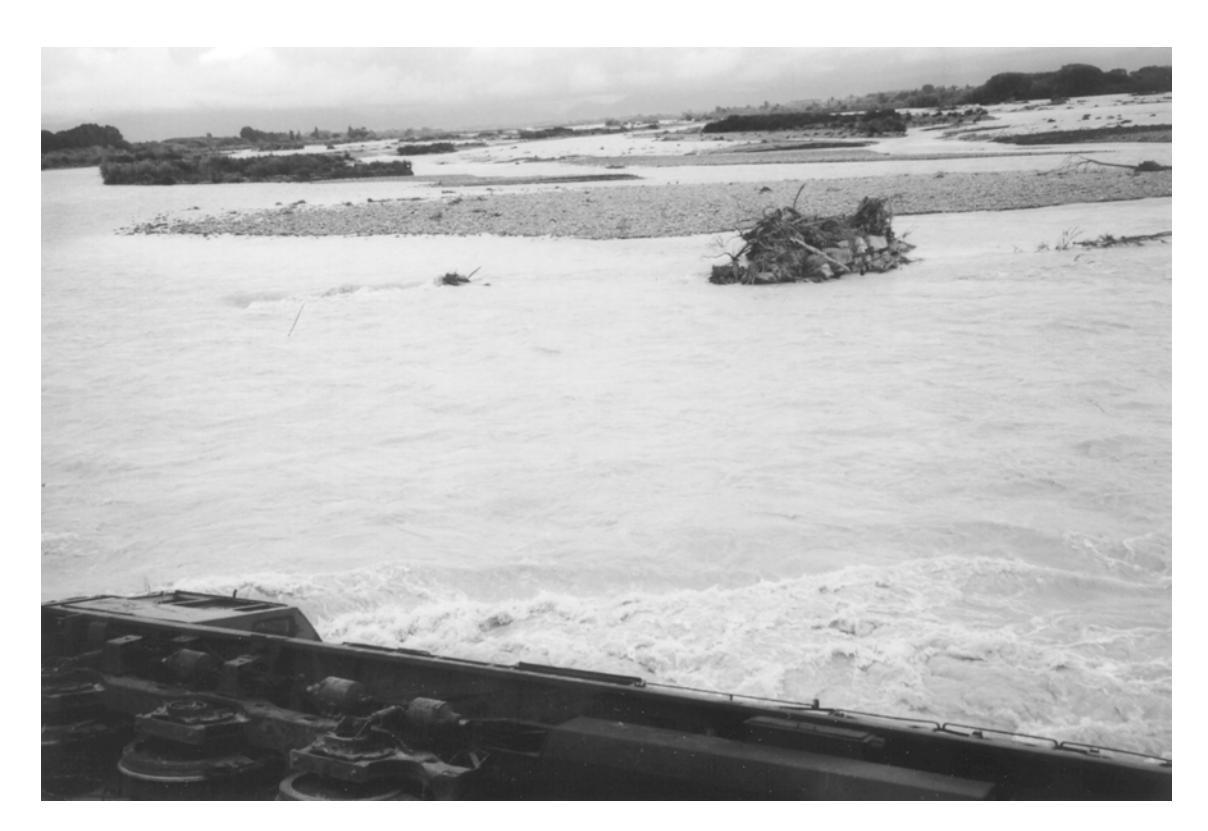
Figure 7 Groyne 2 after the land between it and the track formation had been washed away

- 2. The land mass and most of the poplar trees appeared to have largely withstood the full force of the peak of the river flow. However, some time after the local farmer's last visit the remaining trees collapsed, which probably had the effect of accelerating the erosion rate at the site. However, it was possible that the erosion of the track formation had been going on for some time but had not been visible because of the overhanging vegetation. There had been a dramatic change in the condition of the track formation between the time the local farmer did his last inspection at about 1700 hours, and the arrival of Train 929. The loss of the remaining poplar trees and surrounding land mass probably accounted for the change.

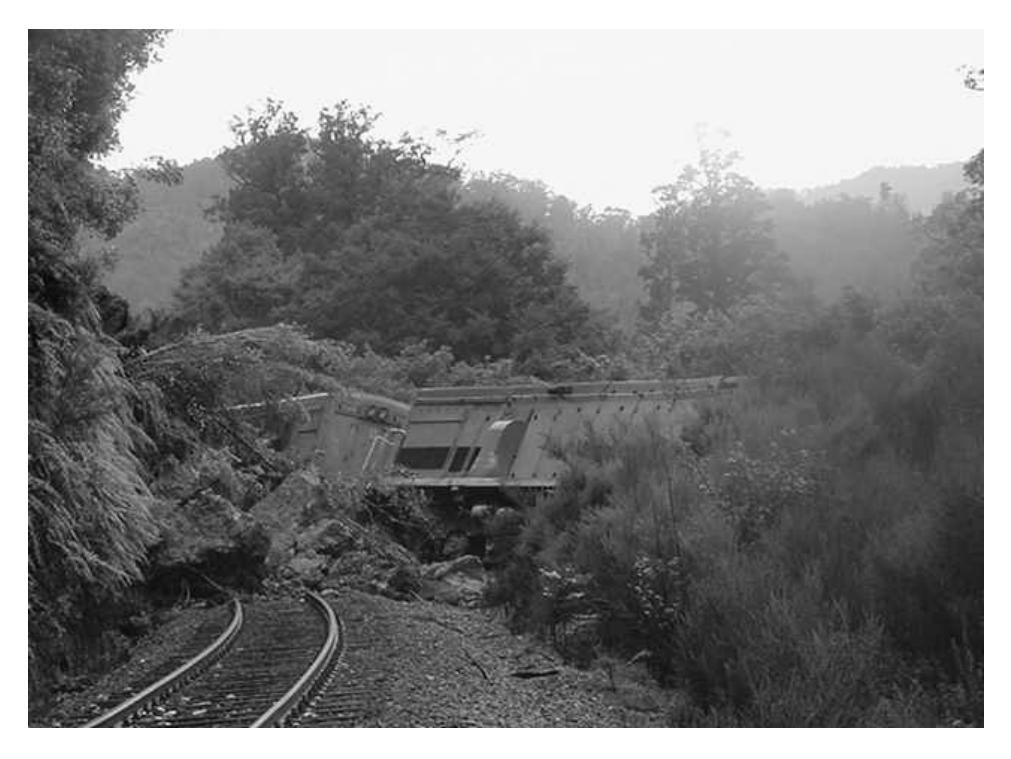
- 3.1.8 The slip occurred at the 106.5 km between Tiriroa and Inangahua. Although this was within an identified area it was not a known particular trouble spot and there had not been any slips there previously.

Figure 8 Looking south at the derailment site (photograph courtesy of Tranz Rail)

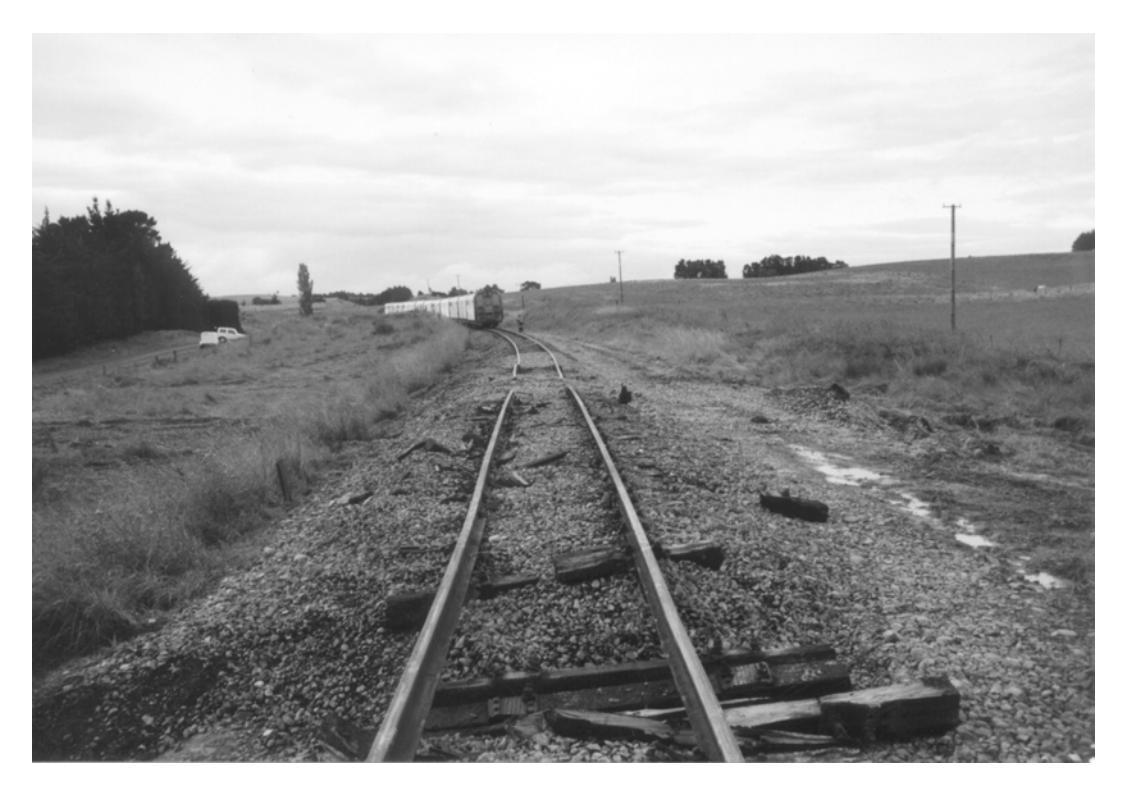
Figure 9 The washout site looking south, the direction from which Train 720 approached (photograph courtesy of Tranz Rail)

- 4.2.8 The area between the culverts rapidly filled with water, which then spread along the track formation for a distance of about 40 m north and 150 m south, and beyond the access road into the field for about 40 m. The track formation south of the culvert was later found to have been washed out in 4 places over a distance of about 100 m.

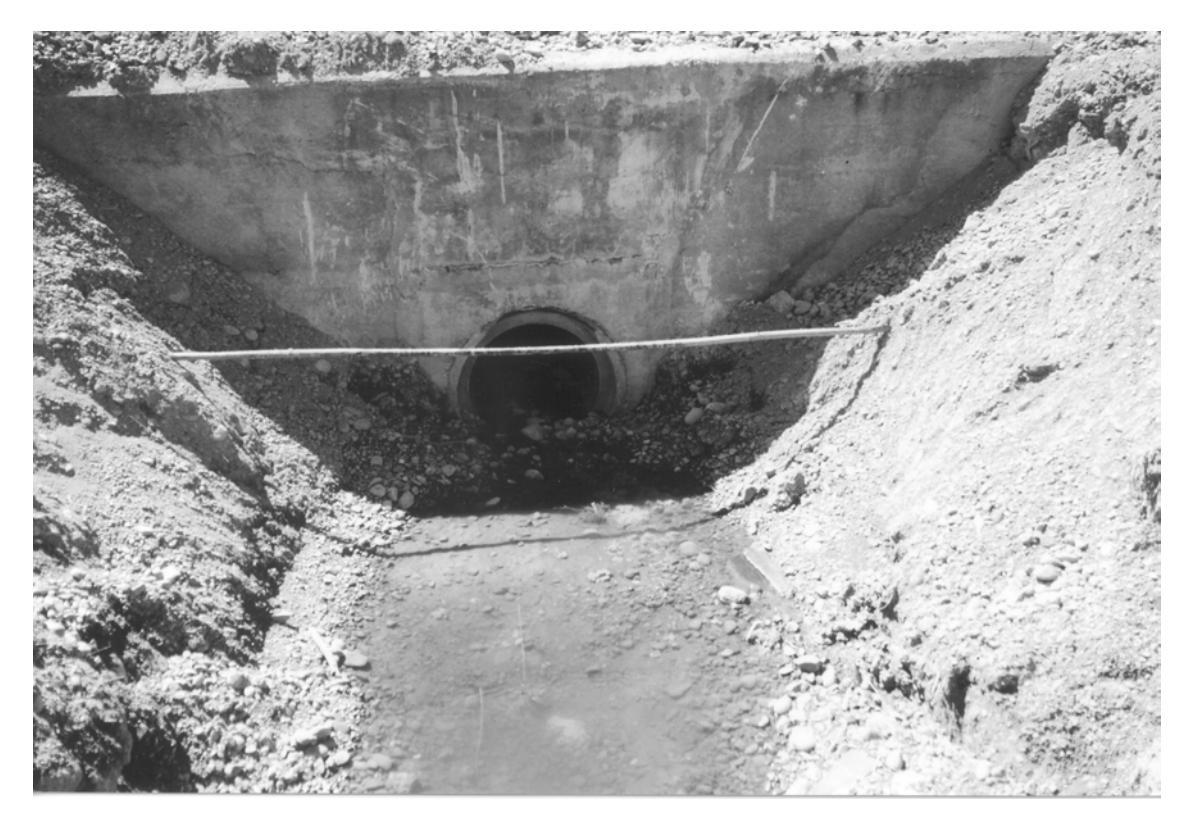
- 4.2.6 In the depression immediately west of the access road, the level to which the water had banked up could be determined from a watermark of debris in the surrounding field (see Figure 11). As the water runoff increased during the rain, the layer of netting had trapped a large amount of debris. As a result of the water building up behind it, the netting detached from the boundary fence and was pushed into the opening to the culvert beneath the access road where it subsequently blocked the water flow. The netting was later recovered from the culvert entrance.

Figure 10 The eastern intake for the culvert beneath the track formation, taken from the access road following the washout (photograph courtesy of Tranz Rail)

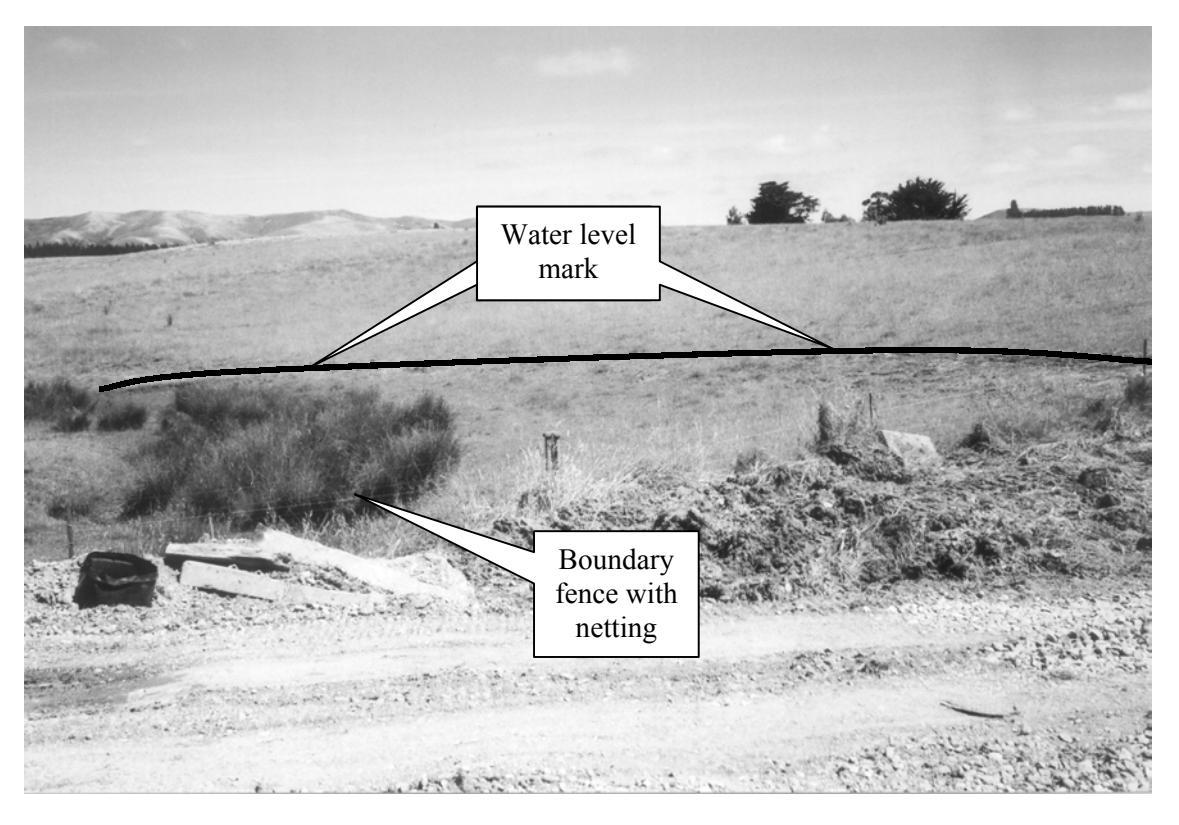
Figure 11 The depression on the western side of the access road showing the water level mark

- 4.2.7 The water banked up against the access road formation then flowed with some force over the top, taking with it clay and shingle as it flowed firstly across the access road then down into the culvert beneath the track formation. This debris settled in the culvert and impeded the flow of water. Tranz Rail had not been able to advise when the culvert was last cleaned out, but regular visual inspections had been undertaken prior to the washout and the culvert had not been obstructed at those times.
