RAILWAY OCCURRENCE REPORT

02-122	express freight Train 215, derailments, Hamilton and Te Kuiti	18 October 2002
	express freight Train 934, derailment, Sawyers Bay	25 March 2003

Report 02-122

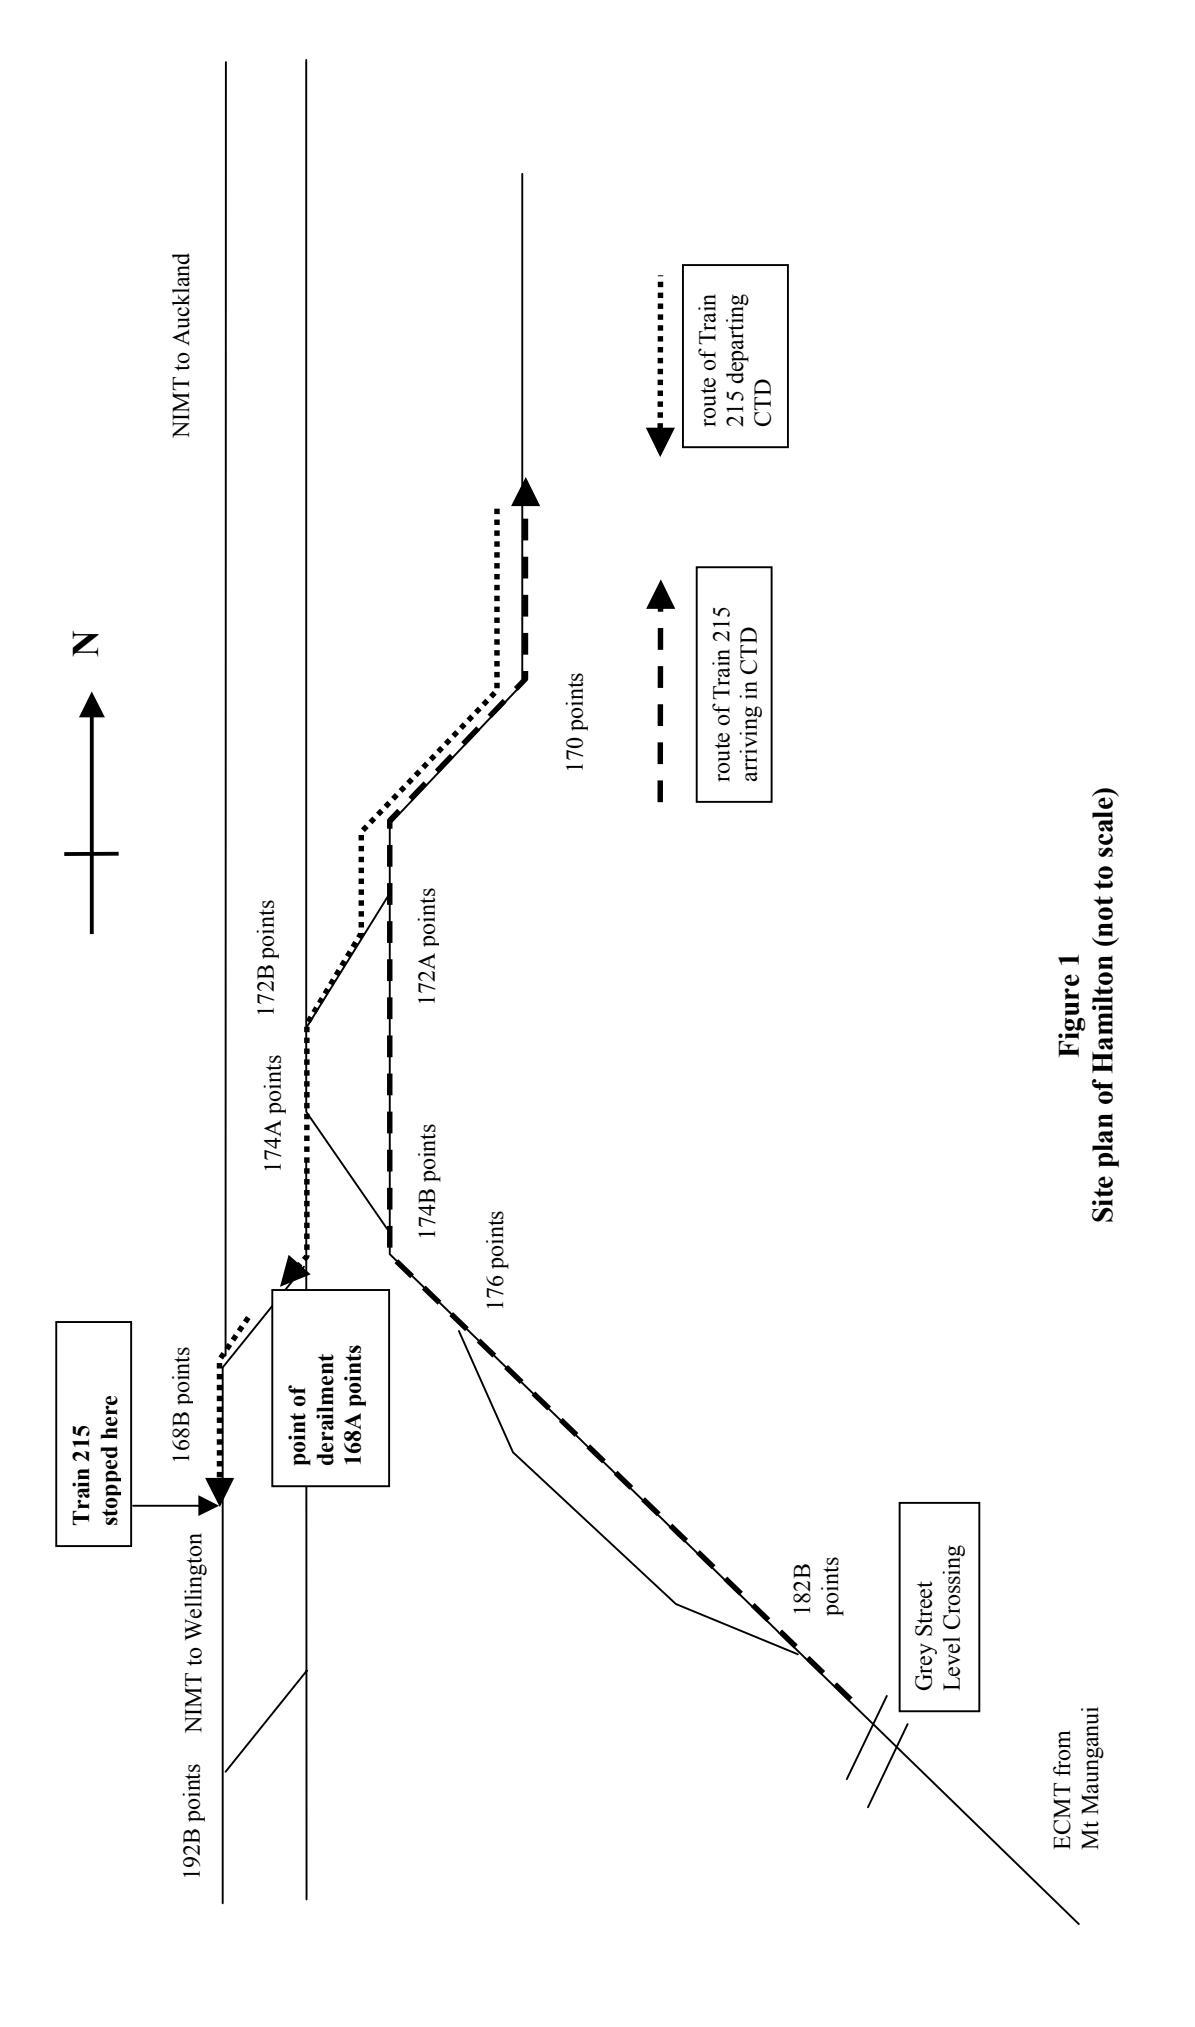
1.2.1 Following the derailment, the area co-ordinator for Transfield Infrastructure Services Ltd⁴ (Transfield) carried out a site inspection in Hamilton. He found minor damage to 182B points and 174B points (see Figure 1), minor gouging on the pavement at Grey Street level crossing, about 2.73 km east of Hamilton (see Figure 2), and ballast disturbance from the level crossing through to where Train 215 had berthed in the CTD, all of which was consistent with dragging brake rigging trailing beneath a wagon.

- 1.2.6 An inspection of the track south of the POD showed 192B points (see Figure 1), were also damaged when Train 215 departed after the derailed wagons had been detached.

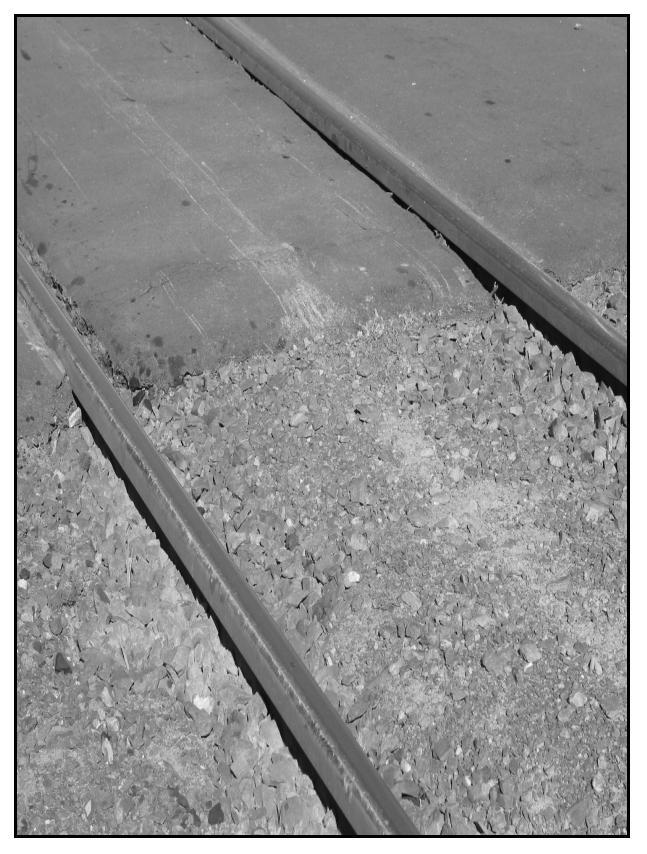
Figure 2 Strike marks at the eastern edge of the pavement at Grey Street level crossing (ECMT) Hamilton

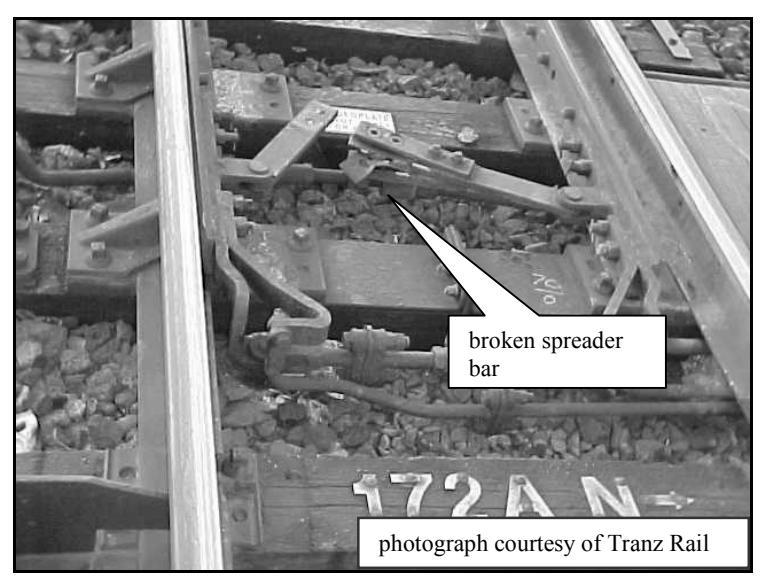
1.2.2 The area coordinator found gouging of the crushed ballast between the rails between 170 points and 172A points, and a broken spreader bar, in 172A points, all of which was consistent with dragging brake gear protruding forward (see Figure 3).

Figure 3 172A points showing the broken spreader bar

- 2.7 Train 215 negotiated several sets of facing points when it departed from CTD, some of which showed damage consistent with being struck by hanging brake rigging. The spreader bar of 172A points was broken, but the rails did not split under the train, probably because a wheel of UK20321 was on the guiding rail of 172A points at the time the spreader bar was broken. Train

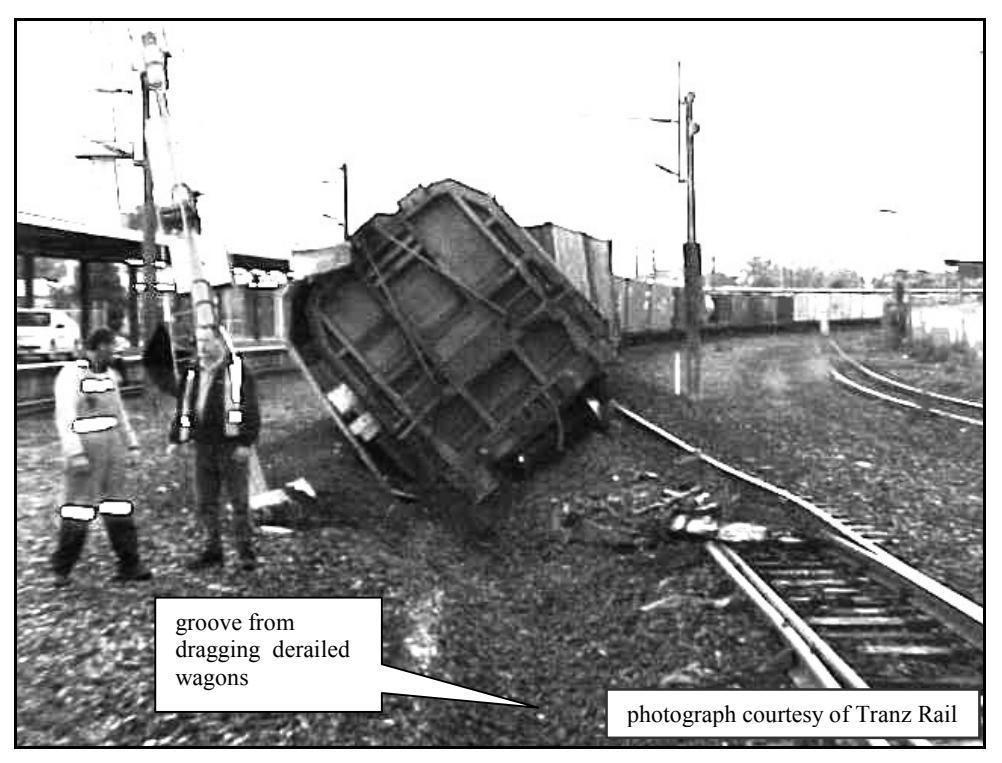
Figure 4

- 1.2.4 PK562 and ZH1109 were then dragged in a derailed state from the POD and through trailing 168B points, the connection to the NIMT, totally destroying the points and the motor controlling their movement. When Train 215 stopped, the CTD team leader found the trailing bogie of PK562 had derailed and ZH1109 had derailed all wheels and was leaning to the left.

The damaged 168B points with ZH1109 in the background. The ballast in the foreground shows evidence of wagons being dragged through 168B points

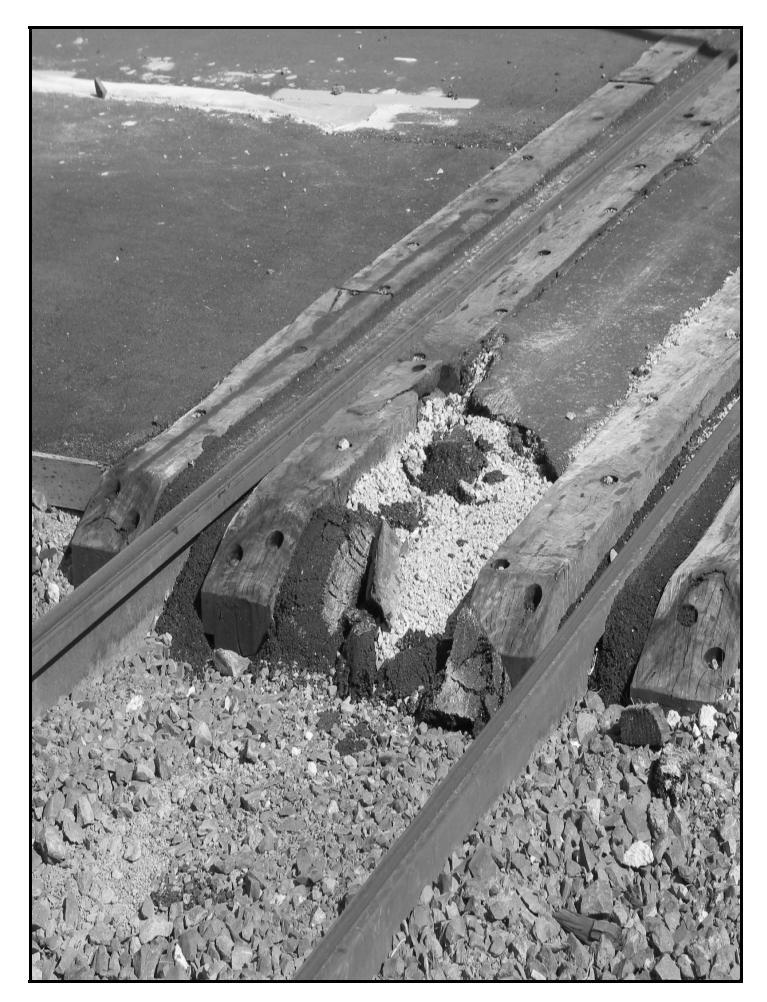
Figure 5 Strike marks at the northern edge of the pavement at Kahikatea Drive level crossing (NIMT), Hamilton

- 2.12 The brake push rod on UK20321 was probably bent before it impacted with No 7 points at Te Kuiti. The pavement at the north edge of the SH3 level crossing, immediately before the POD, showed a strike mark at a left facing angle (see Figure 5) which suggested that the hanging brake push rod was probably bent either when it impacted with the turnouts as Train 215 departed the CTD in Hamilton, or when it struck the edge of the pavement of a level crossing, probably Kahikatea Drive (see Figure 4), after departing from Hamilton. Given the extent of bending and damage sustained, it is considered that the second scenario is the most likely as Train 215 would have been travelling at a much higher speed and the pavement edge at Kahikatea Drive showed evidence of a significant impact.

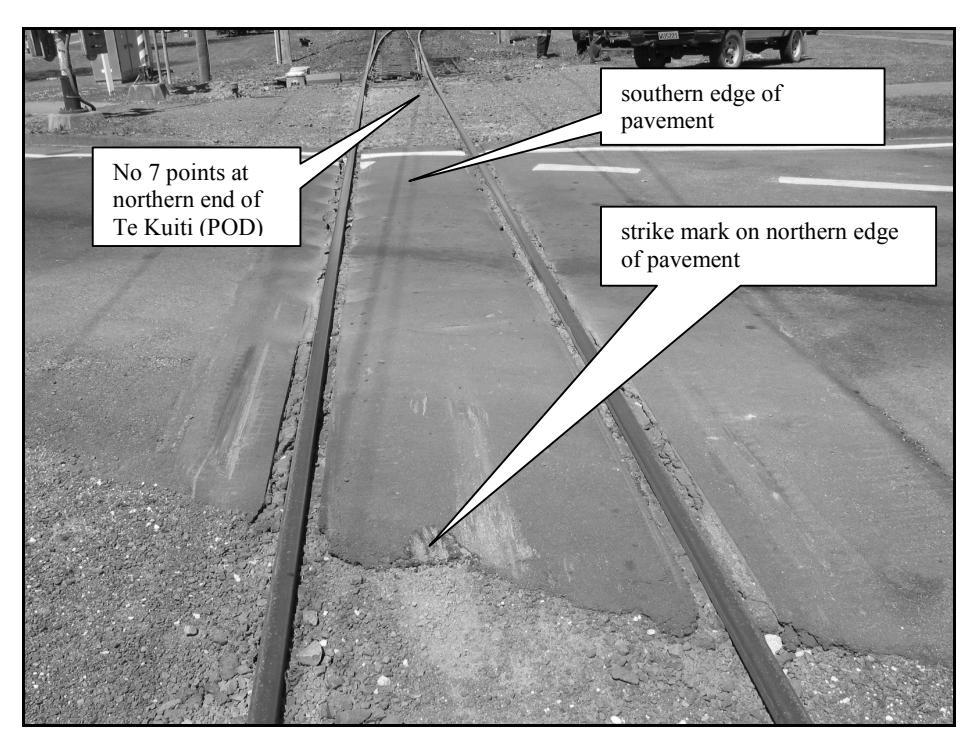
1.2.8 Strike marks again consistent with forward-facing dragging brake rigging were found on the northern edge of the pavement of the State Highway 3 (SH3) level crossing at Te Kuiti (see Figure 6). No 7 points, about 5 m south of the level crossing was identified as the second POD as these points had sustained similar damage to 168A points in Hamilton.

Figure 6 Strike marks at the northern edge of the pavement of State Highway 3 level crossing at Te Kuiti. Beyond the tarmac can be seen No 7 points on which Train 215 derailed

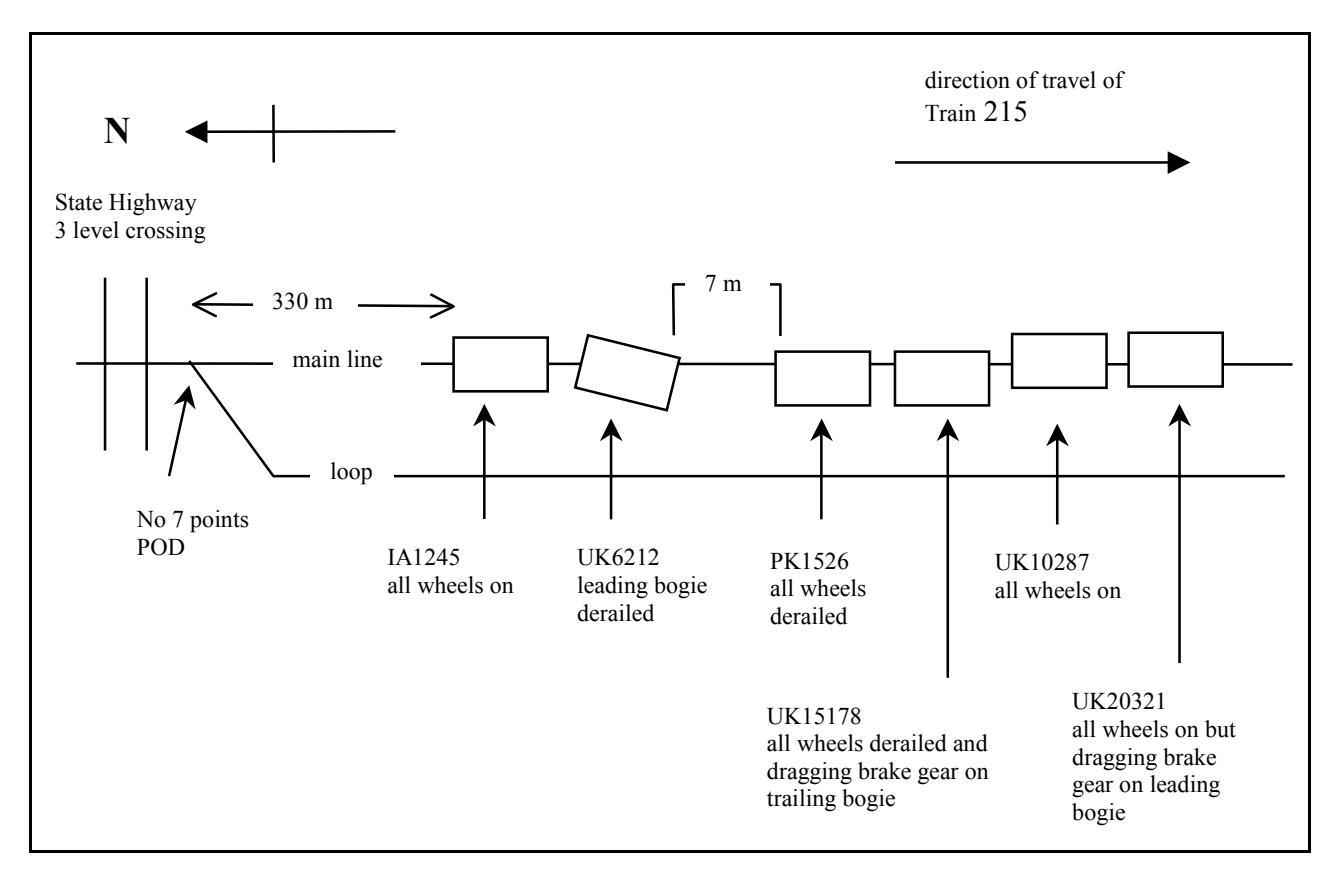
1.2.9 The rear wagon of Train 215 stopped about 330 m beyond the POD (see Figure 7).

Figure 7 Diagram of derailment site at Te Kuiti showing location of wagons (not to scale)

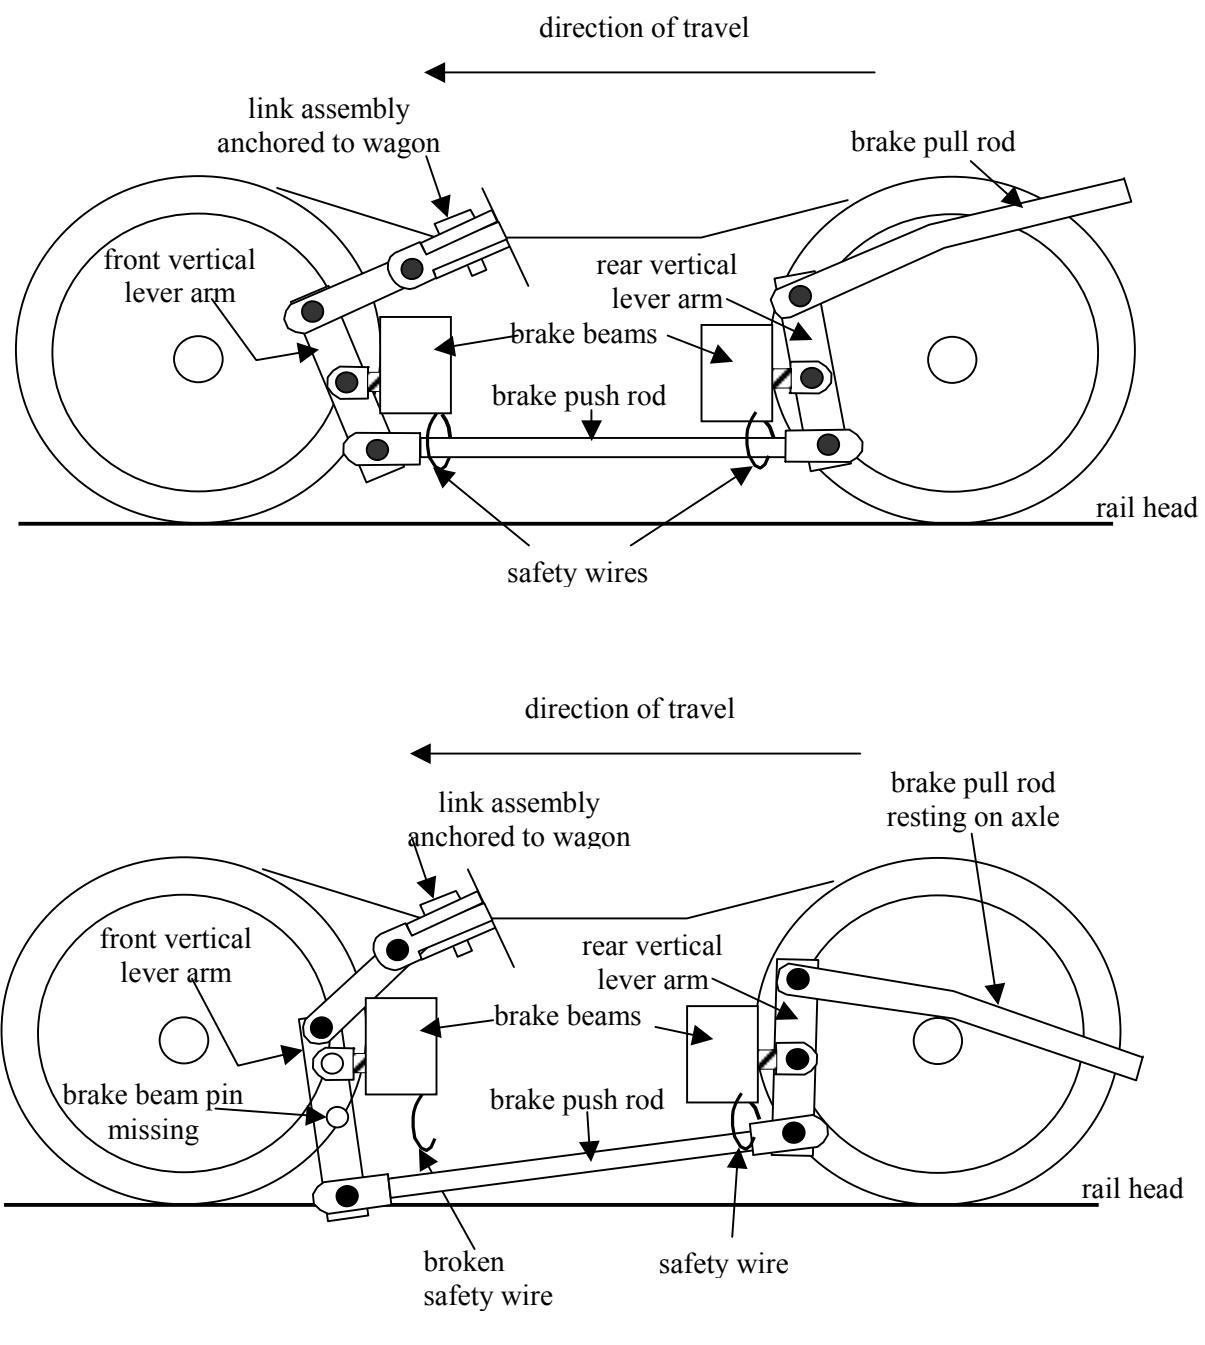
Figure 8 Diagrammatic section of the trailing bogie showing the brake gear as designed (above) and failed (below)

- 2.1 Once the split pin retaining the vertical lever arm pin on UK20321 had failed, the pin subsequently fell out and caused the end of the brake push rod to which it was attached to drop on to the brake rigging safety wire. This initial drop by the brake push rod would not have been very significant and, if it happened before the departure of Train 215 from Mt Maunganui, would probably have been difficult to detect during the terminal inspection prior to departure. However, if the brake push rod had dropped on to the brake rigging safety wire, the resulting loose hanging brake blocks when the brakes were applied should have been detected during the terminal train examination walk-around, if indeed the failure had occurred prior to the departure of Train 215. However, it was not possible to establish when the failure had occurred.

- 2.11 Once the leading brake beam pin dislodged from the brake beam fork assembly, the vertical lever arm dropped until the brake push rod rested on the brake rigging safety wire. If undetected and with continued operation, the brake rigging wire would eventually fail and allow the brake push rod to drop further, pulling the vertical lever further down until the anchor link rested on the top of the brake beam fork assembly. When the brake push rod dropped at the leading end of the bogie, it exerted pressure on the other end of the brake rod and allowed the brake pull rod to drop down until it rested on the revolving axle.

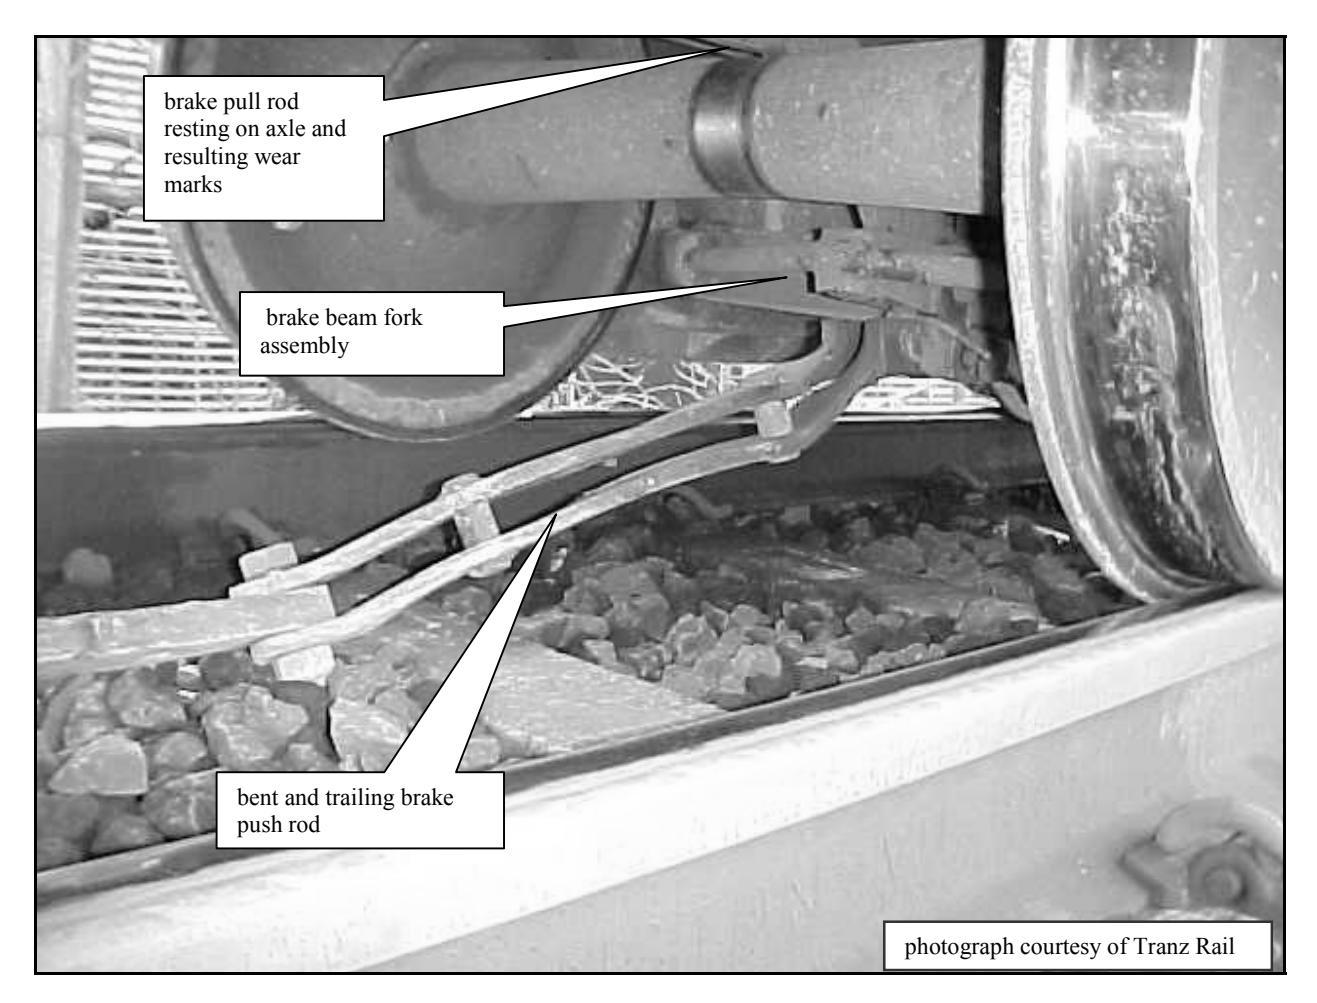
1.5.5 When the Alstom team leader arrived at Te Kuiti he carried out an inspection of the wagons. He found that the brake rigging on the leading bogie of UK20321, which had not derailed, was dragging (see Figure 9). The pin securing the vertical lever arm to the anchor link, was damaged but still in place, but the brake beam pin was missing.

Figure 9 Trailing axle of the leading bogie of UK20321 showing the dragging brake rigging following the impact with No 7 points at Te Kuiti

- 1.5.8 As Train 215 passed over No 7 points at Te Kuiti the dropped brake push rod hit the spreader bar and split the points. The impact forced the already bent brake push rod into a trailing position under the trailing axle of the leading bogie.

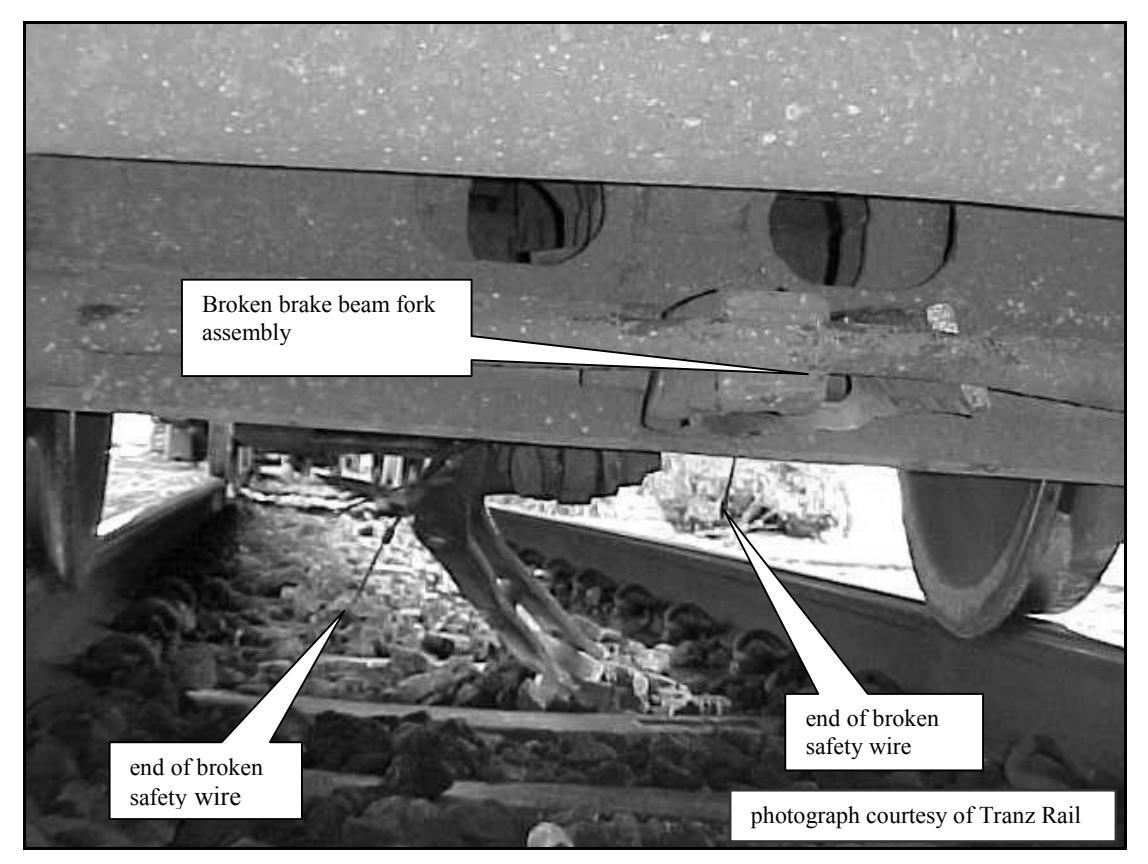
Figure 10

- 1.5.6 An examination of UK30321 following the derailment found the following:
 - the brake push rod was bent and had been forced back beneath the trailing axle of the leading bogie (see Figure 9)
 - the brake rigging safety wire had broken (see Figure 10)
 - the axle and brake push rod both showed wear signs consistent with the brake push rod resting on the revolving axle (see Figure 11).

Looking towards the rear of UK20321 and the trailing brake gear. The two ends of the broken safety wire are visible as is the bent brake push rod

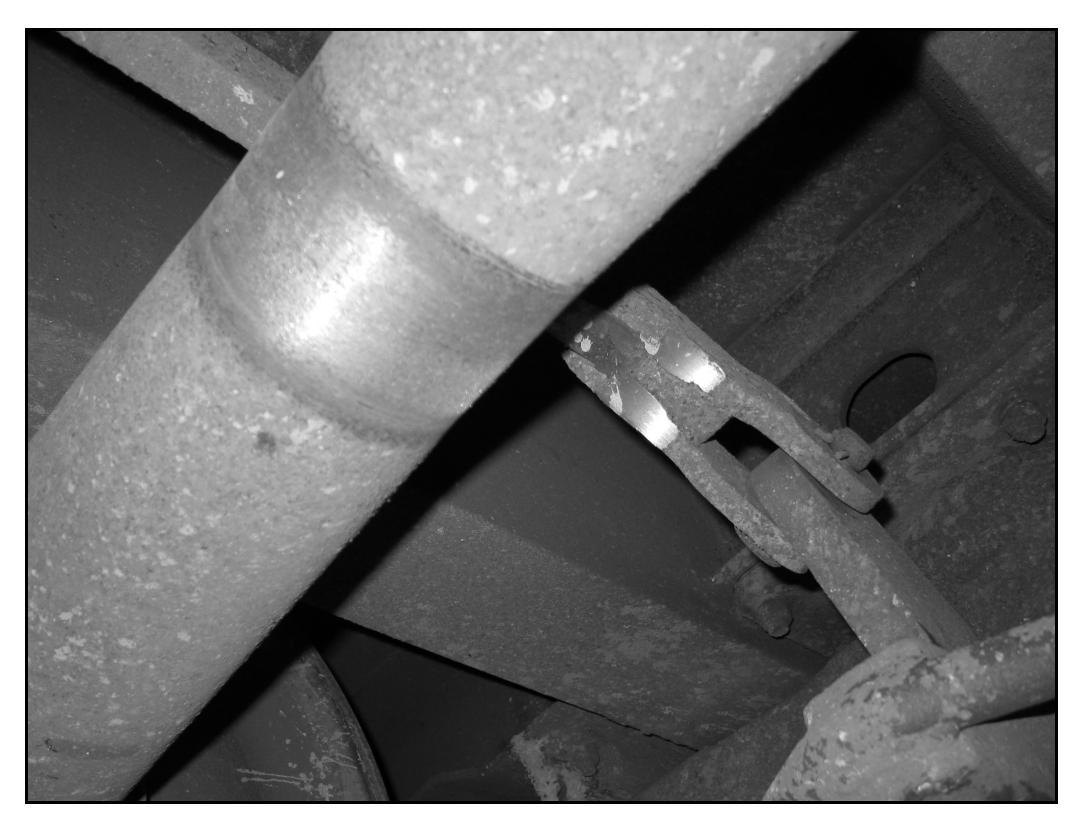
Figure 11 Wear marks on the axle and brake pull rod of UK20321

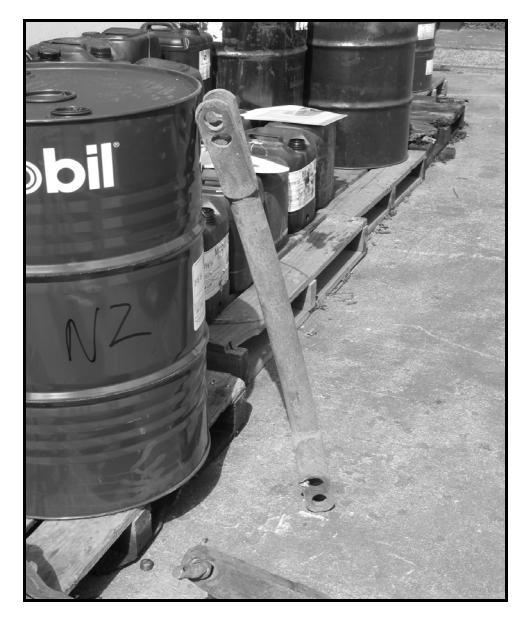
- 1.5.9 The Alstom team leader inspected the bogies of UK15178 after it had been rerailed at Te Kuiti. He found that the brake push rod on the leading end of the trailing bogie was hanging down in a ploughing position in the direction of travel. The leading brake beam pin was missing but the brake rigging was otherwise intact with only a small amount of abrasion evident on the leading edge of the brake push rod.

Figure 12 The brake push rod recovered from UK15178 following the derailment. Note straightness of brake push rod compared to that on UK29321 (see Figure 9)

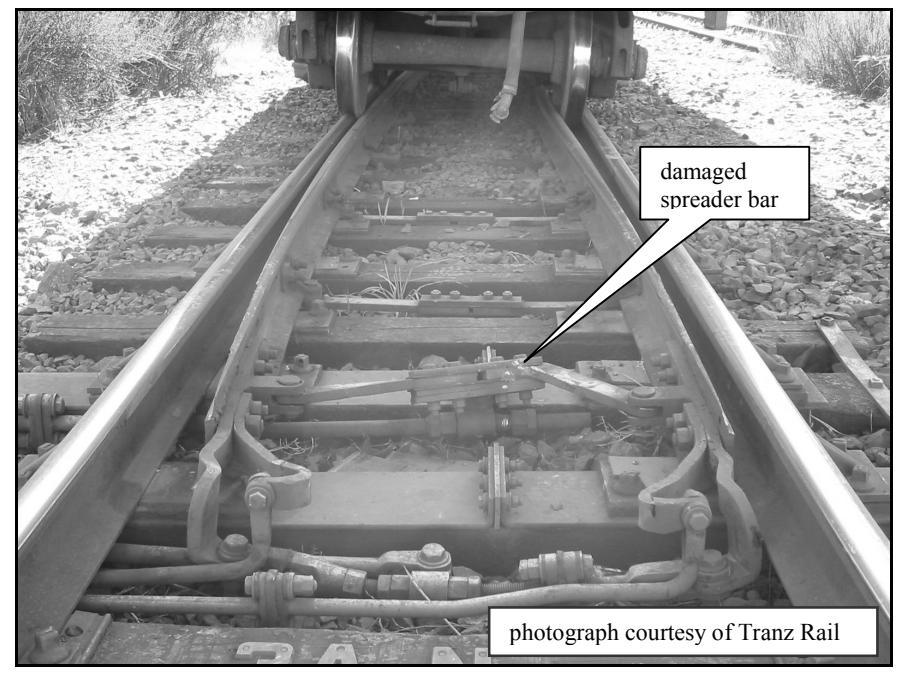
Figure 14 The damaged south-end turnout at Sawyers Bay

1.8.3 The locomotive engineer stopped the train, but not before 12 wagons had derailed causing significant damage to the track.

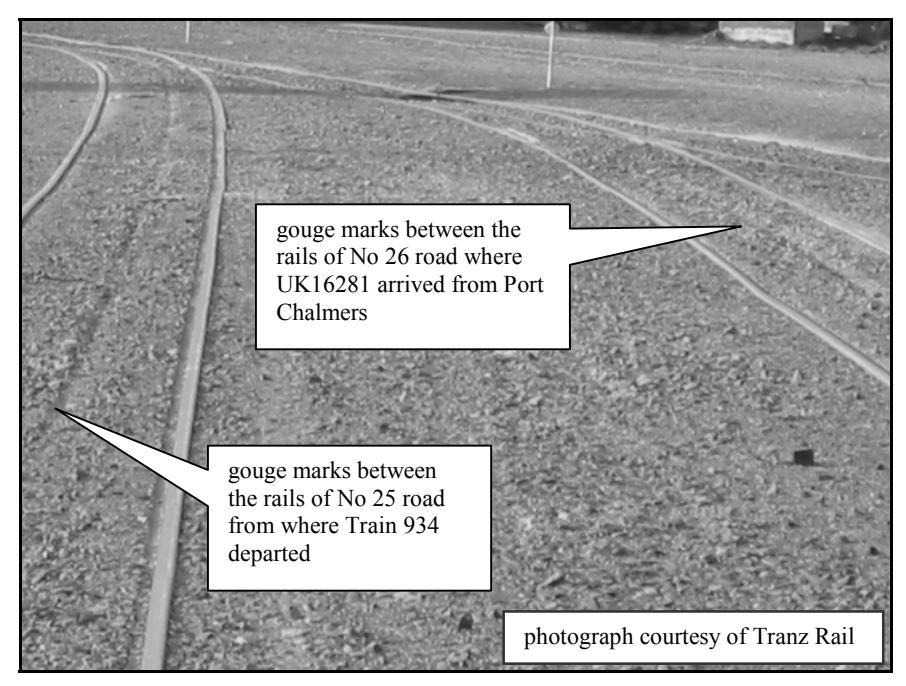
1.8.4 Gouge marks were found in the crushed ballast between the rails of No 25 road and No 26 road in Dunedin (see Figure 15), consistent with the brake rigging dragging when UK16281 was pulled in a northerly direction from No 26 road for placing to No 25 road. Strike marks were also visible on the points traversed by Train 934 when it departed from Dunedin.

Figure 15 Gouge marks between the rails of No 25 and No 26 roads at Dunedin

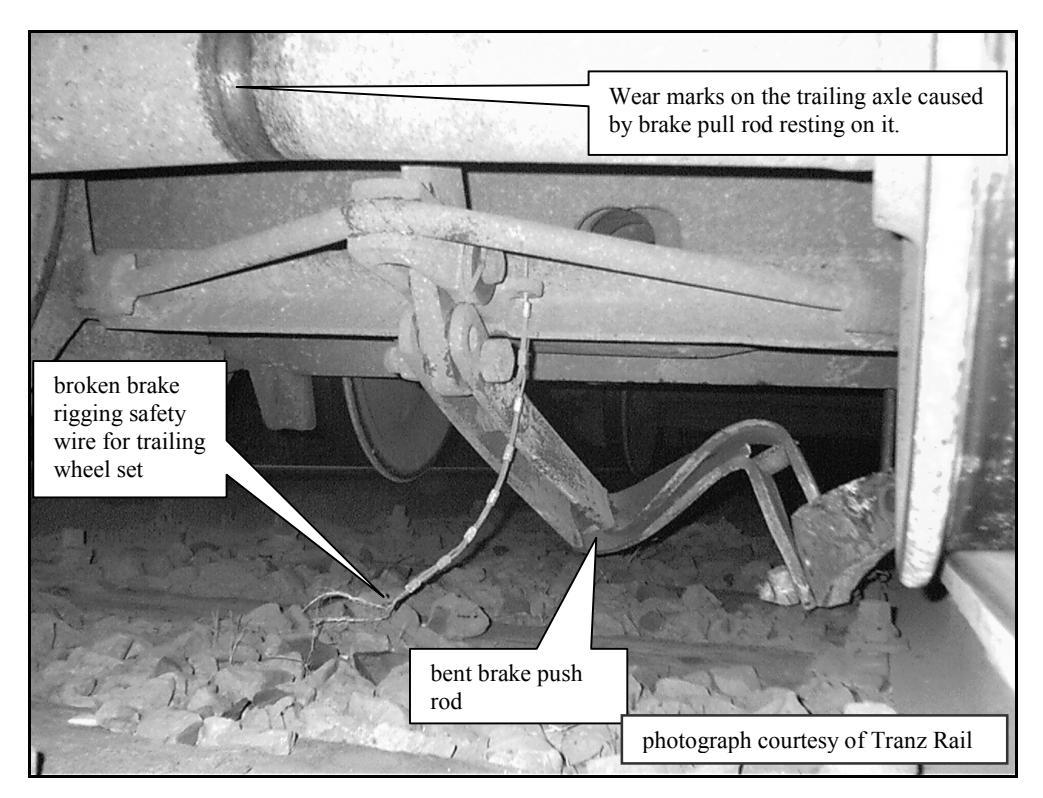
- 1.8.13 UK16281 was the second wagon behind the locomotives on Train 934. It was conveyed from Port Chalmers to Dunedin marshalling yard by shunt service and placed to No 26 road before being moved to No 25 road and attached to the consist of Train 934.
- 1.8.14 Examination of UK16281 following the derailment showed that an impact with track infrastructure had buckled and bent the brake push rod (see Figure 17).

Figure 17 The trailing axle of the leading bogie of UK16281 showing the brake rigging after impacting the south-end turnout spreader bar at Sawyers Bay

- 1.8.16 The split pin securing the vertical lever arm to the brake beam fork assembly on the leading end of the leading bogie had failed, allowing the pin to become dislodged from the brake beam fork assembly and the vertical lever arm. The end of the brake push rod was hanging below railhead level.
- 1.8.17 The brake rigging safety wire for the leading wheel set of the leading bogie was missing and was not found at the derailment site. The brake rigging safety wire for the trailing wheel set of the leading bogie, although broken, was still attached by one end to the wagon (see Figure 17).

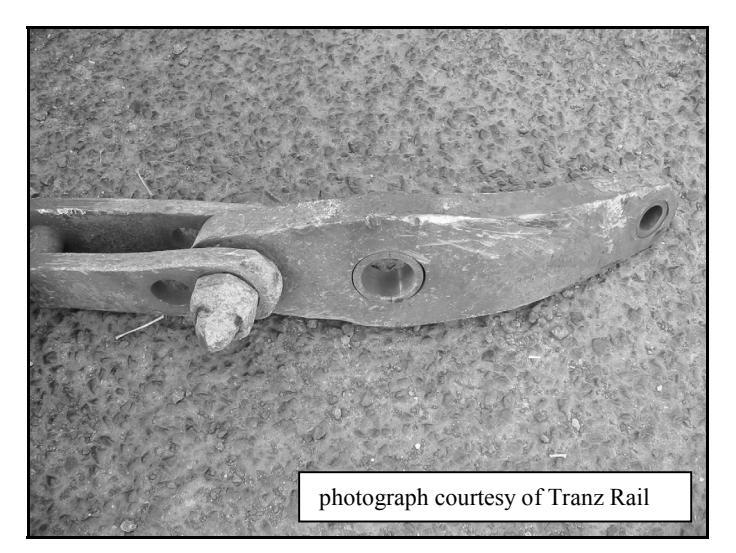
1.8.15 The leading end of the brake push rod showed strike marks consistent with having ploughed through ballast. The leading vertical lever arm, attached to the front end of the brake push rod, was bent and showed signs of having been wrenched from the brake beam fork assembly during the impact (see Figure 18).

Figure 18 The leading edge of the brake push rod with the leading vertical lever arm attached

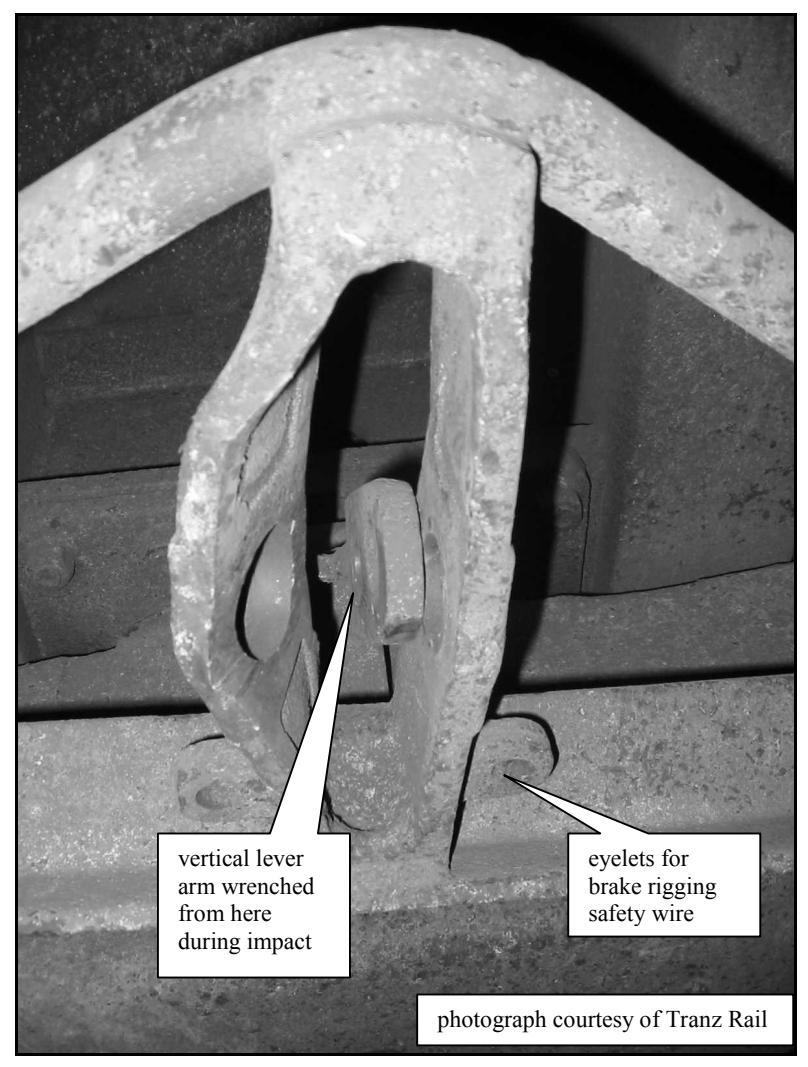
Figure 19 The deformed brake beam fork assembly on UK16281
