MARINE OCCURRENCE REPORT

05-208 Passenger freight ferry *Santa Regina*, near grounding, Tory Channel eastern entrance 9 June 2005

TRANSPORT ACCIDENT INVESTIGATION COMMISSION NEW ZEALAND

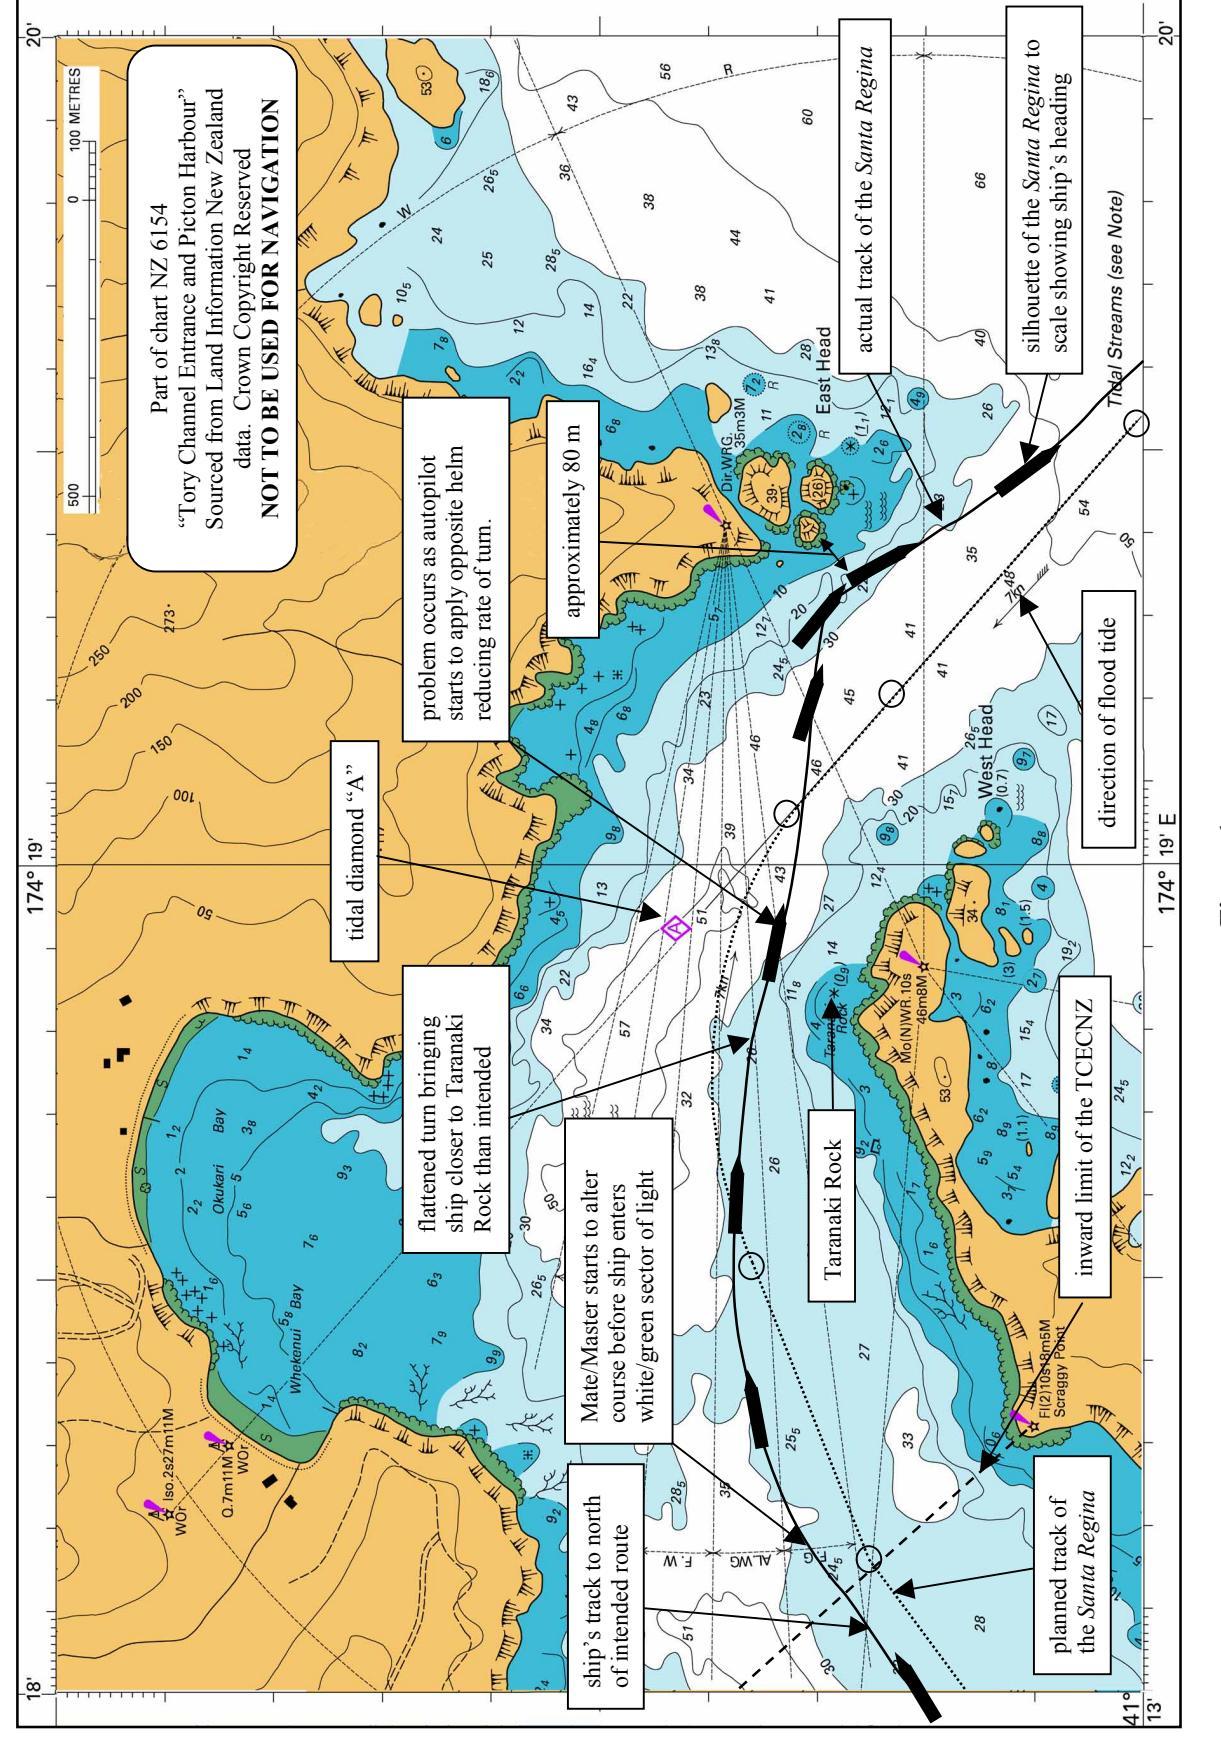
- 1.1.3 As the *Santa Regina* entered the TCECNZ the ship was to the north of the intended track (see Figure 1). The Mate/Master was conning the vessel from the helm station located on the centreline towards the rear of the wheelhouse. He started adjusting the course of the ship to starboard on the autopilot, conning the ship into the alternating white/green sector of the East Head sector light.

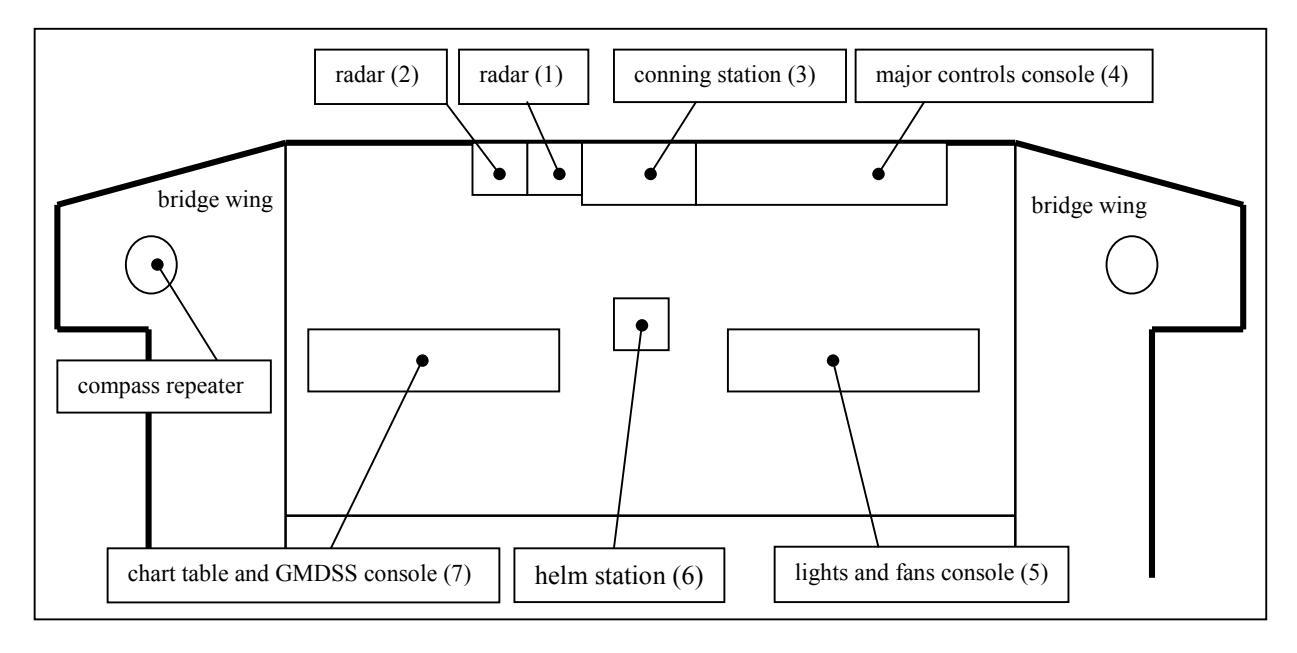
Figure 2 Bridge layout diagram (not to scale)

- 1.2.3 The navigating bridge of the *Santa Regina* was equipped with:
 - a Decca S2690 B/T radar with ARPA function (1)
 - a JRC JMA 7000 radar (2)
 - 2 global positioning systems (GPS), one Racal (7), one Leica (3)
 - a Sailor global maritime distress and safety system (GMDSS) (7)
 - 2 Simrad echo sounders (7)
 - a Sailor RT 5022 very high frequency (VHF) radio transceiver (3)
 - a Sailor KDU 1905 automatic identification system (AIS) (3)
 - a Navtex receiver (7)
 - a Doppler log (7)
 - an ENC display system running Endeavour 5 software (3)
 - portable searchlights.

- fire-detection and pumping arrangements.
- 1.2.4 The design of the navigating bridge was that the major controls for controllable-pitch propellers, engines, bow thrusters, whistles etc. were located on a console to starboard at the bridge front (position 4 Figure 2). The 2 radars were located to port at the bridge front with a retrofitted conning station amidships at the bridge front. The main helm station was on the centreline in the middle of the bridge. There was a console for fans and lights to starboard and the chart table, echo sounders and communications centre to port.

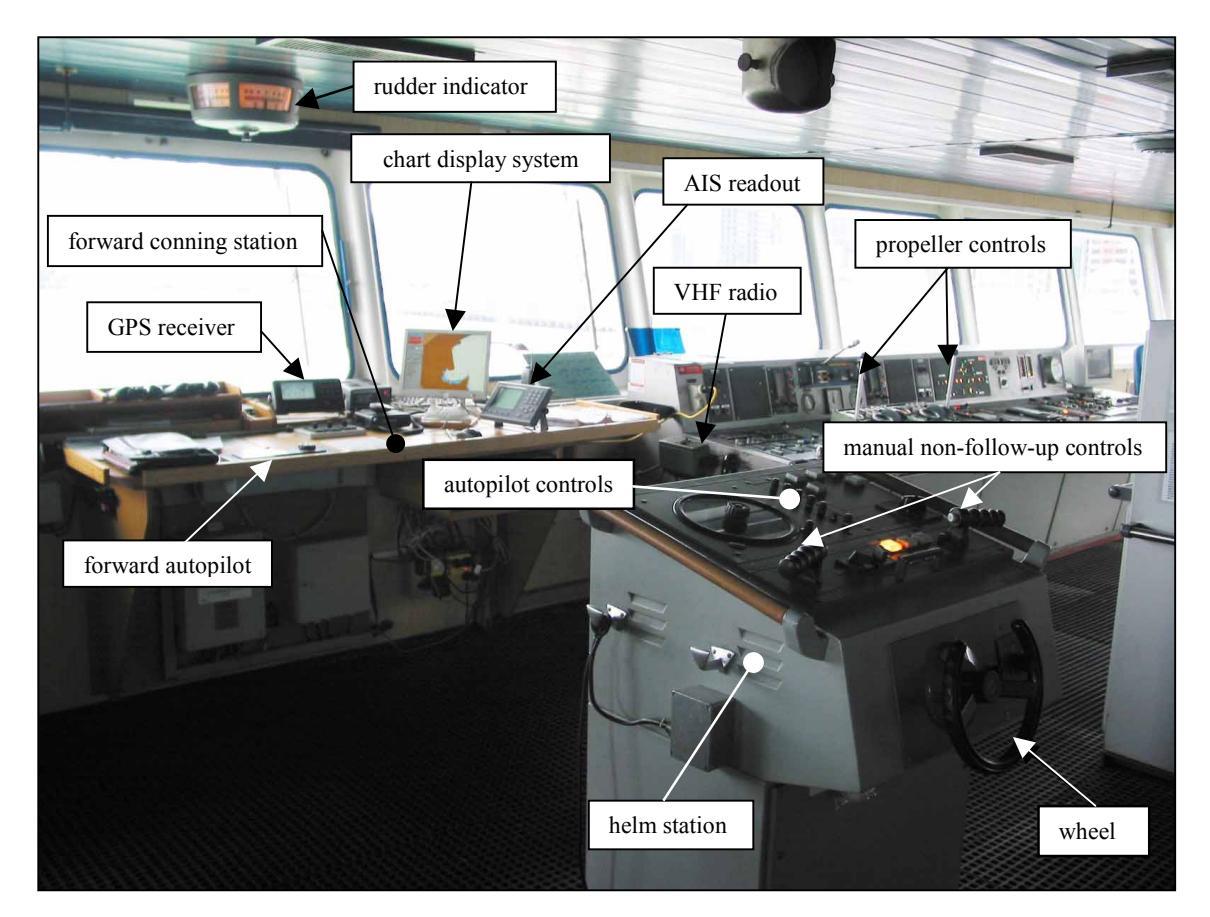
Figure 3 Helm station and conning position on board the *Santa Regina*

- 1.2.5 The retrofitted conning station amidships (position 3 Figure 2) on the bridge froat was intended to provide access to all the equipment and displays while conning the ship in a "cockpit" style environment. The station was equipped with the Leica GPS receiver, AIS readout, ENC display system and a Plath LMP HSC autopilot (switched from the helm station) capable of track following, steering designated courses and following radiused curves. One of the radars was visible to port of the conning station, a VHF radio was to starboard and a helm indicator was located in the deckhead above (see Figure 3).

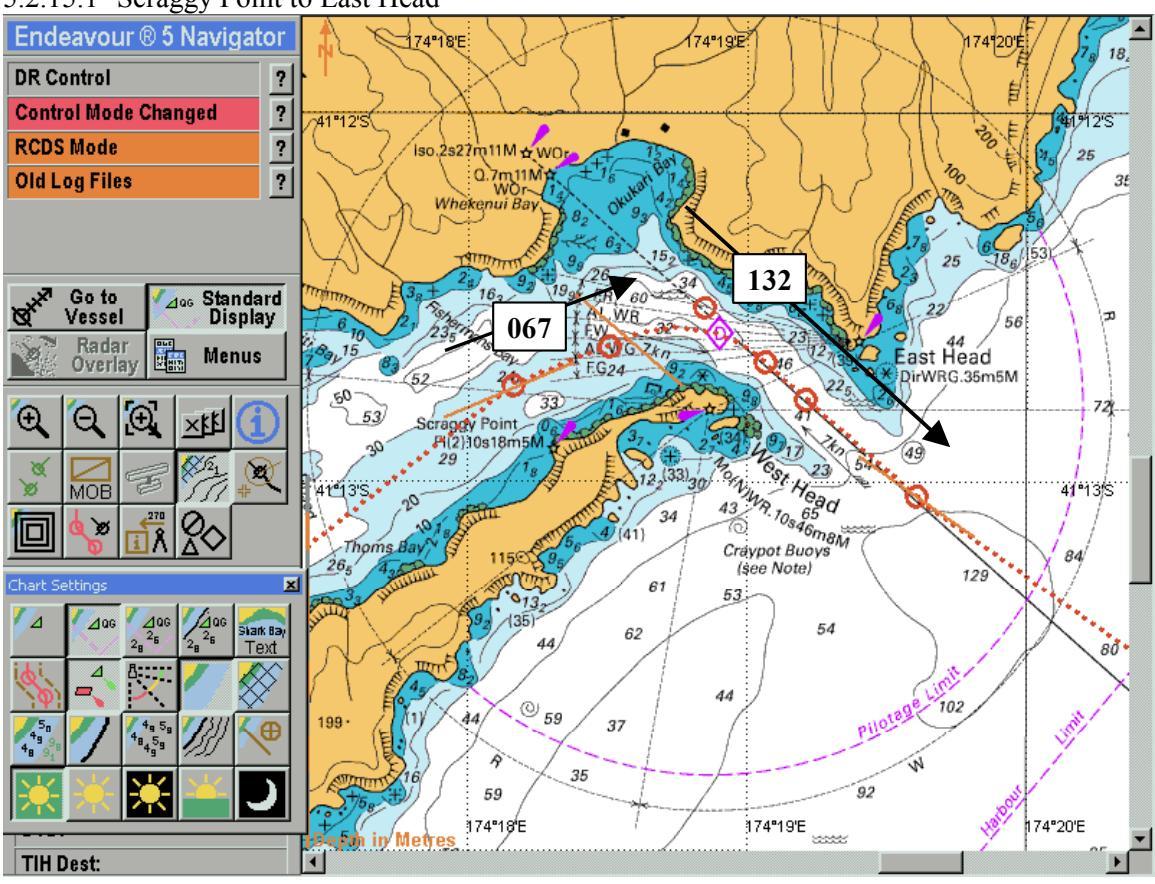
Index: Scraggy Pt to Tory Entrance

- 1.3.3 The course approaching the radiused turn needed to exit Tory Channel was shown as being 067°T, and after the turn as 132°T. Approaching the radiused turn the parallel index distance was shown at 0.17 nm off Scraggy Point and after the turn the parallel index distances were shown as 0.14 nm to starboard off West Head and 0.15 nm to port off East Head (see Appendix 1).
