Report 09-101 (incorporating 08-105): express freight train derailments owing to the failure of bogie side frames, various locations on the North Island Main Trunk, between 21 June 2008 and 7 May 2009

Final Report

Rail Inquiry 09-101 (incorporating 08-105):

express freight train derailments owing to the failure of bogie side frames, various locations on the North Island Main Trunk, between 21 June 2008 and 7 May 2009

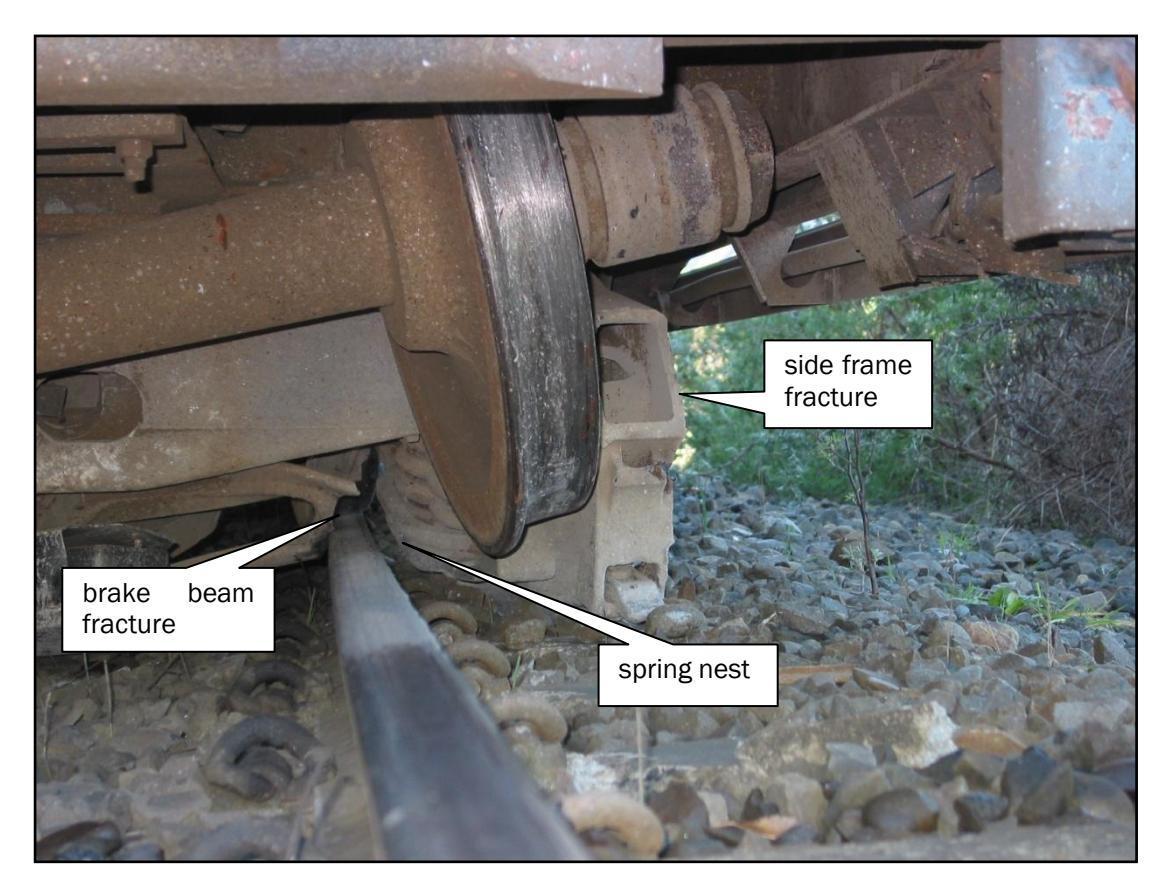
Figure 3 Failed side frame on wagon ZH560

3.2.15. No cracking in the pedestal roof area of the 4 bogie side frames on wagon ZH560 had been recorded during the 10 most recent B and C maintenance checks (see section 3.5).

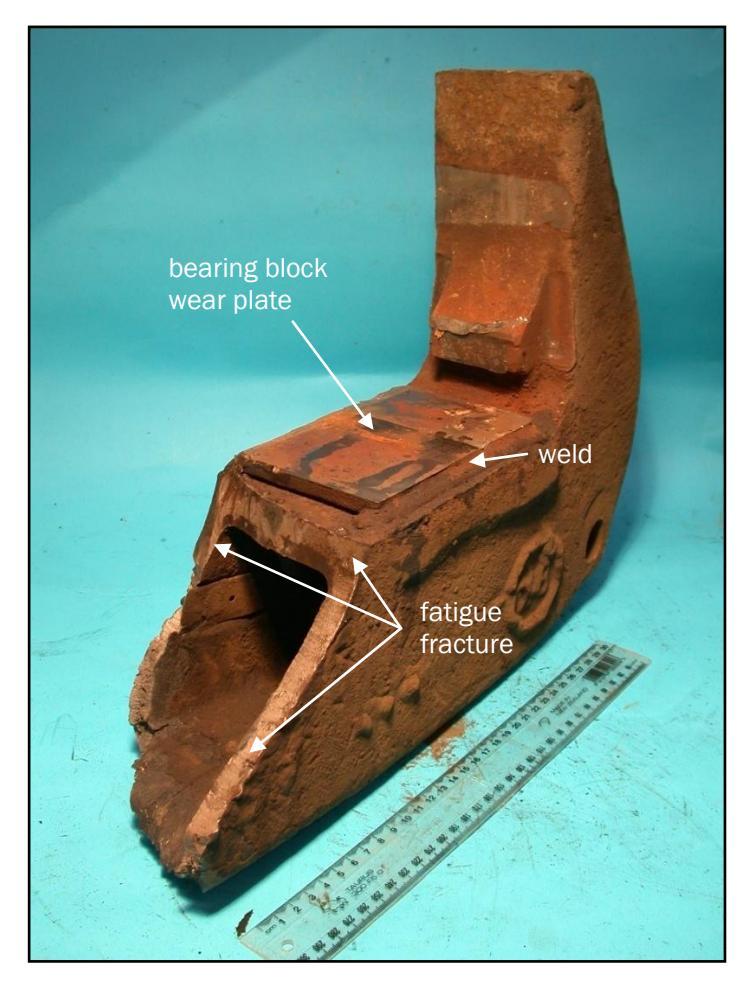
3.2.16. The separated portion of the bogie side frame was recovered and taken to an independent metallurgy laboratory for examination (see Figure 4). There was a large fracture extending through about 80% of the box section. The remaining 20% had failed in overload. Refer to Appendix 1 for a full laboratory report on the failed side frame.

Figure 4 Side frame section inverted from normal orientation on wagon

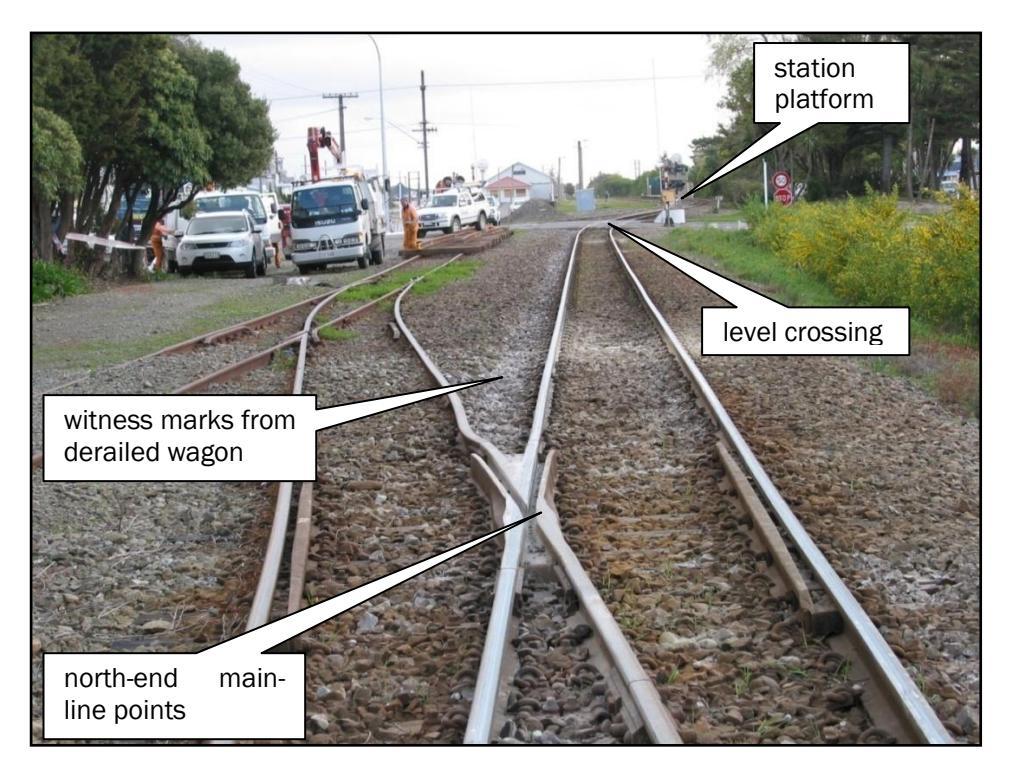
Figure 5 Witness marks from the derailed wagon

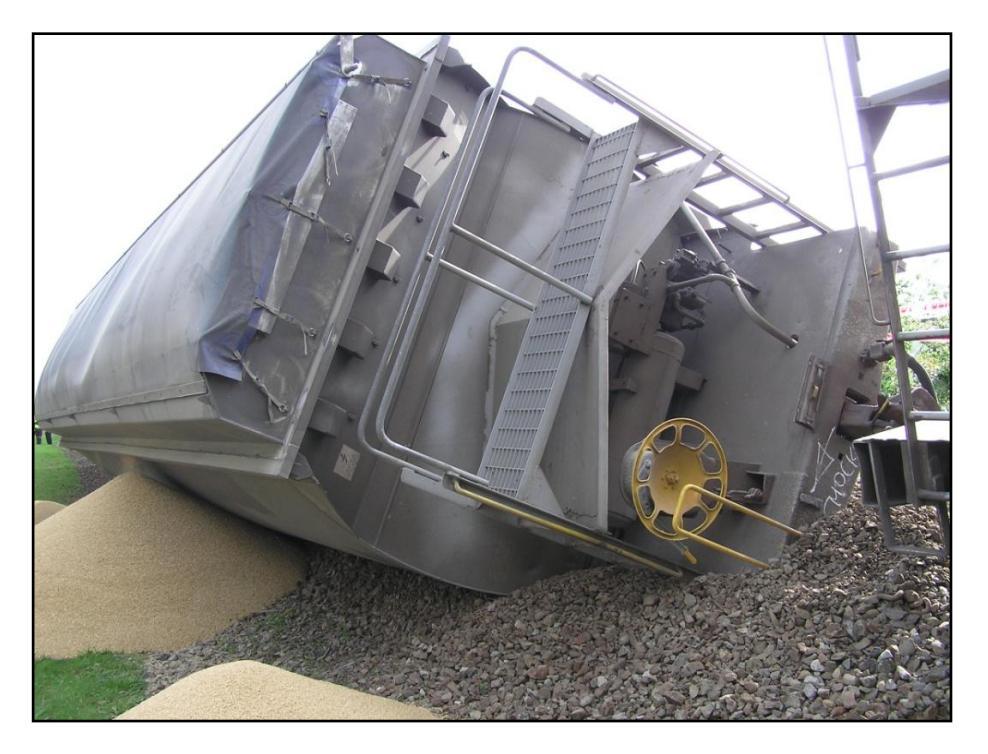
Figure 6 Grain spilt from one of the derailed wagons

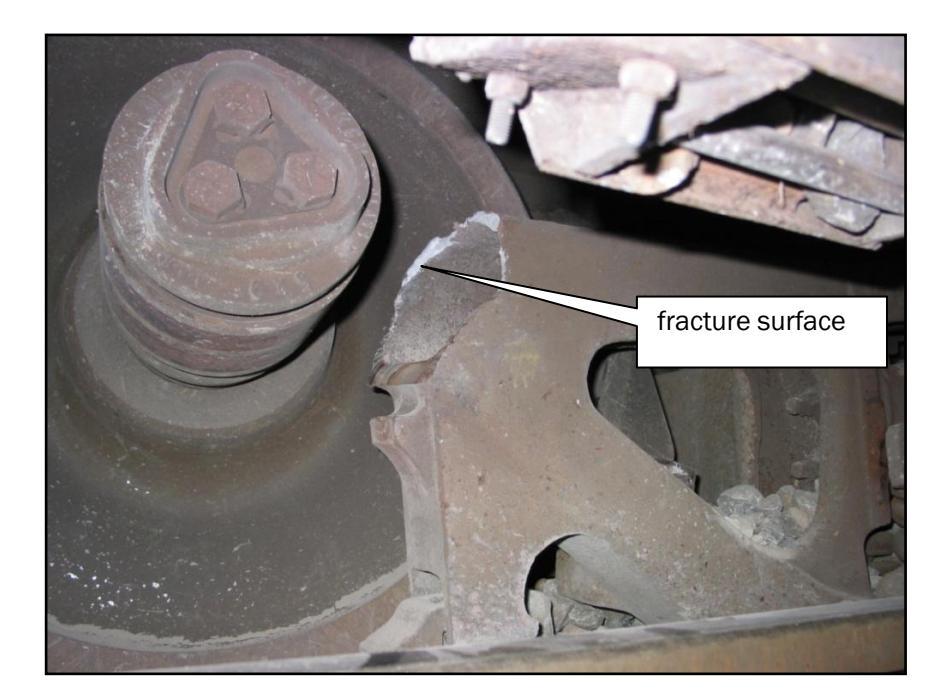
- 3.3.3. The train stopped with the trailing bogie of the eighth wagon over the north-end main-line points. Members of the public approached the locomotive engineer as soon as the train stopped to advise him of grain discharging from derailed wagons (see Figure 6). Eight wagons at the head of the train had derailed. Wagon ZH1766 was coupled directly to the locomotive. The rear pedestal leg on the right-hand side of the trailing bogie had fractured and separated from the side frame (see Figure 7).

Figure 7 Side frame on wagon ZH1766

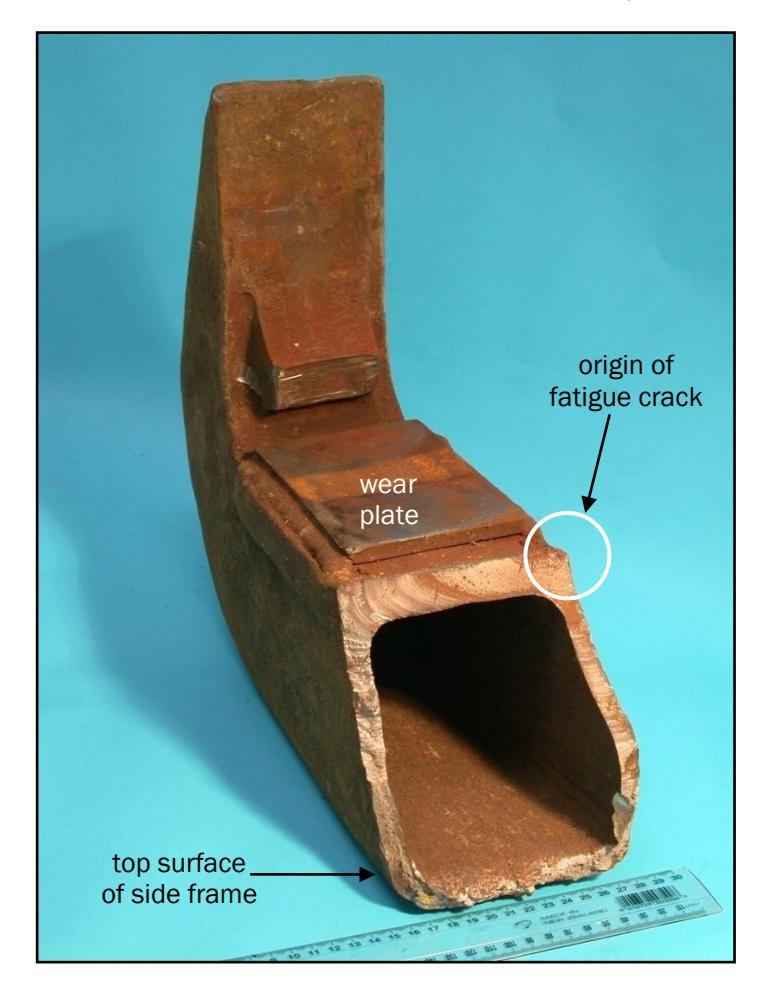
3.3.14. The pedestal leg that separated from the side frame was recovered and taken to an independent metallurgy laboratory for examination (see Figure 8). A major fatigue fracture had propagated through about 70% of the cross-section of the side frame, with the remaining 30% having failed in overload. Refer to Appendix 2 for a full laboratory report.

Figure 8 Pedestal leg of side frame from wagon ZH1766 inverted from normal orientation when fitted

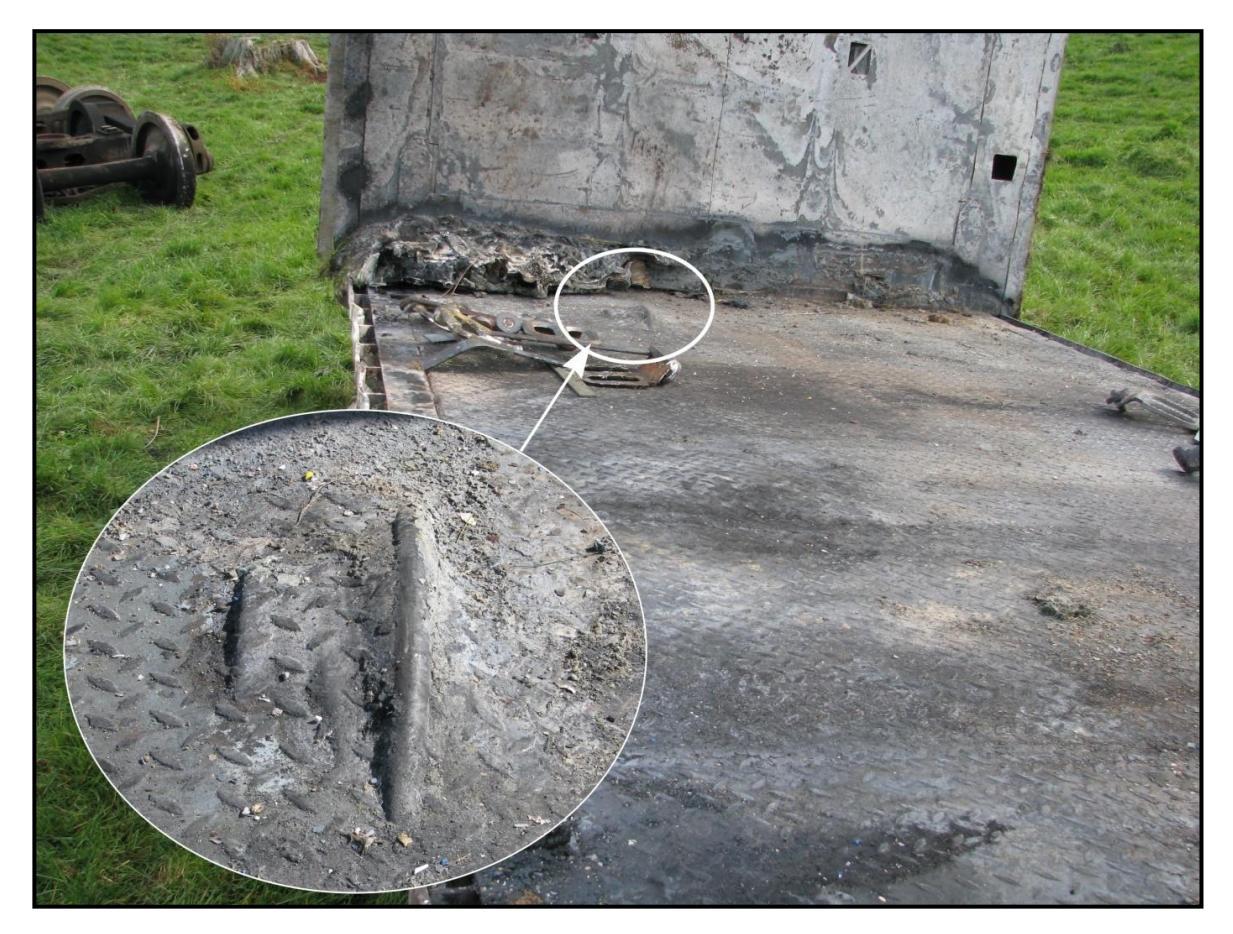
3.4.16. The wagon was completely burnt out following the derailment (see Figure 9). The wagon travelled about 5 km with a failed side frame until it derailed, then it was dragged a further 597 m until the train stopped. Heat generated from the wheel set of the derailed bogie rubbing on the steel deck conducted to a timber pallet stowed above.

Figure 9 Deck of wagon ZH554 after the fire

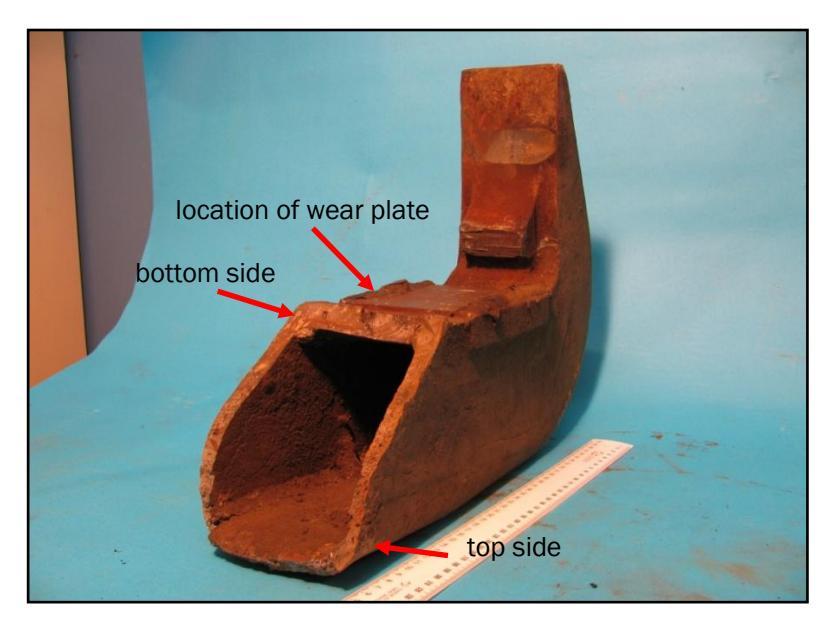
3.4.17. The recovered side frame section was taken to the same independent metallurgy laboratory that had examined the 2 previous failed side frames (see Figure 10). Fatigue cracking had worked its way through about 60% of the box section and the remainder had failed in overload, similar to the previous 2 failures. A full laboratory report has been included in Appendix 2.

Figure 10 Failed side frame section from wagon ZH544 inverted from normal orientation when fitted

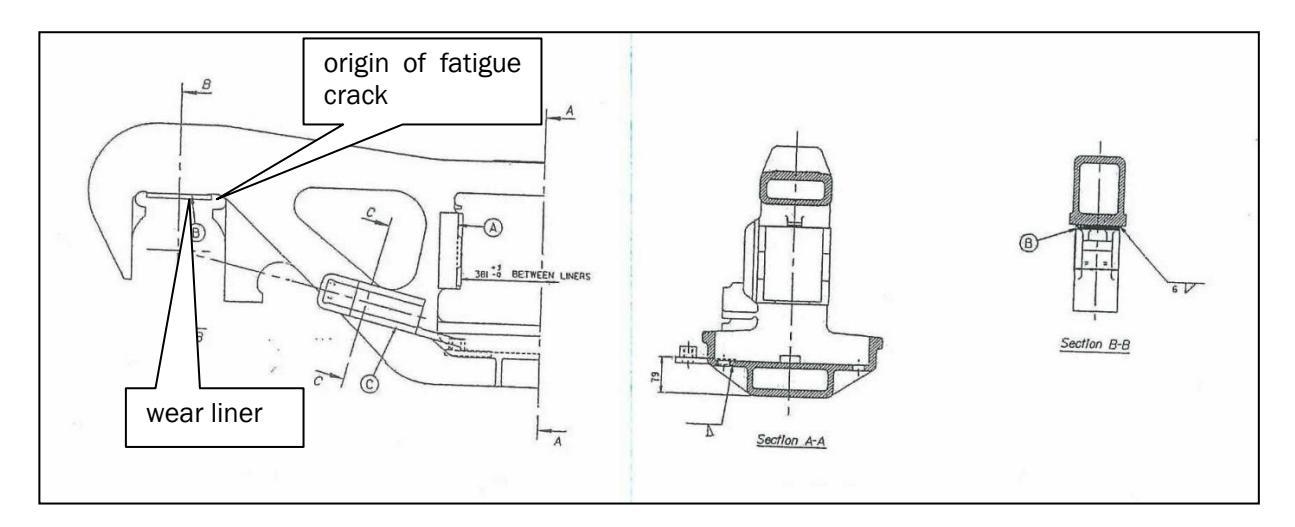
- 3.6.5. The pedestal wear liners on a bogie side frame were replaced at the time of the bogie overhaul. A 6mm fillet weld was applied down both sides of the wear liner but not across the end of the liner (see Figure 11). The origin of the fatigue cracks on the failed side frames was in the highly stressed area in the radius between the pedestal roof and the inner pedestal leg.

Figure 11 Attaching the pedestal roof wear liner

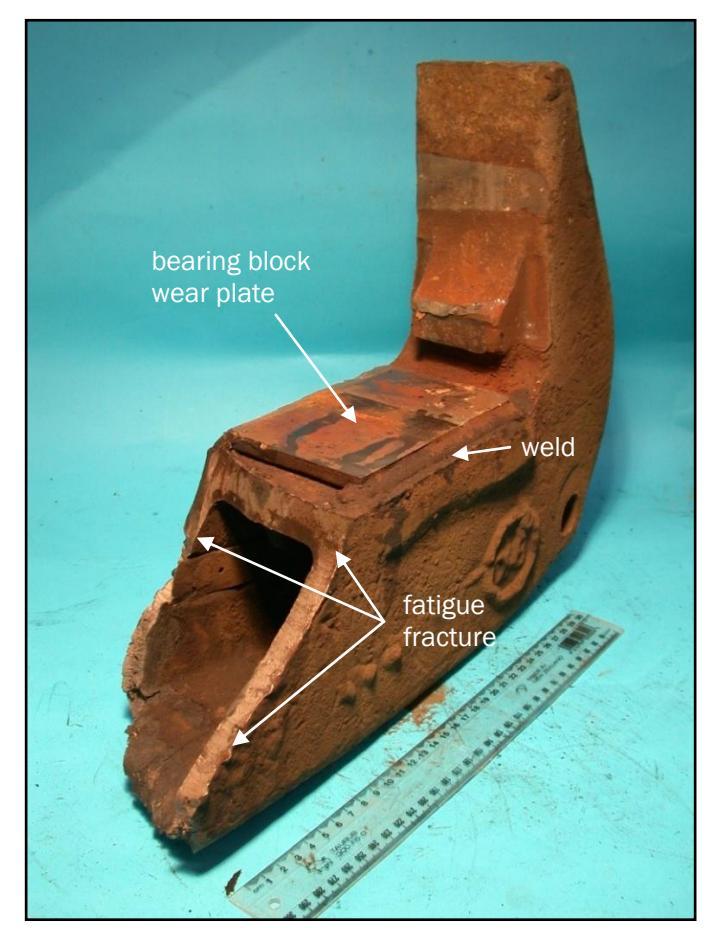
Failed bogie side frame from Wagon ZH 560 (Hihitahi derailment)

Figure 12 (copy of Figure 4) Side frame section inverted from normal orientation on wagon

- mechanical impact damage had occurred on the fatigue fracture after the failure
 - occasional weld spatter balls were present near the end of the fillet weld but none was seen at the fracture origin

- the pedestal wear plate had a small amount of wear.

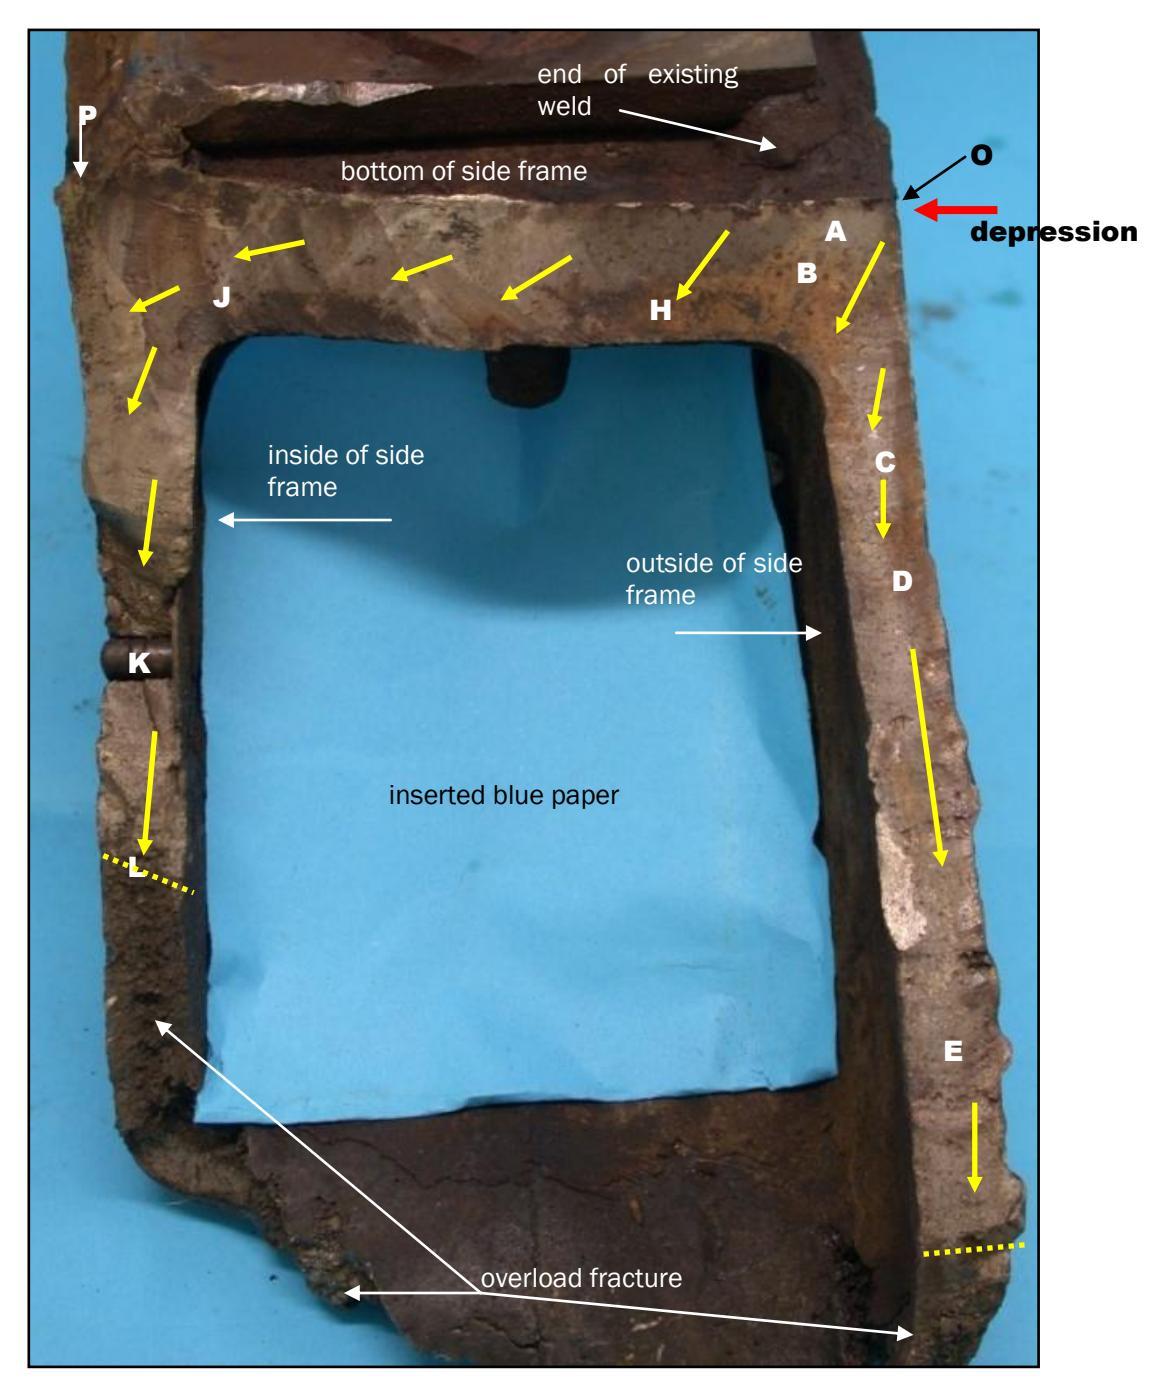
Figure 13 Fatigue fracture surface with regions marked

1.2. A section of material was taken from region A that included origin 0 (see Figure 13). The specimen was ground and polished in the direction indicated by the red arrow in Figure 13.

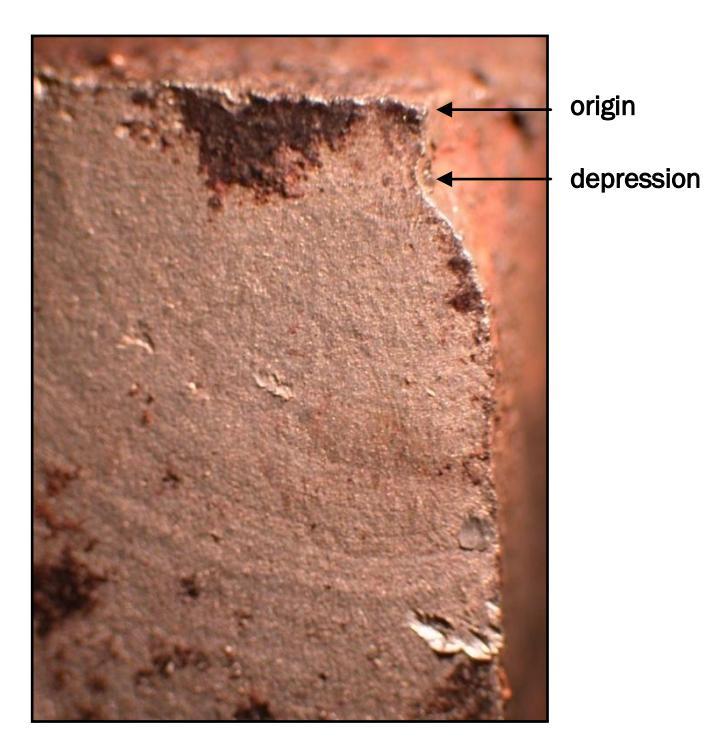
Figure 14 Origin of the fatigue fracture

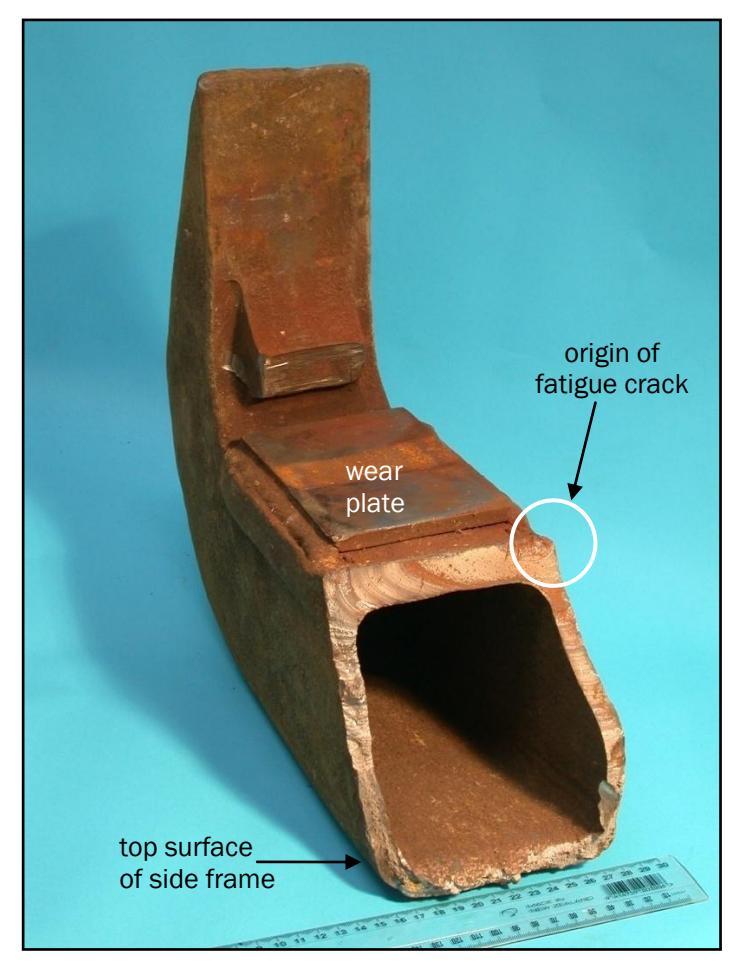
Failed bogie side frame from Wagon ZH 1766 (Levin derailment)

Figure 15 (copy of Figure 8) Pedestal leg of side frame from wagon ZH1766 inverted from normal orientation when fitted

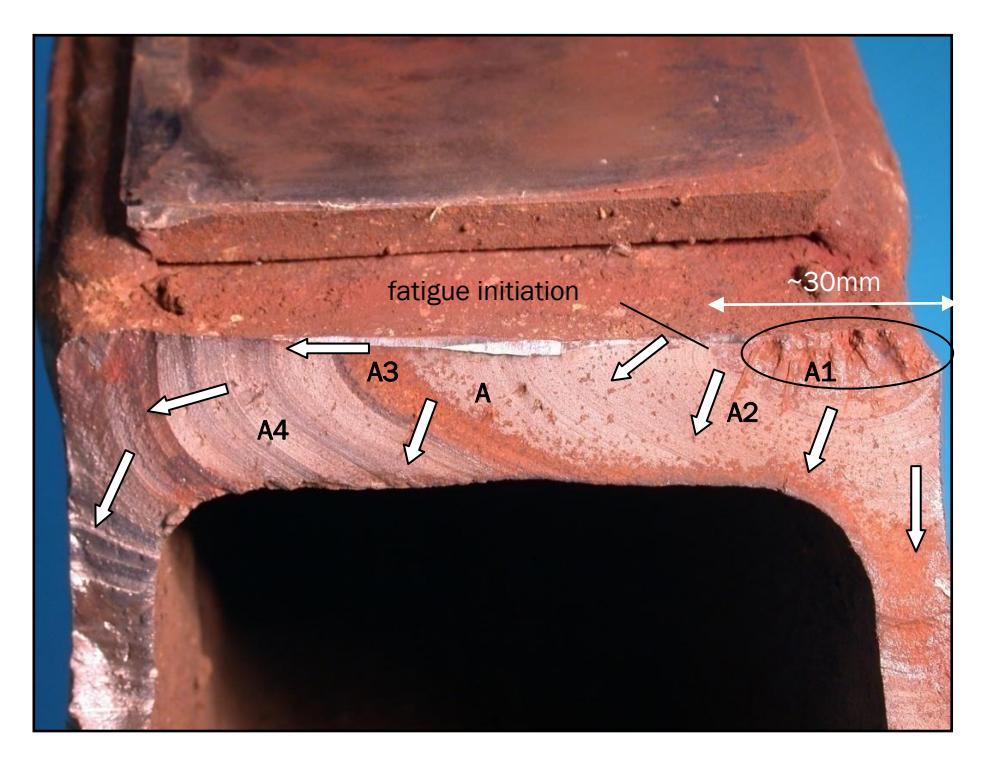
- there were several patches, following the contours of the arrest marks, where polishing had occurred. One such area was labelled A4. Another was present much further along the fatigue crack and was labelled A3

- the surface of the fatigue crack was free of substantial corrosion. The light corrosion product in region A was consistent with very recent corrosion resulting from exposure to the atmosphere after the final overload failure.

Figure 16 The major fracture regions

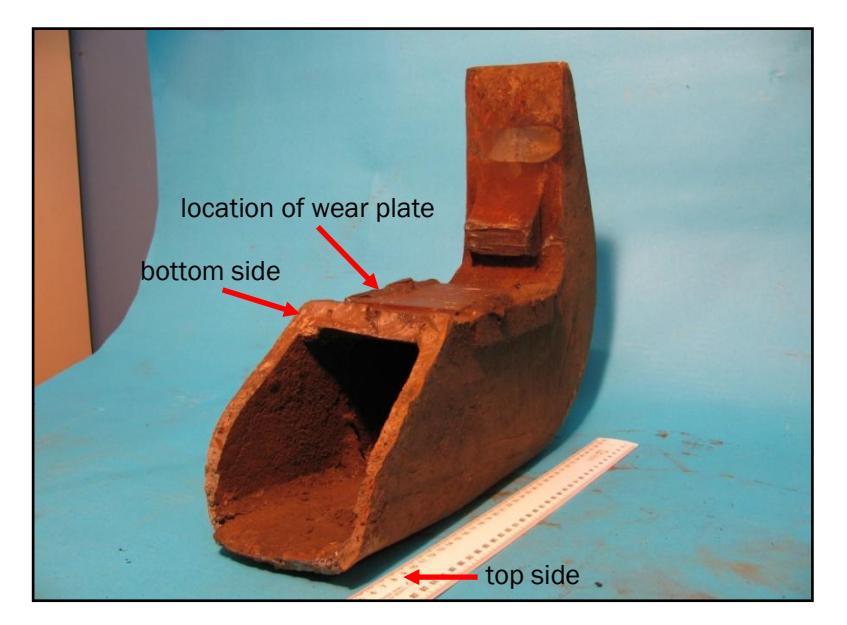
Failed bogie side from Wagon ZH 554 (Hunterville derailment)

Figure 17 (copy of Figure 10) Failed side frame section from wagon ZH544 inverted from normal orientation when fitted

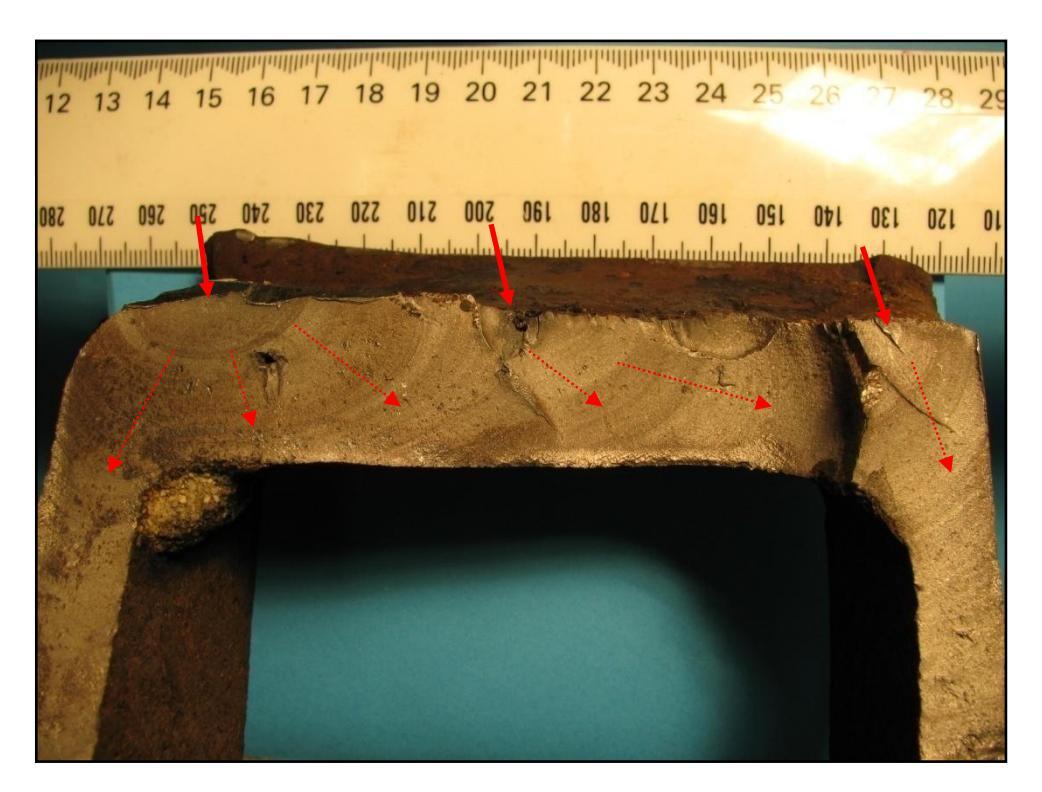
- the fatigue crack propagation regions were mostly smooth and flat, with many closely spaced arrest marks present, which would be consistent with a high number of changes in service conditions

- the remainder of the box section appeared to have failed under ductile overload. The top side failed in bending overload that produced a lip, which experienced some mechanical damage, most likely to have occurred after the failure of the part.

Figure 18 Initiation points and fatigue cracking propagation
