Inquiry AO-2014-002: Kawasaki BK117 B-2, ZK-HJC, Double engine power loss, Near Springston, Canterbury, 5 May 2014

Final Report

Aviation inquiry AO-2014-002 Kawasaki BK117 B-2, ZK-HJC Double engine power loss

Near Springston, Canterbury 5 May 2014

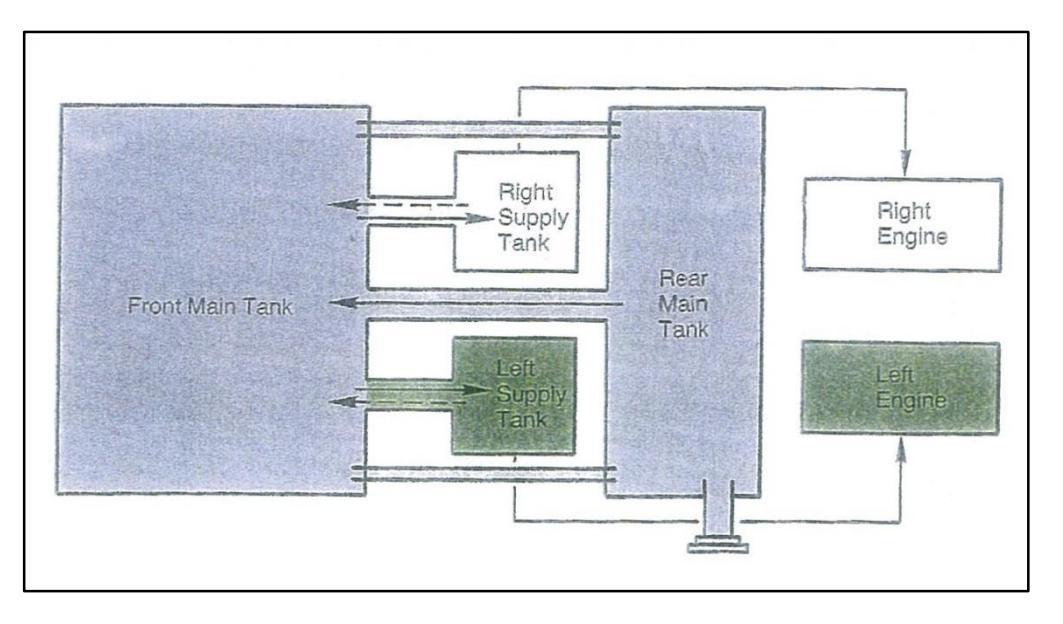
Figure 1 Fuel tanks

- 3.3.4. Each engine had an engine-driven fuel pump that would draw fuel from its respective supply tank; the left engine drew fuel from the left supply tank and the right engine from the right supply tank. Both of these supply tanks were connected by transfer tubes to the front main tank. To ensure the supply tanks remained full, two transfer pumps were fitted inside the front main tank (see Figure 2). The transfer pumps sent fuel into both supply tanks through the transfer tubes, meaning that if one transfer pump failed the other would still provide sufficient fuel to feed both engines. The fuel flow from these transfer pumps exceeded the amount required to run both engines, so the excess fuel was transferred back to the front main tank via overflow tubes near the top of the tanks.
