Transport Accident Investigation Commission

Final Report

Aviation inquiry AO-2017-003 ATR72, ZK-MCY Landing gear failure Nelson 9 April 2017

October 2019

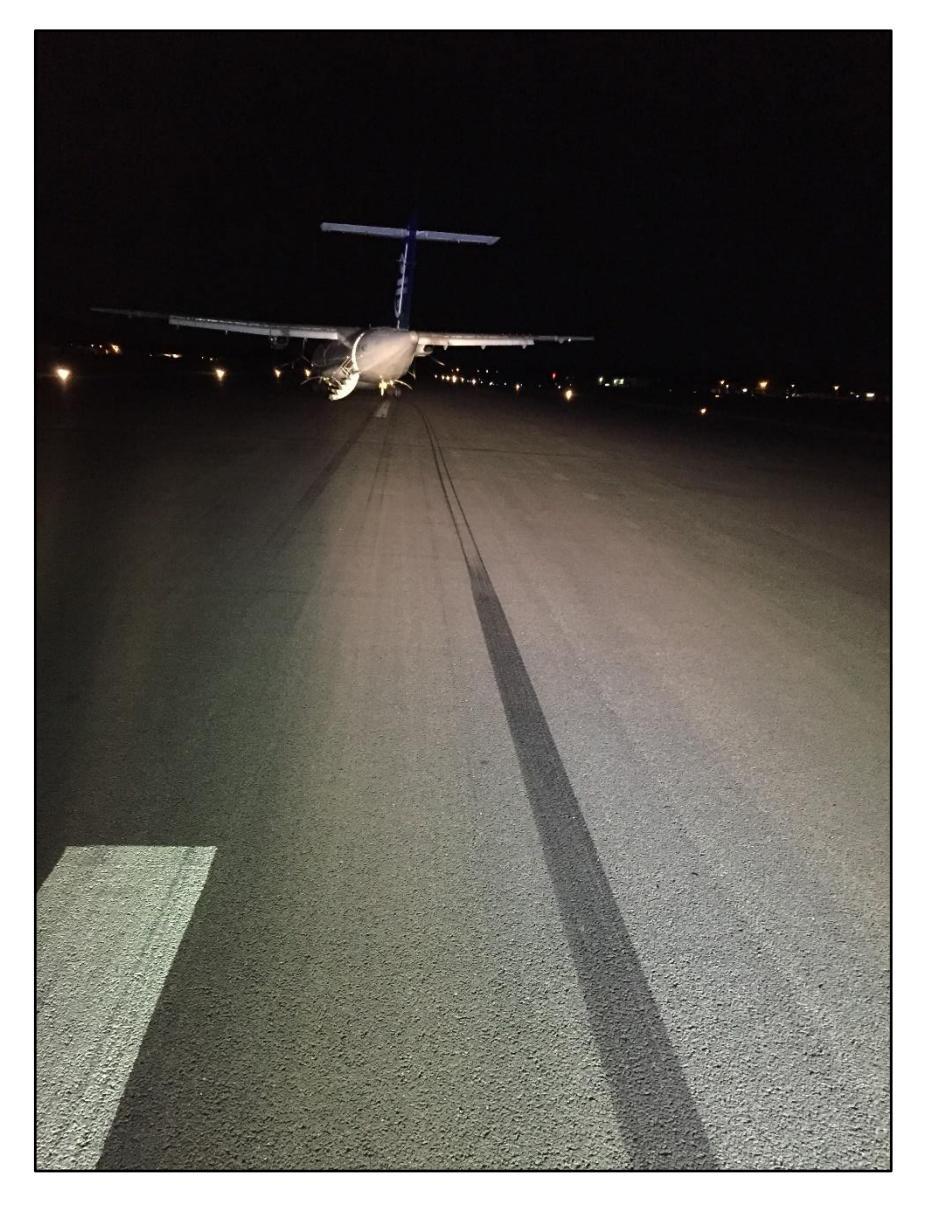
Figure 1: Aeroplane after landing

2.15. The aeroplane landed on runway 07 at Palmerston North.¹³ The aeroplane had come to a stop approximately 1,400 m from the start of the runway – approximately 500 m before the far end. The aeroplane had stopped near the centre of the runway, heading about 10° to the left of runway alignment. The right outer main tyre was found deflated. A skid mark led to this tyre, showing that the wheel had locked and skidded about 150 m before bursting (see Figure 1).

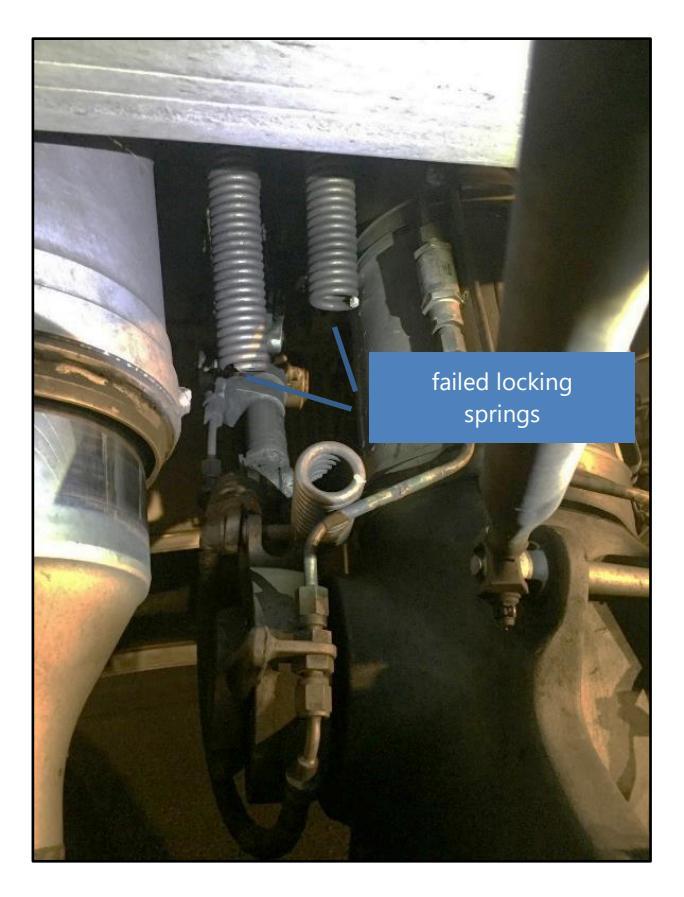
Figure 2: Failed locking springs

2.16. An examination of the right main landing gear found that the two locking springs that pulled the secondary alignment brace into an over-centre locked position had broken. The two springs were still attached at each end and the locking mechanism had not fully engaged (see Figures 2 and 3). The CVR was removed and a download of flight data information from the quick-access recorder was completed. See section 0 for further information on the recorders.

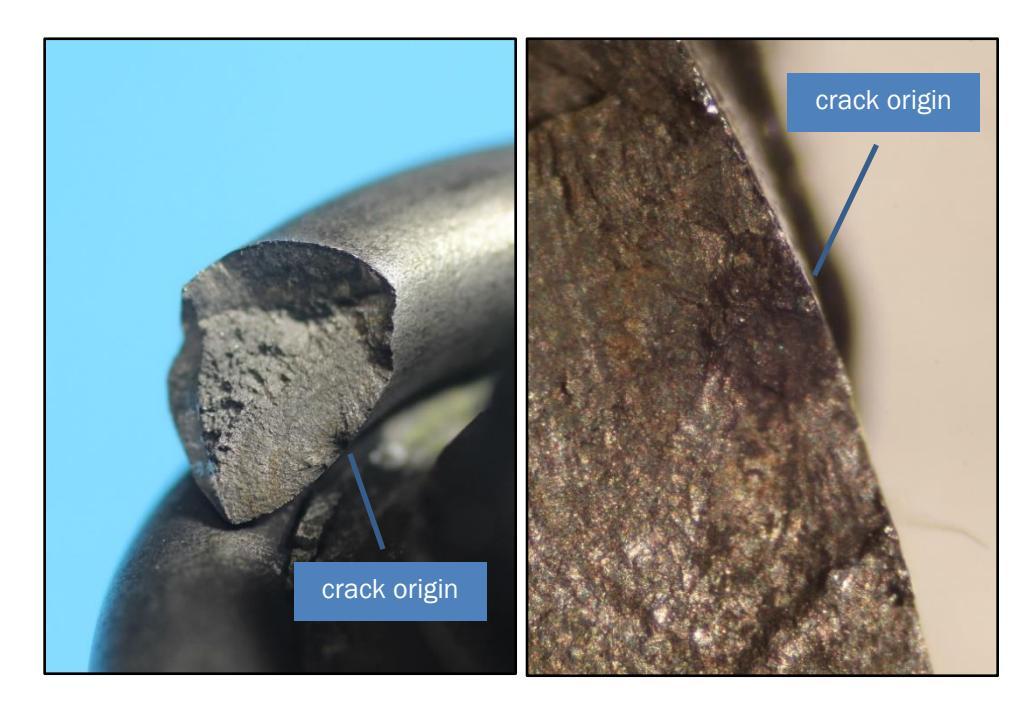
Figure 5: Fracture surfaces on the right rear spring MN1276

- 2.33. The two broken locking springs from the aeroplane, serial numbers MN1276 (right rear) and MN1282 (right forward), were subjected to metallurgical examination by Quest Integrity (Quest). See Appendix 2 for a summary of the examination report.

- 2.34. The examination found that the locking springs failed as a result of stress corrosion cracking followed by fatigue initiated corrosion. The cracking then propagated until the section of spring could no longer support the load and failure occurred. The corrosion crack originated on the inside diameter surface of the springs (see Figures 5 and 6).

- 2.35. The fracture surfaces of the two locking springs were almost identical in appearance. Quest was unable to determine if they had failed at the same time. Quest commented that while the springs were made of stainless steel, they were not immune to chloride (salt) induced corrosion and stress cracking.

- 3.6. The cracking in each spring originated on the inside of the coil facing the major axis or centre of the spring. The inside diameter of a spring was subject to greater stress than the outside diameter. When the landing gear was extended, the springs passed through the point of maximum tension and continued to remain under tension in the down and locked position. This tension resulted in the extension of the springs, which exposed the inside of the springs to the elements, where foreign matter could collect and where salts could concentrate. The aeroplane was operating in a corrosion environment that was classified as 'severe' according to the Federal Aviation Administration's Advisory Circular 43-4B (AC 43-4B).

- 3.7. Metallurgy examinations of the locking springs found that both failed because of intergranular corrosion followed by stress corrosion cracking and fatigue. The springs finally broke in overload. The corrosion was likely initiated by salt depositing on the springs and over time reacting with the stainless steel.

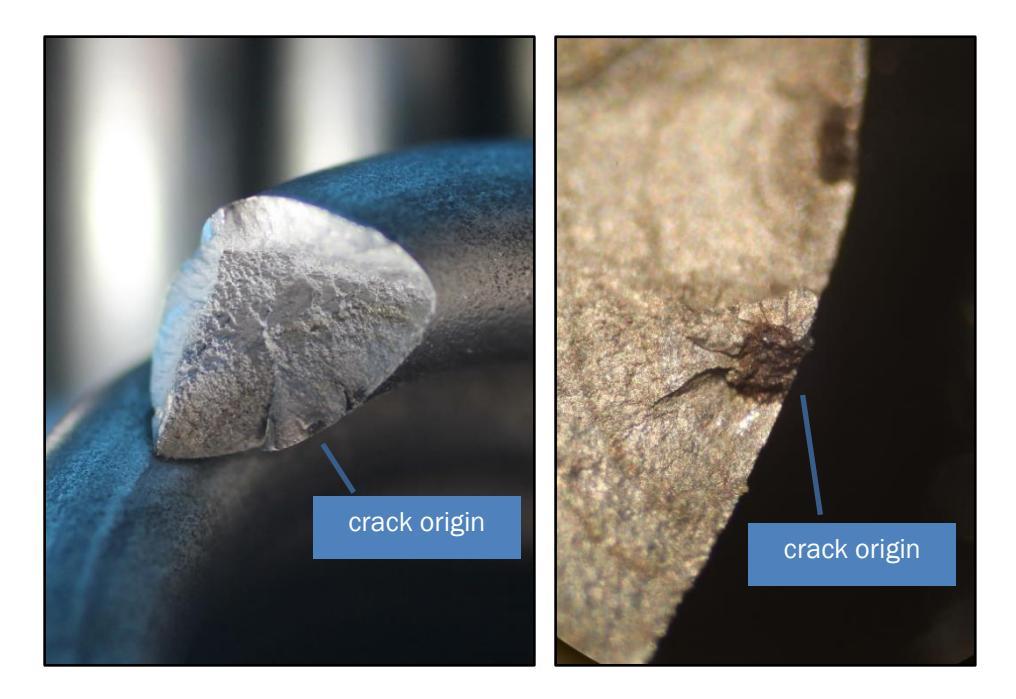
Figure 6: Fractures surfaces on the right forward spring MN1282

- 2.37. The examination by Safran found that the forward spring (MN1282) failure was initiated by intergranular corrosion²⁶ that then expanded by stress corrosion cracking followed by fatigue. The identification of chlorine and sodium suggested that the environment might have influenced the onset of the corrosion. See Appendix 3 for a summary of the

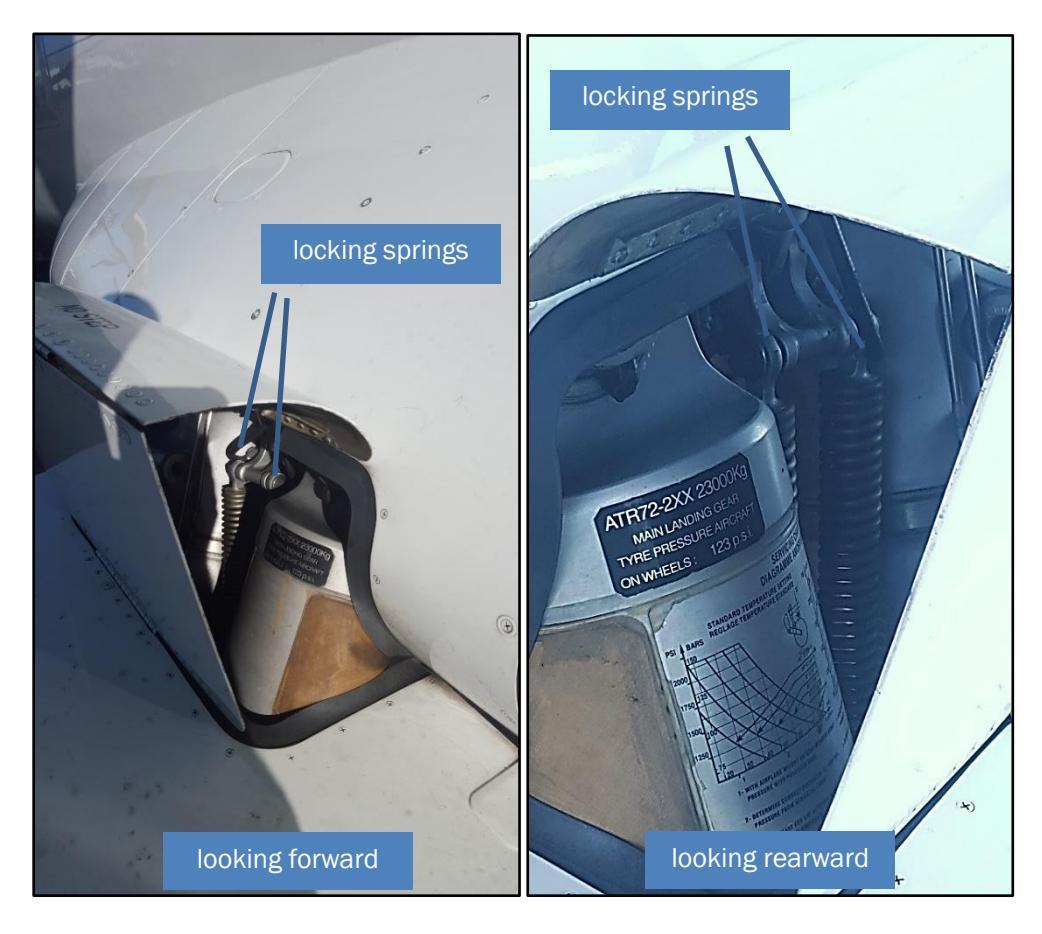
Figure 7: Main landing gear

3.24. However, a thorough inspection should be able to detect a broken spring. There are large components surrounding the main landing gear locking springs, and these do make it difficult to see the entire length of the spring from a single location. However, observing the springs from different locations would have allowed for their complete inspection, and almost certainly would have allowed for the detection of an abnormal condition (position or orientation) had one of them failed (see Figure 7).

3.25. The specific visual check required a "detailed visual inspection of the MLG [main landing gear] locking springs to be sure that they are not damaged or broken". The specificity of this check would have almost certainly ensured that any failed locking springs were identified. Therefore, both locking springs almost certainly failed after their last specific visual check. The investigation was unable to determine if the stress corrosion cracks had been present at the time of the last specific visual check.
