Final report

Aviation report AO-2018-001 Tandem parachute UPT Micro Sigma, registration 31Z Double malfunction Queenstown 10 January 2018

June 2021

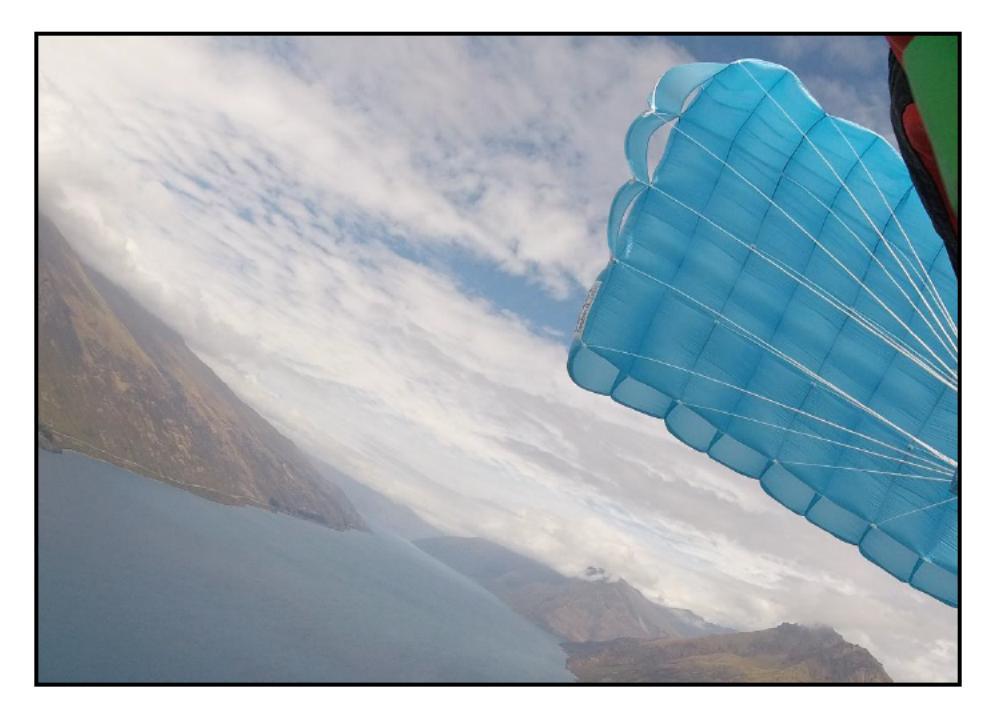
- 2.5. The right-hand side of the reserve parachute did not open properly, which caused the tandem pair to enter a clockwise spin (see Figure 3). The tandem master was unable to correct the problem, but was able to reduce the spin rate intermittently by pulling down on the left brake line to well beyond the normal control movement.

Figure 3: The reserve canopy spinning at about 1,400 feet (420 m) (from the accident flight video)

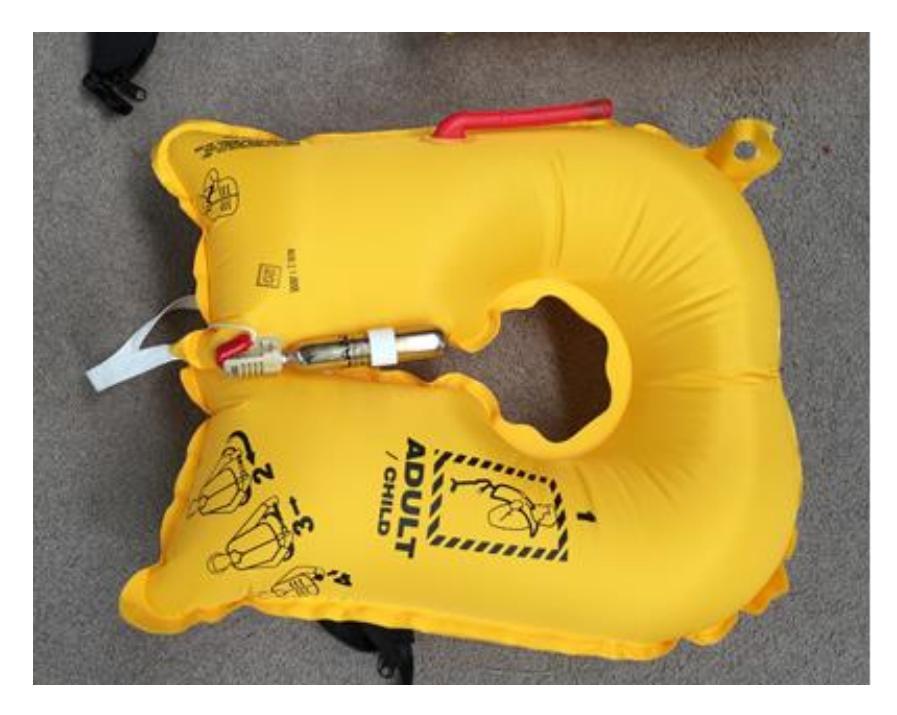
Figure 5: AV-200 lifejacket

- 2.33. The modification removed a whistle and light and changed the container from a sealed plastic bag to a waist-mounted zipped bag. This enabled the lifejacket to be fitted on the front of the tandem rider with a belt.
- 2.34. The lifejacket had a single inflatable cell that was inflated by pulling a red handle attached to a mini-inflator. The action of pulling on the handle normally pierced the membrane of a small, compressed-gas cylinder that was screwed to the mini-inflator. The compressed gas then vented into the lifejacket cell. A separate red mouthpiece was provided for additional manual inflation.

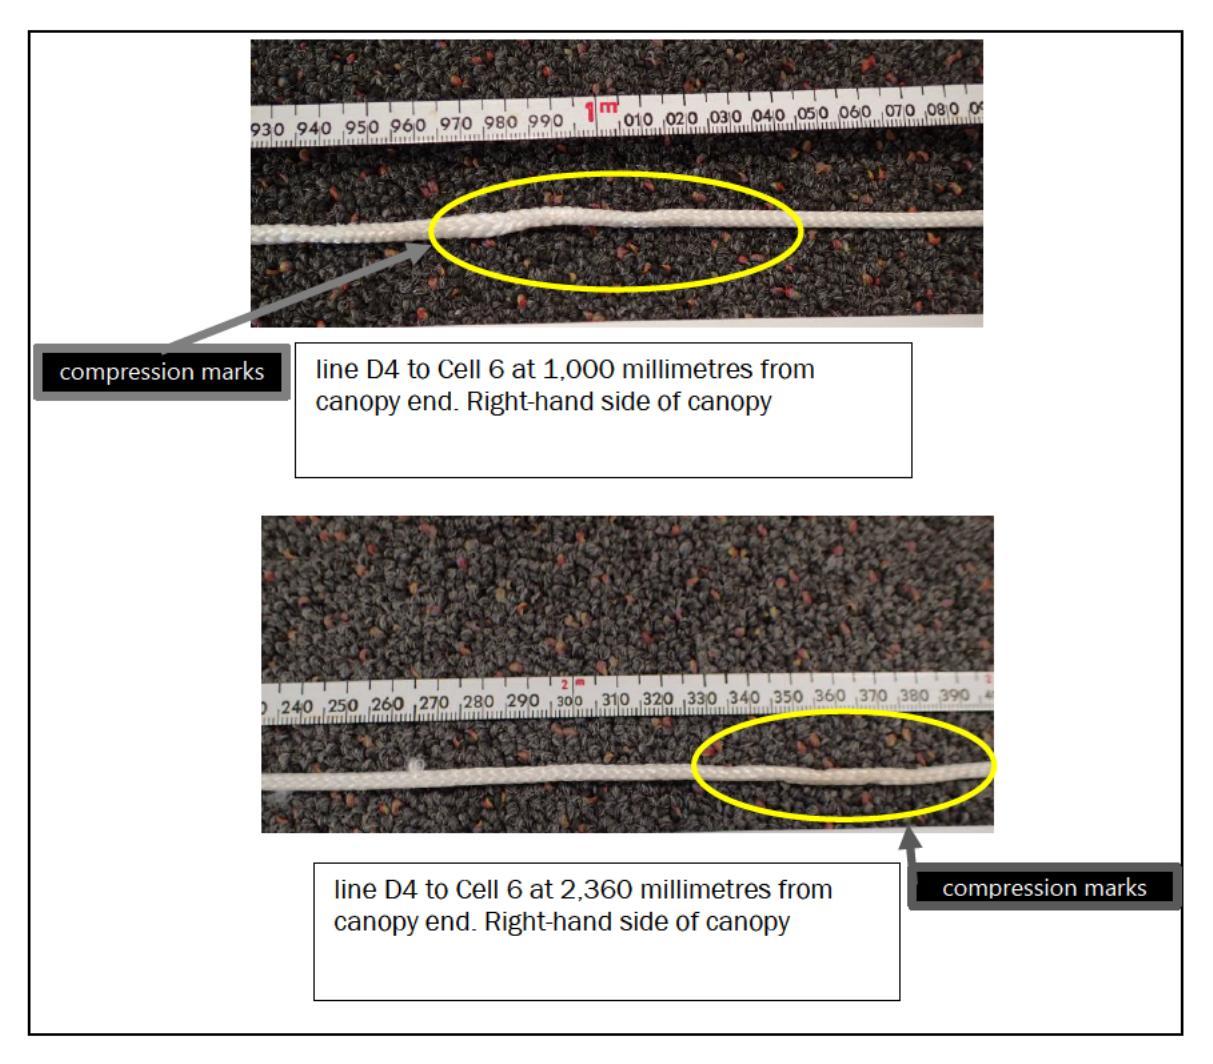
- two reserve parachute suspension lines to the two outer right-hand cells had permanent compression marks in three localised spots (line D4 to Cell 6 and line C5 to Cell 8, shown in Figure 6). The suspension lines were new and the fibre weave was loose from not having been under tension before, so the localised compression marks were visually different from the rest of the suspension lines. No other lines had similar marks. These compression marks were consistent with the pressure that could be exerted by a tension knot. These lines connected to the rear right-hand side of the canopy and passed through the same eyelet in the slider²¹ (see Figure 7)

Figure 6: Compression damage to line D4 on Cell 6

3.42. The permanent compression marks found in the two suspension lines in the reserve parachute were likely caused by a tension knot. The accident flight was the first in which the reserve parachute had been deployed. The two compressed sections of suspension line D4 to Cell 6 shown in Figure 6 were about 1,300 millimetres apart, which coincided with the length of one 'S' fold in the free bag's line pouch. The other line that showed a similar compression was line C5 connected to Cell 8. Both lines passed through the same grommet in the rear right of the slider and were therefore likely to have been involved in the same tension knot.

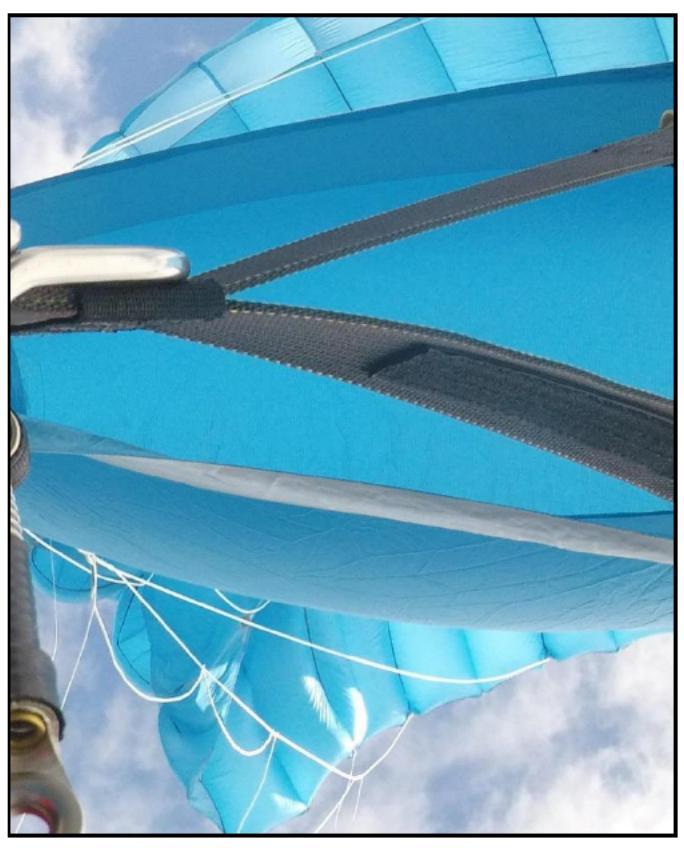
Figure 9: Deformed reserve canopy

- 3.18. The reserve parachute immediately entered into a steep spin to the right. The video recording showed that the right-hand-side brake lines near the canopy tail were loose and flapping in the airflow. The tandem master reported seeing two tension knots in the lines either side of the brake cascade knot.

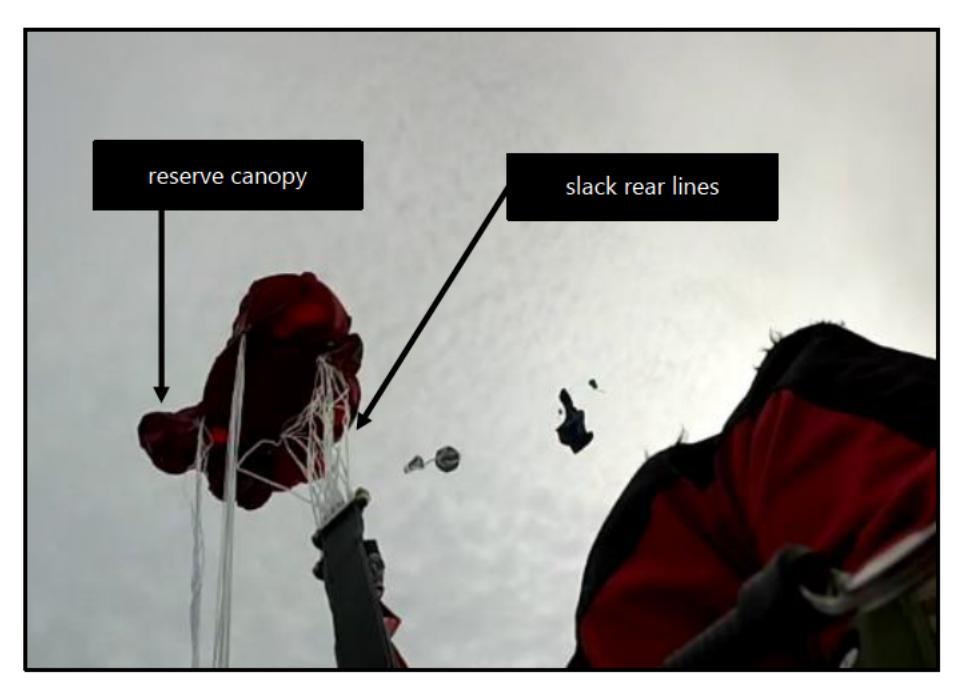
Figure 10: Example of line tension during reserve opening (Credit: NZONE from another cutaway)

- 3.43. A tension knot is unable to form without a slack loop of line. Therefore it is likely that a tension knot formed in the right-rear line group in lines D4 and C5 as the lines unfurled from the free bag pouch, and that the knot passed through the slider grommet but remained knotted and caused the canopy distortion. The example in Figure 10 from another incident shows the reserve canopy starting to inflate with the shorter front line groups taut and the rear line groups still slack and affected by the disturbed airflow around the tandem pair.
- 3.44. As with the main parachute malfunction, the Commission considered the contribution of equipment, the tandem pair's attitude at opening, and packing in the reserve parachute malfunction.

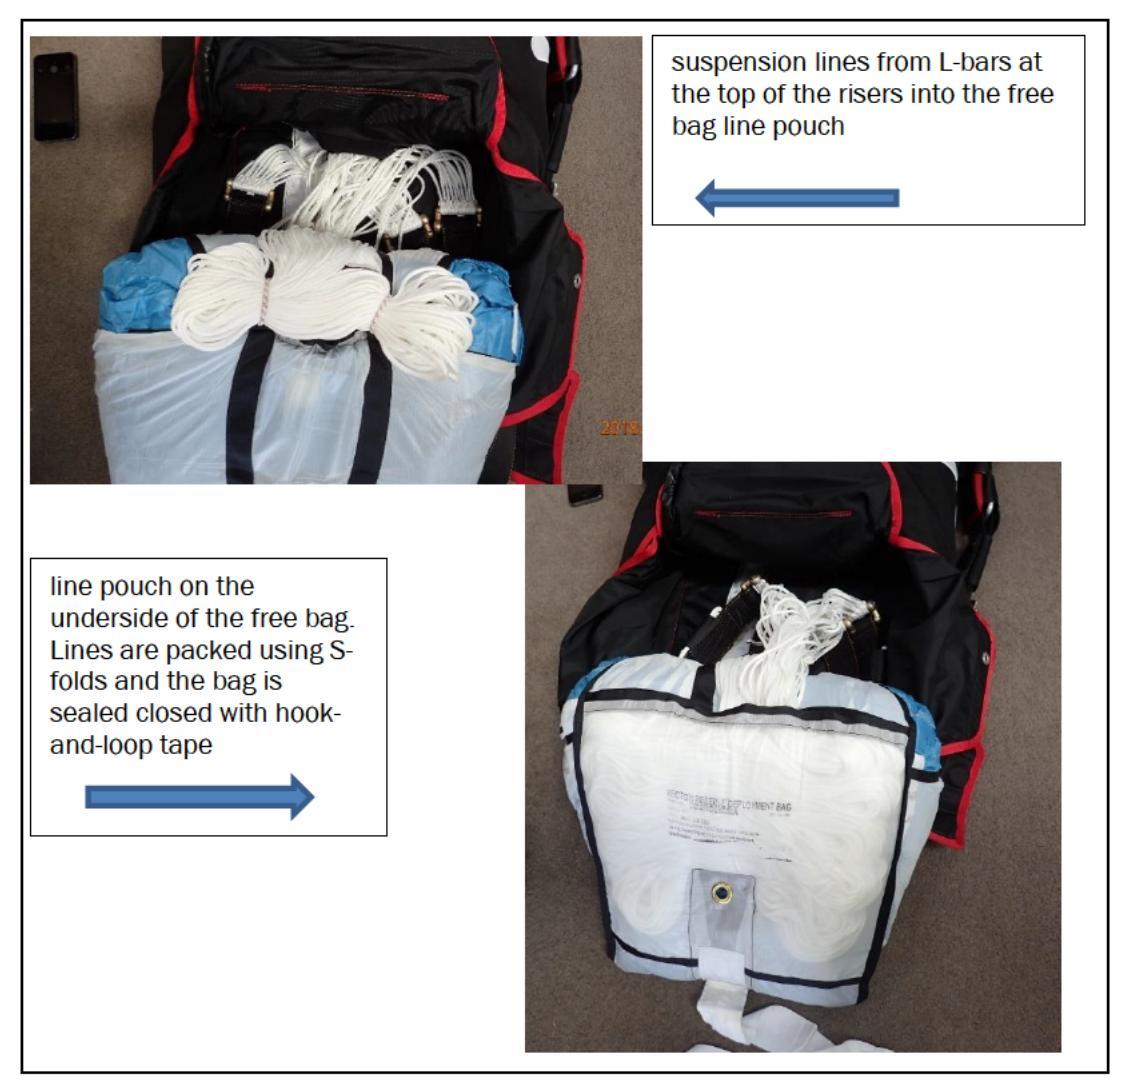
Figure 11: Suspension lines packed into the reserve free bag

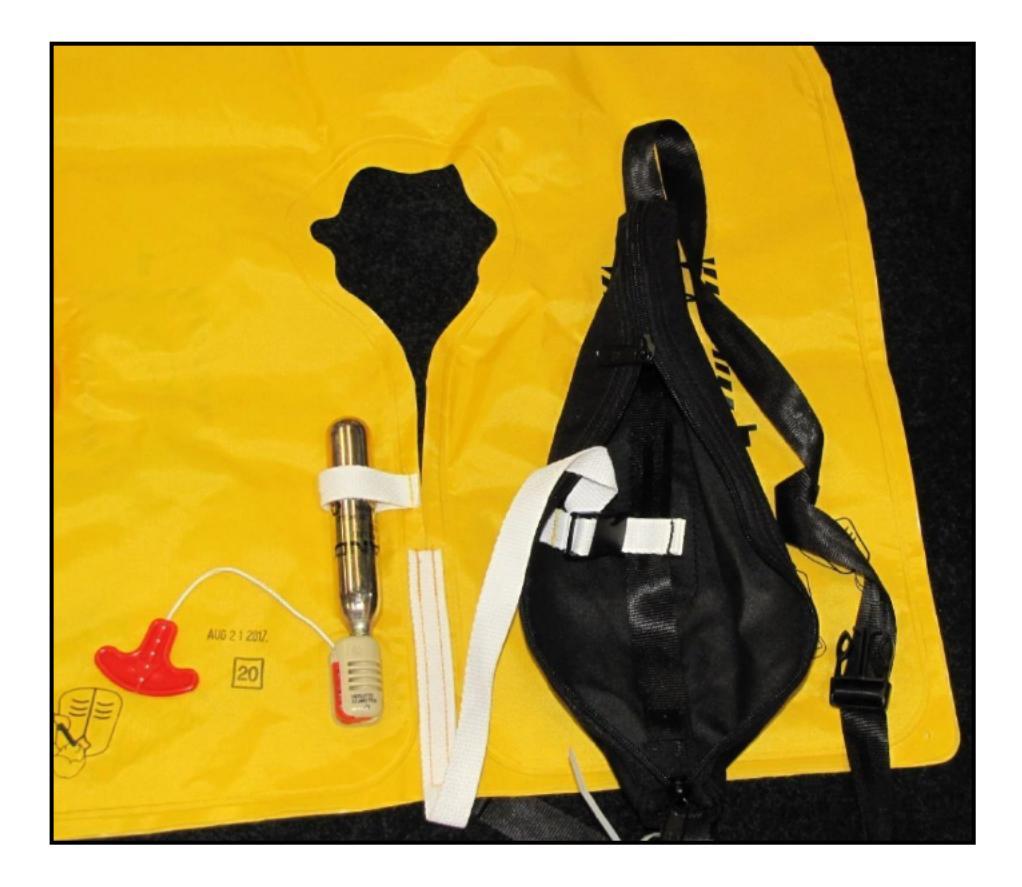
- 3.69. While the lifejackets were new, they were in unsealed, zippered pouches. The greater risk was for the end users. There was no external marking to indicate that the lifejackets were still in a serviceable state before being worn (much like the details a tandem master would check when conducting a parachute pre-flight check³⁷). The operator has since implemented a maintenance and inspection programme to ensure that only serviceable lifejackets are made available for parachute descents.

- 3.71. The reason for the lifejacket used on this parachute descent not fully inflating could not be conclusively determined and it has not been recovered. Possible reasons in sequential order of occurrence are: a manufacturing fault; an empty or loose gas bottle when either it was last packed and placed on a rack ready for use or, during the descent after being fitted on the tandem rider; damage upon impact with the water; and damage while in the water.

Figure 12: Lifejacket and waist pouch container
