Final Report

Aviation inquiry AO-2018-005 MD Helicopters 600N, ZK-ILD Engine control malfunction and forced landing Ngamatea Station 14 June 2018

June 2021

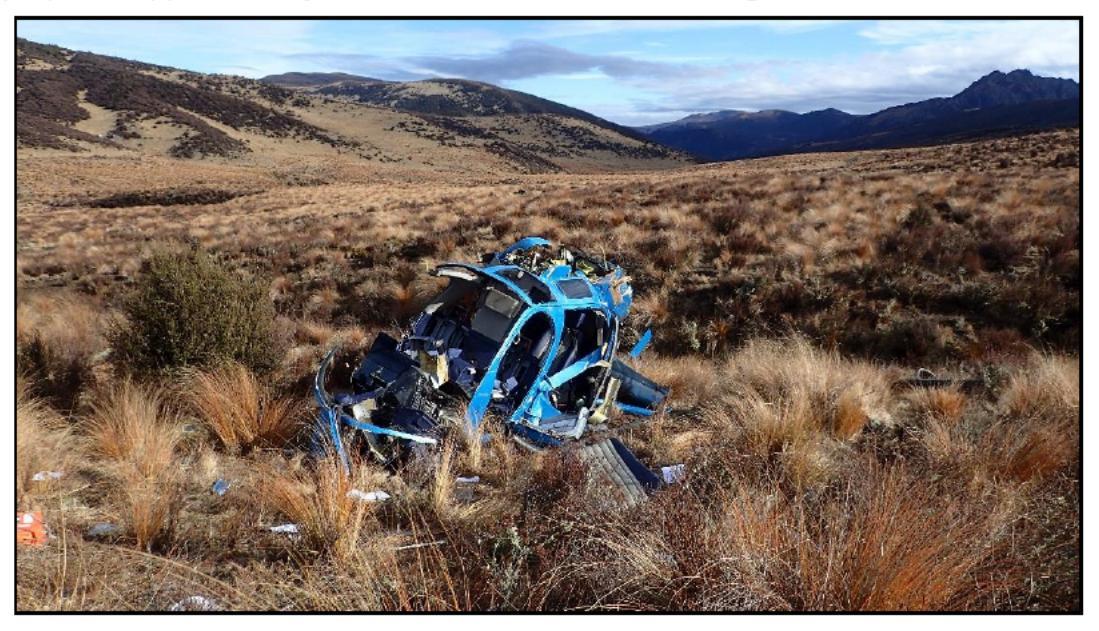
Figure 4: Accident site

- 2.13 The tail section, which included the NOTAR[®] tail cone, both horizontal stabilisers and both vertical stabilisers came to rest in the creek.
- 2.14 The helicopter cabin structure was damaged. The front-right side of the canopy was severed by the main rotor blades. All rear cabin doors and the engine compartment doors remained attached to the helicopter.

- 2.15 There was fire damage to the airframe structure on the right side above the engine compartment.
- 2.16 The left landing gear cross tubes splayed outward from the ground impact. A seat cushion was found trapped directly underneath the left skid tube.

- 2.17 The main rotor head and driveshaft, with three main rotor blades still attached, came to rest to the left of the main cabin structure. Two other main rotor blades were in the creek nearby and the remaining rotor blade was located in front of the helicopter.
- 2.18 The main rotor transmission and its associated supporting airframe structure were propelled approximately 30 metres from the main wreckage.

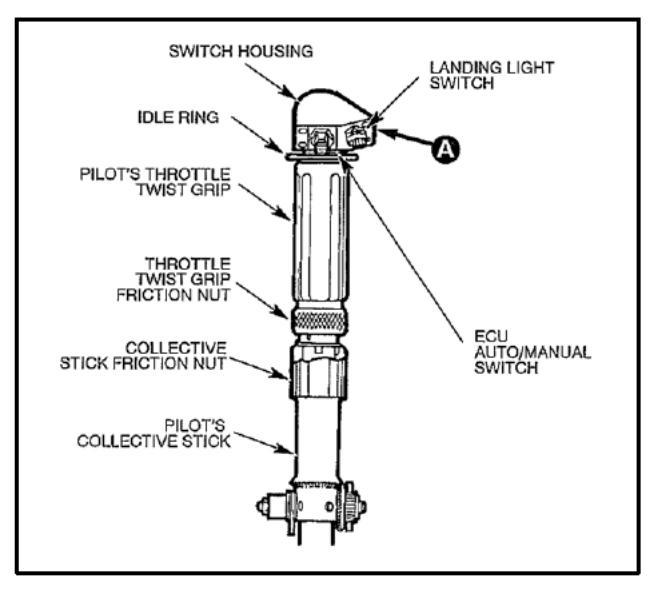
Figure 6: MD 600N Collective with ECU auto/manual switch (Credit: FADEC Auto/Manual Section of MD 600N Rotorcraft Flight Manual)

- 3.6 With both the ECU's primary channel and the reversionary governor having failed, the FADEC system reverted to fuel flow fixed mode, as designed.
- 3.7 The pilot needed to select manual, using the auto/manual switch on the collective to be able to control the main rotor speed, with the FADEC system in fuel flow fixed mode. The recorded ECU data showed that the auto/manual switch on the collective lever was not selected to manual at any stage during the accident flight.

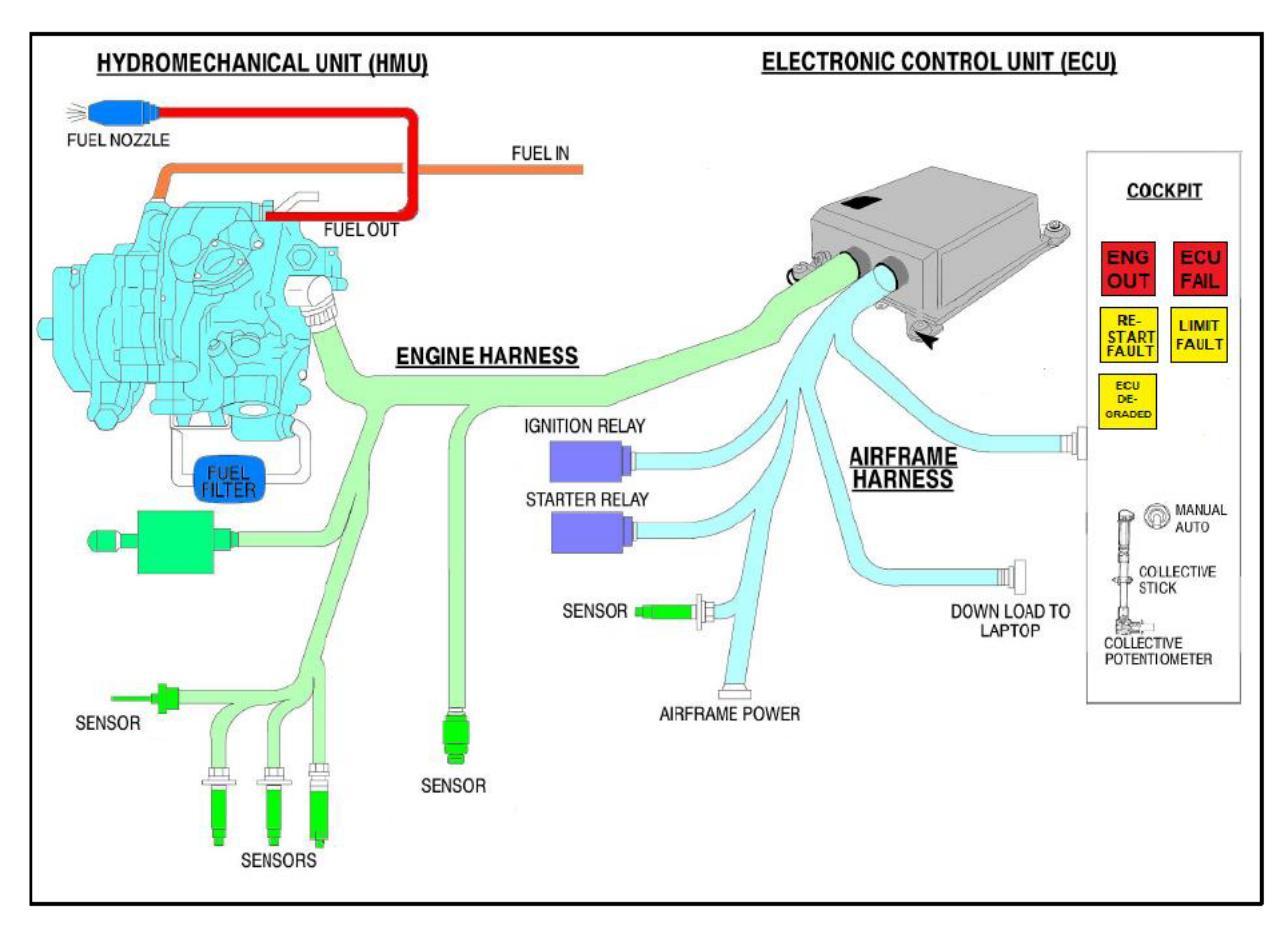
Figure 7: Simplified Schematic of the FADEC system (Credit: MD Helicopters' MD 600N Pilot Transition Training Manual)

- 3.4 The ECU primary channel compared fuel-flow measurements from two different sources within the HMU. The ECU data showed that during the accident flight the difference between these two measurements exceeded a predefined value. This discrepancy caused the primary channel to declare a 'step count fault'²⁰ and then fail, at which point the FADEC system changed to the reversionary governor mode.

- 3.5 The reversionary governor measured the rate of engine speed change using two sets of measurements. About seven minutes and 55 seconds after taking control, the difference between these two measured values exceeded limits, resulting in the reversionary governor also failing.

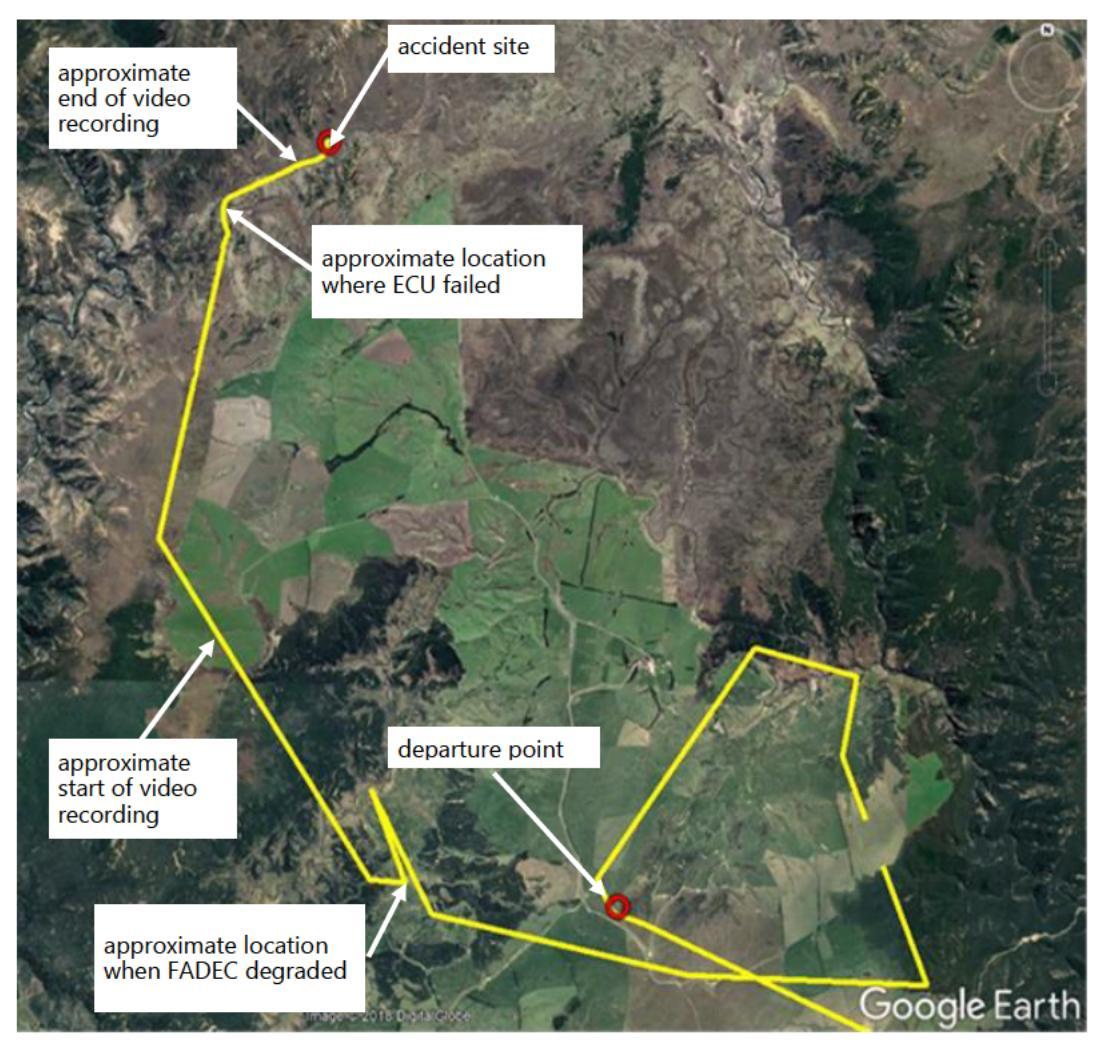
Figure 8: Approximate accident flight path²⁷

3.37 Earlier in the accident flight, when the primary channel failed and control transitioned to degraded FADEC system under the reversionary governor, the helicopter was flying over open farmland. Several options for a precautionary landing were available at the time, including a return to the point of departure, which was less than two minutes away. However, the pilot continued toward a more remote area with fewer options for a safe precautionary landing and no practical mode of communication from ground level.
