Final report Tuhinga whakamutanga

Aviation inquiry AO-2019-006 Cessna 185A, ZK-CBY and Tecnam P2002, ZK-WAK Mid-air collision, near Masterton 16 June 2019

September 2022

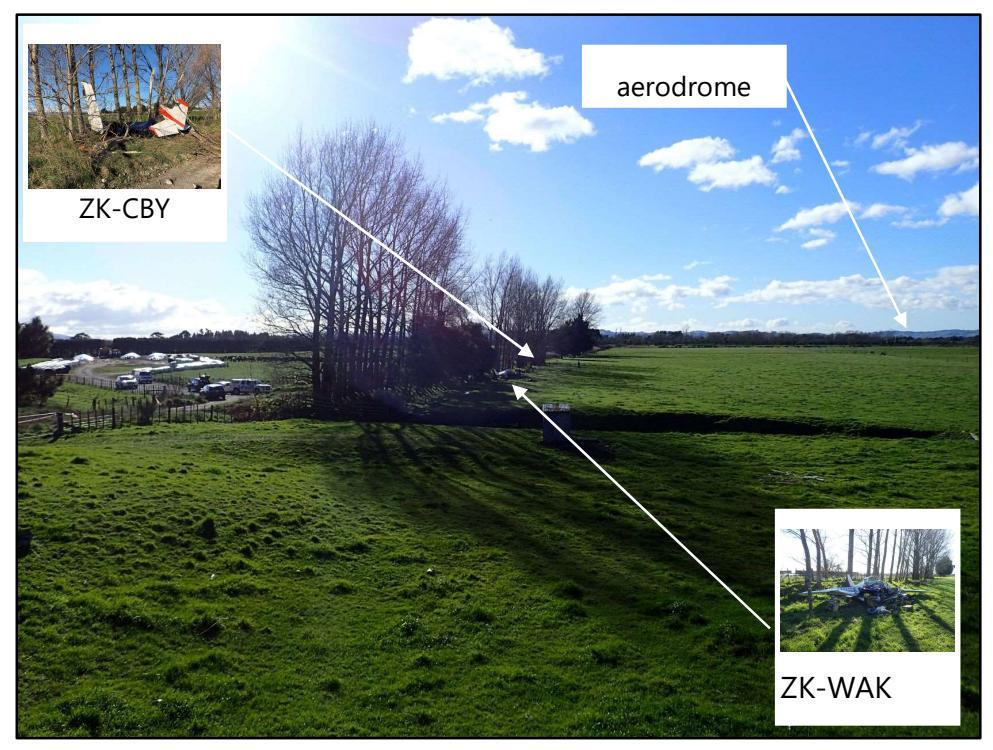
Figure 5: Accident site

- 2.6. At 1112:32, the pilot of ZK-WAK radioed advising "Masterton traffic, Whisky Alpha Kilo is on final for runway 06, full stop Masterton". ZK-WAK and ZK-CBY collided immediately on completion of this transmission.
- 2.7. The pilot of the helicopter reported not hearing the landing call from ZK-WAK, but did see the two aeroplanes collide and spiral to the ground. ZK-CBY caught fire as it impacted the ground. The pilot of the helicopter landed nearby and, along with several witnesses, attempted to assist the occupants. The two pilots suffered fatal injuries (see figure 5).

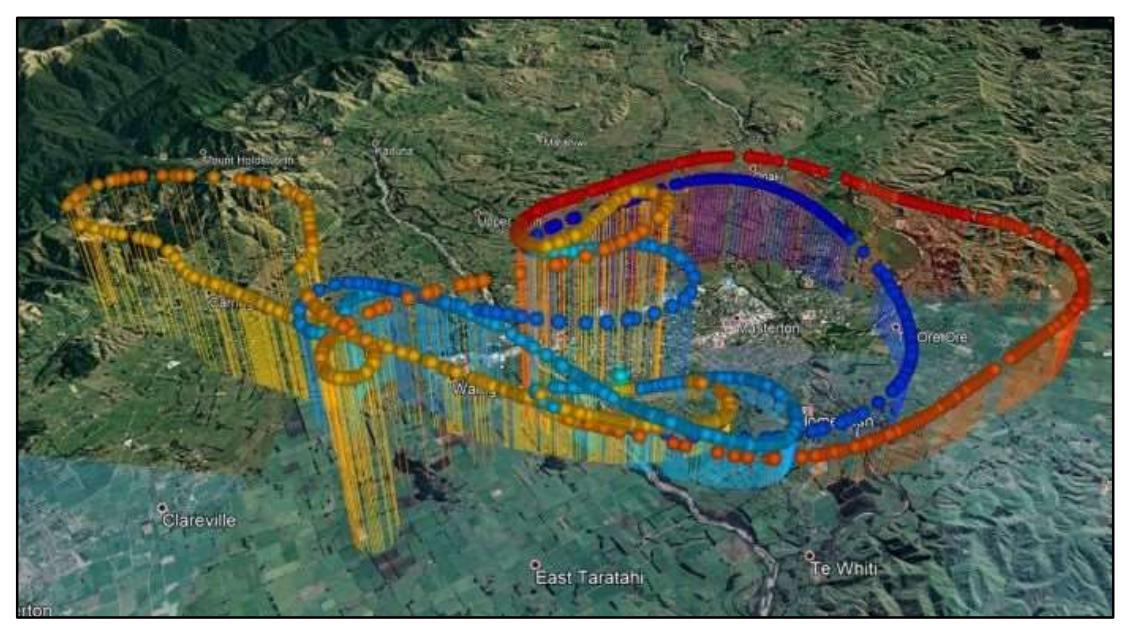
Figure 6: FLARM flightpath (Credit: Wellington Skydive)

- 2.31. The FLARM tracking data from ZK-CBY for the approximately 30 previous flights were obtained as part of the investigation. The data provided an accurate record of the flightpaths of ZK-CBY from power-up to shut down, including all of the accident flight information (see figure 6).

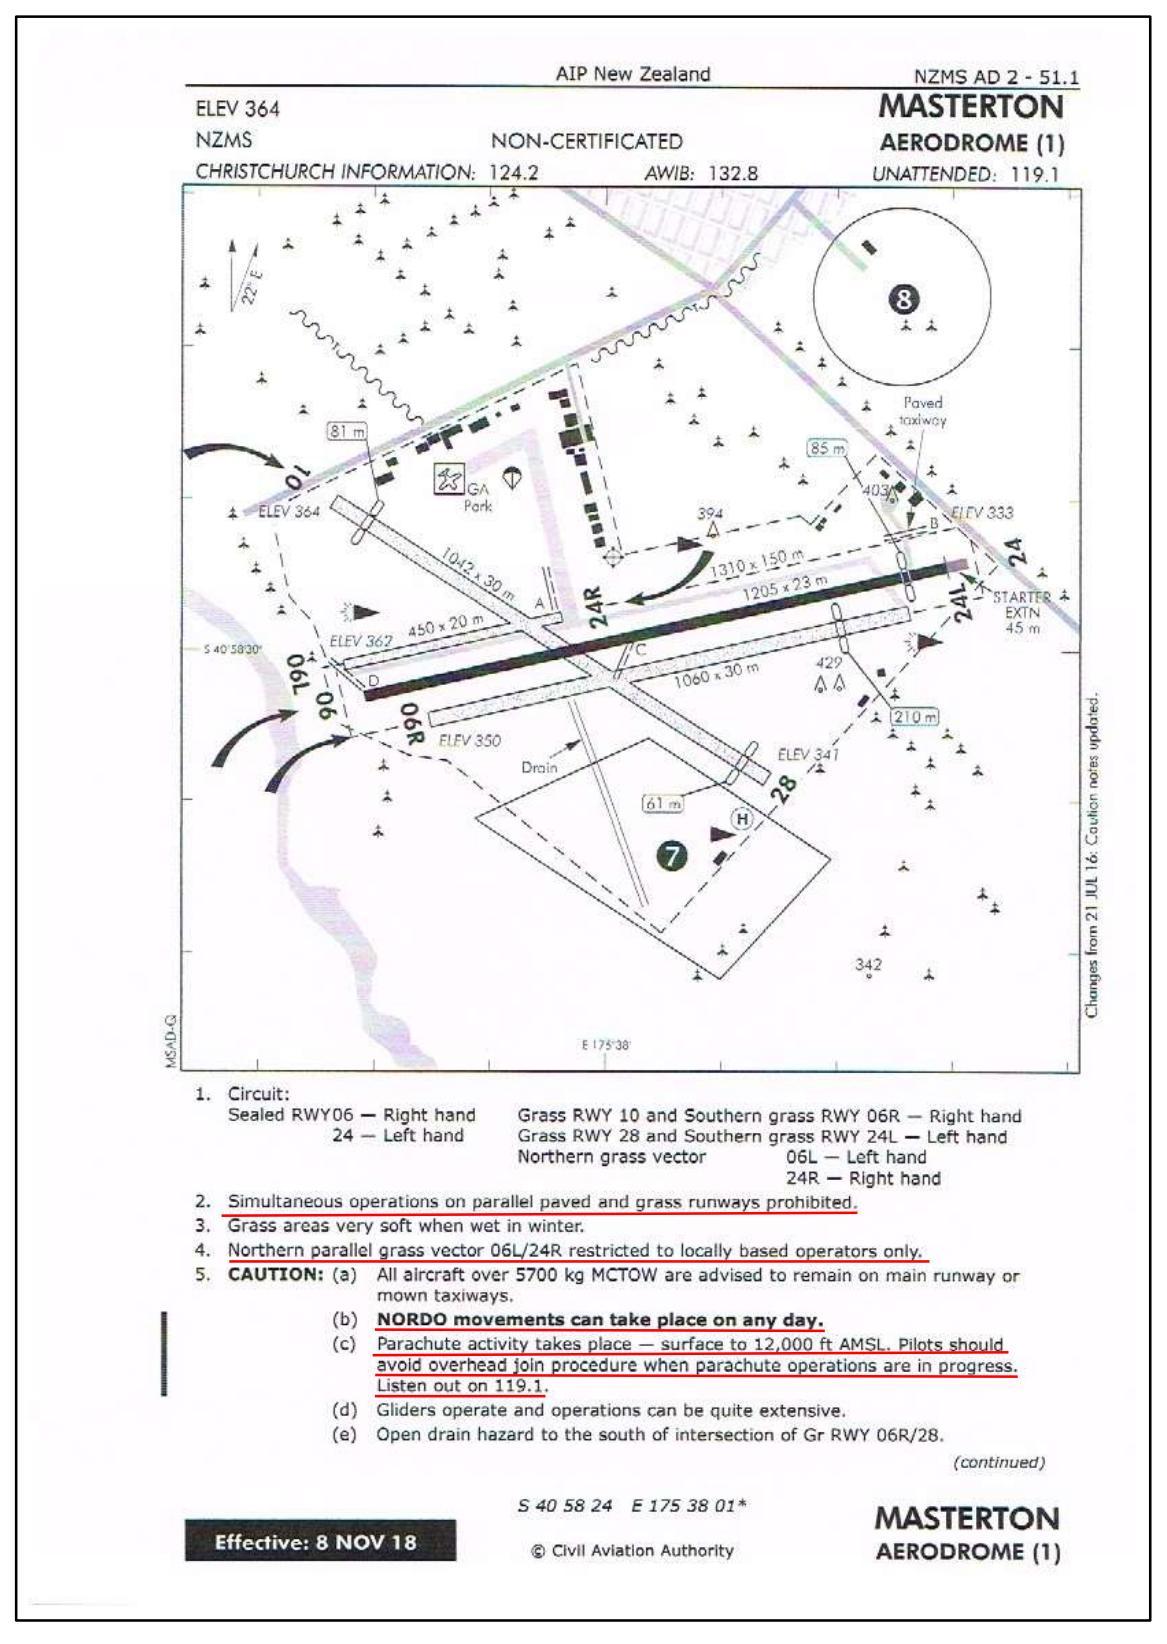
Figure 7: Aerodrome chart (current at time of accident)

- 1.5. Both aeroplanes were approaching the runways at the same time. The aerodrome chart informed pilots that 'simultaneous operations' were prohibited. However, there was no definition of what 'simultaneous operations' were, and as a result there were a range of interpretations. A recommendation was made to address this deficiency and review aerodrome charts generally to ensure they are relevant and consistent.

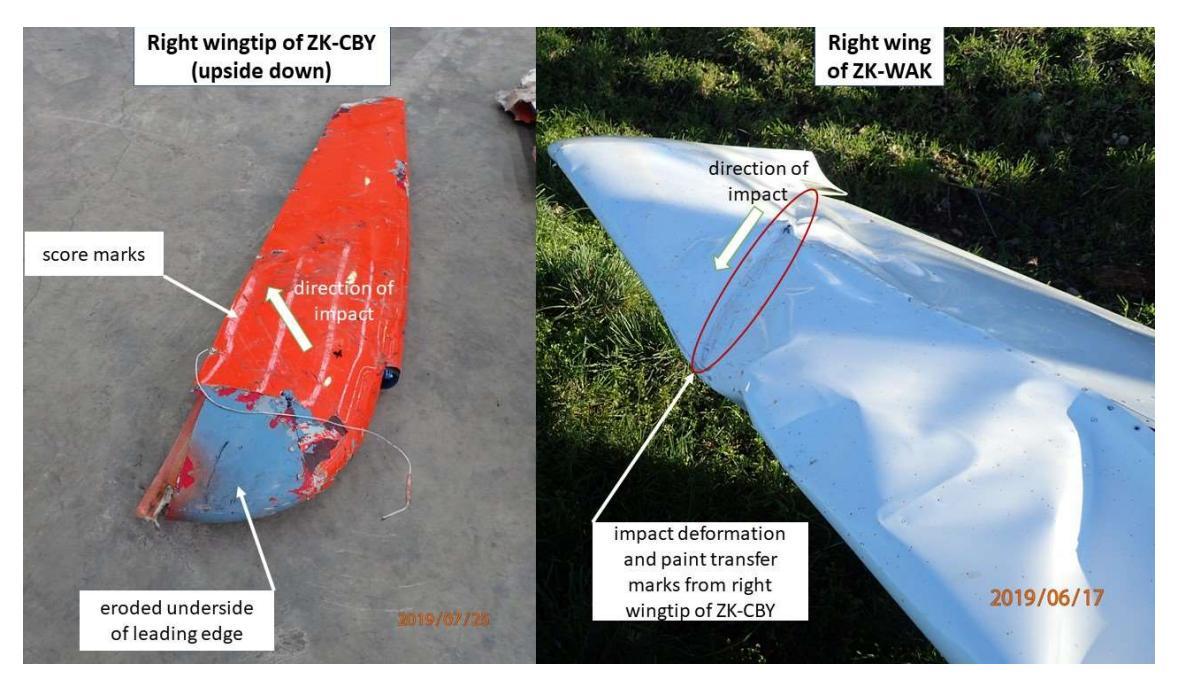
Figure 9: Collision evidence

- 2.52. Examination of ZK-WAK identified rubber transfer marks on the right side of the cabin area, about in line with the aeroplane's seating. Paint transfer was also evident on the right upper wing surface, between 1 and 2 metres in from the wingtip. There were gouging or dents coincidental with the paint transfer marks. The transfer marks were of a pale red or orange colour. This colour matched the colour painted on ZK-CBY. The damage on the upper surface of the right wing of ZK-WAK was also consistent with the damage sustained by the right wingtip of ZK-CBY (see figure 9).

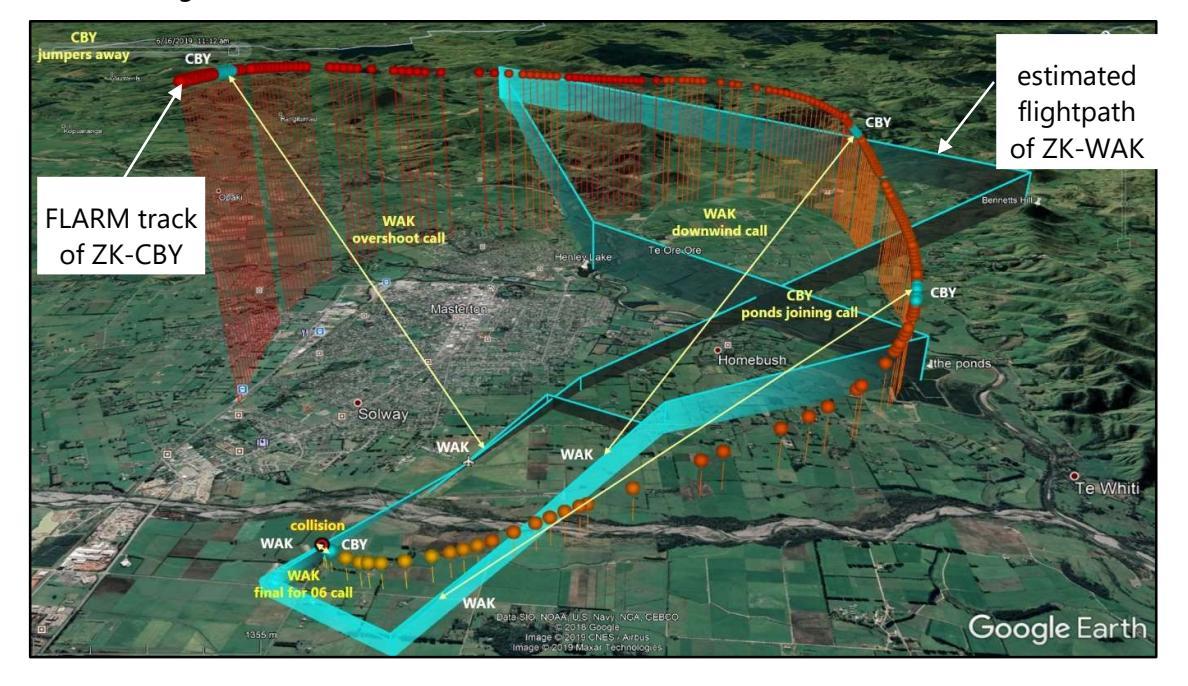
Figure 11: Flightpaths of ZK-CBY and ZK-WAK

Note: The location of ZK-CBY when the calls were made (the blue dots) is based on the FLARM data matched to the recorded timing of the calls so is considered to be accurate. The position of ZK-WAK at these times is approximate.

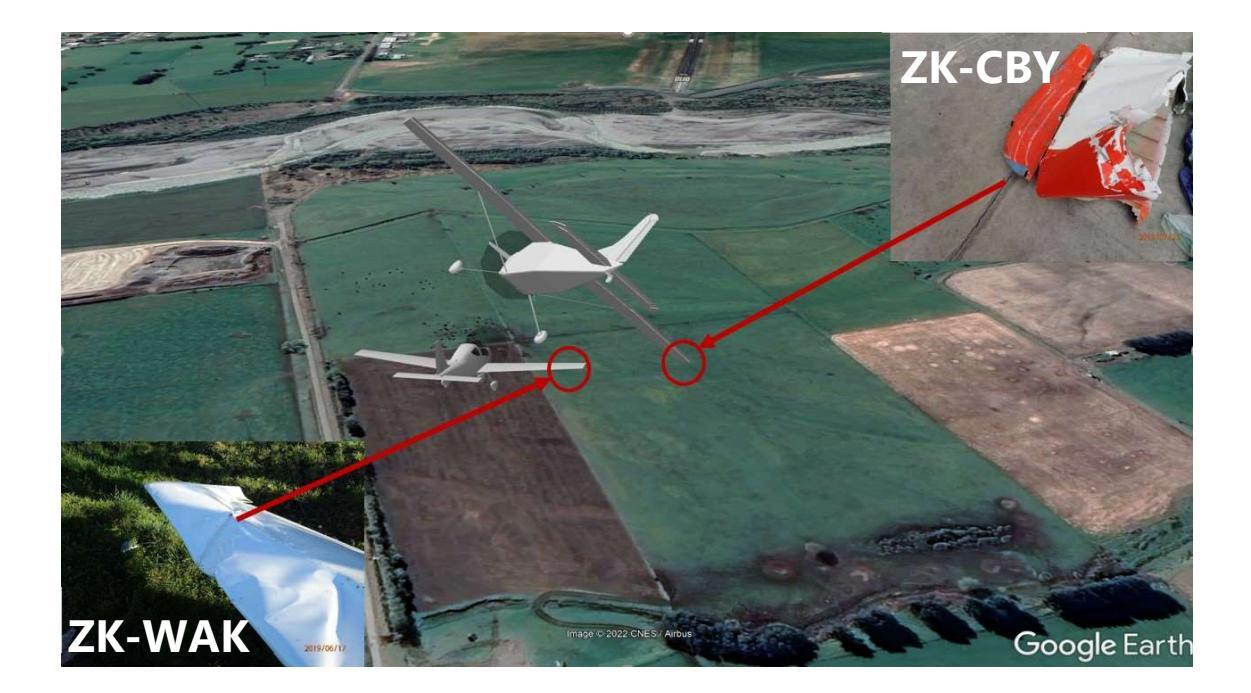
Figure 12: Relative positions shortly before collision (approximate only)

wing struck the right side of the cockpit and right wing, respectively, of ZK-WAK (see figure 12). The two aeroplanes collided heavily and initially tangled before separating and spiralling to the ground.
