Transport Accident Investigation Commission

Aviation inquiry AO-2020-002 Glider, Schleicher ASK21, ZK-GTG Impact with Terrain Mount Tauhara, Taupō 31 May 2020

November 2023

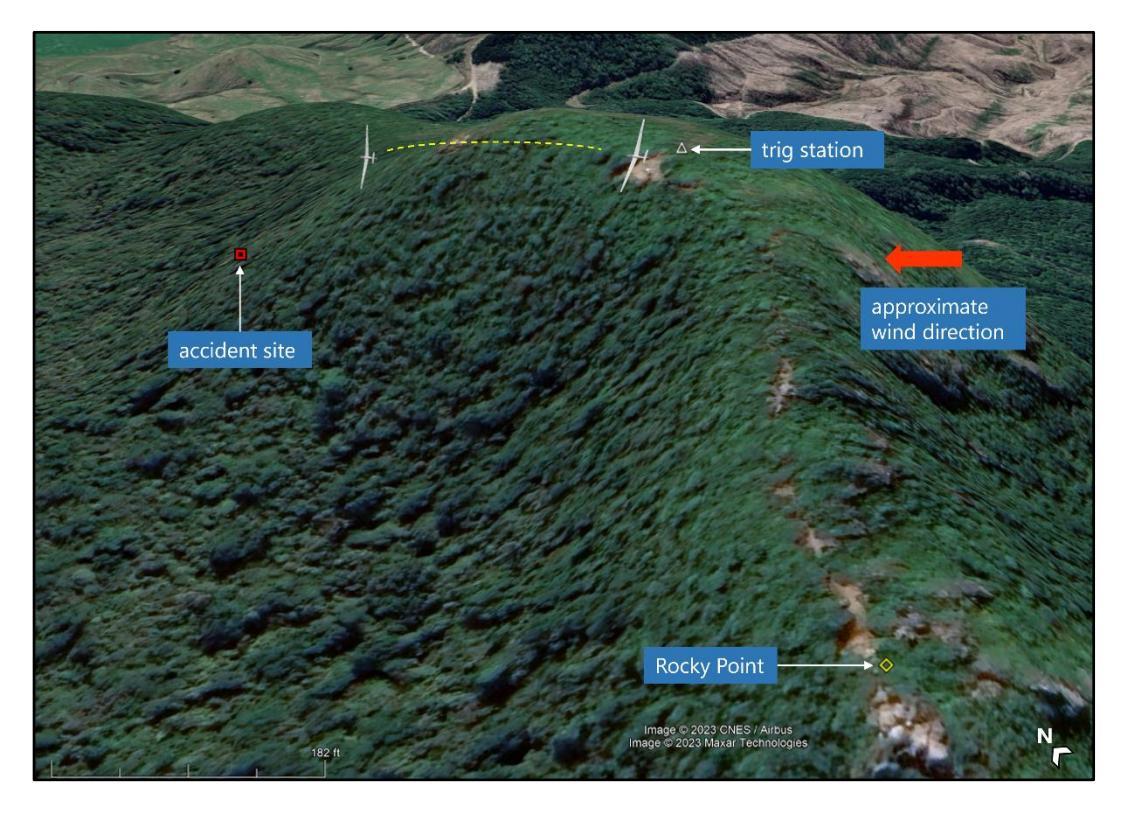
#### Figure 3: Likely glider path immediately before impact (Base picture from Google Earth Pro)

known as Rocky Point and The Trig. Some of these witnesses reported later that they saw the glider fly in a northerly direction to the west of the trig station at the mountain's peak and then descend and impact with terrain just below the trig station (*see* Figure 3). Timing from various sources confirmed that the accident occurred at about 1433.

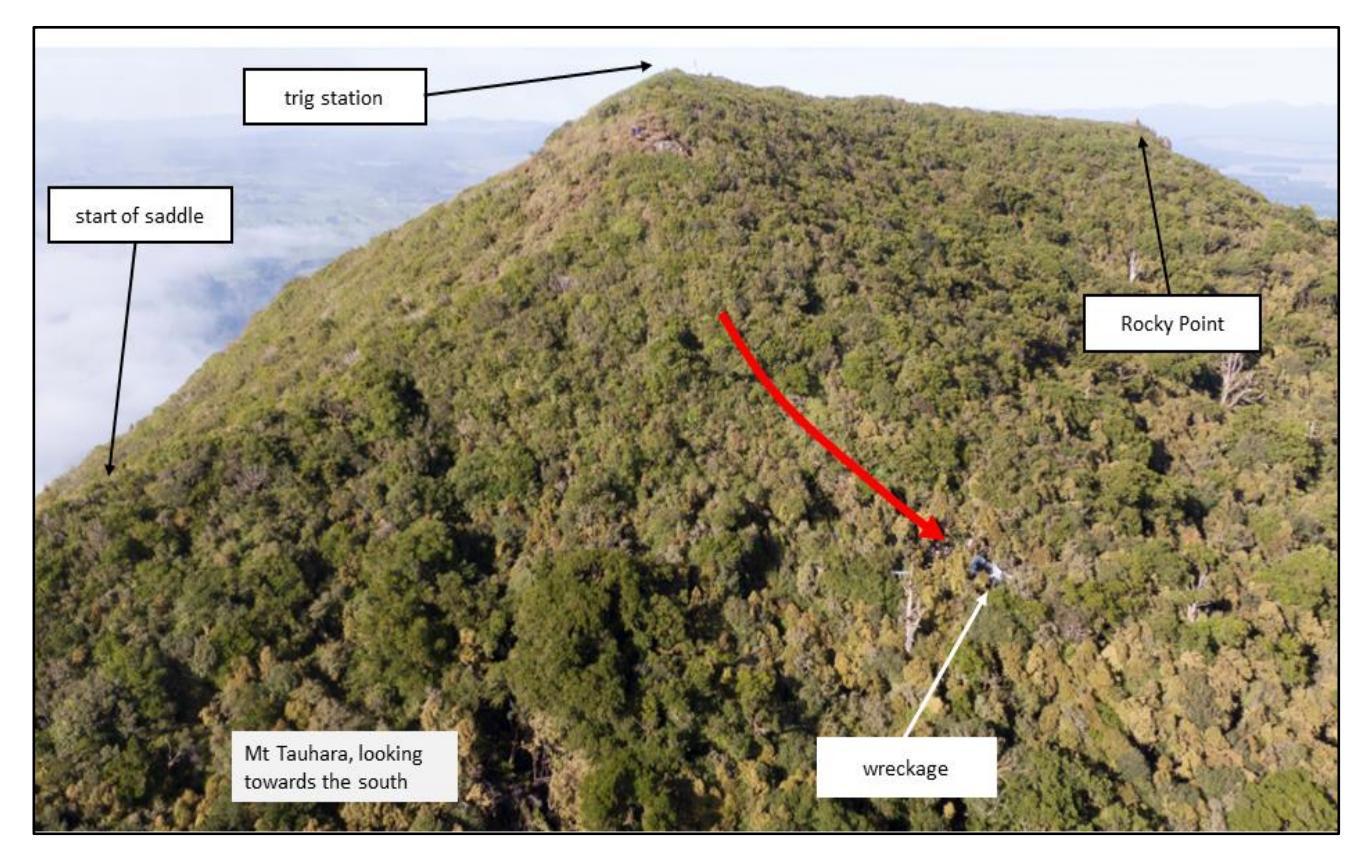
Figure 4: Glider impact path (looking south)

- 2.29 The glider's flight path immediately before impact, as confirmed by witness reports and ground impact scars, was at a height that was about level with the trig station and slightly to the west. The glider was seen heading in a northerly direction (*see* Figure 3). Along the glider's flight path, the ground level dropped away to a crater valley. That valley ended at a saddle at the edge of the mountain.
- 2.30 The wreckage was located on Mount Tauhara approximately 110 metres north and 60 metres below the trig station (*see* Figure 4). The first part of the glider to impact the terrain was the left wing tip (*see* Figure 5). It cut a clearly defined left-hand, curved slice through the scrub and bush canopy (the red curved line in Figure 4). The glider fuselage impacted later during the accident sequence (near the arrowhead in Figure 4) in an almost vertical nose-down attitude.

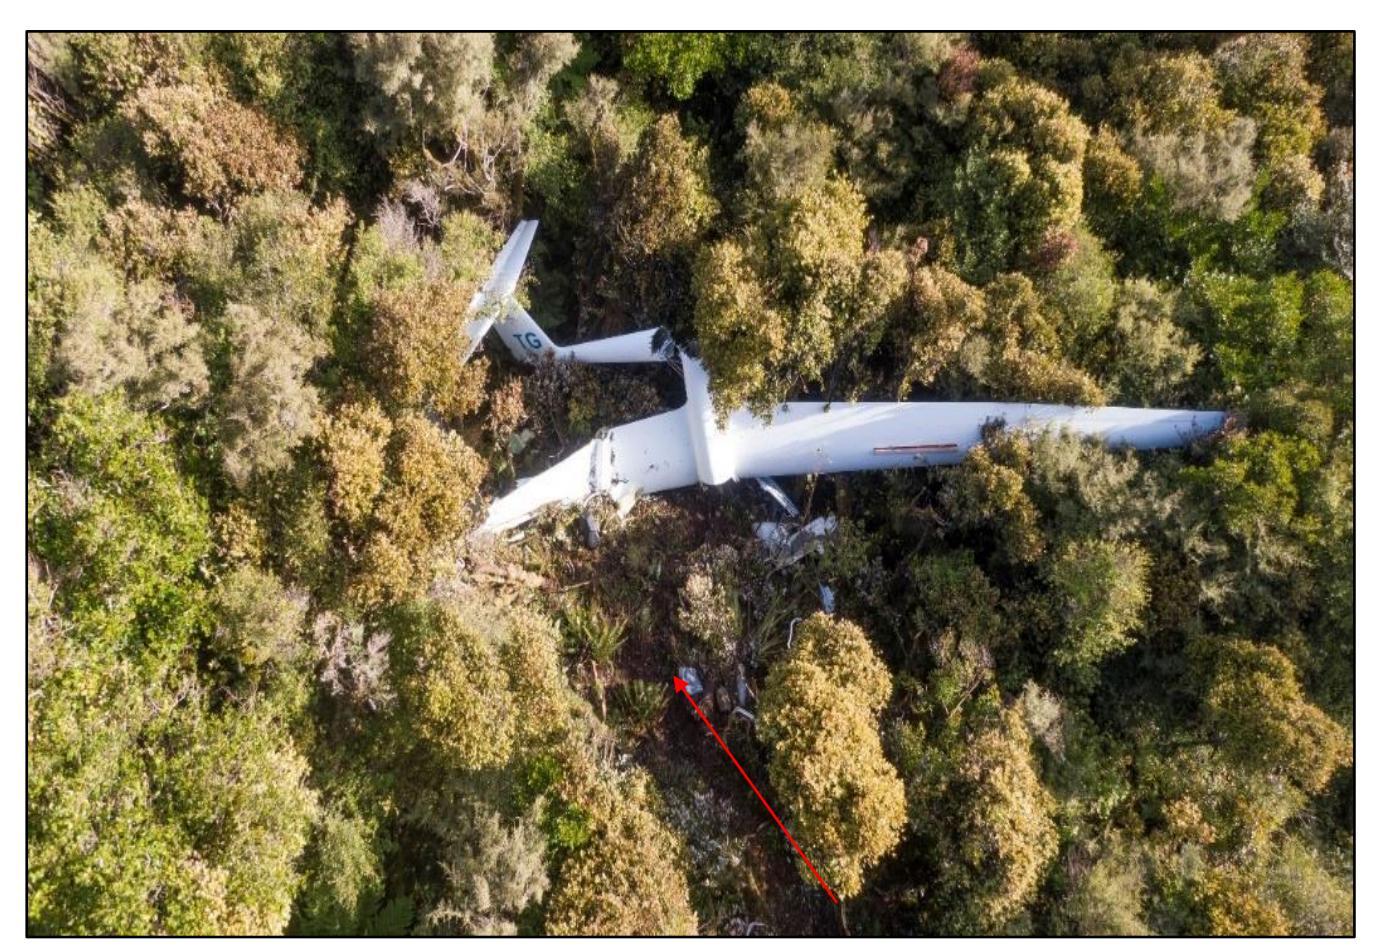
Figure 6: Wreckage and impact path (red arrow) – top of photo is north

2.31 The glider continued to slide through the bush, with the right wing leading and the fuselage near vertical until the right wing lodged in a tree trunk. The fuselage fell back slightly, twisting the right wing. The tail section broke off just aft of the wings as the glider came to rest in the bush (*see* Figure 6).

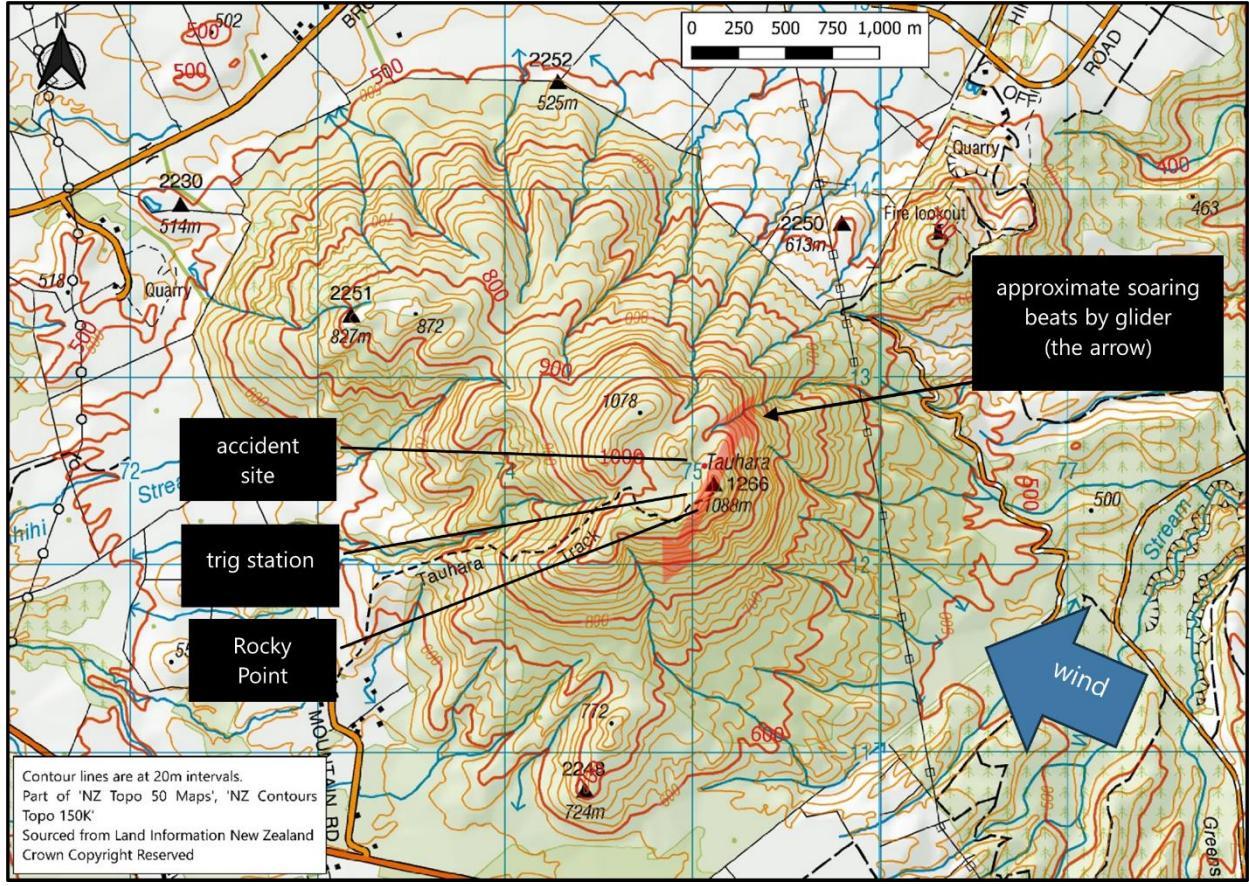
Figure 8: Mount Tauhara

- 2.37 Mount Tauhara has four main faces that can be soared (*see* Figure 8): the north face near the club's base, the southwestern face near the township, the eastern face near a quarry, and the southeastern or back ridge on the opposite side of the mountain from the base. Some faces produce stronger lift than others and some are shorter in length. If the wind changes (in either direction or strength) the lift may also increase or reduce or shift to a different face.

- 2.38 The wind was from the southeast on the day of the accident, as shown with the blue arrow in Figure 8. The approximate glider flight path on the ridge runs, as determined from the video of the first flight, is shown as a red double-pointed line.

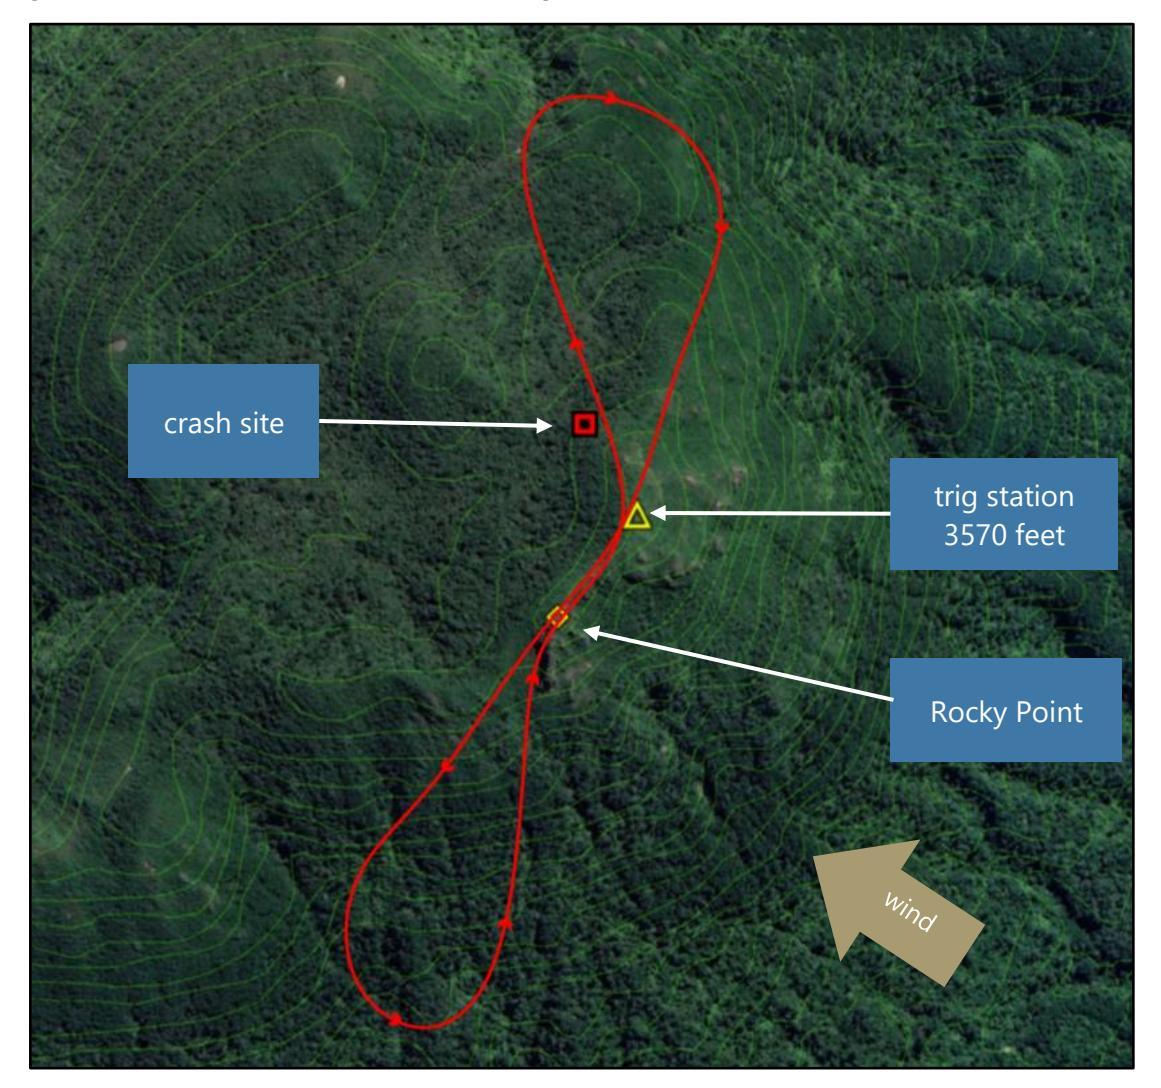
#### **Figure 9: Estimated ridge soaring beats for the first flight, from video** (Base picture from Google Earth Pro)

- 3.19 Pilots must maintain awareness of gliders' relative positions over ridges, and alert to areas of high risk. If a pilot allows a glider to get too close to the ridge or drift downwind of the crest, they need to respond promptly and have an escape route in mind that leads to lower ground.
- 3.20 In the first flight, the instructor approached Mount Tauhara from the south over Rocky Point then flew north and to the left of the trig station with 50–100 feet clearance above the top of the mountain (*see* Figure 9).
