# Final report Tuhinga whakamutunga

Aviation inquiry AO-2022-002 Robinson R22, ZK-HEQ Loss of control in flight Karamea, West Coast 2 January 2022

December 2023

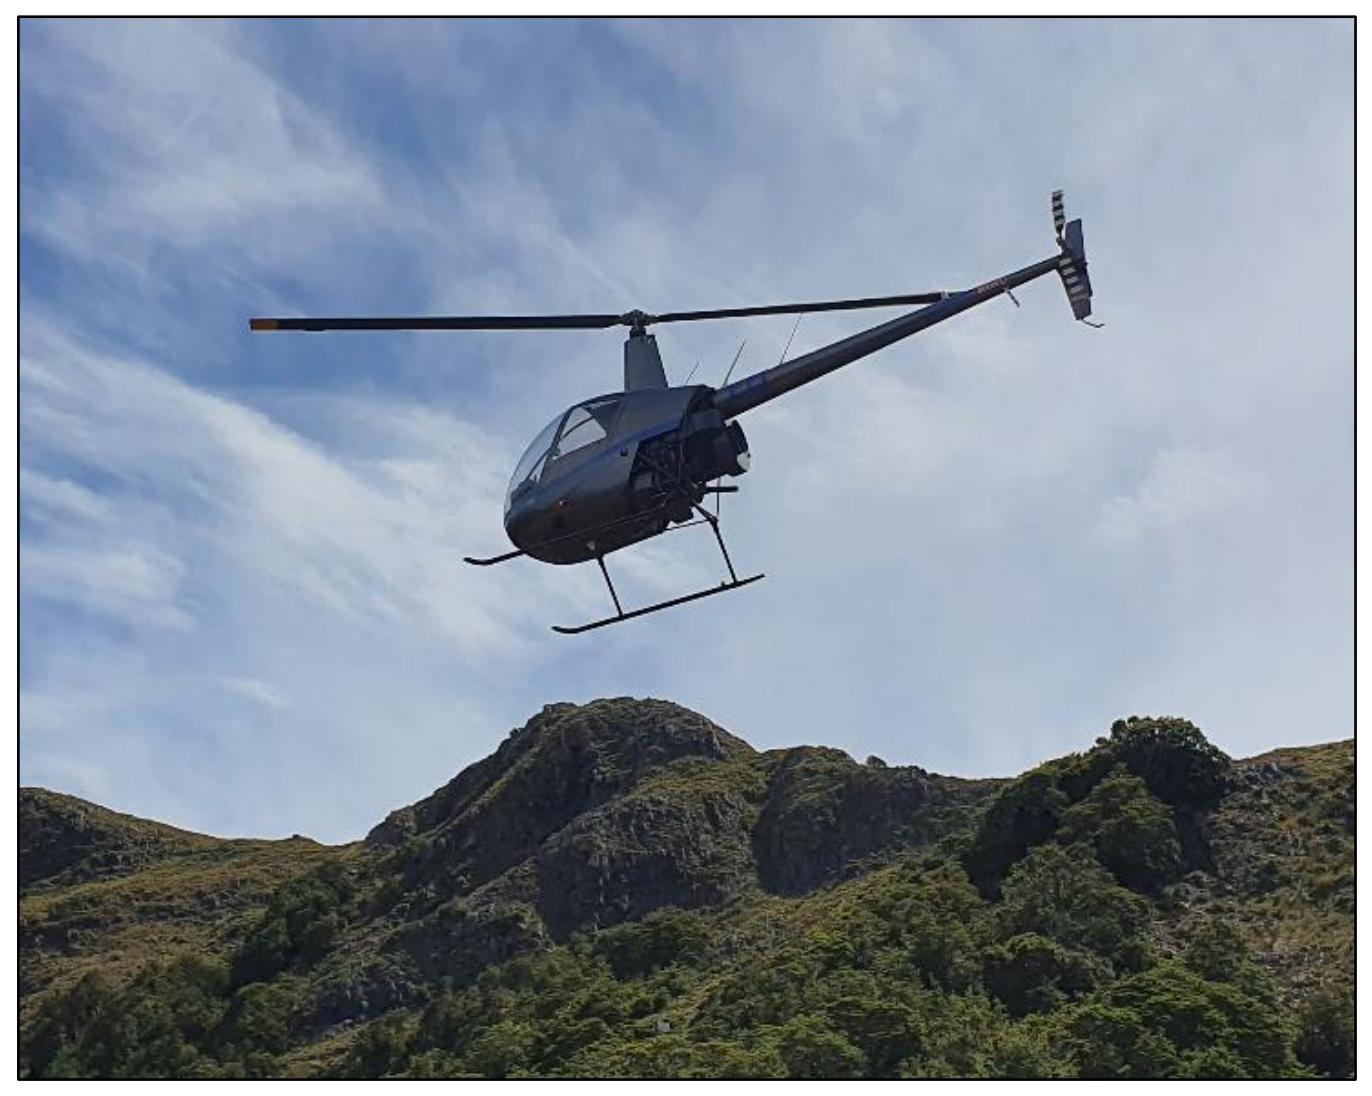
Figure 1: The helicopter, Robinson R22 Beta II, ZK-HEQ (Credit: Photo taken by passenger at drop-off point)

- 3.45. The pilot had reported a regular banging noise about 15 seconds after lift-off, after dropping off the second passenger. During the examination of the wreckage, impact dents were found on the left fuel tank and engine side panel external surfaces. In addition, the left seat belt webbing damage was characteristic of the seat belt being jammed in the passenger's door and dangling outside the helicopter during flight.
- 3.46. There was a possibility that the left-hand seat belt buckle banging against the outside of the fuselage in flight matched the vibration and noise reported by the pilot. A photograph taken by the passenger at the drop-off point showed the helicopter departing but no seat belt dangling from it, so this was discounted (*see* Figure 1).

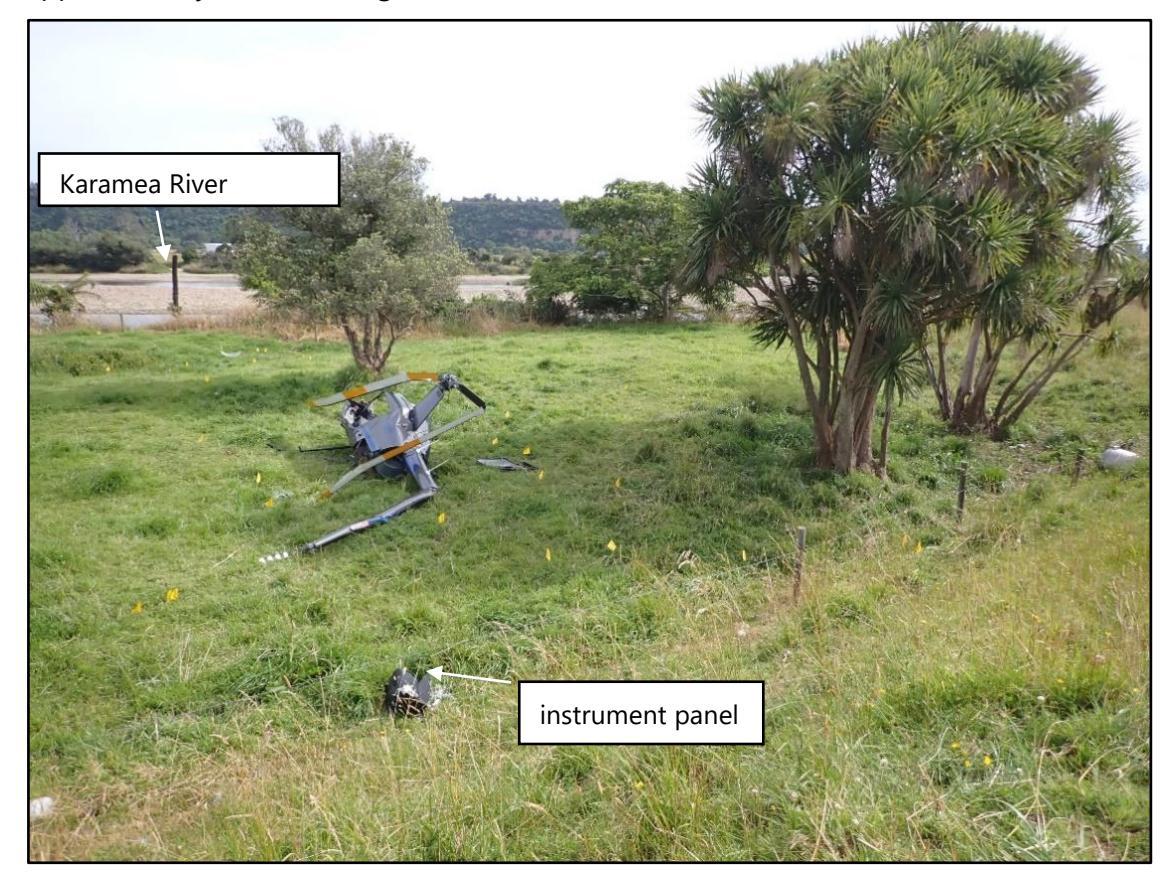
2.40. The accident site was the riverbank at the north side of the Karamea River, on a grass paddock about 110 m from the pilot's hangar, the original departure location. The impact damage indicated the helicopter had fallen to the ground almost vertically in a right skid-low attitude. The helicopter was sitting upright resting on the engine, facing approximately south (*see* Figure 5).

Figure 5: Accident scene

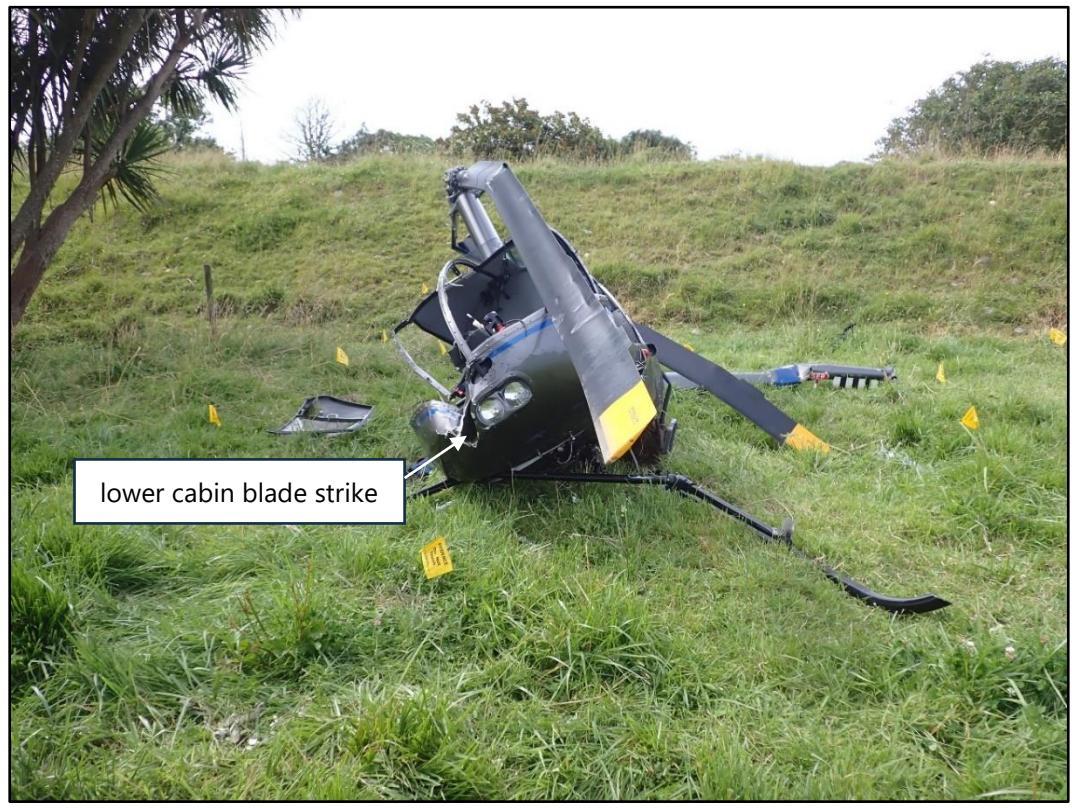
Figure 6: The helicopter after the accident.

- 2.41. Both main rotor blades were still attached to the main rotor hub assembly. One main rotor blade spindle tusk (which limits blade downward deflection) had sheared in overload and was found on the ground close to the helicopter. A main rotor blade had struck the lower front right of the cabin (*see* Figure 6). This caused the top section of the instrument panel to be projected about 9 m to the rear of the helicopter wreckage (*see* Figure 5). The pitch horn for this blade and both main rotor blade pitch link rod ends had broken.

- 2.42. Impact damage was found on the main rotor blade teeter stops, but the damage had not progressed to the main rotor shaft.
- 2.43. The engine's cooling fan (*see* Figure 7 and Appendix 5) was securely fitted to the tapered shaft and the alignment mark was present, showing no signs of movement between the cooling fan and the fan shaft. This ruled out the engine cooling fan being a possible source of the helicopter vibration.

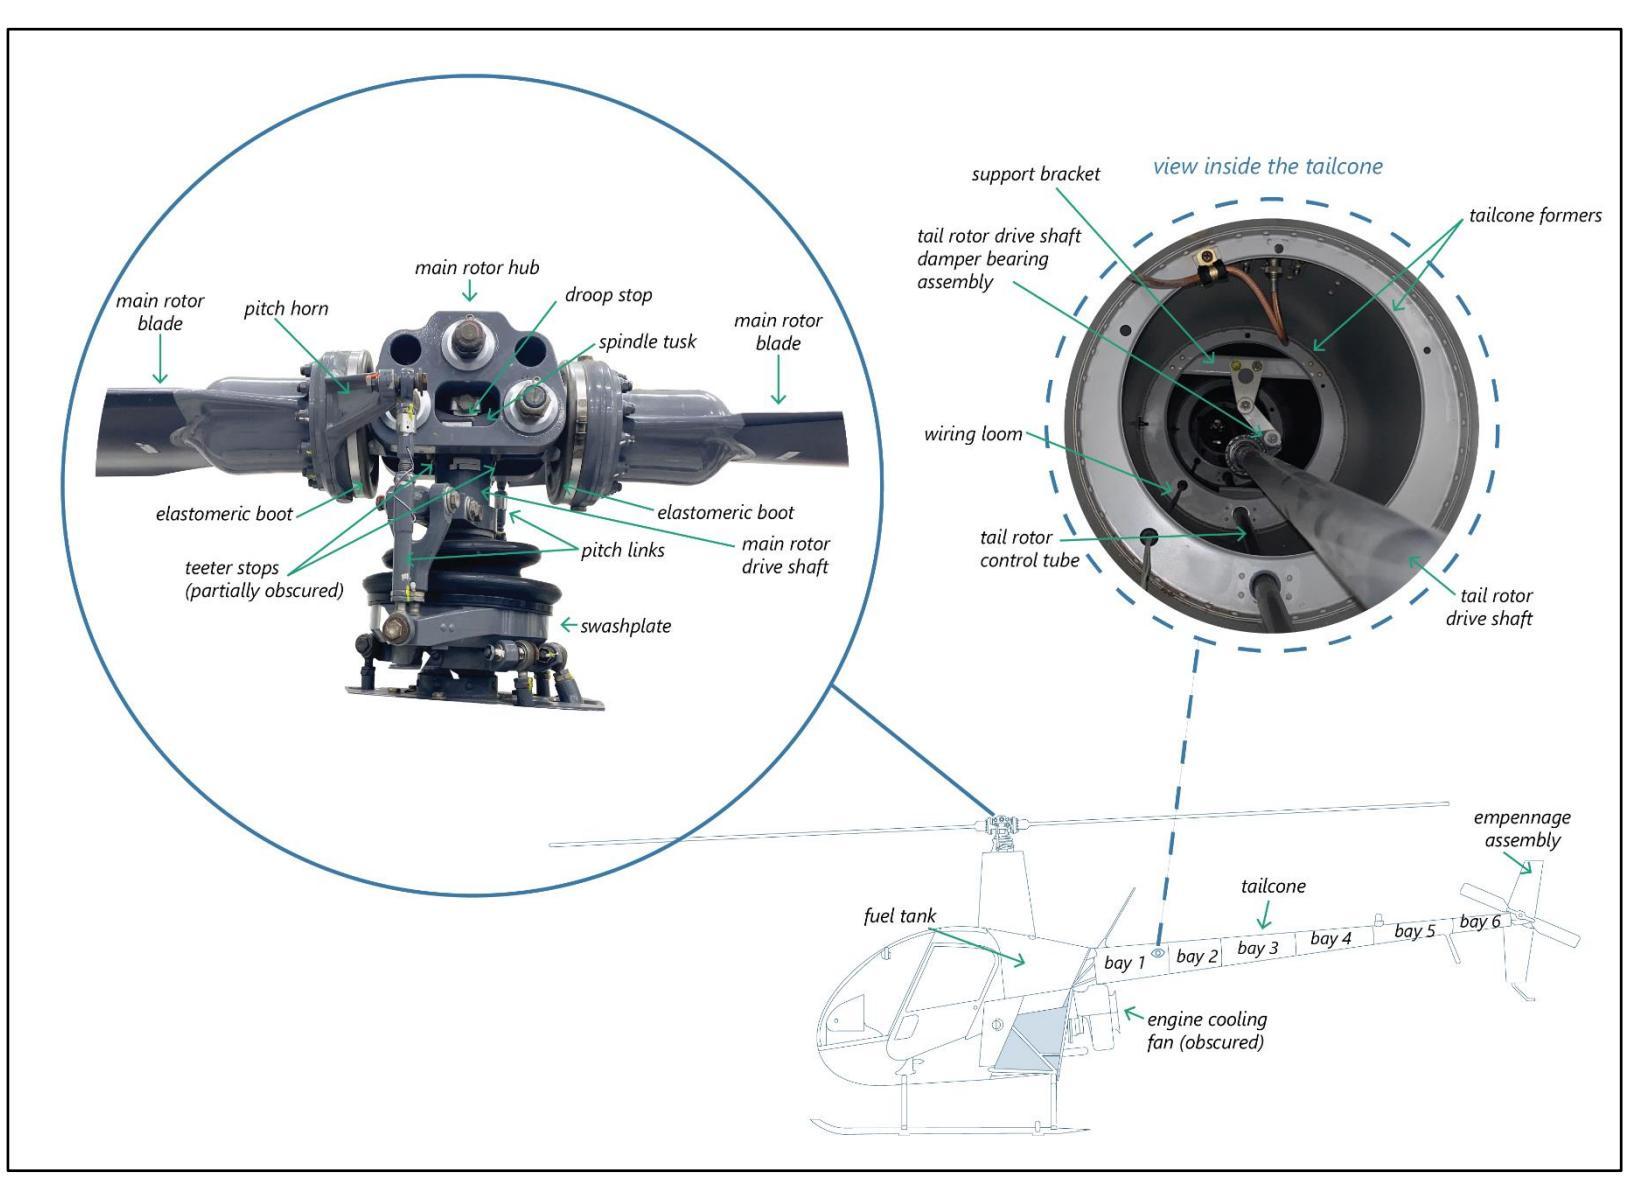
Figure 7: Robinson R22 main rotor hub assembly and view inside the tailcone

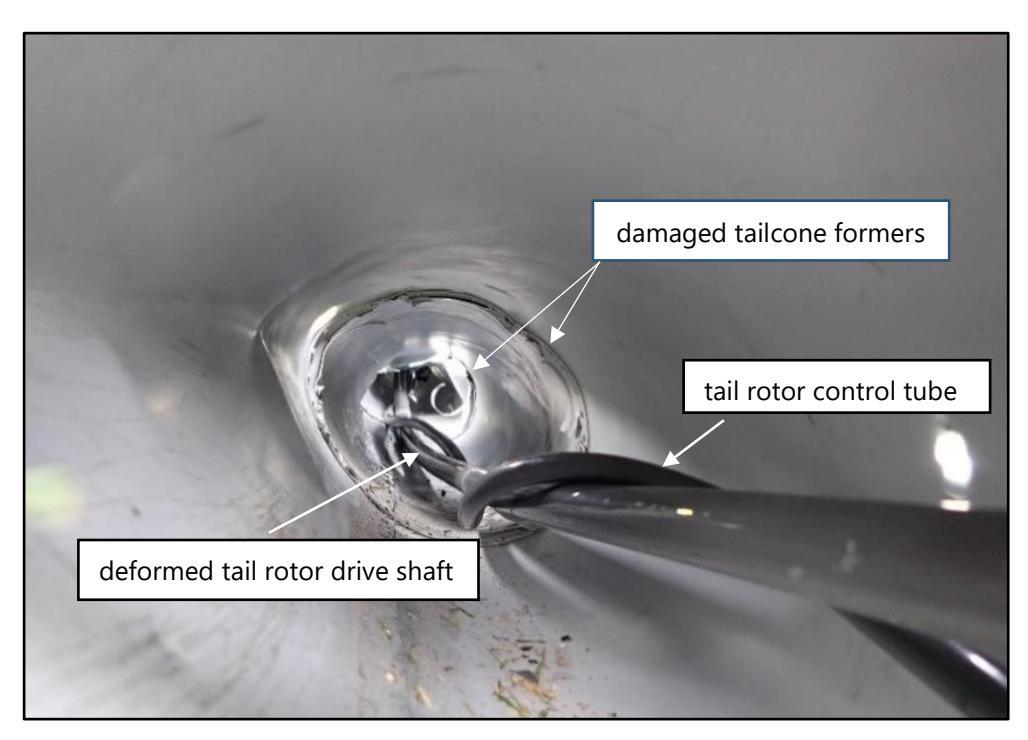
mounting on the tailcone frame and exhibited a surface depression by the damper bearing. The lower arm of the damper bearing assembly had bent and fractured in overload below the upper friction washer assembly. The remainder of the damper bearing assembly affixed to the shaft, had cut through the tailcone skin from the inside.

Figure 8: View from inside tailcone, looking aft from bay three

3.14. The deformed tail rotor drive shaft exhibited marks around its outer surface where it had contacted and structurally damaged the tailcone formers. The formers near the aft section of the tapered tailcone were flattened by the deformed tail rotor drive shaft gyrating in the tailcone (*see* Figure 8).

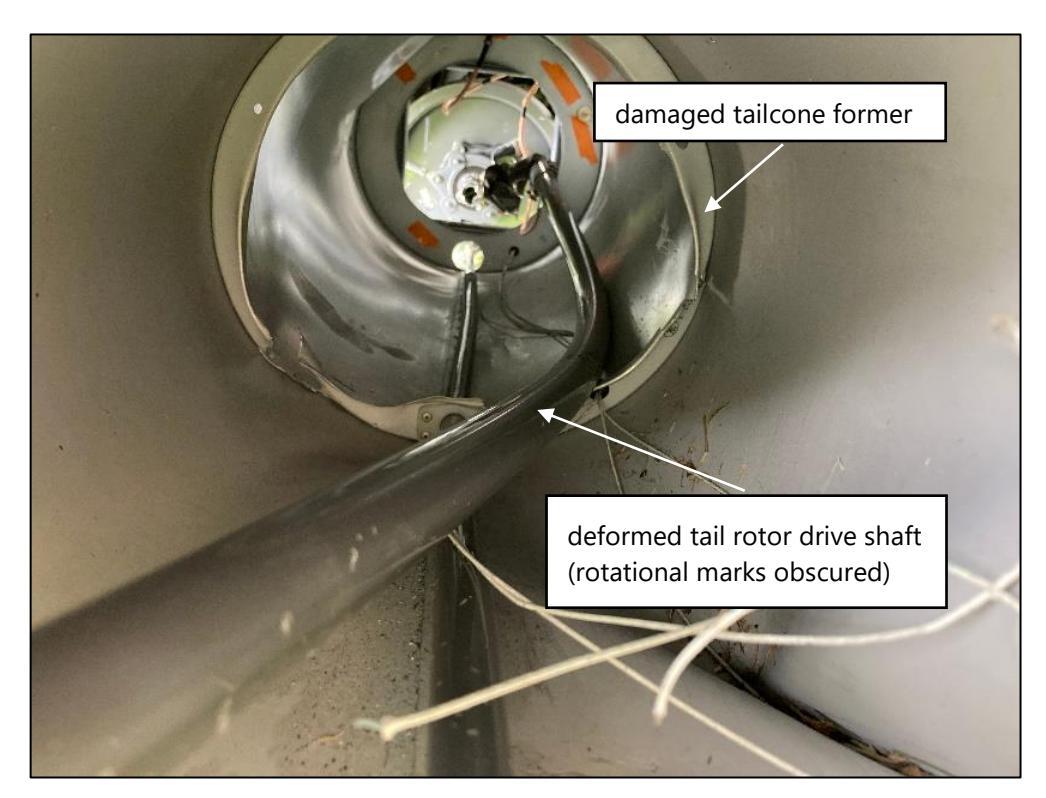
Figure 10: Tailcone internal view looking forward from bay two.

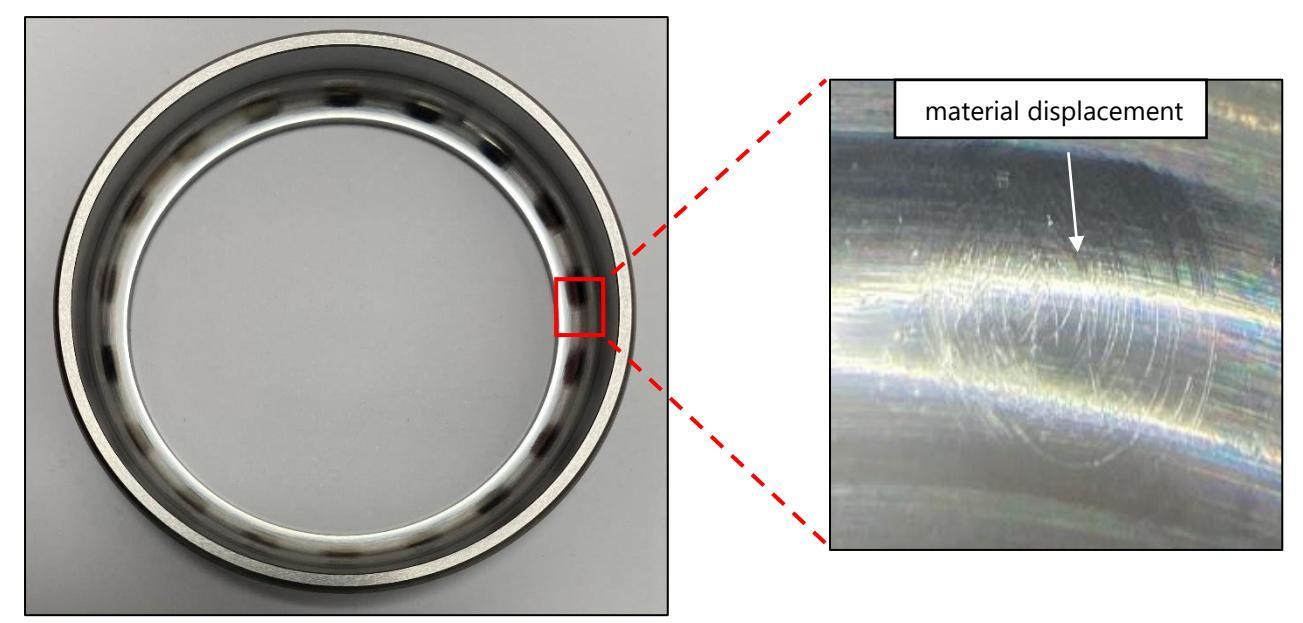
- 3.17. The main rotor pitch change bearings can be damaged by overload forces during a rotor overspeed. The centrifugal force pulling the main rotor blades outwards is exponential to the main rotor RPM. Therefore, overspeeding the rotor can subject the pitch change bearings to loads above their design limitations, causing permanent damage to them in the form of brinelling. Brinelling occurs when the internal raceways of a bearing have been permanently damaged by contact forces that exceed the material limit.

- 3.18. When the bearings were inspected, they exhibited a noticeable notch (jerky movement) when they were rotated. This was consistent with permanent damage from overloading.

- 3.19. The main rotor pitch change bearing assemblies were then disassembled by an authorised Robinson maintenance organisation under the supervision of a Commission investigator. A later examination revealed evenly spaced, polished marks and material displacement around the bearing's race (*see* Figure 11), indicating bearing brinelling. The material displacement was indicative of a rotor overspeed.
- 3.20. Robinson advised the Commission that there had been an increase in reports from Robinson R22 operators of premature wear and brinelling of main rotor pitch change bearings. Robinson advised, examinations of operators' bearings revealed areas of material wear but did not exhibit the notchy characteristics and material displacement typically associated with bearings subjected to overspeed conditions (*refer to* Appendix 2).

Figure 11: Main rotor pitch change bearing, outer race

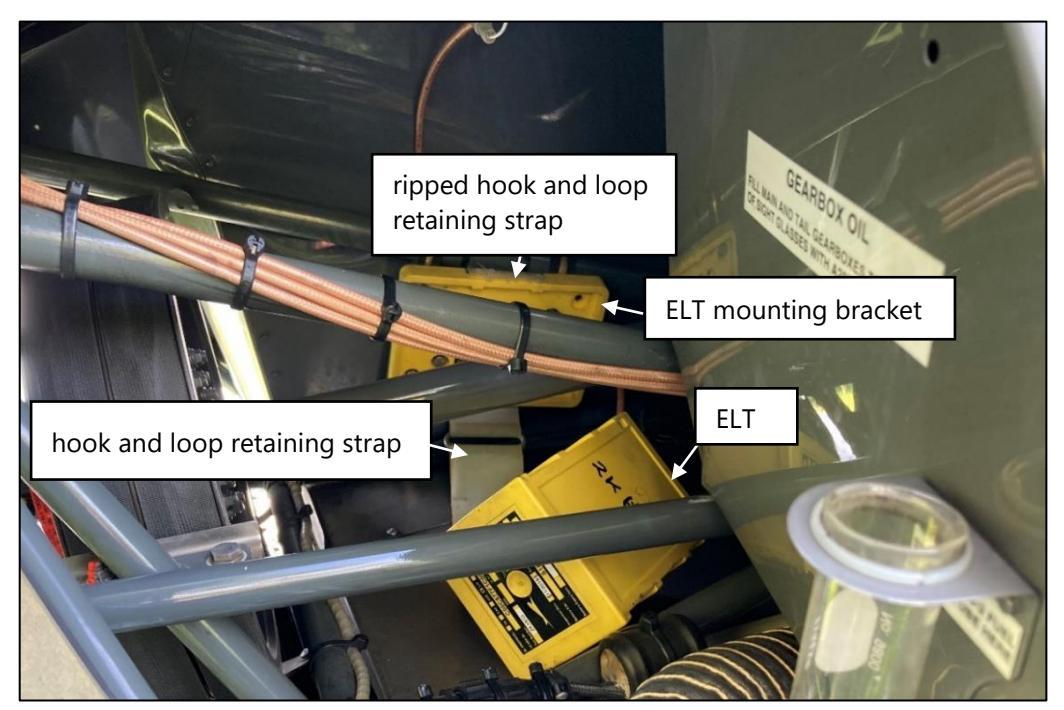
- 3.52. The ELT was mounted with a hook and loop retaining strap.<sup>42</sup> The strap ripped during the helicopter's impact with the ground, allowing the ELT to separate from its mounting bracket (*see* Figure 13). The ELT switch was in the arm position.<sup>43</sup> The ELT failed to activate in this accident. It is **virtually certain** that the activation force was dampened when the ELT separated from its mounting bracket.

- 3.53. The ELT was found free from its mounting bracket and retaining strap but still connected to the antenna cable. The wiring for the remote switch had been pulled out of the connector, preventing the ELT being manually activated from inside the cabin.

Figure 13: ELT ripped retaining strap

- 3.62. The retention characteristics of the hook and loop retaining strap degrade over time because of wear and environmental degradation from vibration, temperature and/or contamination. Inconsistent installation practices and non-prescriptive inspection limits can lead to the hook and loop retaining strap not having the necessary tension and durability to perform its intended function. Additionally, some manufacturers do not impose mandatory replacement intervals for hook and loop retaining straps.

- verify the ELT is properly seated in the mounting bracket
  - verify the hook and loop retaining strap has no slack or deterioration
  - replace the hook and loop retaining strap if damaged or every 12 years

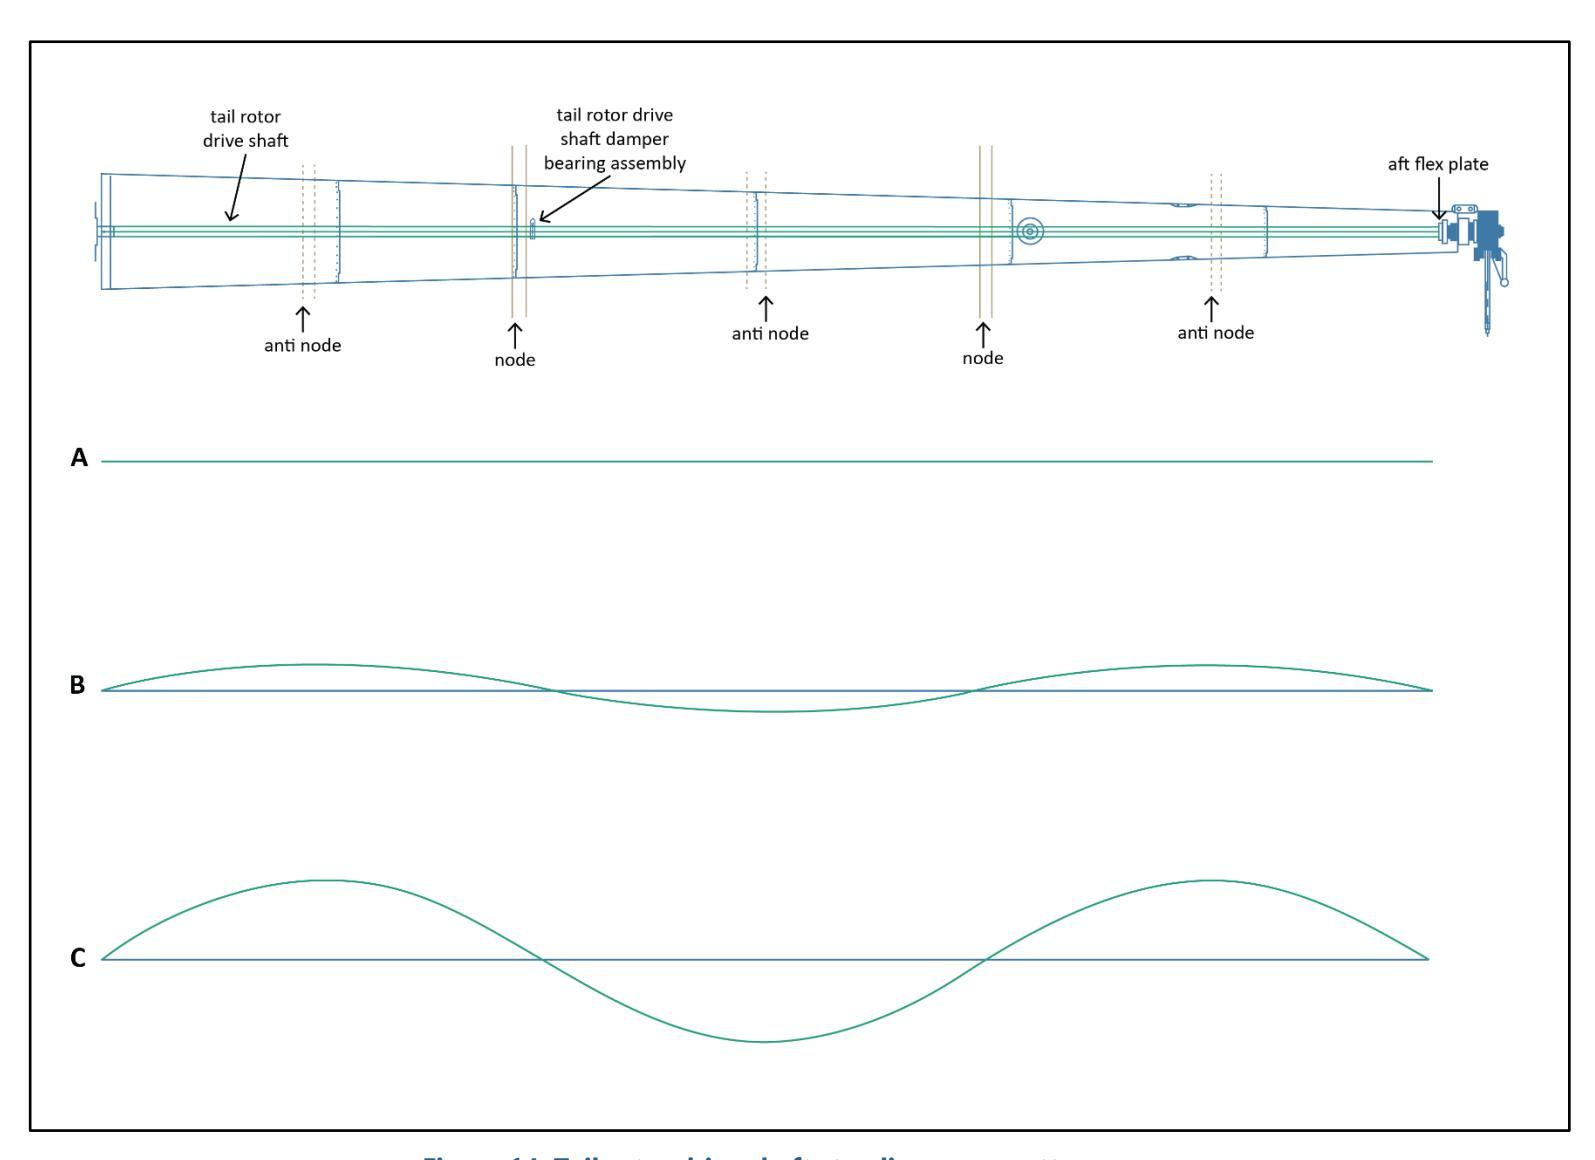
- 3.12. A rotor overspeed will cause the tail rotor drive shaft to overspeed. The rotor RPM is maintained within a given operational value by the support of the helicopter's governor and correlator (*see* para 3.21).
- 3.13. The helicopter **very likely** exceeded its maximum rotor RPM limit. The rotor RPM exceedance **very likely** caused the tail rotor drive shaft RPM design limit also to be exceeded, resulting in elastic and subsequent plastic deformation<sup>34</sup> in the tail rotor drive shaft (*see* Figure 10). If the deflection or deformation of the tail rotor drive shaft is within the elastic limit of the shaft's material, it should return to its original shape once the rotor RPM is decreased. However, if the deflection or deformation range, the tail rotor drive shaft will retain its deformed shape even after the rotor RPM is decreased (*see* Appendix 1 and Figure 14).

#### **Figure 14: Tail rotor drive shaft standing wave pattern** (Credit: TAIC, in liaison with Robinson Helicopter Company design engineers)

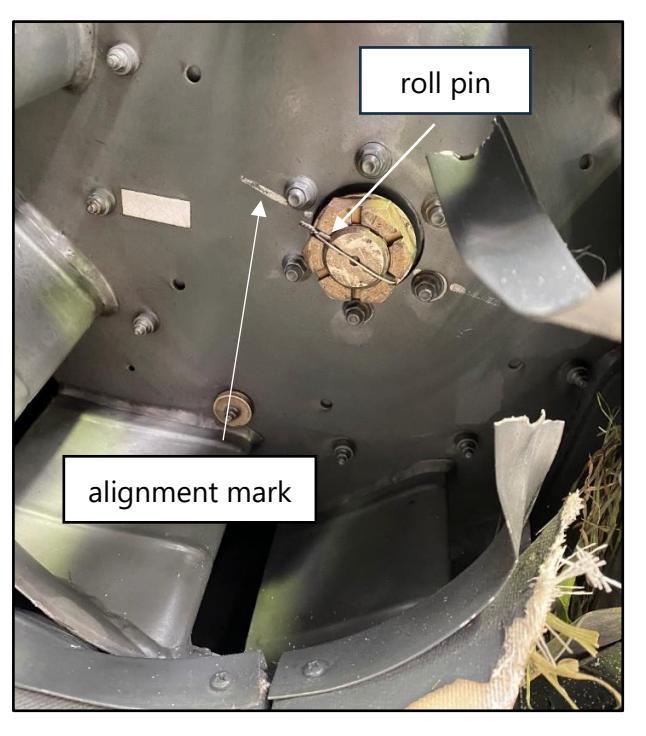
Figure 15: The helicopter's engine cooling fan

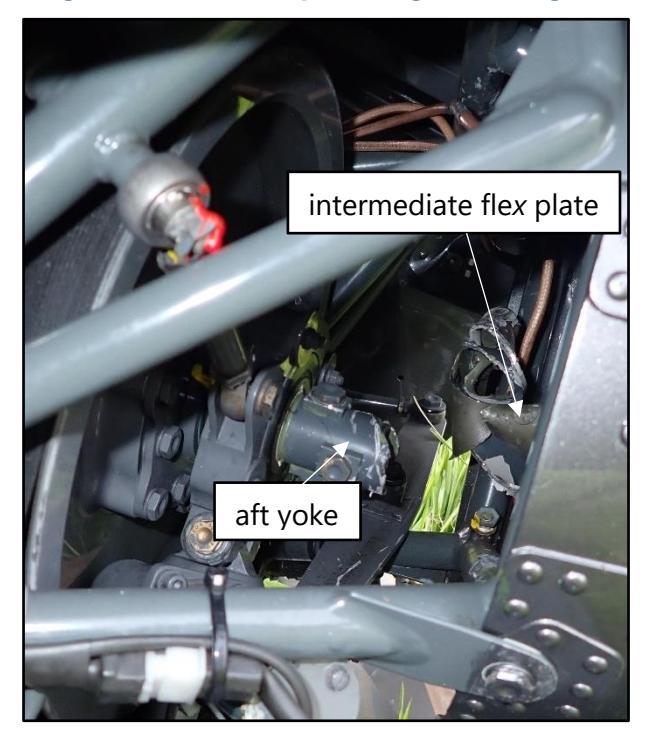
Figure 16: Torsional failure of the aft yoke
