Transport Accident Investigation Commission

Final report Tuhinga whakamutunga

Aviation inquiry AO-2023-001 Airbus Helicopters AS350B2 (ZK-IDB) and EC130B4 (ZK-IUP) Reported close air proximity Queenstown Aerodrome 27 December 2022

June 2024

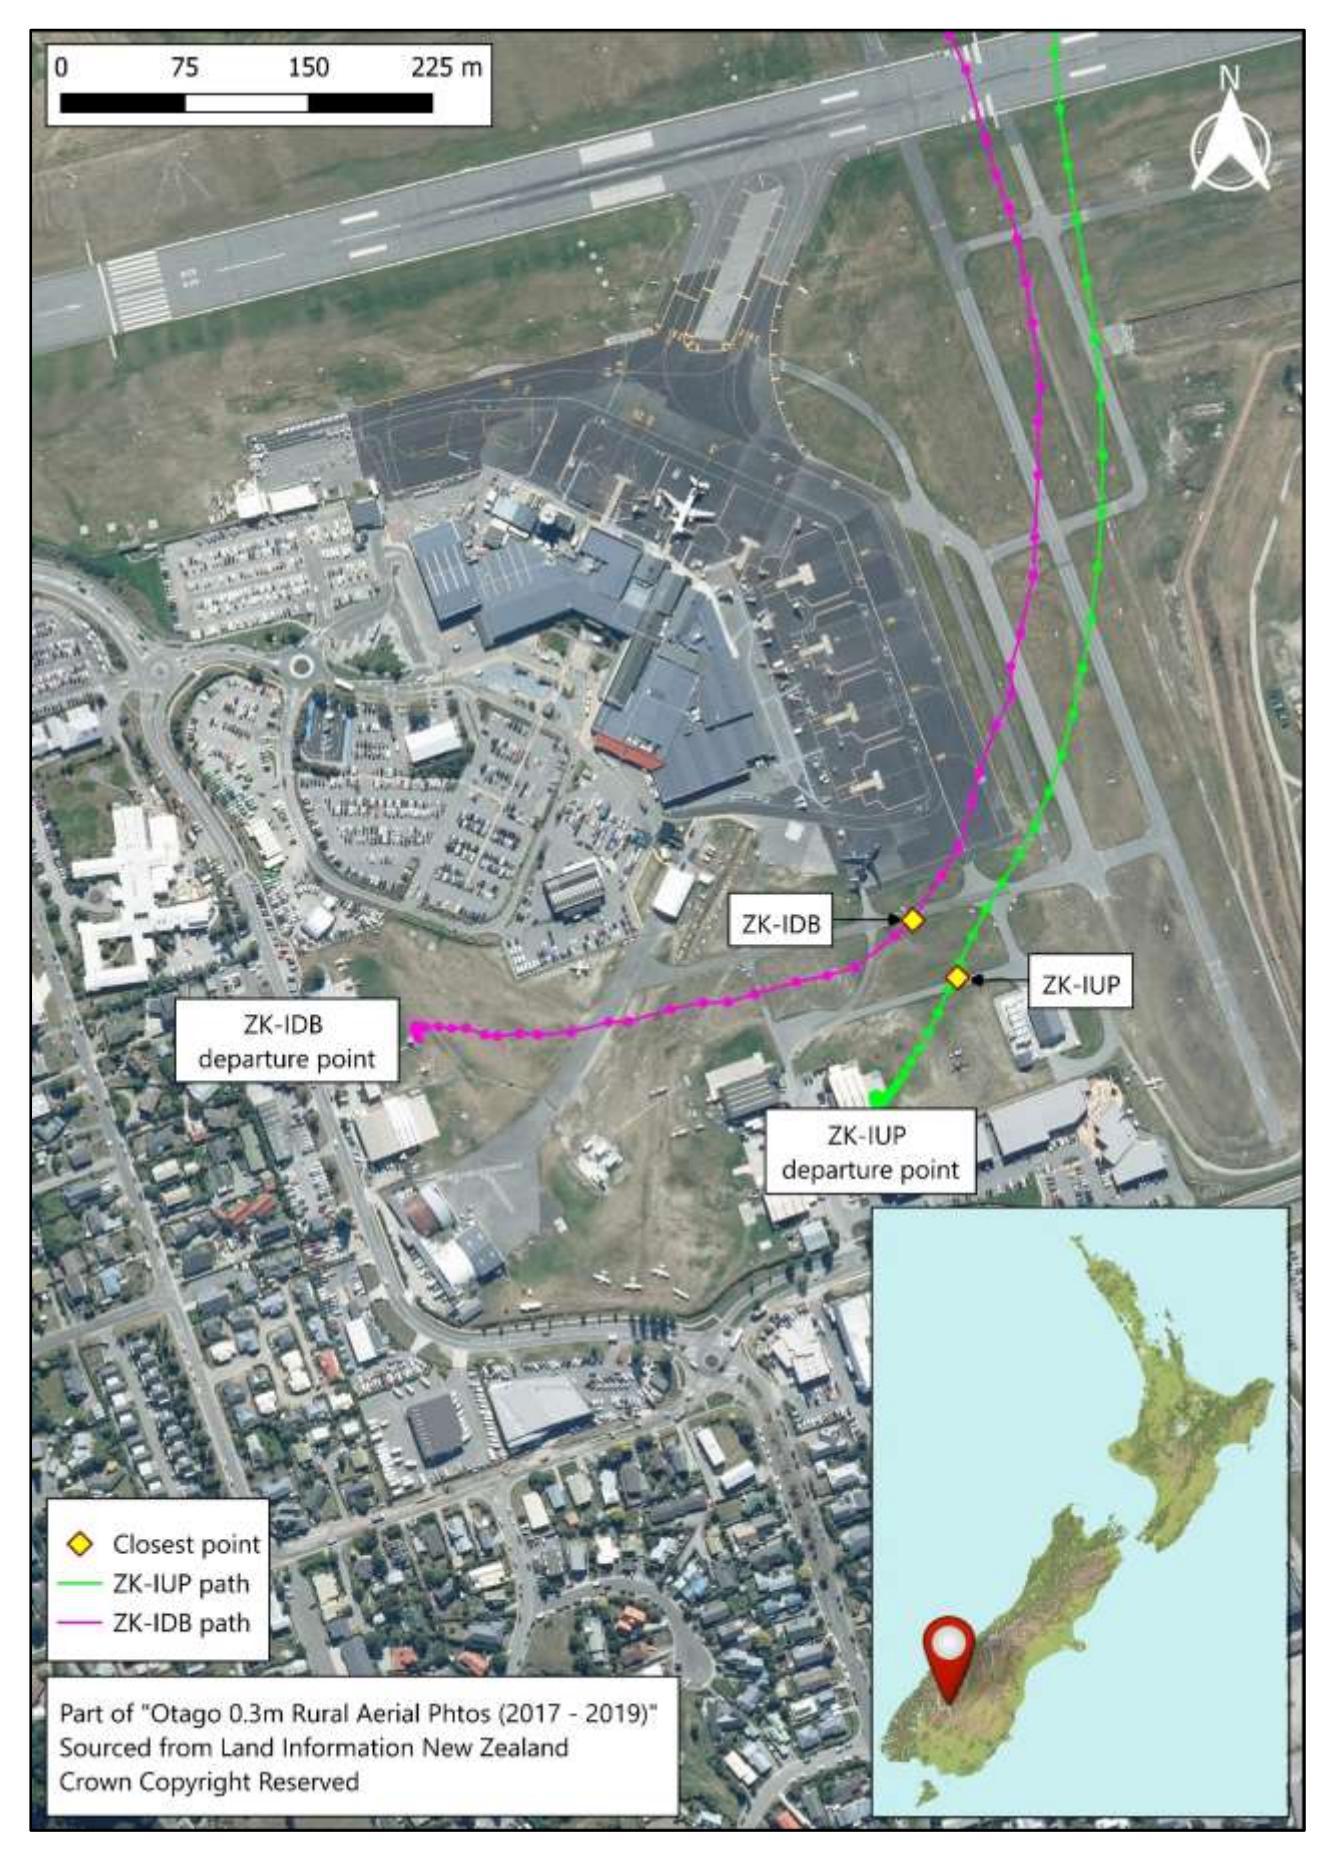
Figure 3: Queenstown Aerodrome – location of incident, when the helicopters were at the point of minimum separation

- 1.4 The pilot of ZK-IDB assumed that ZK-IUP had already departed, given the time since each helicopter had received their clearance to take off.
- 1.5 A reported evasive manoeuvre was found to be a standard turn on departure by ZK-IDB. At their closest point, the helicopters were found to be 44 metres (m) apart.

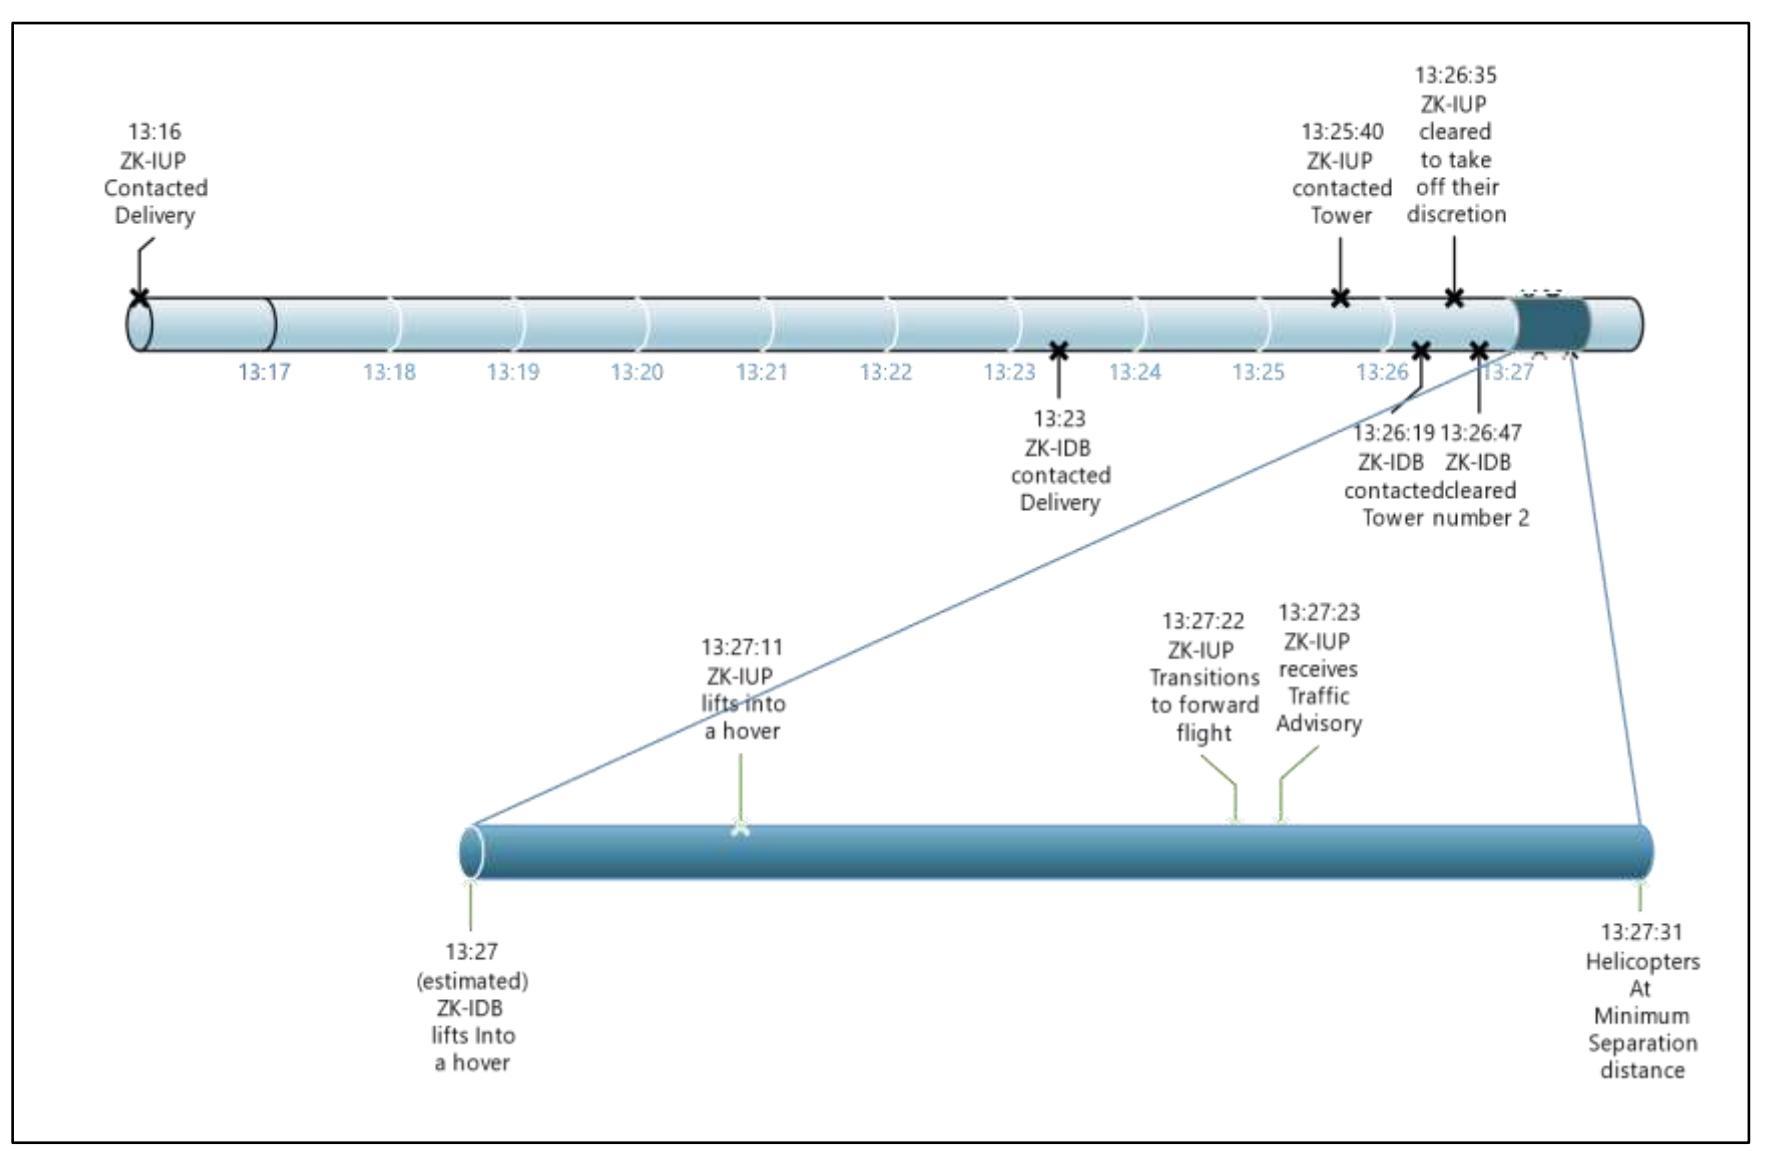
Figure 5: Timeline

- 2.7 At 1327:31 the helicopters were at their closest point after IDB passed above and to the left of IUP. The flights then continued uneventfully. *See* Figure 5 for the full timeline.

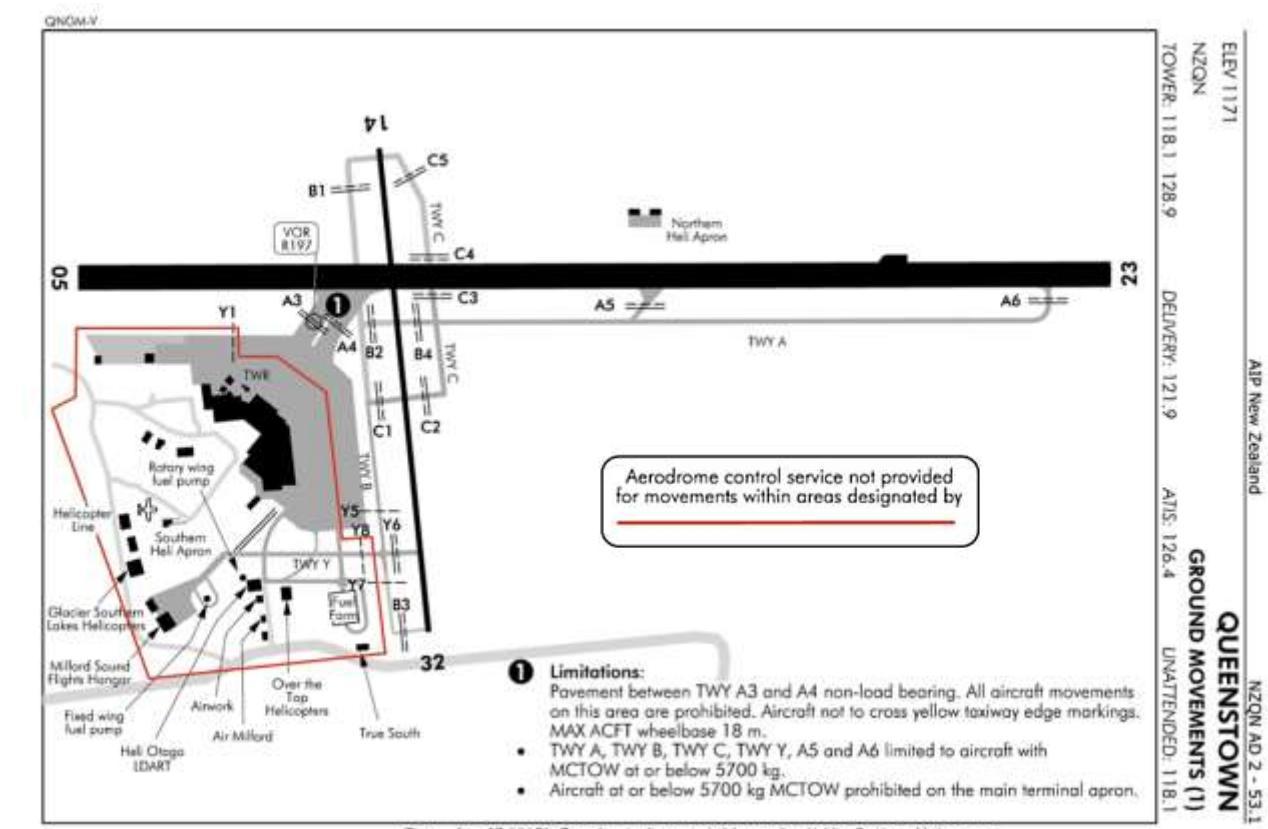
Figure 6: AIP Queenstown ground movements (1), showing area not covered by aerodrome control service

60 knots (kt) indicated airspeed (IAS)⁶. This differs from the definition of taxiing in Civil Aviation Rules (CARs) Part 1⁷ and air taxiing in AIP Gen 2.2⁸.

- 3.32 The potential for differing practices also stemmed from the way air taxi was defined in the Queenstown AIP (*see* paragraph 2.13). Airways deemed this to be a grey area in terms of responsibilities. The southern apron was an uncontrolled area, regardless of the height and speeds that aircraft were flying within that area. The term used to describe the flight profile of the aircraft (i.e., air taxi or airborne) does not change whether the southern apron was subject to an aerodrome control service.

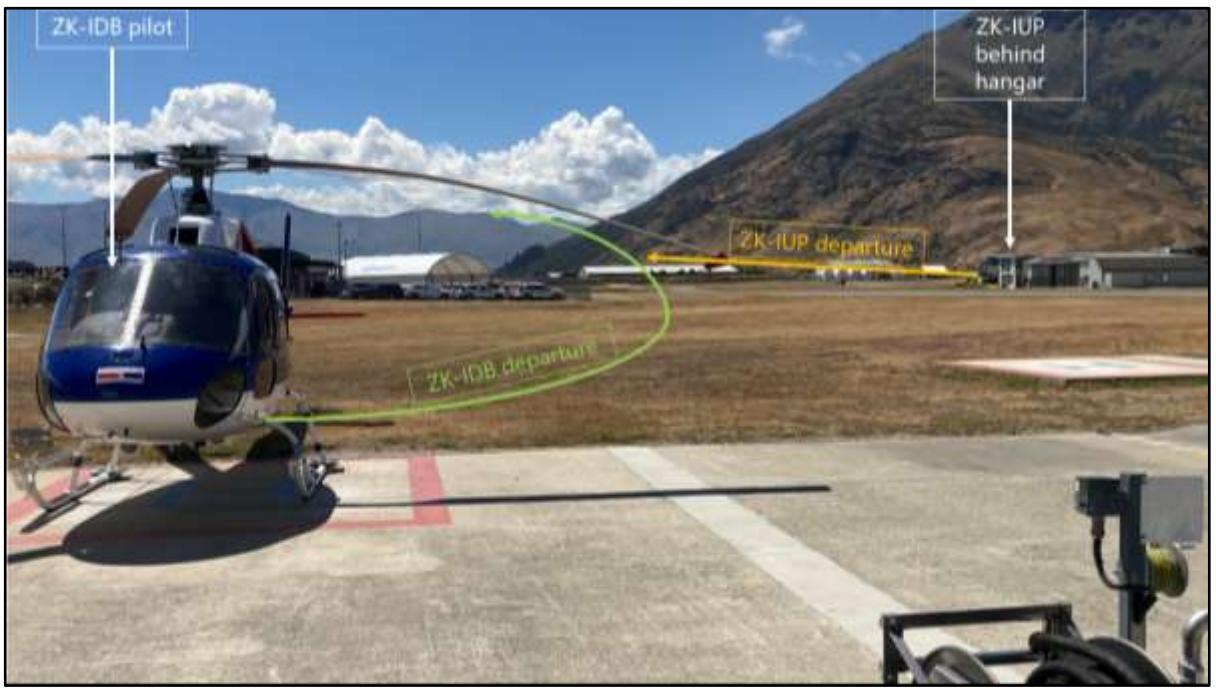
Figure 7: View from ZK-IDB helipad towards the ZK-IUP helipad

3.5 Before take-off, the pilot of IDB could not see IUP because of the orientation of IDB and the location of a hangar between their respective helipads (*see* Figure 7). The pilot of IDB recalled that they had assumed that IUP had already departed, and that

they had expected to see IUP passing the white half-round hangar¹² by the time IDB had lifted off the helipad and turned around.

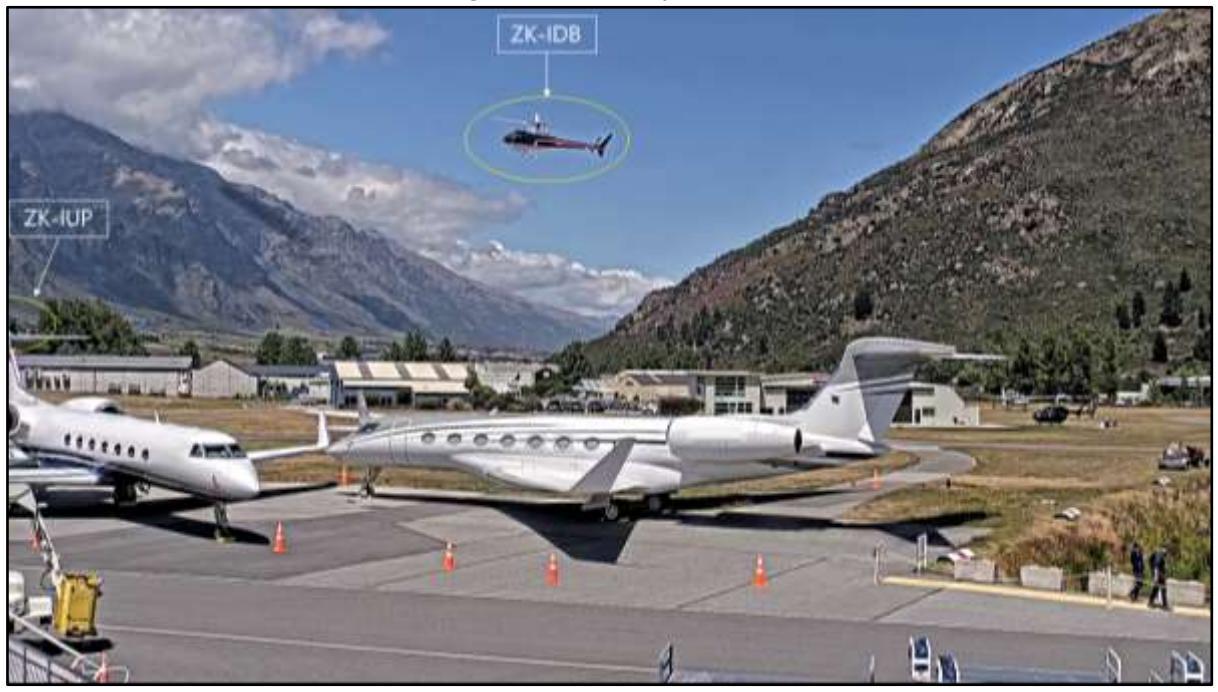
Figure 8: CCTV footage from apron towards ZK-IUP helipad and hangar (Credit: Queenstown Airport Corporation)

- 3.9 The pilot of IDB recalled that they did not take evasive action, and instead were already in a turn as a normal part of their departure flight path. From the perspective of IUP's pilot, who saw IDB momentarily when they looked in their direction, it appeared IDB was conducting an evasive manoeuvre.
- 3.10 The Commission found that neither pilot took evasive action, nor was it required.
- 3.11 The Commission considers that while the defence of 'see and avoid' has its limitations, as detailed in the Commission's report AO-2019-006,¹⁴ it remains a critical element for

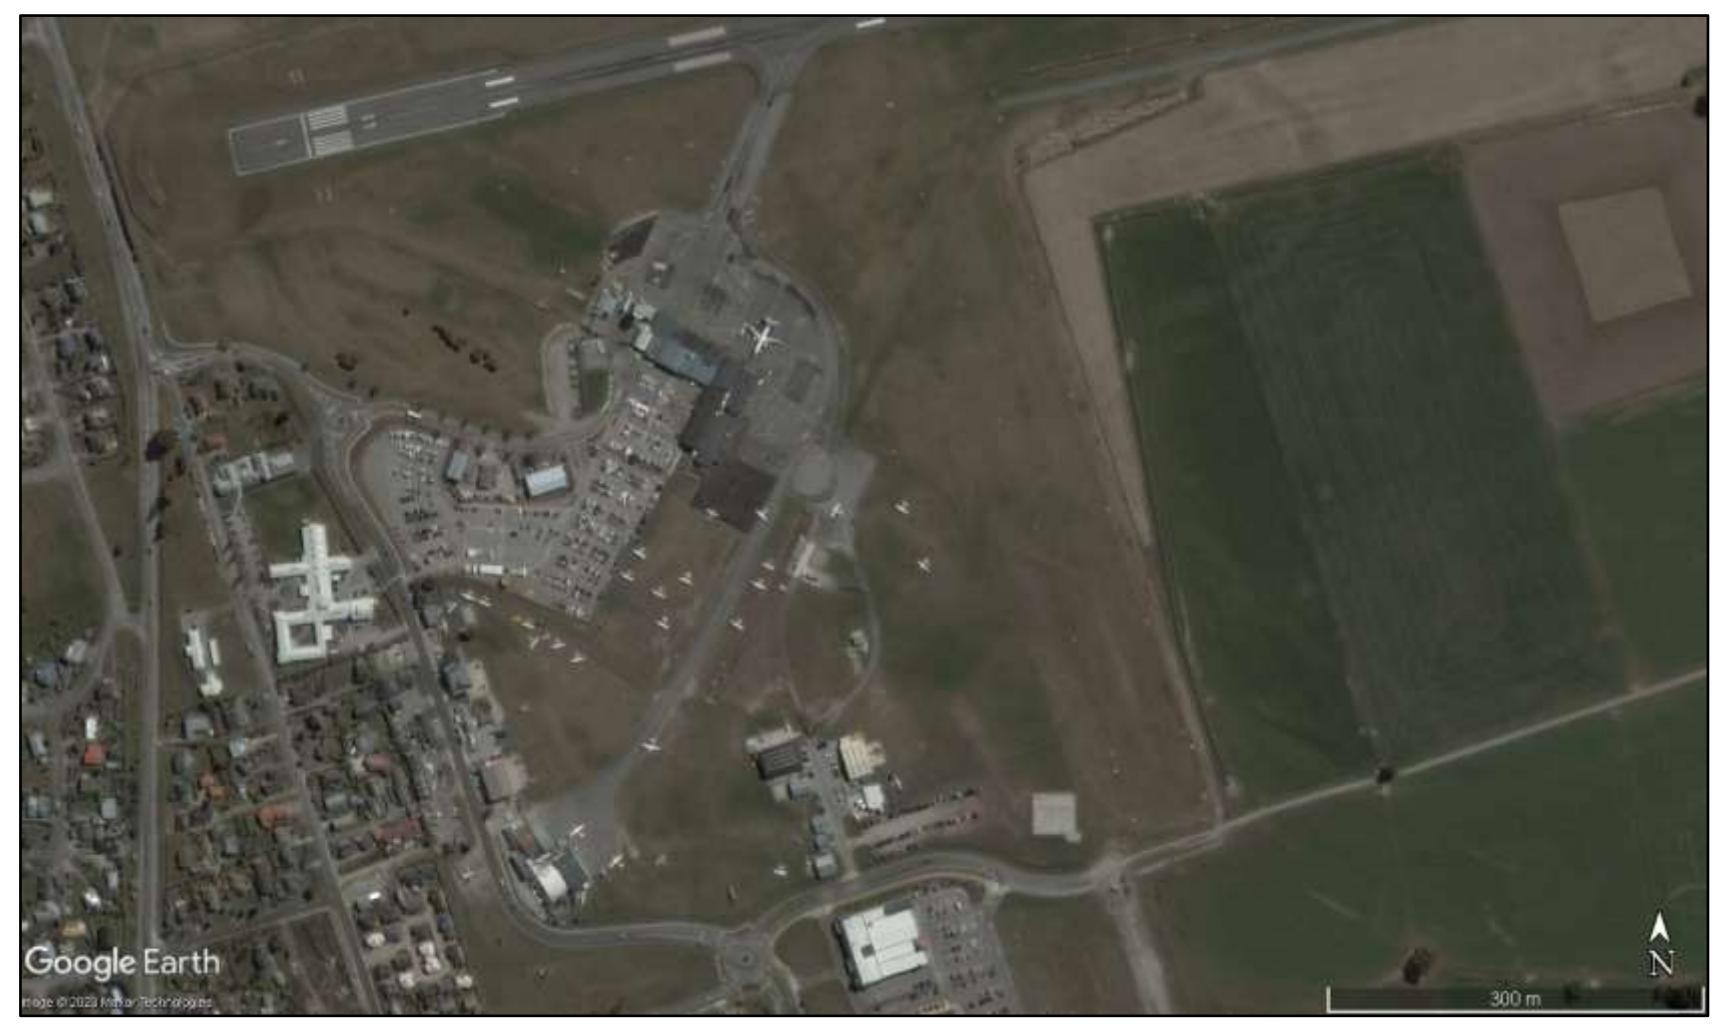
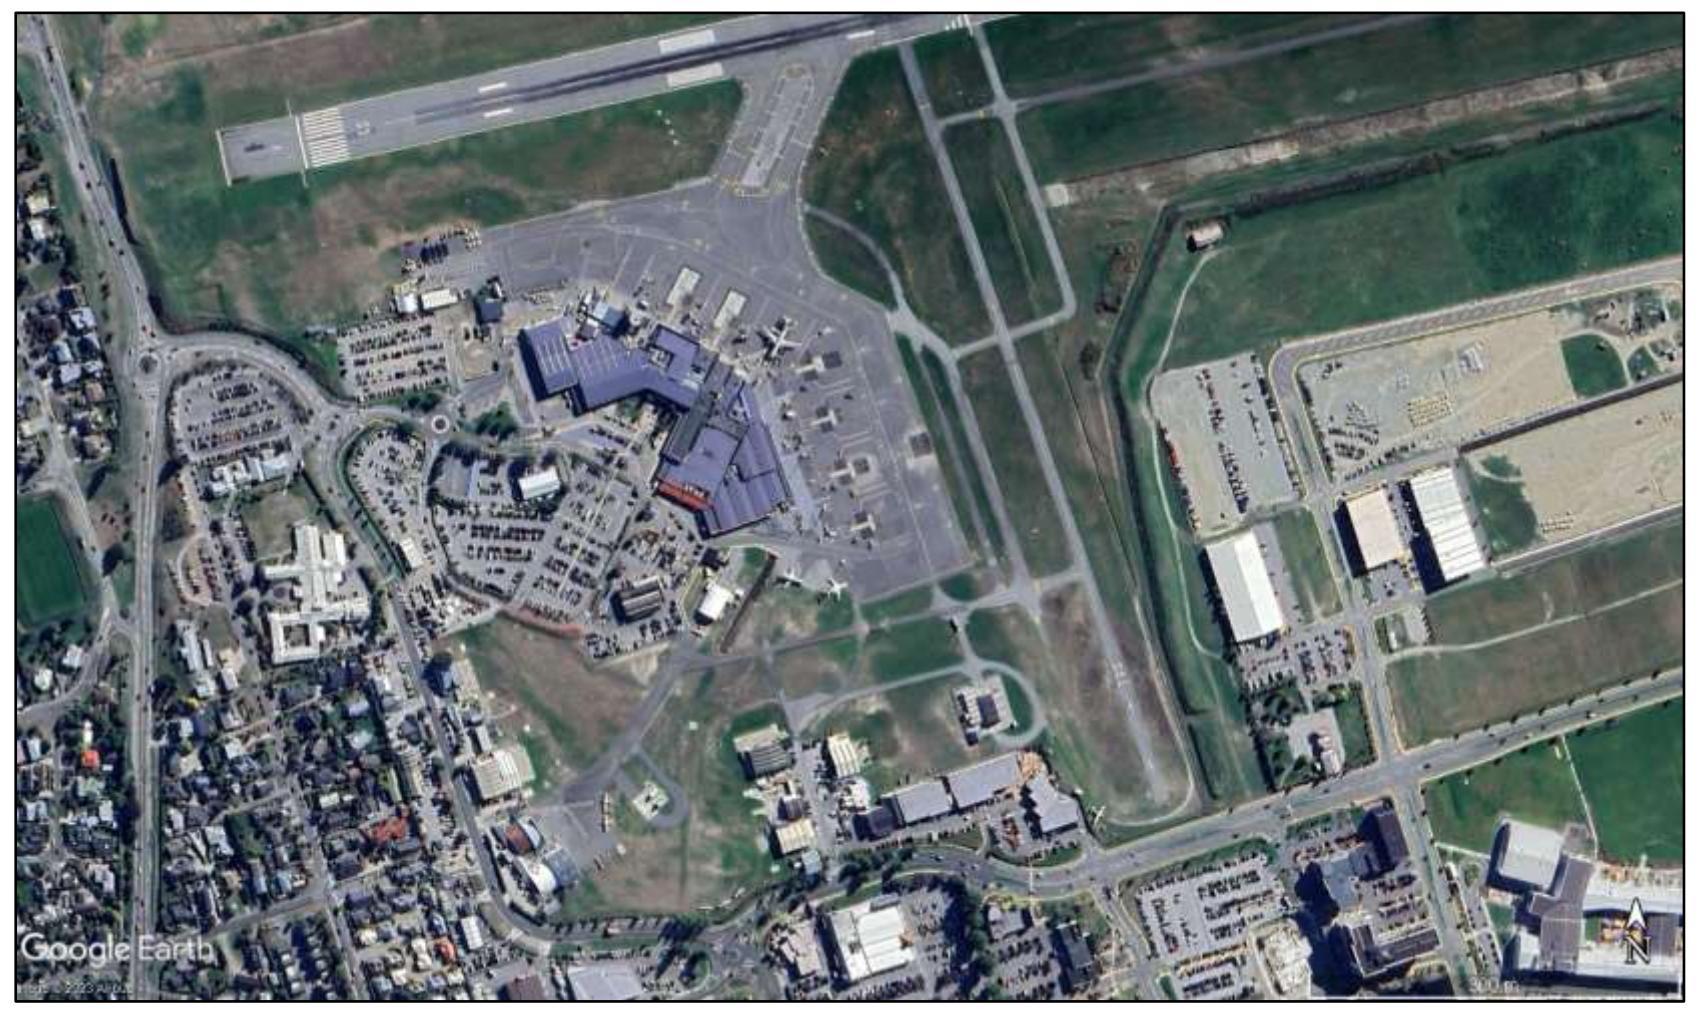
- 3.19 The Commission undertook further analysis of the layout of Queenstown Aerodrome, with a focus on changes to the southern apron over time. It considered the assessment of risks to the safety of aviation versus commercial considerations.
- 3.20 Review of historical imagery of Queenstown aerodrome shows ongoing development with significant changes to the southern apron and expansion of the main apron. These changes have progressively reduced the space available for helicopters and light aeroplanes to operate. *See* Appendix 1 for a comparison of the apron areas in October 2004 and June 2022.

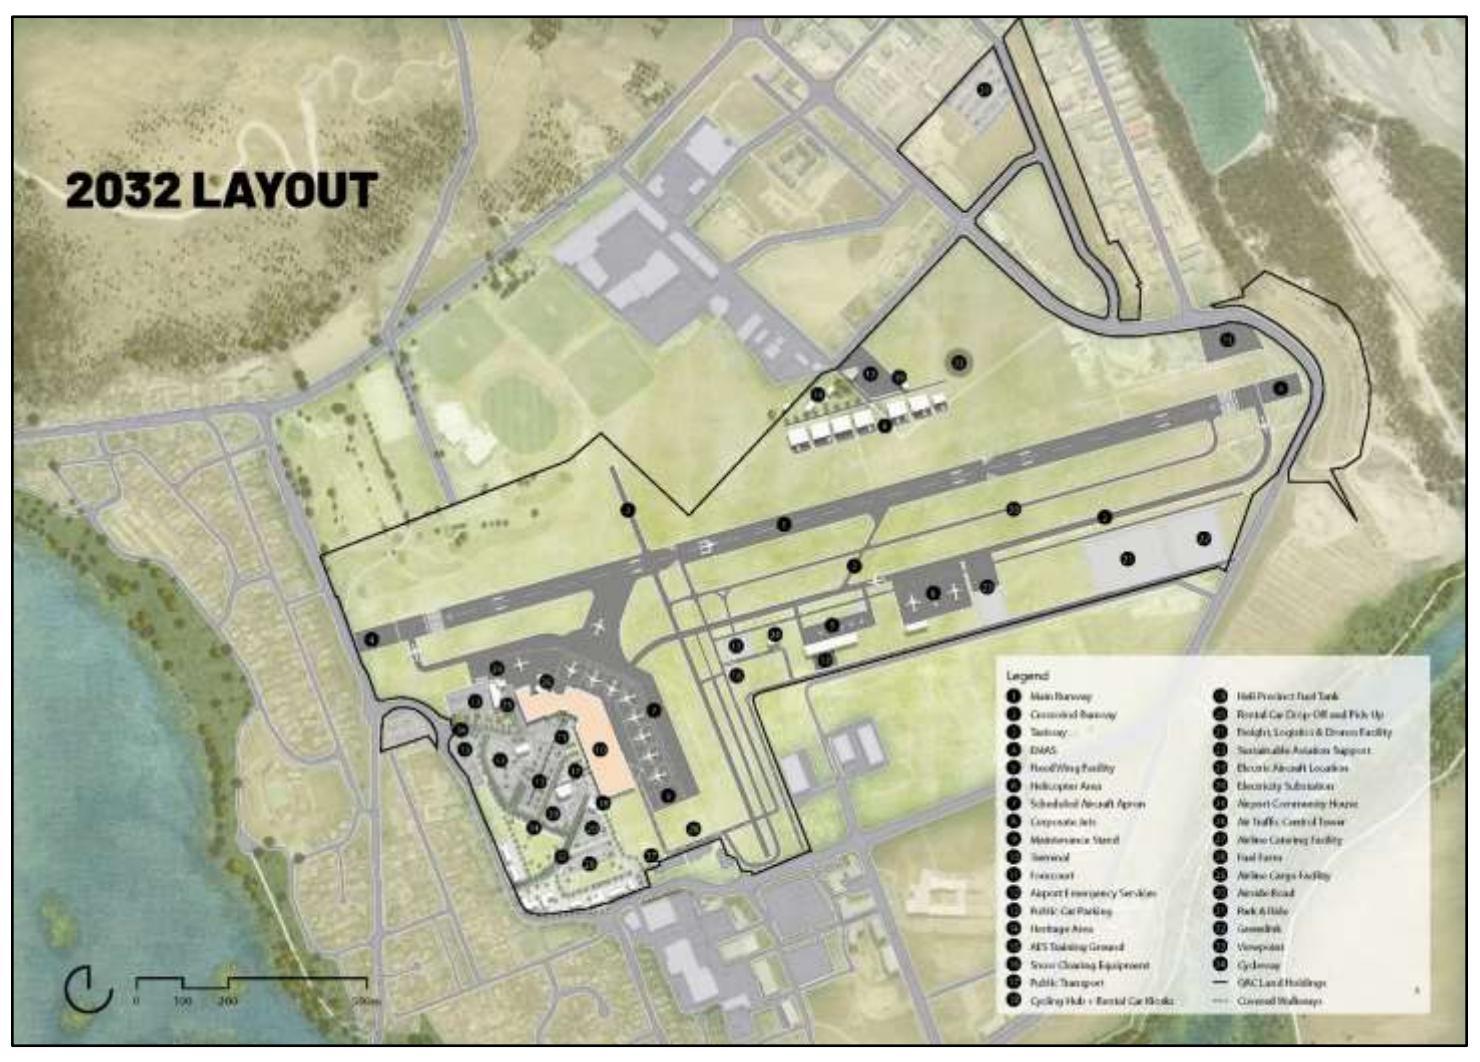
Figure 12: Queenstown aerodrome proposed layout (Credit: Queenstown Airport Corporation)

- 3.29 In May 2023 QAC announced a major expansion plan with the release of their draft *Queenstown Airport Master Plan* (Queenstown Airport Corporation, 2023). This included moving helicopter operations to a new northern aviation precinct and the fixed-wing and corporate-jet operators to a precinct south of the main terminal.
- 3.30 The Master Plan¹⁹ aims to address the challenges of the current layout of Queenstown Aerodrome, including separation of aeroplane and helicopter operations. CAA advised the Commission that aerodrome changes of this nature would require QAC to undertake an aeronautical study and submit it to CAA as part of the approval process under CARs Part 139.
