Transport Accident Investigation Commission

Final report Tuhinga whakamutunga

Aviation inquiry AO-2023-010 Kawasaki BK117 B-2, ZK-HHJ Collision with terrain Mount Pirongia 19 September 2023

April 2025

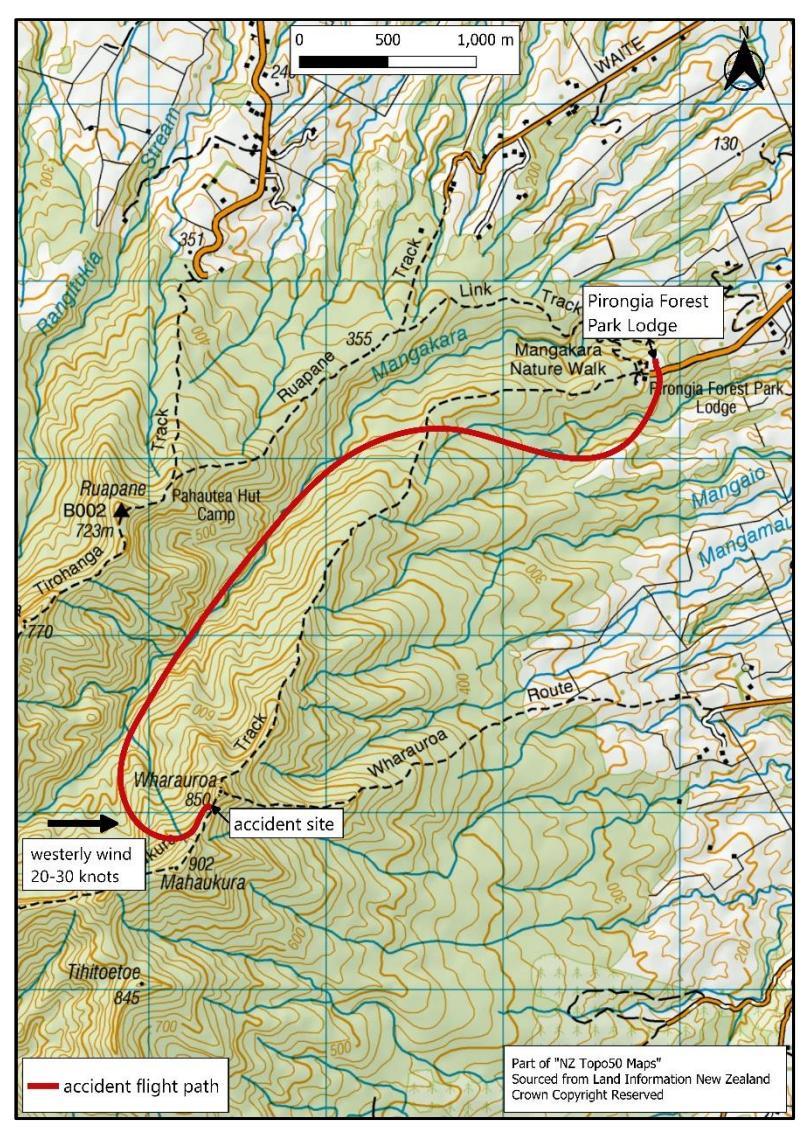
Figure 4: Accident flight (Credit: Land Information New Zealand | Toitū Te Whenua)

- 2.4. At about 1645 the crew located the patient and their partner on the Mahaukura Track, situated below and on the southern side of Wharauroa lookout (*see* Figure 4). The crew conducted a reconnaissance of the site and found that there was no suitable place for the helicopter to land near the patient and that a winch extraction would be the most suitable method of recovery.
- 2.5. The pilot then flew the helicopter to a nearby staging area at Pirongia Forest Park Lodge so that the crew could reconfigure the cabin for a winch operation. After the pilot landed and shut down the helicopter, the crew reconfigured the cabin and checked the winch was functional. They then discussed the procedures for recovering the patient by winch extraction.

2.6. At 1702 the helicopter departed Pirongia Forest Park Lodge and flew up the valley on the western side of Wharauroa Lookout. After passing abeam Wharauroa Lookout the helicopter entered a 180-degree climbing turn to the left and continued ascending to an altitude of 3000 feet (ft). The pilot continued the left turn before starting a descent onto final approach towards the patient on the windward side of a ridge (*see* Figure 4).

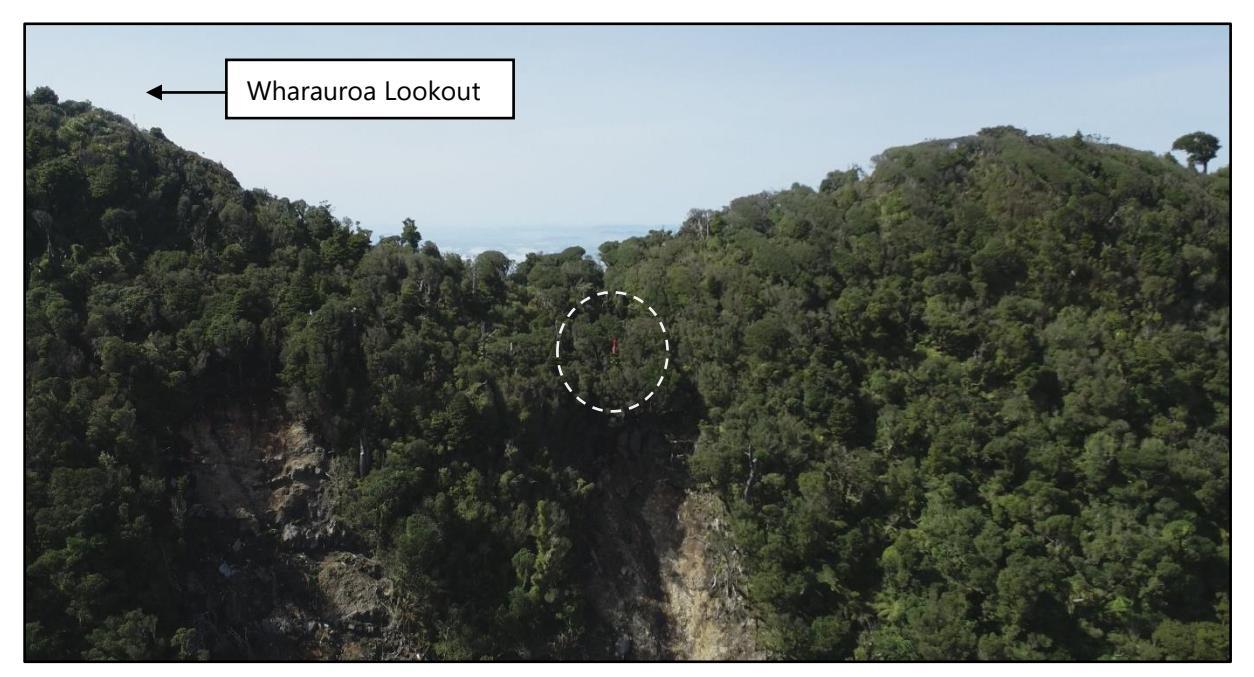
Figure 5: Accident site

- 2.39. The accident site was on Mount Pirongia on a west-facing escarpment covered by dense native forest, about 108 m southwest of Wharauroa Lookout (*see* Figure 5). The helicopter was sitting upright, wedged between trees below a ridge line (*see* Figure 6).
- 2.40. Damage to trees at the site indicated that the helicopter had fallen almost vertically through the tree canopy. All the wreckage was contained within a 15 m radius of the main fuselage.
- 2.41. The forward and aft cross-tubes of the landing-gear assembly had splayed outwards, causing the right side of the assembly to fracture in overload near the fuselage attachment fittings (*see* Figure 16 in Appendix 1).

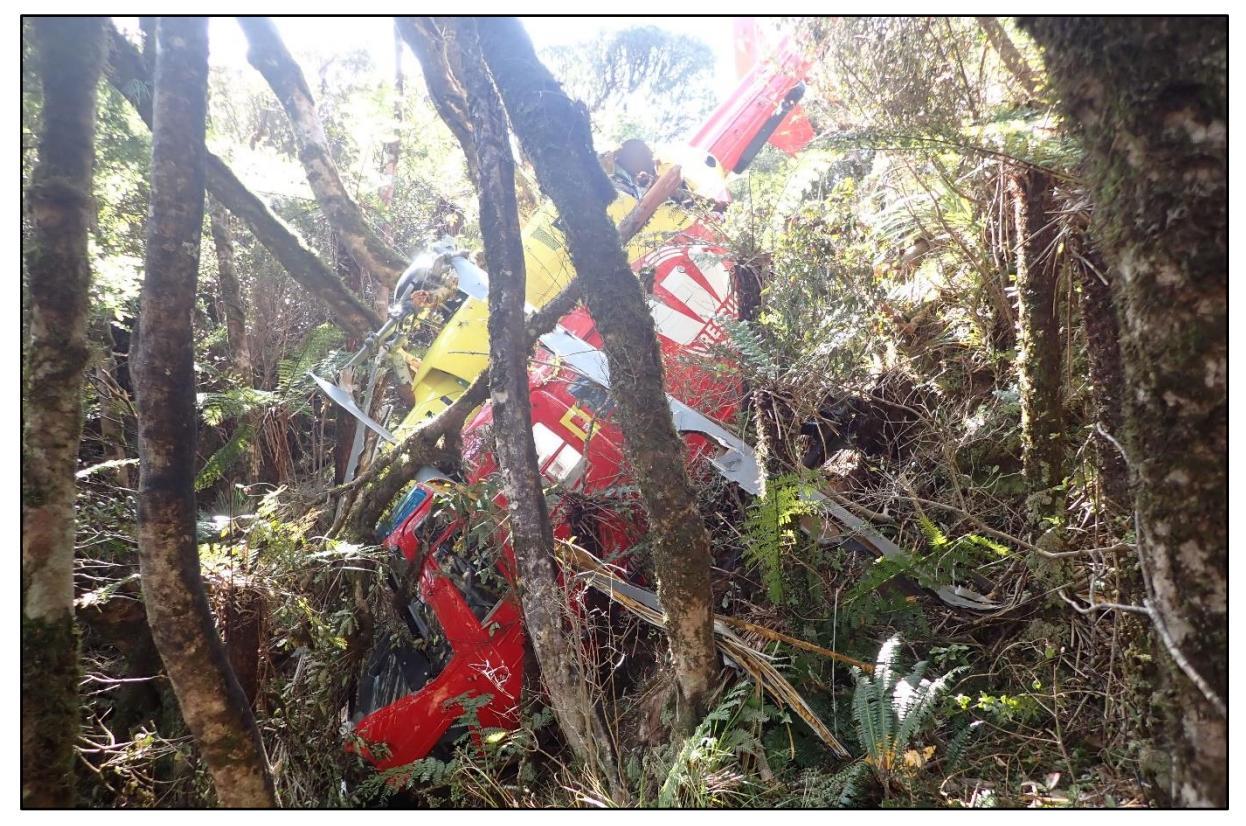
Figure 6: Accident scene

- 2.42. The markings on the trees surrounding the helicopter, and the damage to its main rotor blades, was characteristic of an impact with the blades having had high rotational energy. The outboard section of each main rotor blade was severely strike damaged. The main rotor blades had fractured outboard from the primary and secondary attachment bolts. One of the four main rotor blades had separated from the rotor head during the accident and was found lying next to the wreckage.

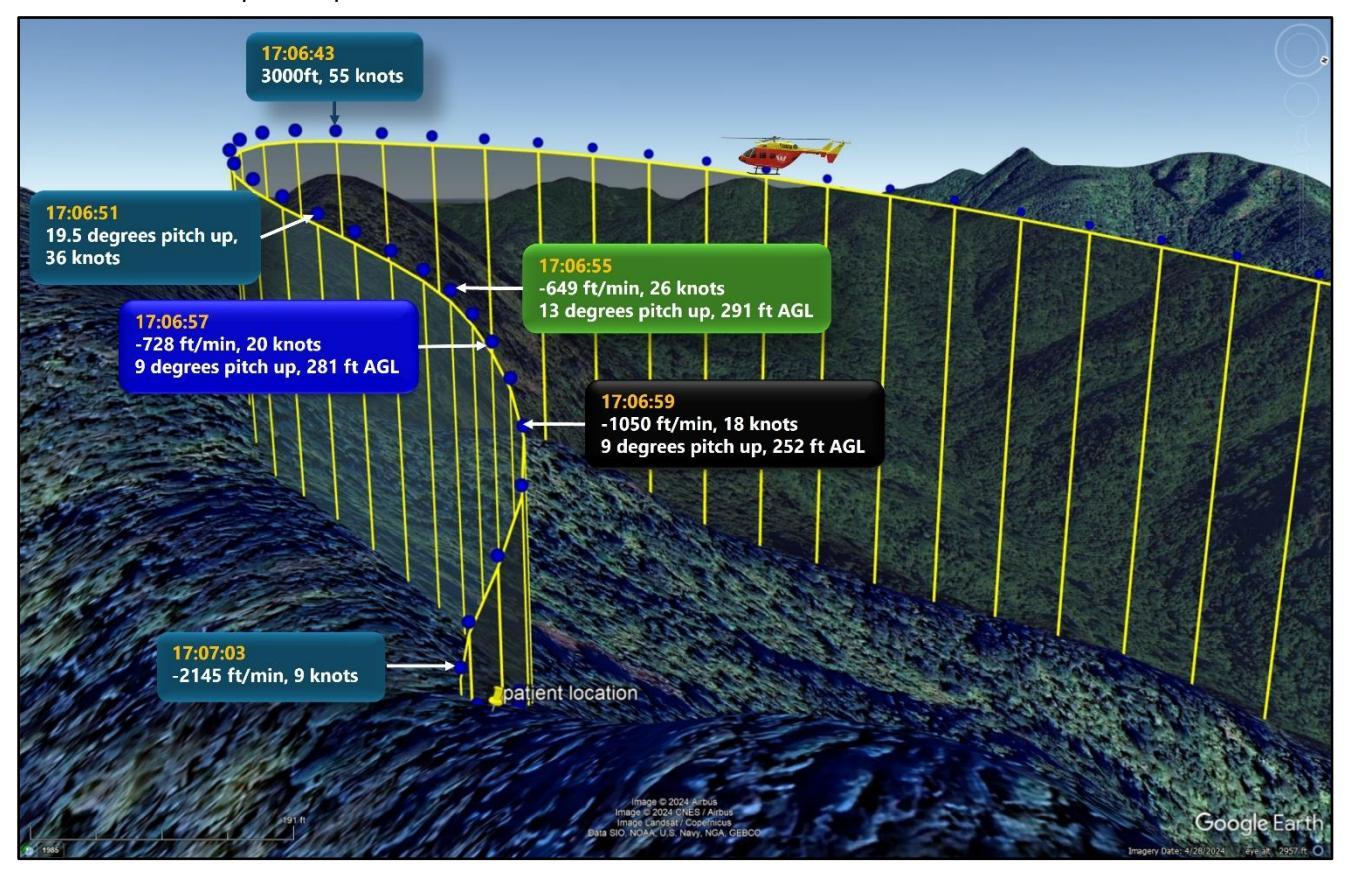
Figure 11: The helicopter's flight trajectory

- 3.10. The helicopter's speed progressively decreased during its final approach, as depicted in Figure 11, which illustrates the helicopters trajectory. At 17:06:51 the helicopter's pitch angle reached a maximum of 19.5° (nose up). This in turn reduced the helicopter's speed and increased its rate of descent.

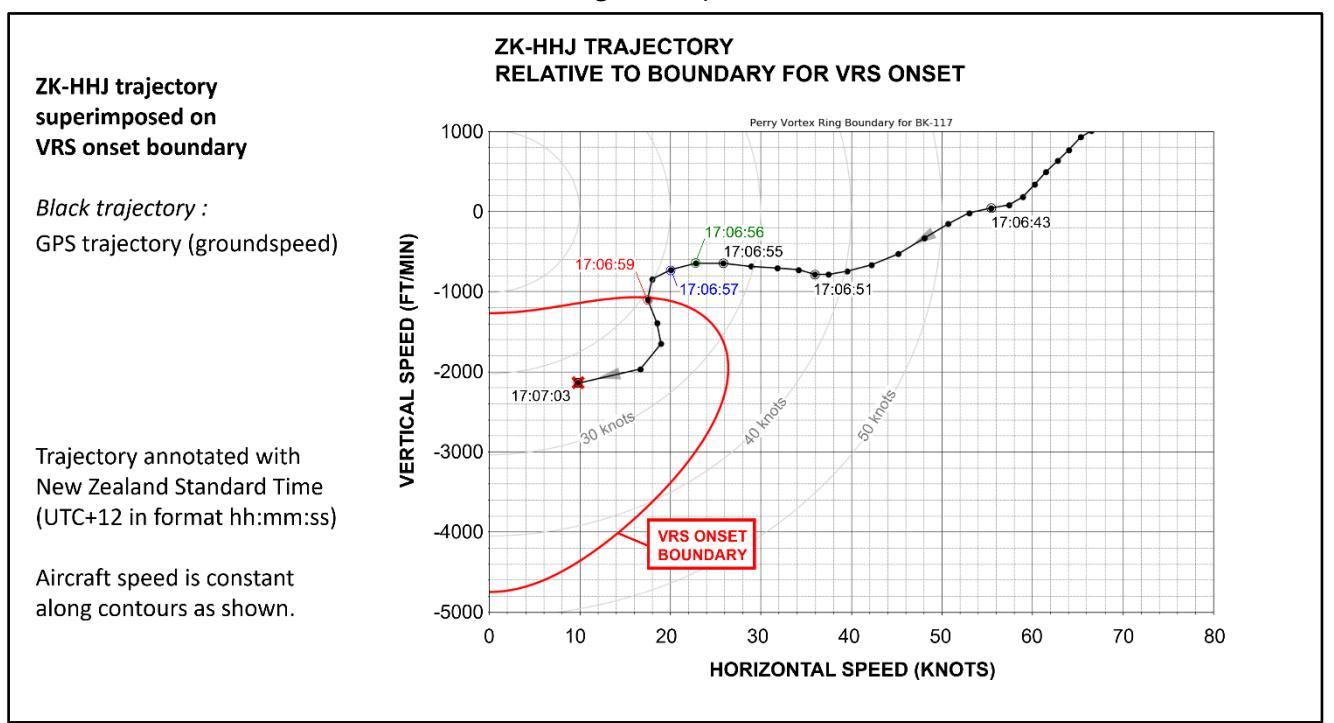
Figure 12: ZK-HHJ trajectory relative to boundary for VRS onset

3.30. Figure 12 shows the location of the boundary for VRS onset on the flight envelope, as defined by mapping the location of flight conditions at which the disturbances to the wake structure are able to reach the main rotor. If the axes in this figure are interpreted as the speeds of the helicopter relative to the ground, then the figure suggests that a BK117 B-2 helicopter with the weight and geometric characteristics of the accident helicopter, when flying at the altitude of the accident site, would have encountered VRS when flying at descent rates between 1050 and 4750 ft/min if flying horizontally at speeds less than 27 kt (groundspeed). The black line shows the

horizontal speed and descent rate of the accident helicopter at various points along its final trajectory, as measured relative to the ground. According to the diagram, the helicopter will have entered VRS at 17:06:59 by crossing the onset boundary with a descent rate of 1050 ft/min and a groundspeed of 18 kt.

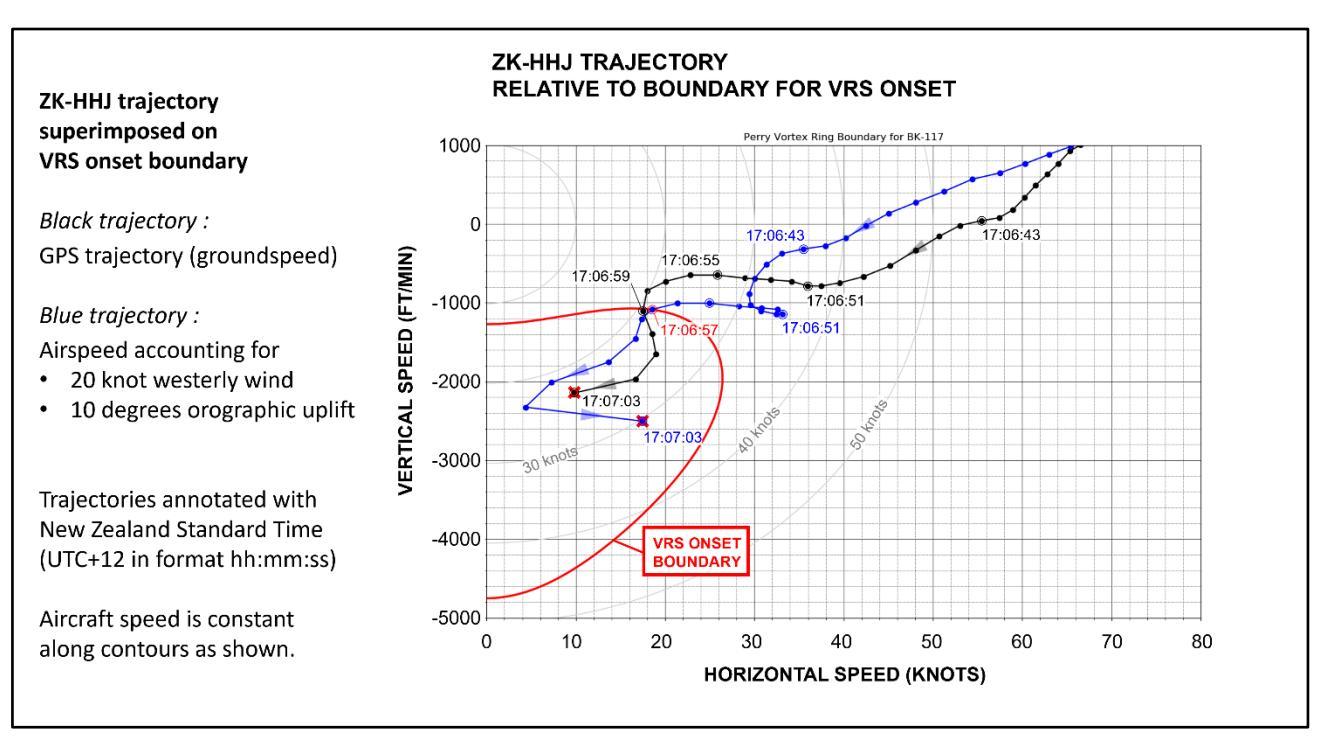
Figure 13: ZK-HHJ trajectory, accounting for 20 kt westerly wind and 10° orographic uplift

- 3.32. An analysis of the wind conditions at the time of the accident concluded that the wind speed was 20 kt, with gusts to 30 kt, from a westerly direction. The topography would have induced an upward component of wind flow relative to the helicopter's trajectory, known as orographic uplift. This upwards component of the wind would have appeared to the rotor as an increase in its effective descent rate. The blue trajectory (*see* Figure 13) depicts the helicopter's velocity, represented as a horizontal airspeed and descent rate, factoring in the influence of wind. This figure shows that, on accounting for the effect of the wind, the helicopter would have encountered VRS at 17:06:57, two seconds earlier than if the effects of the wind were not accounted for. By referring back to the trajectory shown in Figure 12 it can be inferred that the helicopter would have entered VRS at a substantially lower descent rate and higher forward speed (728 ft/min with a groundspeed of 20 kt) compared with the effects of the wind being omitted from the analysis.

3.33. An important factor was the change in the helicopter's heading around 17:06:59, causing a shift in the wind to blow from behind the helicopter (tail wind), effectively reducing the helicopter's airspeed. This shift in the relative wind contributed to the helicopter penetrating more deeply into VRS than if the heading of the helicopter had remained unchanged. As a result, the pilot would have experienced significantly exacerbated symptoms of VRS, as well as potentially greater difficulty in recovering to normal flight.

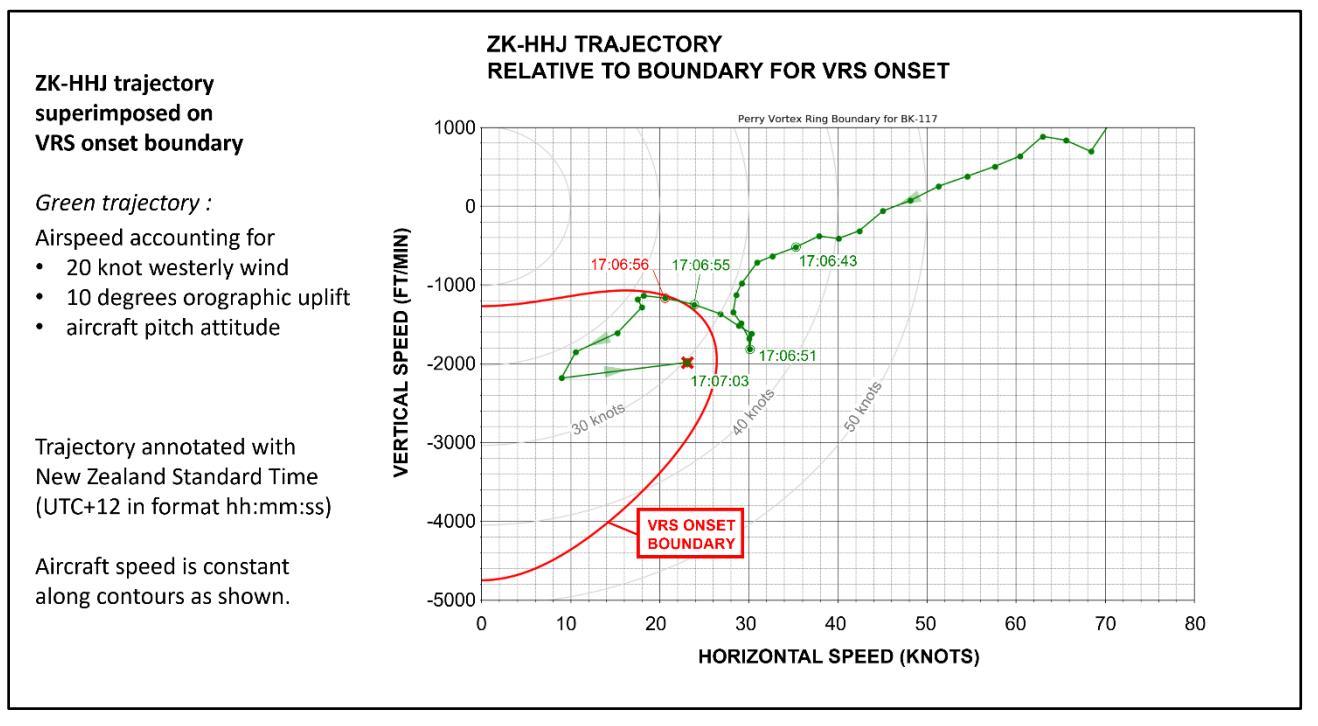
Figure 14: ZK-HHJ trajectory accounting for 20 kt westerly wind, 10° orographic uplift and pitch attitude

- 3.35. In Figure 14, the green trajectory denotes the airspeed and descent rate as measured relative to the helicopter's rotor, accounting for the changes in pitch attitude of the helicopter, while descending along the ridge line. The effective inclination of the rotor to the airflow was calculated by subtracting the helicopter's mast inclination angle (5°) from the helicopter's pitch attitude, as recorded by the Flightcell DZMx.

3.36. At 17:06:51 the helicopter's pitch attitude reached a maximum of 19.5°. The analysis presented in Figure 14 then shows that the helicopter would have crossed the VRS onset boundary sometime between 17:06:55 and 17:06:56, 3.5–4 seconds earlier than if the pitch attitude and wind were ignored in the analysis. Referring back to the speeds relative to the ground (the black trajectory in Figure 12), the helicopter would have entered VRS at a descent rate of 649 ft/min with a groundspeed of 25.8 kt.

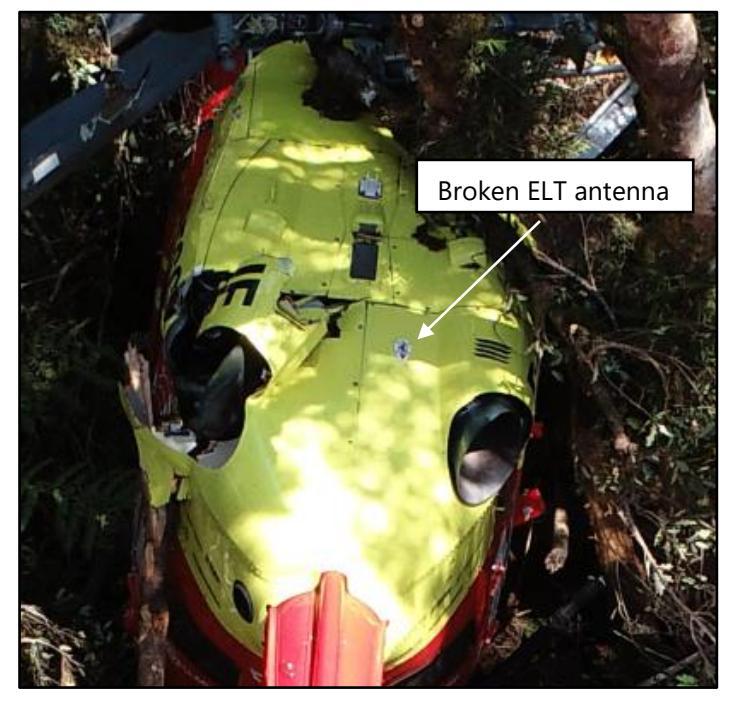
Figure 15: broken ELT antenna after the accident sequence

- 3.54. The ELT activated as intended, but was unable to transmit a signal because its antenna broke off during the accident sequence. As a consequence, RCCNZ did not receive a notification from the ELT.

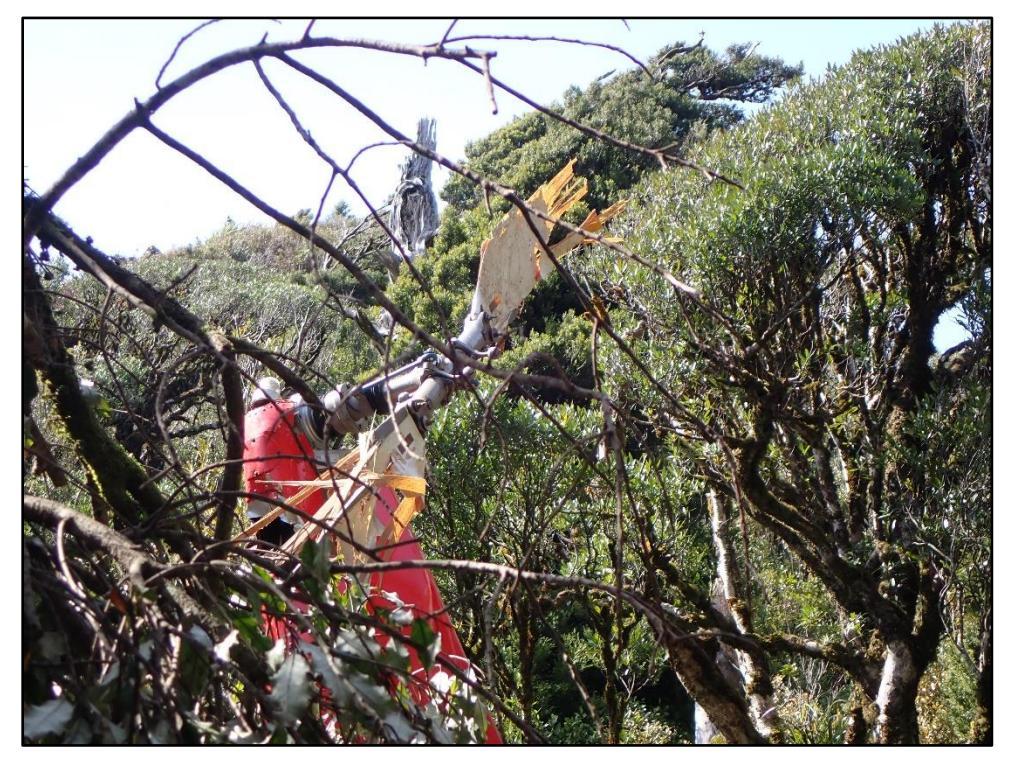
Figure 17: Tail rotor

- 2.43. Both tail rotor blades exhibited strike damage, but both were still attached to their mounting fork (*see* Figure 17 in Appendix 1).
- 2.44. The engine drive shafts of both engines had exhibited torsional¹⁸ failure (*see* Figure 18 in Appendix 1). This is consistent with the engines having continued to drive the main rotor transmission under resistance as the main rotor blades struck the surrounding trees.
