# Interim Report

Marine inquiry 11-204 Containership MV Rena grounding on Astrolabe Reef 5 October 2011

### **Transport Accident Investigation Commission**

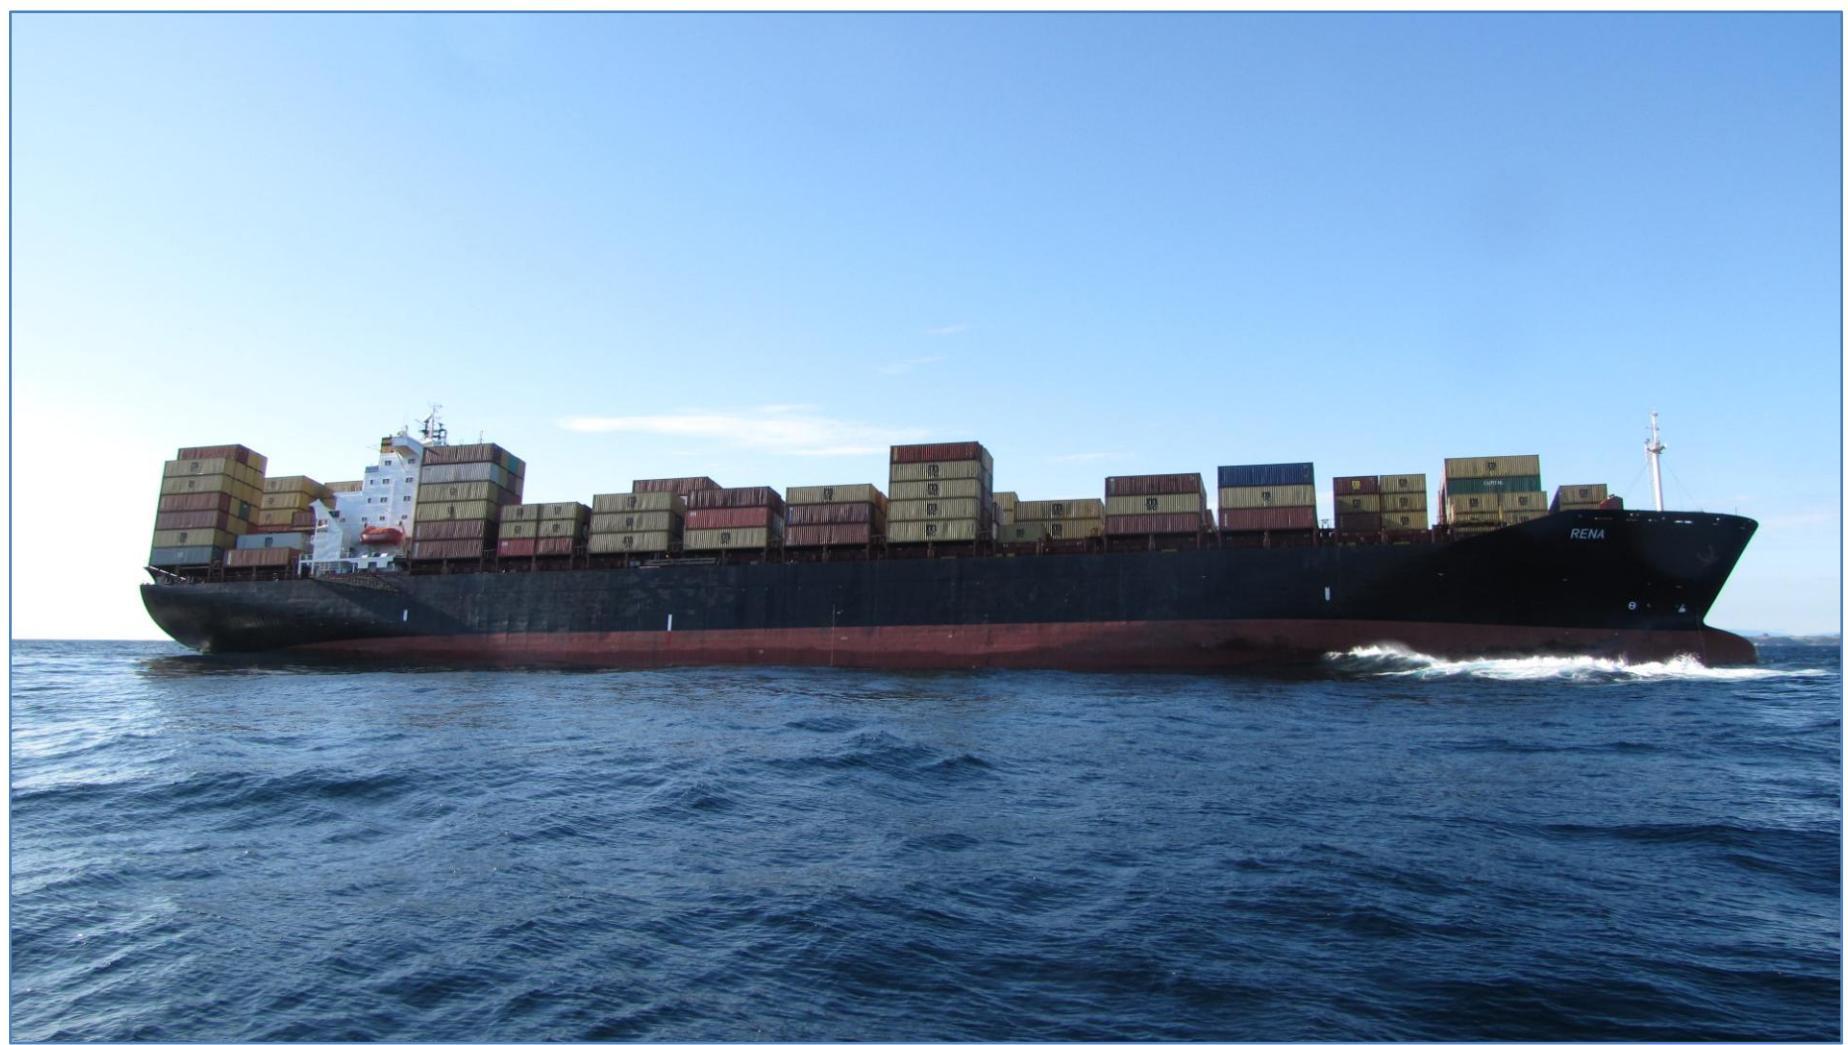
The MV Rena aground on Astrolabe Reef (photograph taken 6 October 2011)

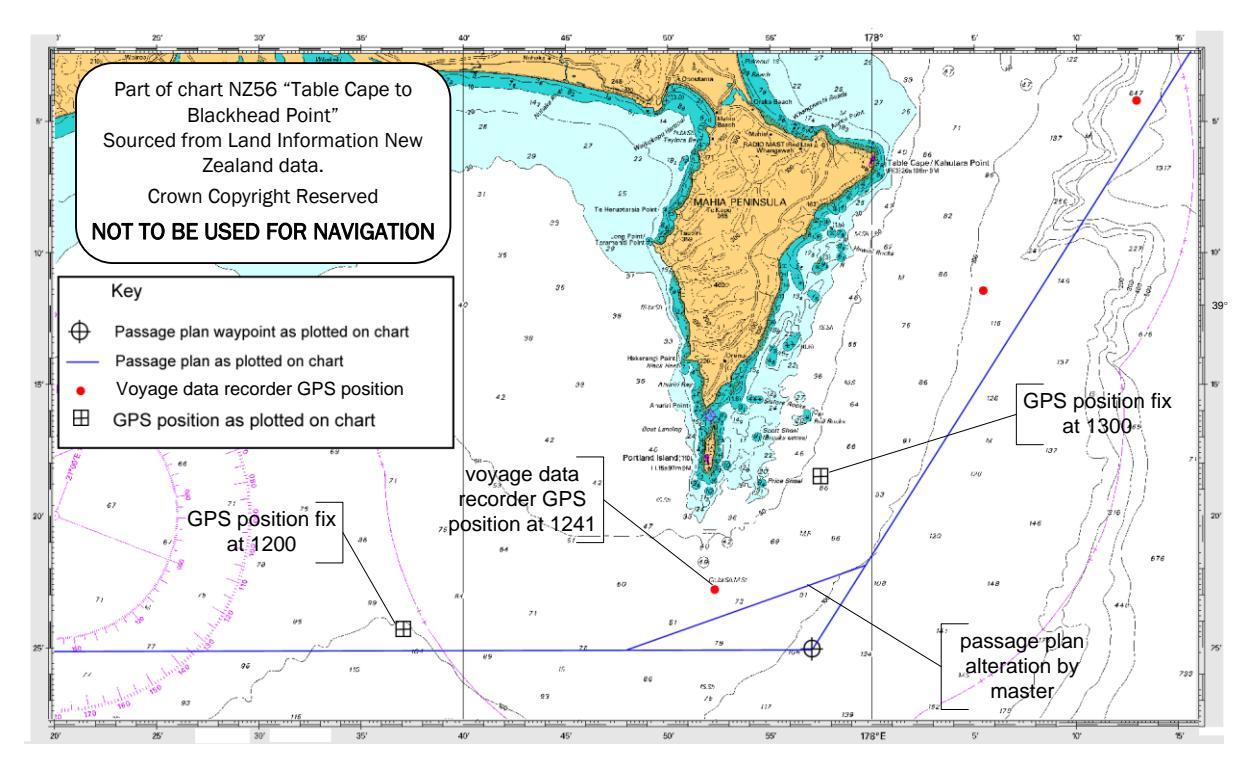
#### Figure 1

2.2.5. The master modified the vessel's planned passage on the chart to shorten the distance around Mahia Peninsula, as seen in Figure 1. The master handed control of the *Rena* to the third mate at 1100 as the vessel approached Mahia Peninsula. The passage plan that was in use during the voyage required that the vessel's position be plotted hourly, which was typically done using co-ordinates from the GPS. At times during the voyage the position was plotted more frequently than hourly.

Part of chart NZ56 showing passage plan, plotted positions and GPS positions obtained from the voyage data recorder on passage around Mahia Peninsula

- 2.2.7. The *Rena* rounded Mahia Peninsula at about 1300 and proceeded up the coast. The plotted positions were inshore of the course lines. A position plotted on the next chart used in the passage (NZ55) included a position at just over 5 nautical miles inshore of the planned passage.

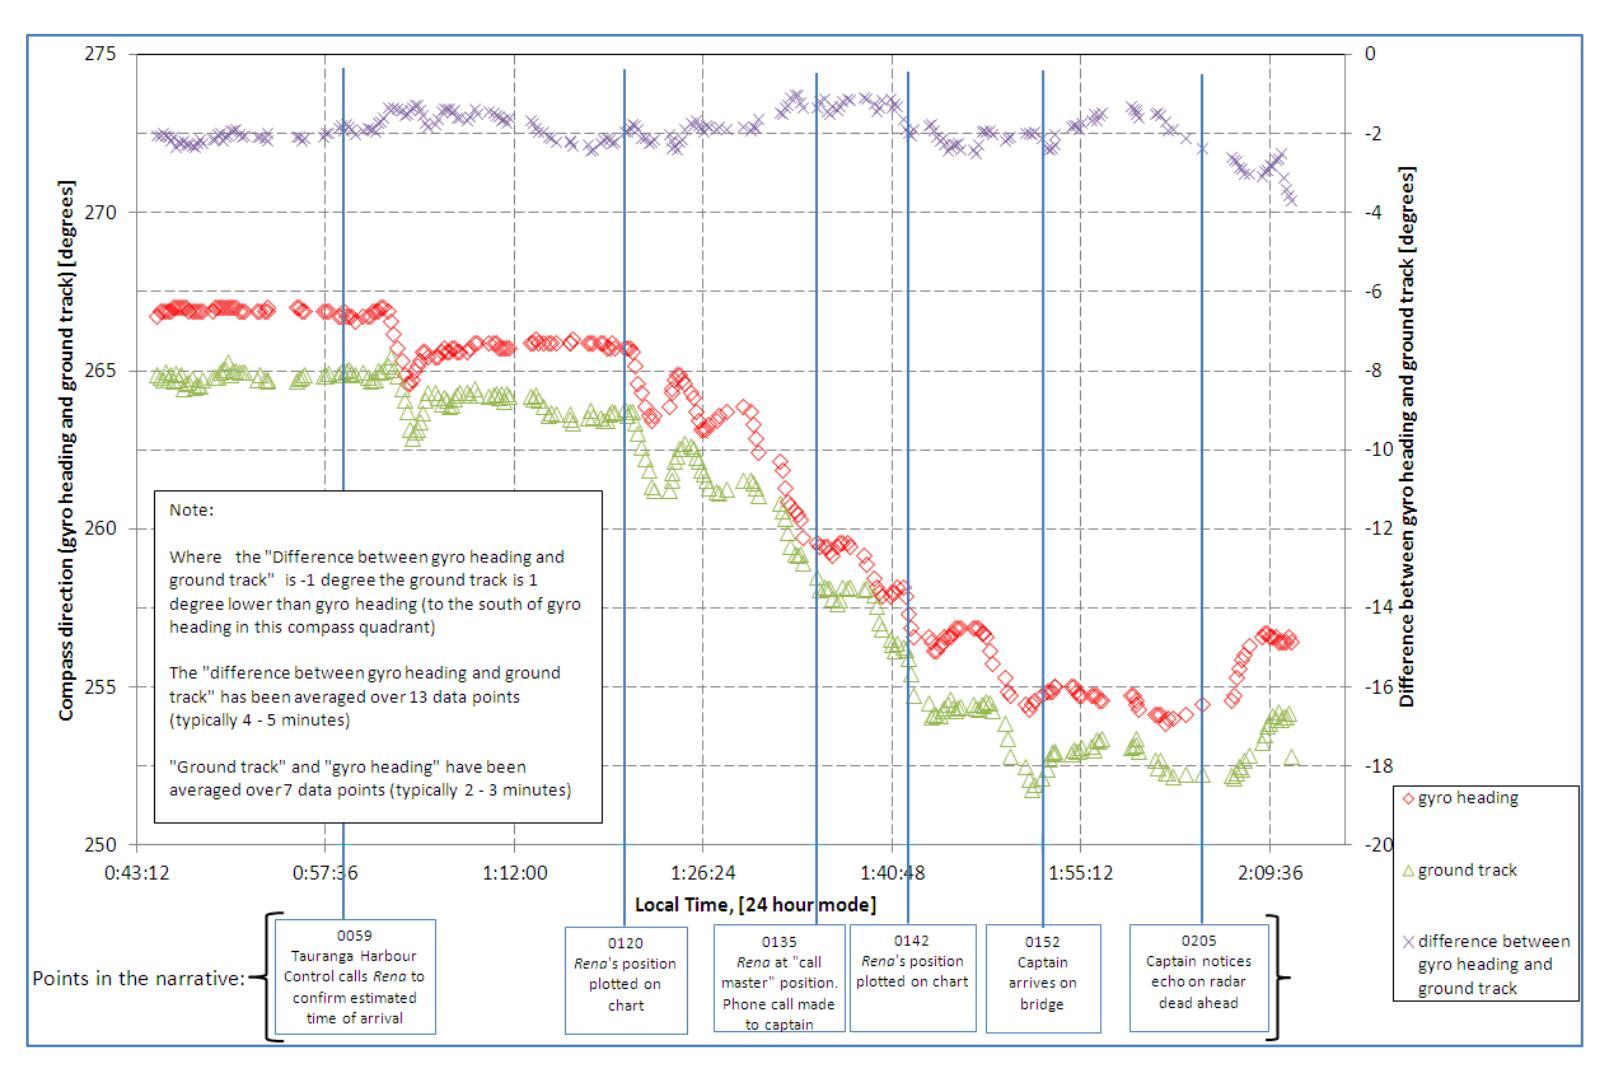
- 2.2.13. Figure 2 shows the *Rena*'s gyro heading and ground track and the difference between the 2. This data was taken from the automatic identification system and includes any error from that system. For clarity the data scatter was "smoothed" by taking an average over several data points. The bottom axis shows the time of day beginning at 0043 on 5 October 2011 and ending at around 0215 the same day. The vessel's gyro heading and ground track are read from the left-hand axis, which shows the gyro heading as recorded by the automatic identification system. The difference between the gyro heading and the ground track of the vessel is read from the right-hand axis. Some points in the narrative have been superimposed on the data for reference.

- 2.2.14. At about 0101 the course was altered to the south by about one degree as seen in Figure 2. Between 0120 and 0150 the gyro heading and ground track altered a further 10 degrees to the south, resulting in a gyro heading of about 255 degrees at about 0150.

Automatic identification system data showing vessel gyro heading and ground track and the difference between the 2. Some points of the narrative have been overlaid on the plot (automatic identification system data provided by Marico Marine NZ Limited)

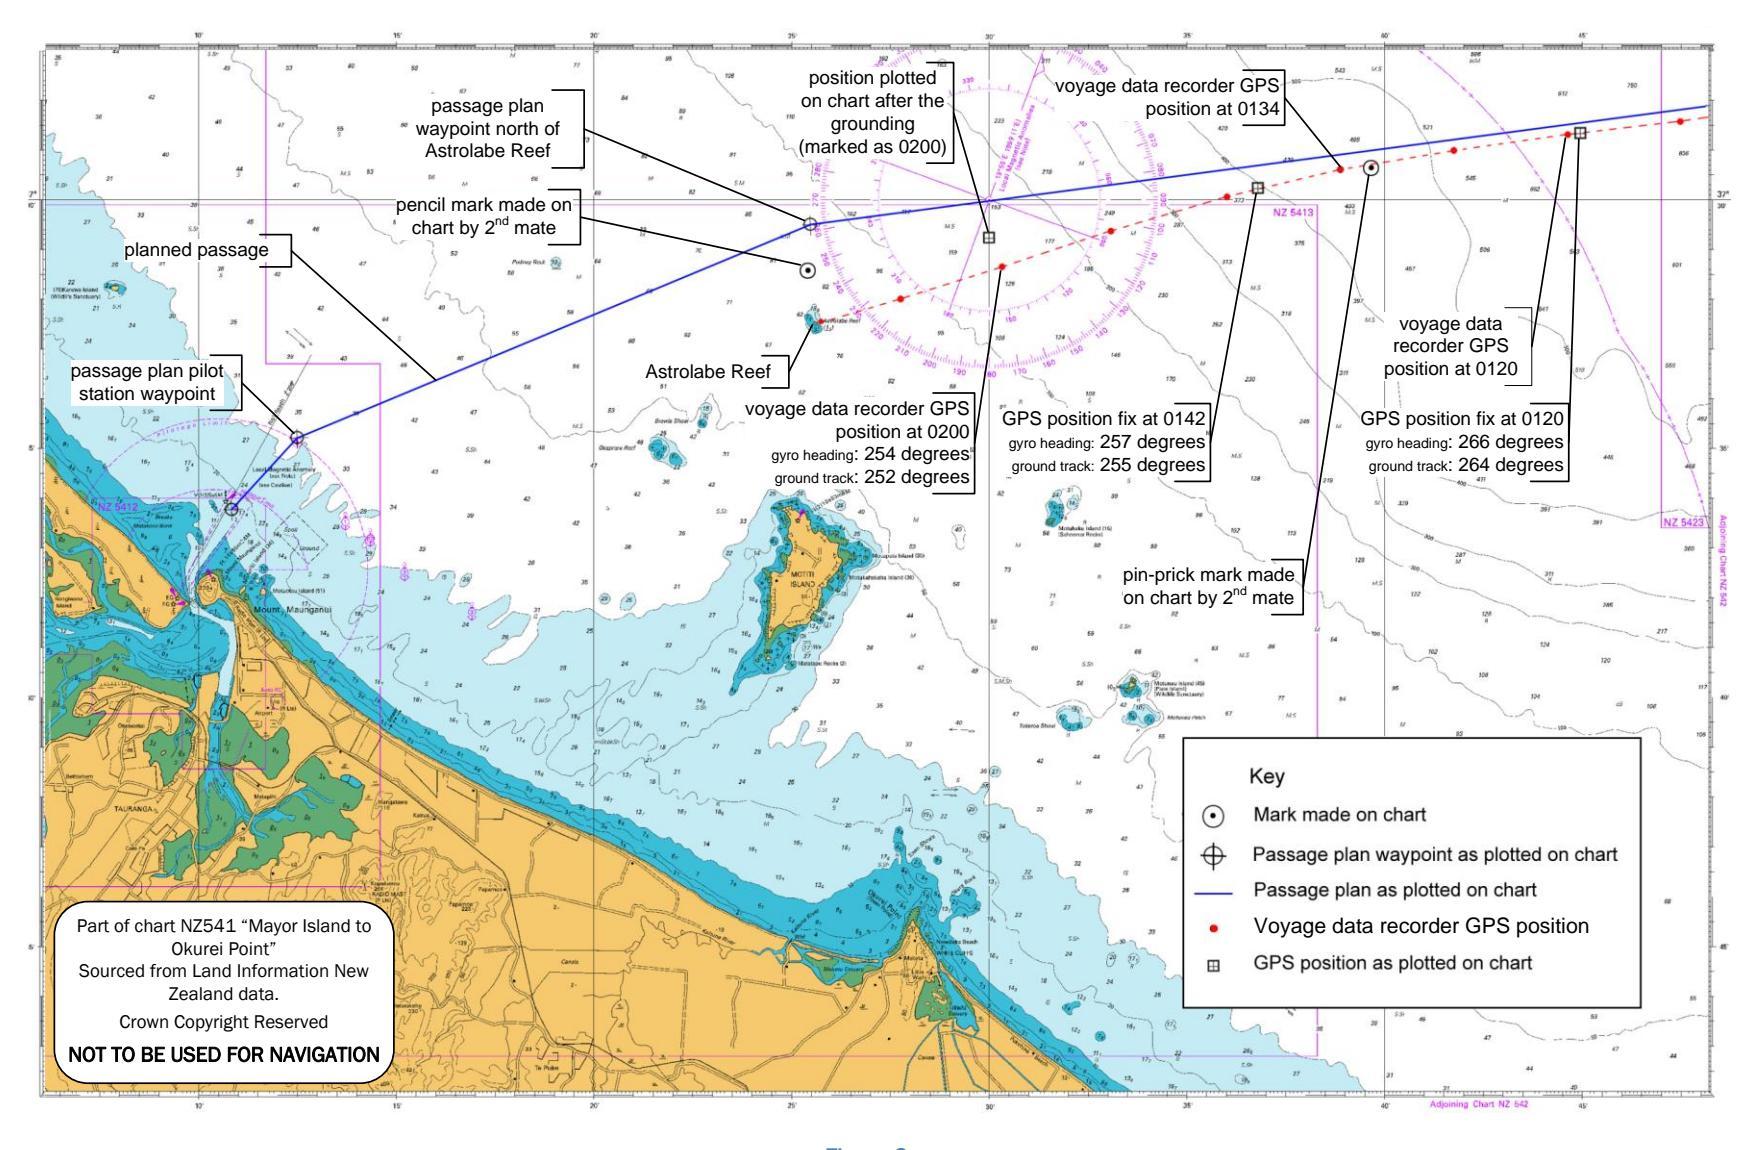
Figure 3 Part of chart NZ541 showing passage plan, plotted positions and voyage data recorder GPS positions on approach to Tauranga

- 2.2.17. The second mate's plan was to navigate closer to Astrolabe Reef. He said he placed a mark on the chart about one nautical mile north of Astrolabe Reef (shown in Figure 3), which was the point to which he intended to navigate the *Rena* before making the final course adjustment to the pilot station. The master has stated that the mark made on the chart one nautical mile north of Astrolabe Reef was put there after the grounding. The contradicting statements from the master and the second mate will be the subject of further consideration within the Commission's final report.

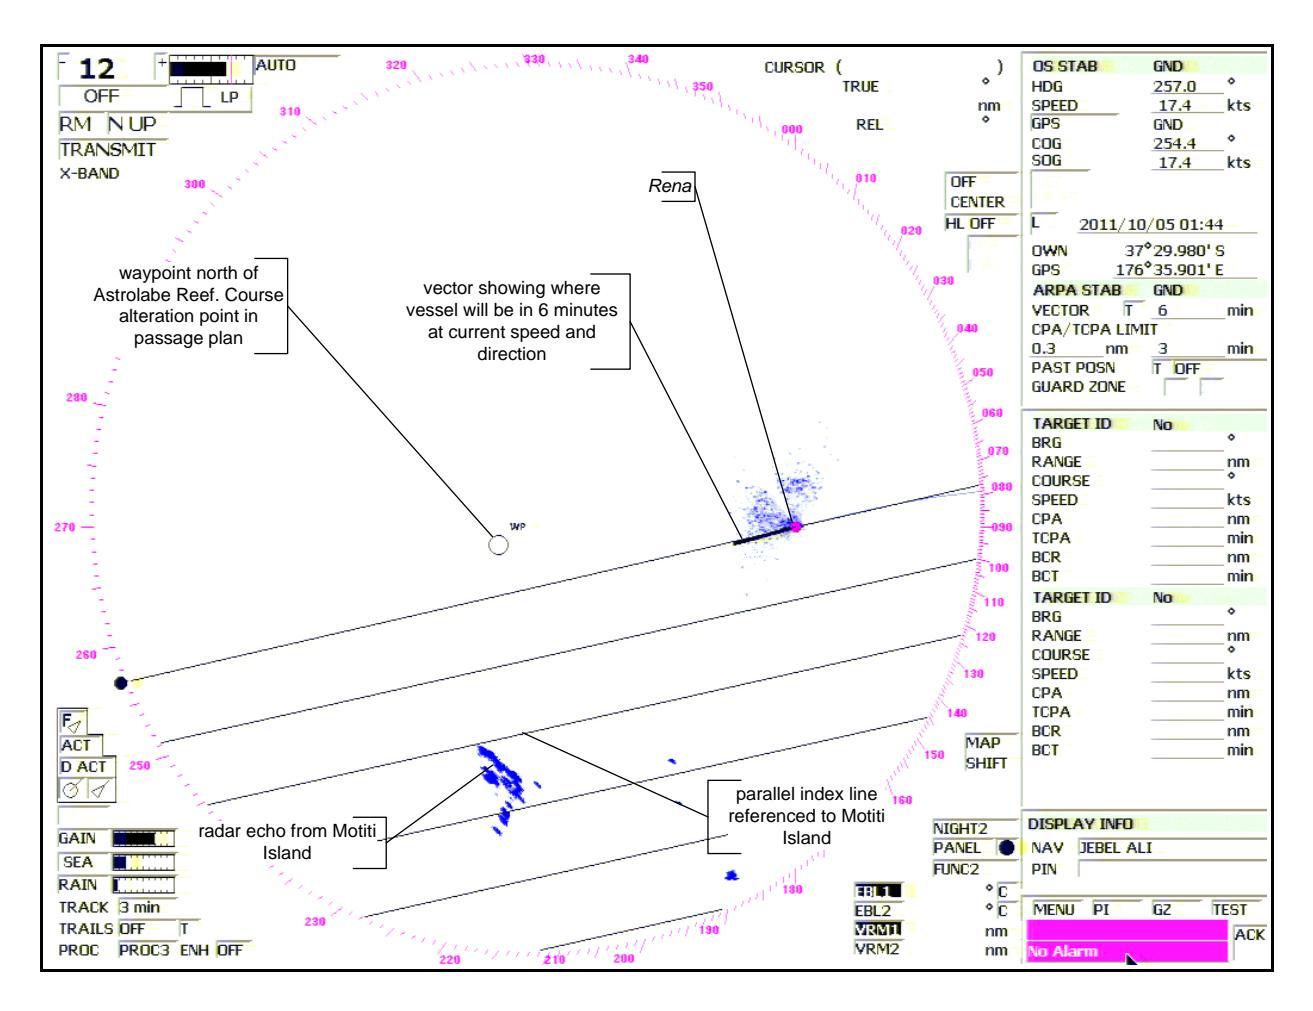
- 2.2.21. The voyage data recorder captured a screenshot of the *Rena*'s radar at about 15-second intervals. Figure 4 shows a radar screenshot captured at the time when the parallel index (referencing Motiti Island) was set up. The screenshot has been annotated with labels to identify the vessel, its course vector, Motiti Island, parallel index lines and the passage plan course alteration waypoint north of Astrolabe Reef.

Figure 4 Annotated screenshot of the Rena's radar (colour reversed for clarity)
