Final report

Marine inquiry MO-2018-206 Bulk carrier Alam Seri contact with seabed Approach to Bluff Harbour 28 November 2018

October 2021

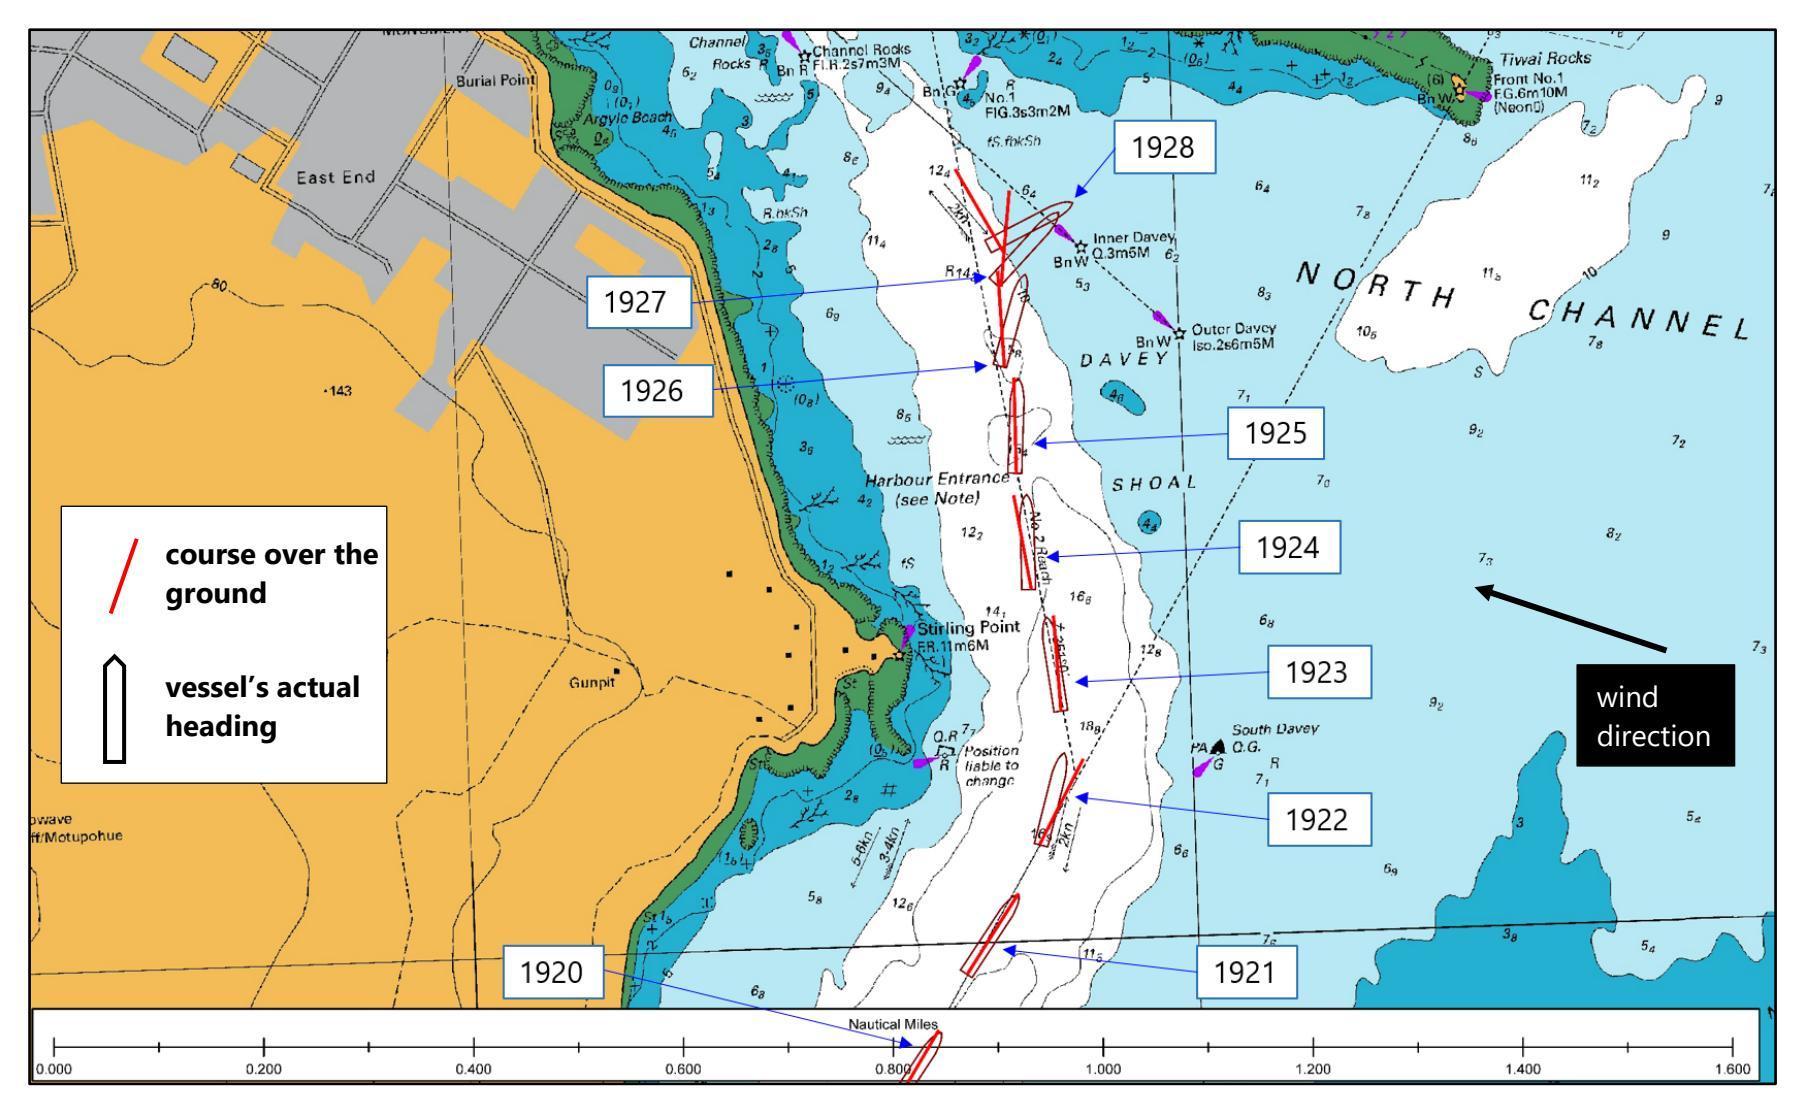
Figure 5: The *Alam Seri's* track from Number 1 Reach to Number 2 Reach (Credit: Land Information New Zealand)

2.19 The *Alam Seri* began to move astern and track to the west of Number 2 Reach (see Figure 5) towards Stirling Point.

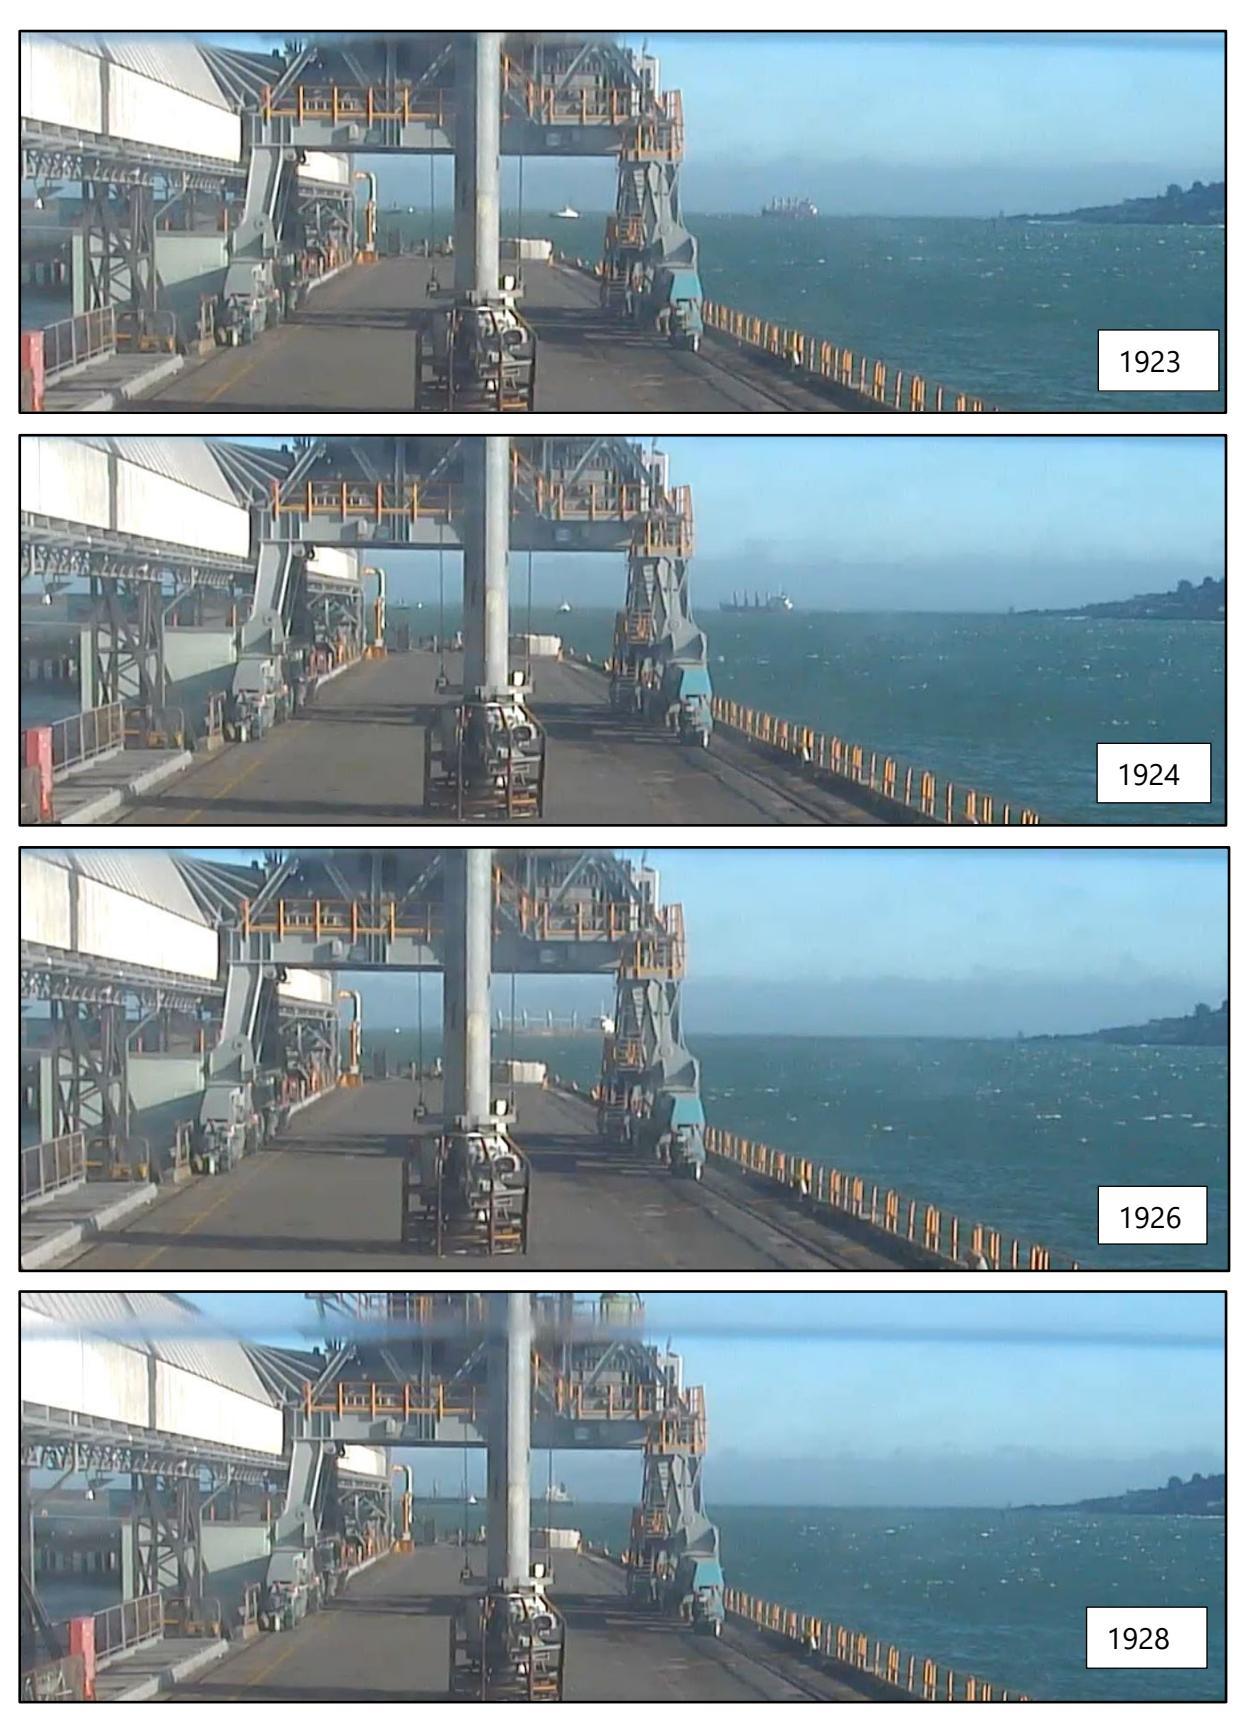
Figure 6: Series of stills from CCTV recording on Tīwai Wharf (Credit: New Zealand Aluminium Smelters)

- 2.17 At approximately 1929 the crew succeeded in deploying the starboard anchor, but it was no longer required and was immediately recovered.
- 2.18 A closed-circuit television camera (CCTV), located on Tīwai Wharf, recorded the occurrence. Images from the recording are shown in Figures 6 and 7 and can be referenced with the time stamps shown in Figure 5.

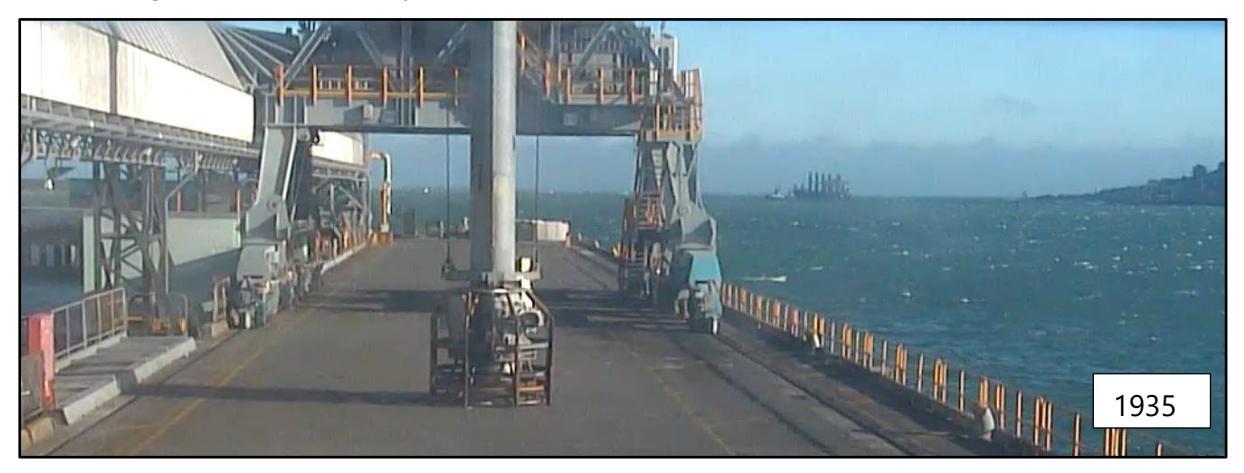
Figure 7: The *Alam Seri* with the tugs secured, as seen on CCTV from Tīwai Wharf (Credit: New Zealand Aluminium Smelters)

- 2.20 At 1933 the *Hauroko* was secured to the stern of the *Alam Seri*, and the *Te Matua* was secured forward at 1935 (see Figure 7).
- 2.21 At 1942 the *Te Matua*'s towline parted. Shortly afterwards a replacement line was run and the *Te Matua* was reconnected.
- 2.22 As the pilot recovered control of the *Alam Seri*, both the tugs and the *Alam Seri* were damaged when the tugs contacted the ship while manoeuvring at close quarters and in the rough seas.
- 2.23 At 1945, with the assistance of both tugs, the pilot conned the vessel into Bluff Harbour. At about 2010, while turning off the berth, the towline on the aft²² tug, the *Hauroko*, parted. A new towline was secured at 2018 and the *Alam Seri* was secured alongside Tīwai Wharf by 2100.

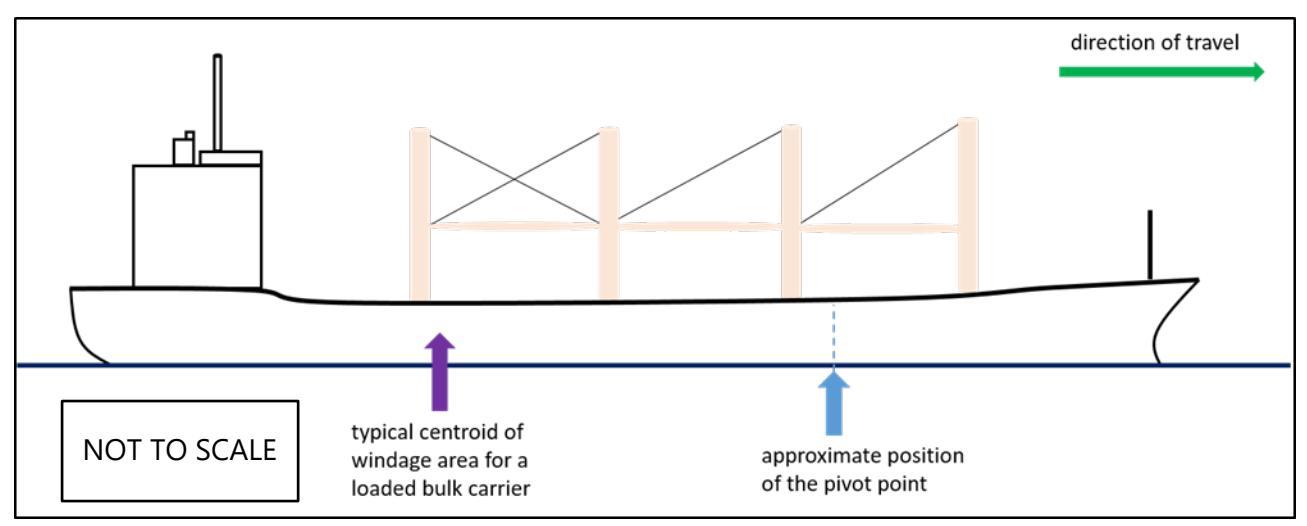
- 3.11 The wind acted on the starboard side of the vessel, and with the accommodation block located aft there was a greater surface area aft of the vessel's pivot point for the wind to act on (see Figure 9). This caused the tendency of the stern to move to port and the heading of the vessel to change to starboard, commonly referred to as 'rounding up into the wind' (see Figure 10). This tendency for the ship to veer to starboard was countered by the helmsman applying port rudder to maintain the courses ordered by the pilot (see Figure 11 and Appendix 2).

Figure 9: Profile of a typical loaded bulk carrier showing the relative positions of a beam wind influence and the vessel's pivot point when moving ahead

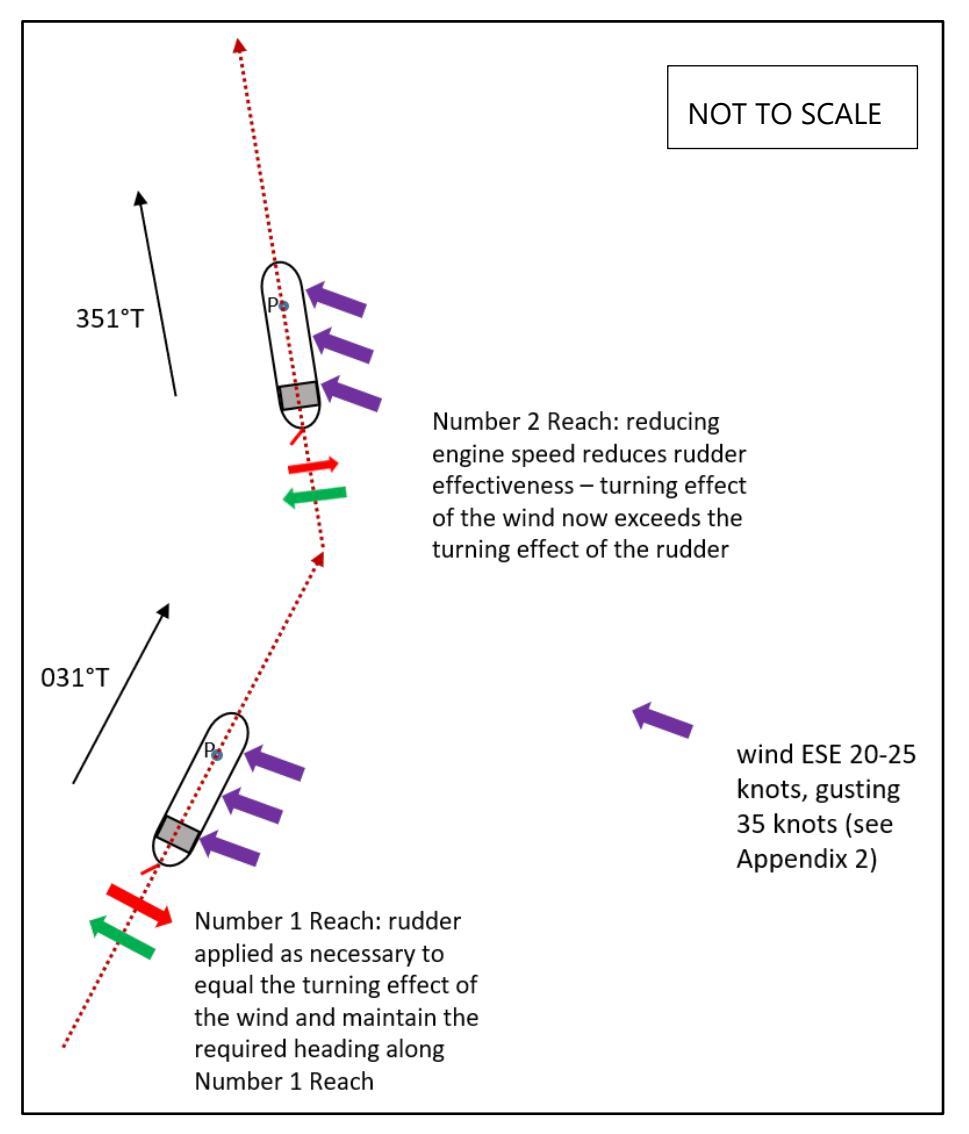
3.14 The two successive engine reductions had two effects: they reduced the speed of the vessel (see Appendix 2) and they reduced the propeller wash past the rudder, thereby reducing the rudder's effectiveness. As the vessel approached the new heading of 352°, the force of the wind was acting more on the starboard quarter²⁸. The wind's effect of pushing the stern to port was therefore slightly reduced, but so too was the water flow over the rudder.

Figure 10: The change in manoeuvring influences when the *Alam Seri* altered course into Number 2 Reach

3.15 The result was that when the helmsman attempted to steady the vessel's head on 352°, they found that even with the rudder almost hard to port, the vessel was still swinging to starboard. The helmsman was prompt in telling the bridge team that the vessel was

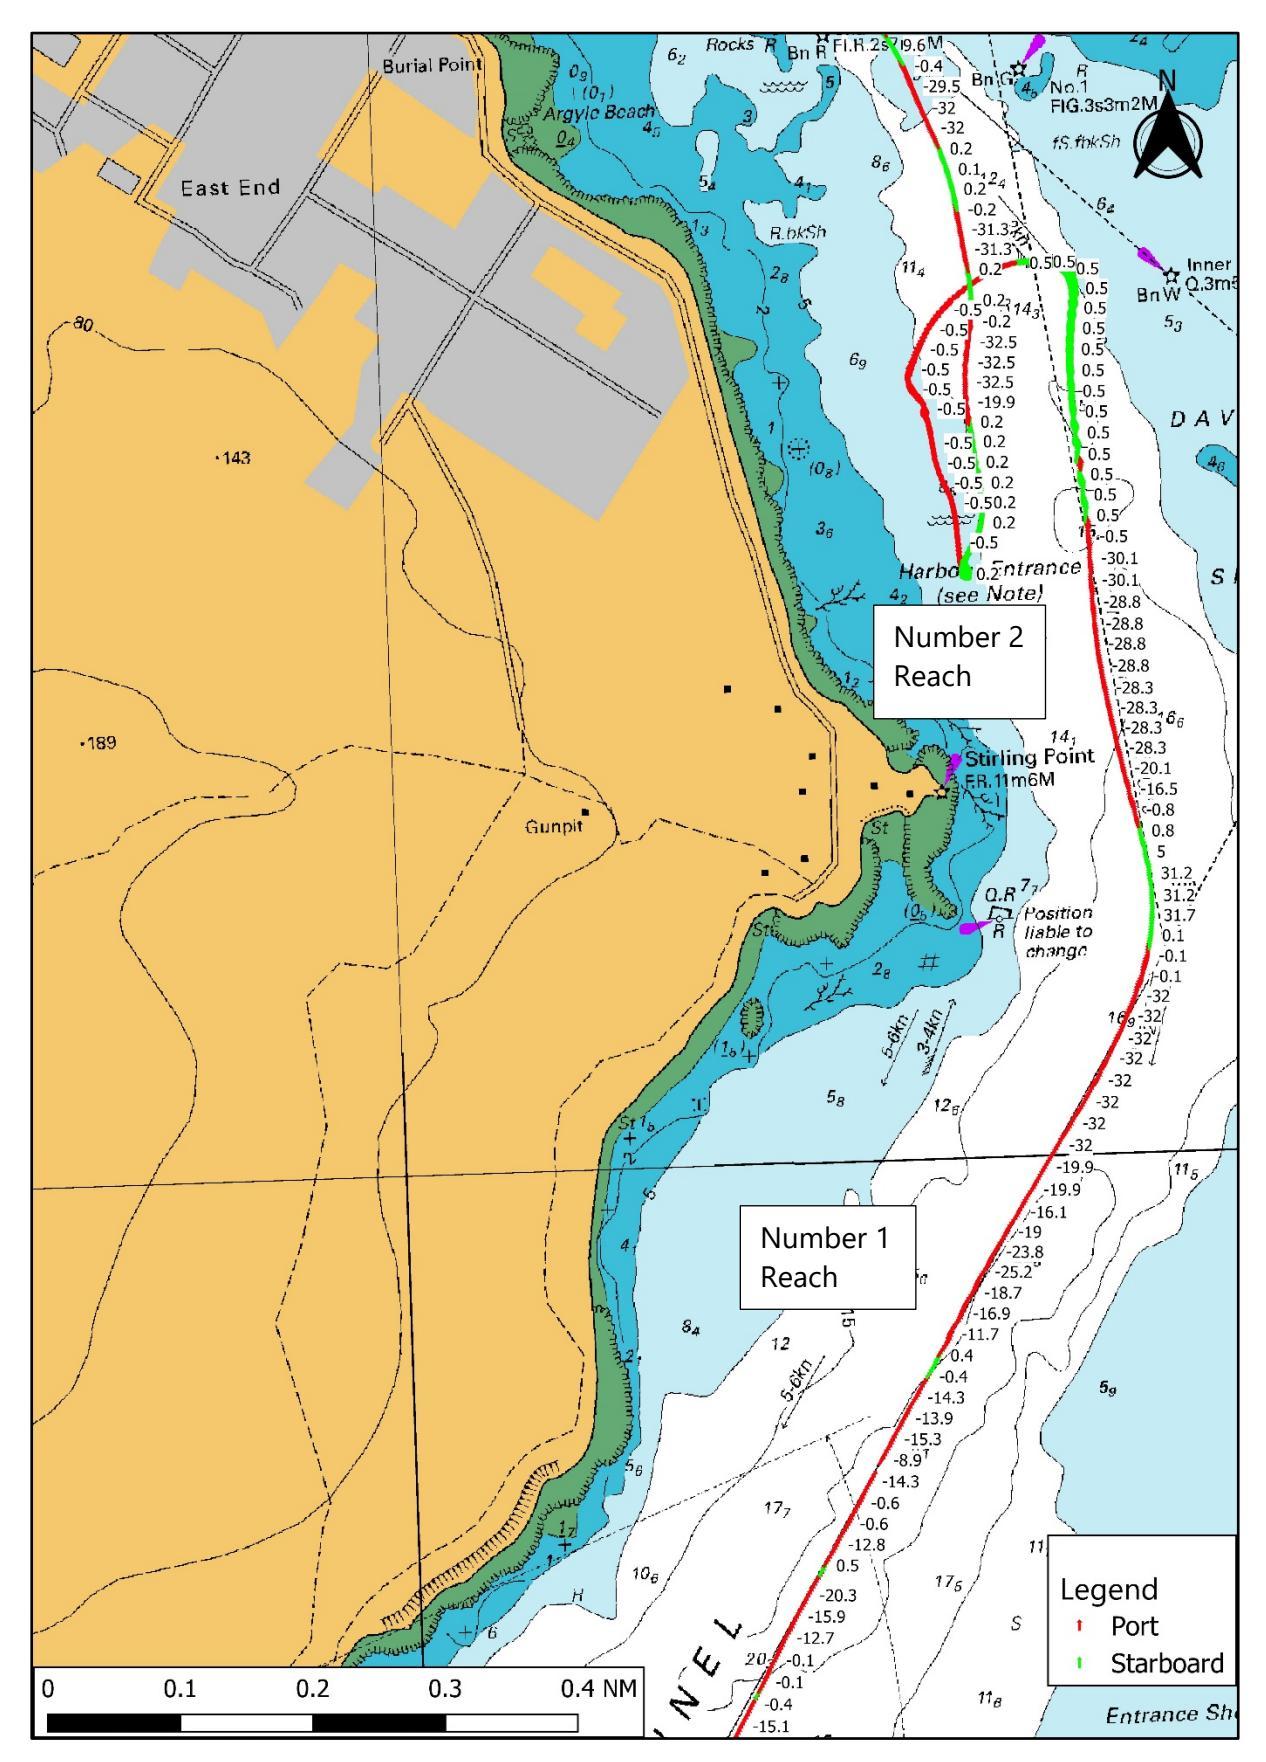
Figure 11: The track of the *Alam Seri* and the rudder angle (°) applied during the transit of Number 1 Reach and Number 2 Reach (Credit: Land Information New Zealand)

3.28 As the ship transited Number 1 Reach, the amount of port helm required(see Figure 11) to maintain the desired course should have engendered a discussion among the bridge team about the effect of the wind and how that would affect the vessel making the turn into Number 2 Reach. There was no such discussion, so the bridge team had no way of knowing what adjustments the pilot was making to the standard approach to allow for the conditions on the day.

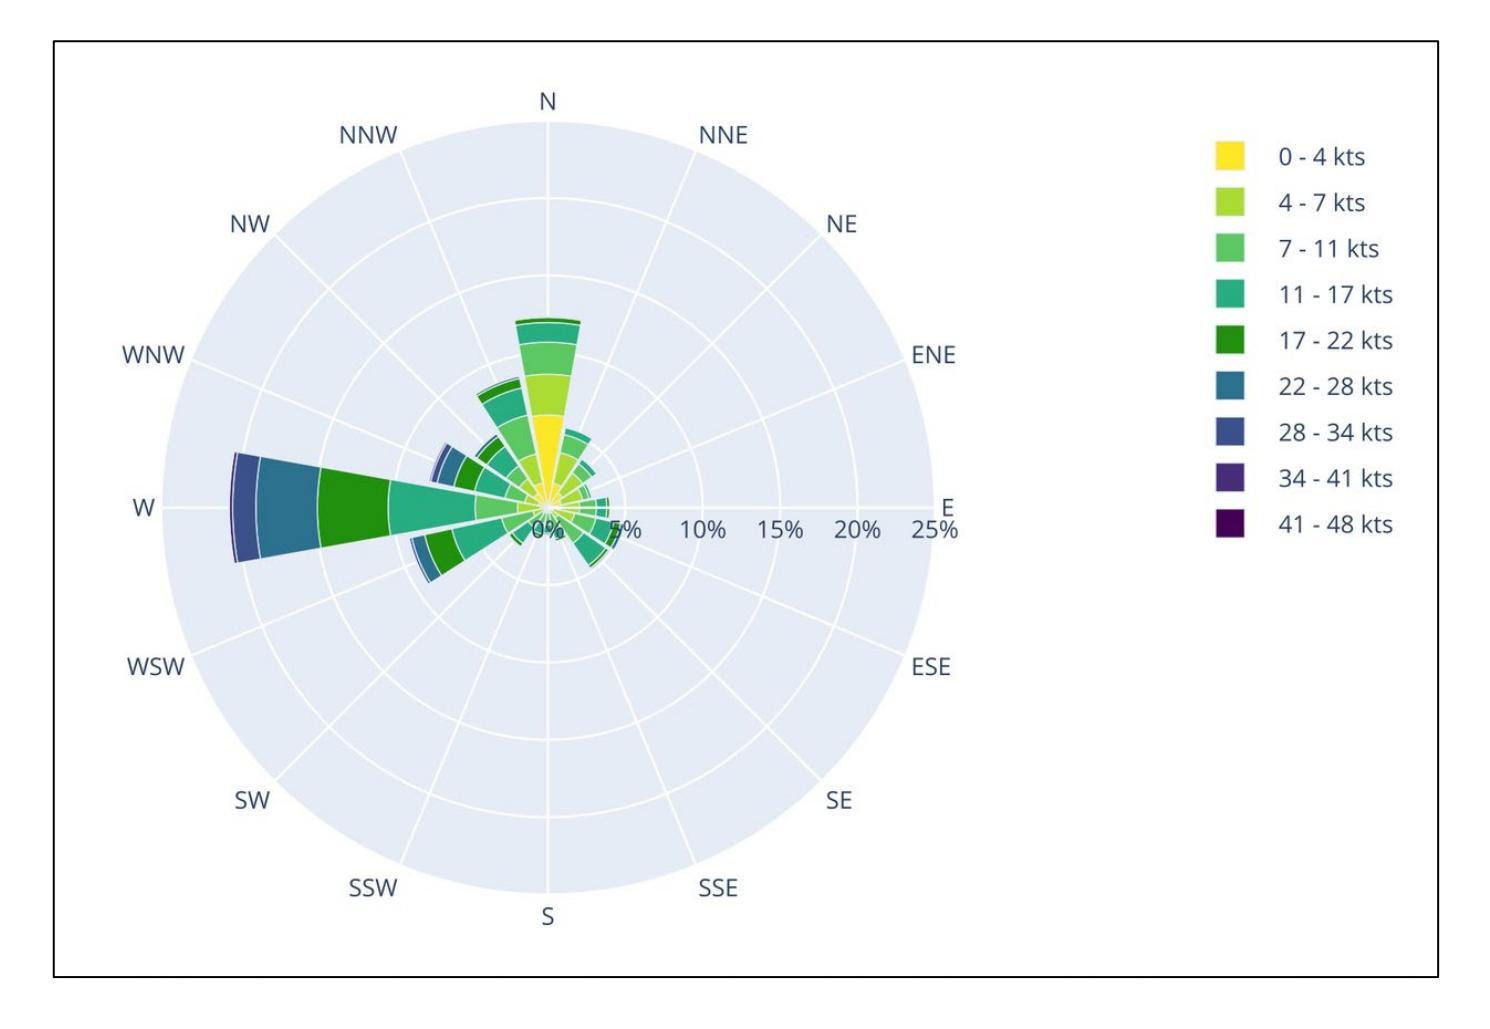
When easterly winds occur, they are likely to be associated with a weather pattern known as a low-index situation. A low-index situation happens when there is an intense anticyclone south of New Zealand and low pressure over the Tasman Sea or the North Island. Once established, this weather pattern can cause easterly winds to persist over southern New Zealand for prolonged periods³⁴. During these conditions, the wind and sea have an uninterrupted flow across the approaches to Bluff Harbour. There is no shelter from the land and there is unlimited fetch³⁵, resulting in rough sea conditions in the area of Number 2 Reach. In the more prevalent westerly wind conditions, Number 2 Reach is relatively sheltered from the land and has calmer sea conditions. Therefore, easterly winds present a higher risk on Number 2 Reach than the prevailing westerly wind conditions.

Figure 12: Wind direction and speed, percentage frequency for Tīwai Point, 2017, 2018 and 2019 (raw data sourced from NIWA)

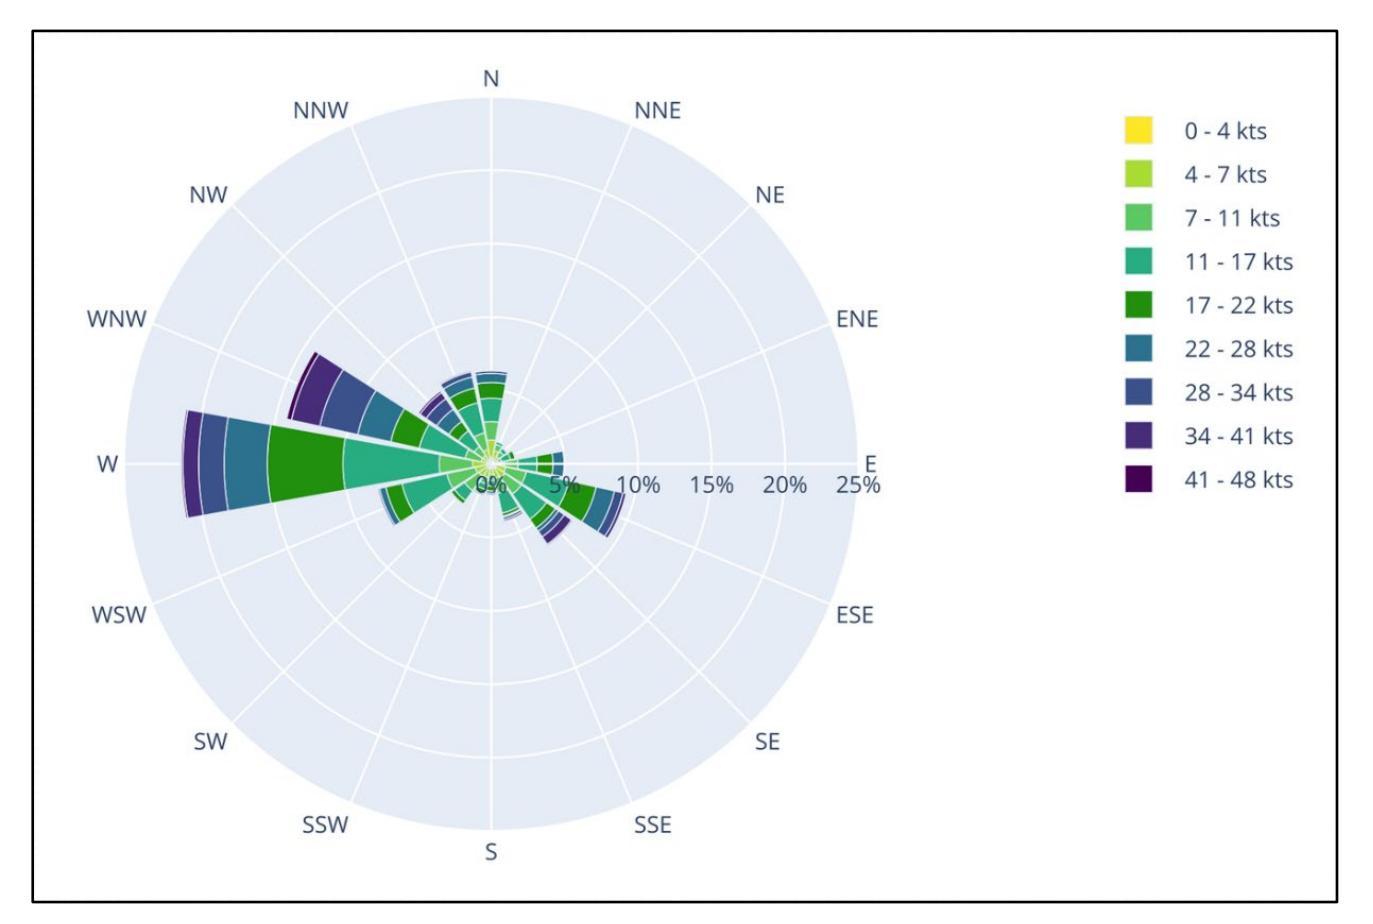
Figure 13: Wind data from the Number 3 channel beacon for November 2016, 2017 and 2018
