Final report

Marine inquiry MO-2019-202 Fatal jet boat accident Hollyford River, Southland 18 March 2019

February 2020

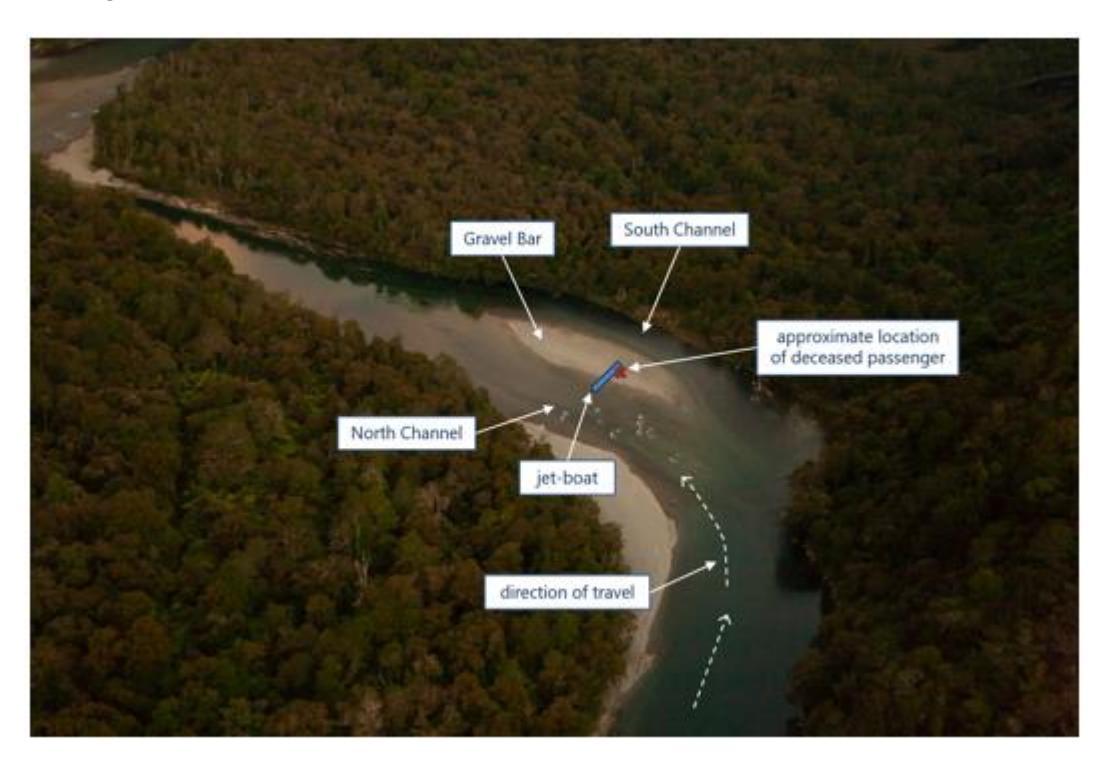
Figure 5: Location of accident

- 2.12. About 5.5 kilometres downstream from McKerrow Island Hut, in the vicinity of a lefthand bend, a gravel bar split the river into two channels. The channel to the north of the gravel bar was wider than that to the south (see Figure 5) but had exposed rocks and logs.

- 2.13. The channel to the south of the gravel bar was narrower but deeper, and had a greater volume of water flowing. The southern channel was favoured by commercial jet boat drivers because the northern channel was shallower and had exposed logs.

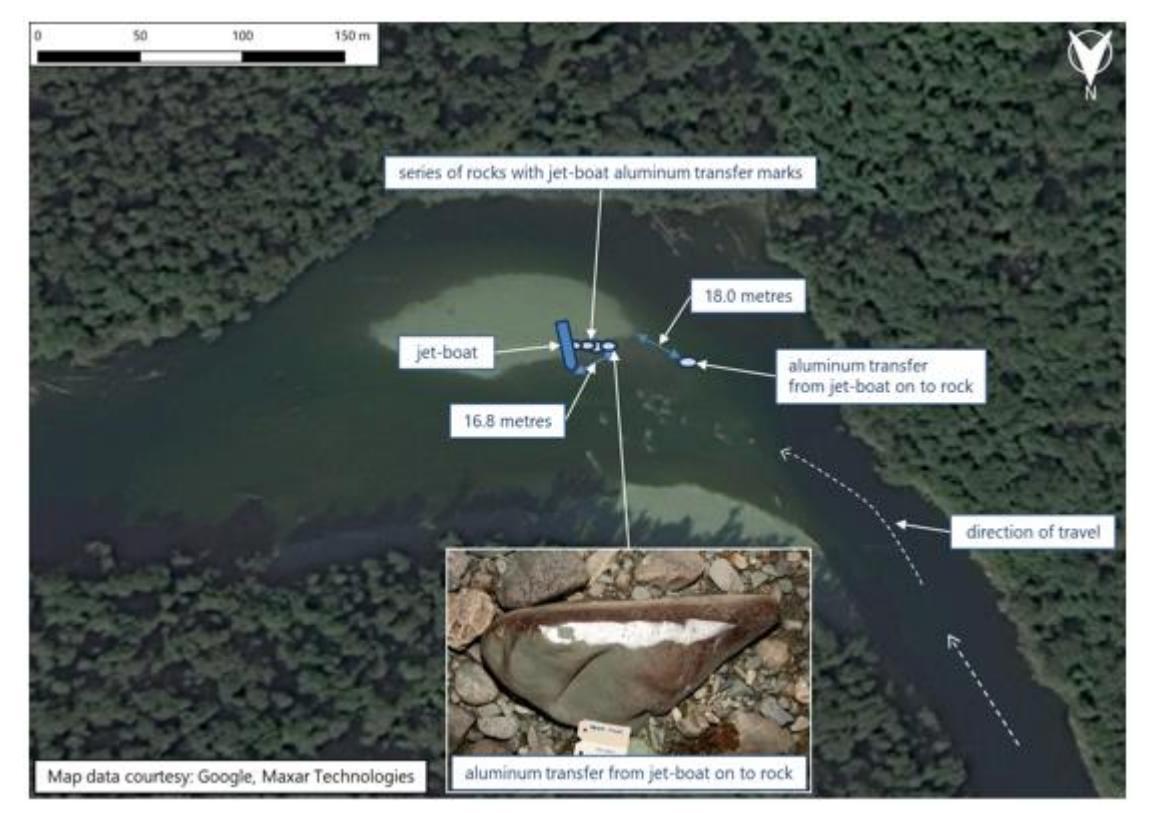
Figure 6: Approximate position of rocks

- 2.14. As the jet boat approached the bend in the river, the driver saw the gravel bar and steered the boat towards the northern channel.
- 2.15. As the driver started to negotiate the turn, the starboard quarter of the jet boat made contact with a rock (see Figure 6) and skidded onto its starboard side before hitting the ground and landing upright on the gravel bar. The jet boat was pointing towards the north when it came to rest.

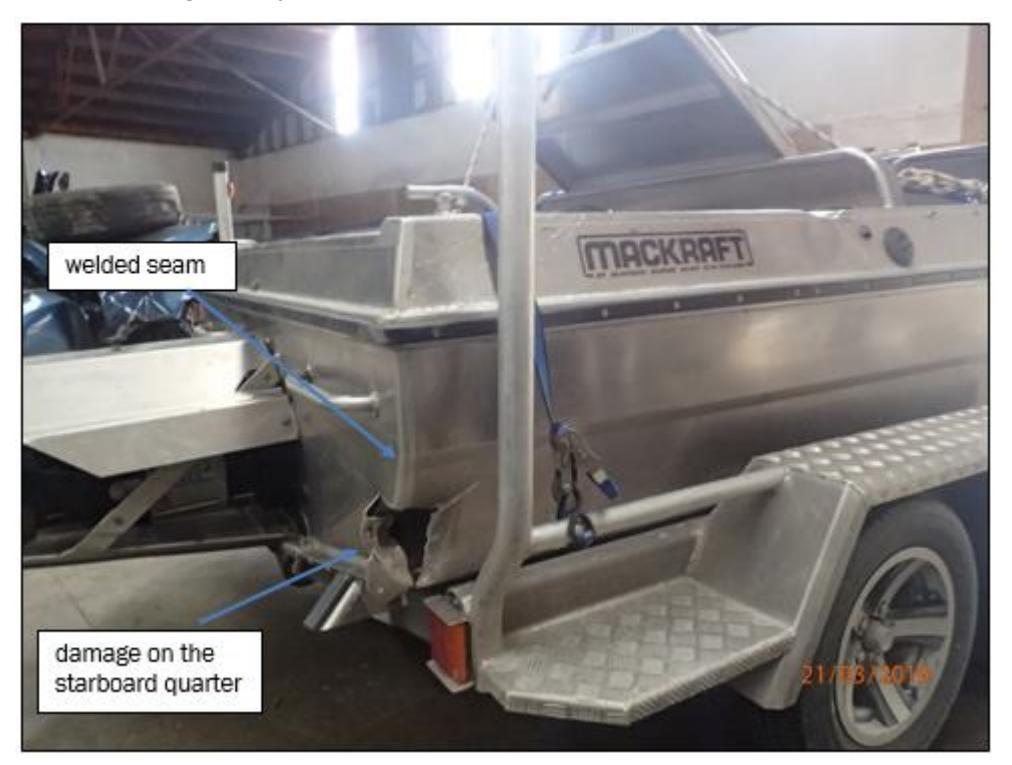
Figure 7: Damage sustained on the starboard quarter

2.32. On the starboard side of the hull there was significant damage along the welded seam. At the aft starboard corner the hull had been breached with a hole that was consistent with the boat hitting a rock (see Figure 7). There was a second hole about one metre forward of the first along the same side.

2.33. The boat suffered a dent on the port side along the gunwale⁶ near the driver's seat and one near the engine bay area.
