Final report

Marine inquiry MO-2019-204 Capsize of water taxi Henerata, Paterson Inlet, Stewart Island/Rakiura 12 September 2019

November 2020

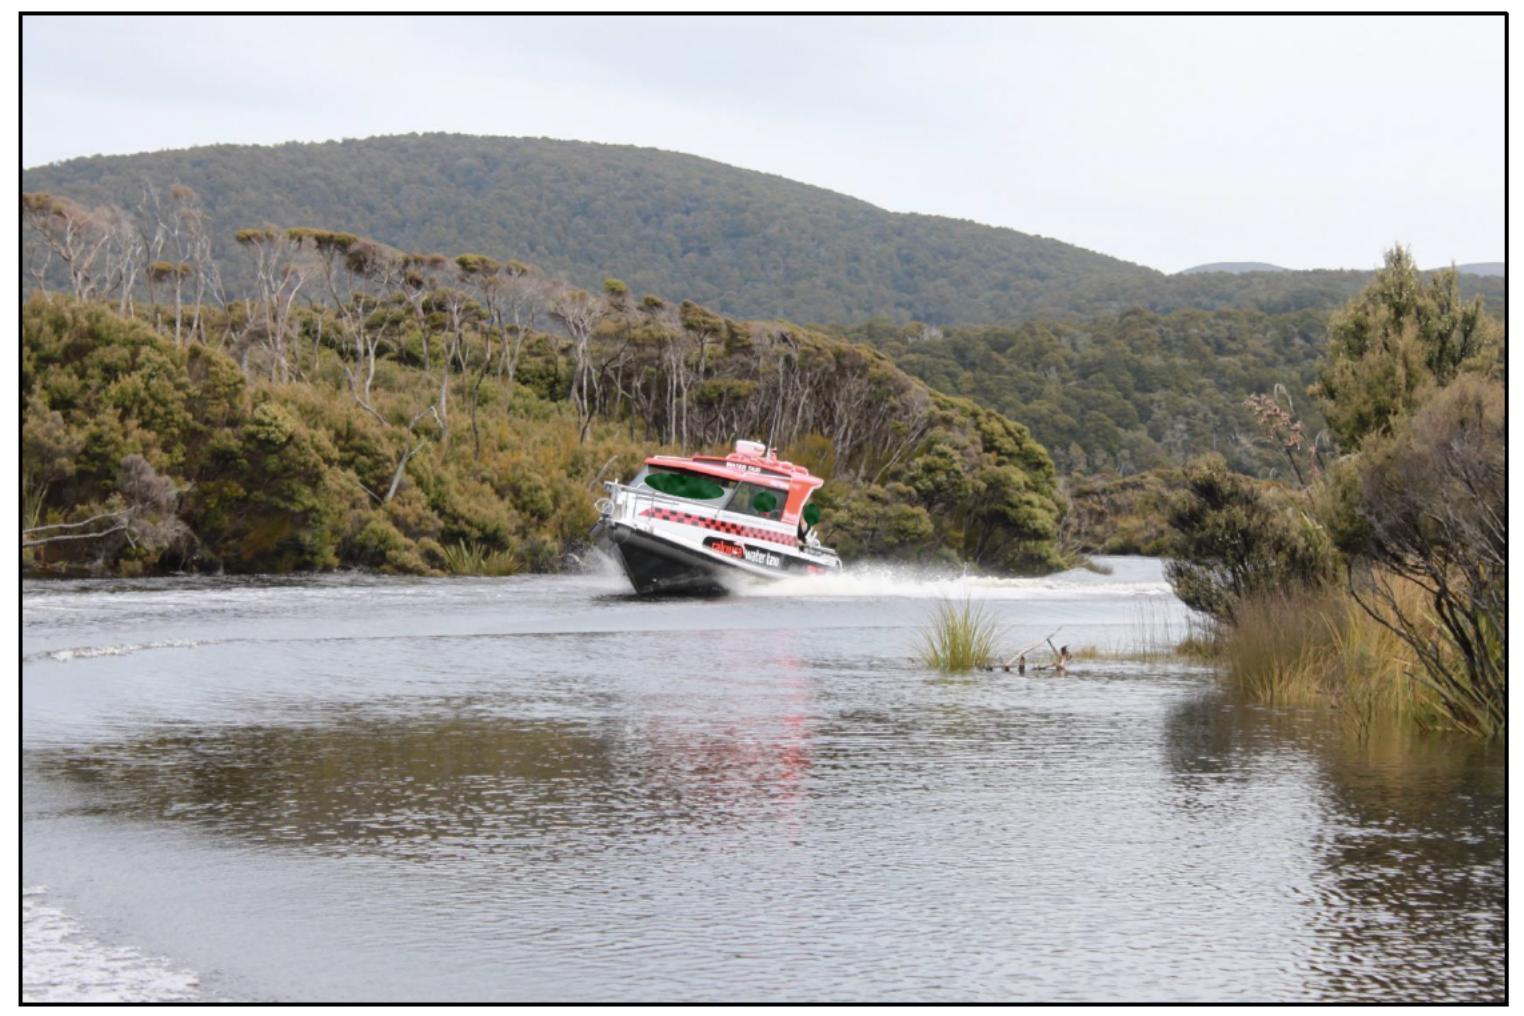
Figure 1: Water taxi, *Henerata* (credit: Rakiura Charters Limited)

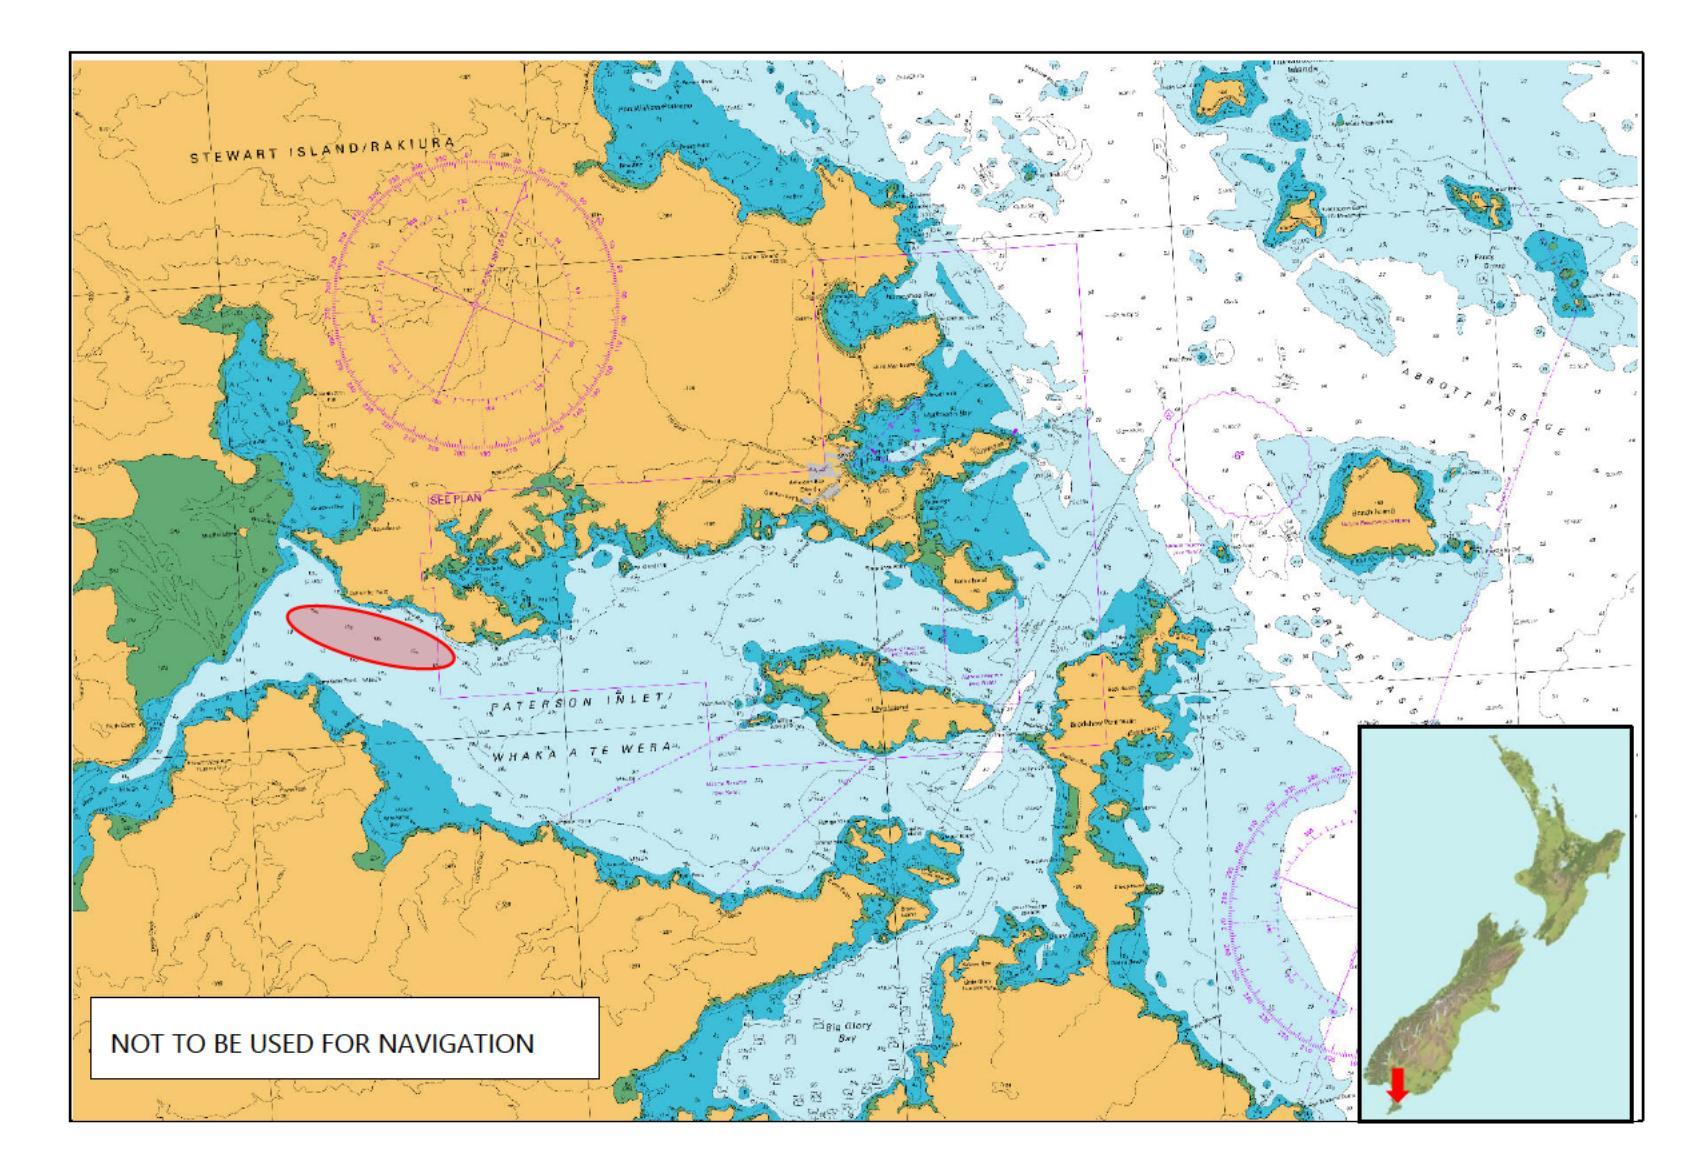
Figure 2: Location of accident on Chart NZ6825 (credit: Land Information New Zealand)
