Final report Tuhinga whakamutunga

Maritime inquiry MO-2020-204 Container Vessel, Rio De La Plata Serious injury to crew member during unmooring operations, Timaru Port 14 November 2020

May 2022

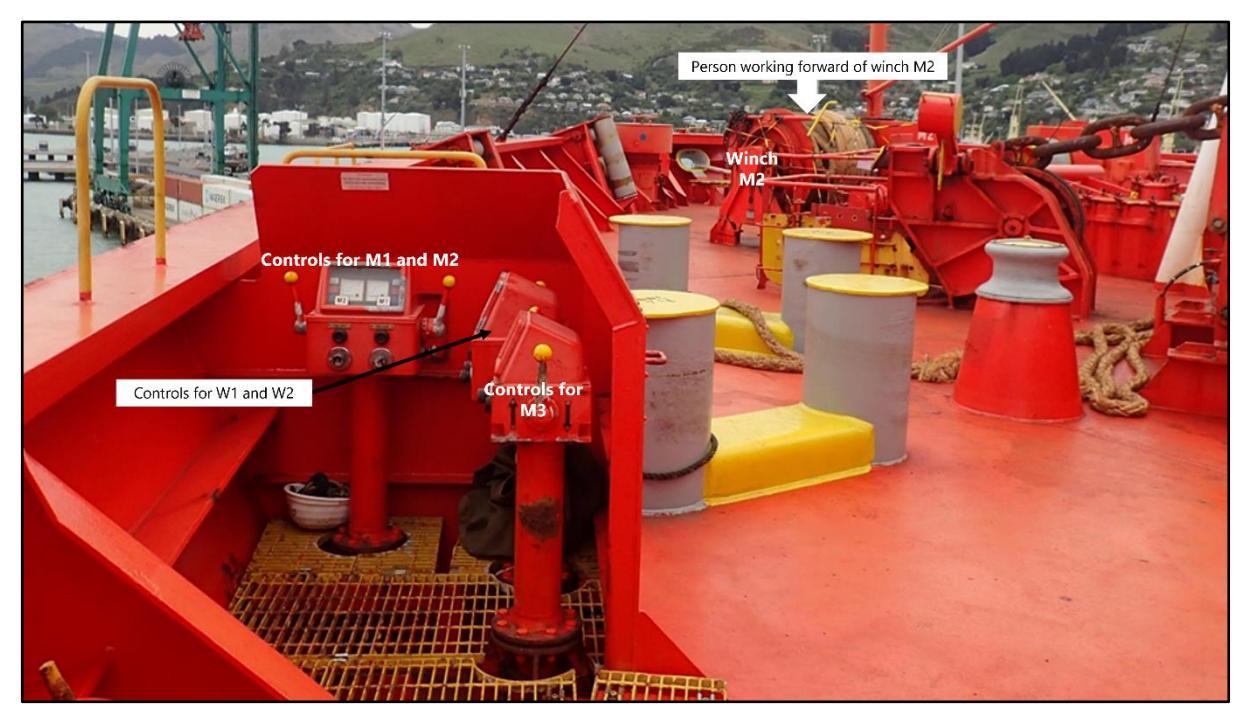
2.13 The AB seaman positioned himself at the port side remote control station and took control of the mooring winches, while OS1 and OS2 (injured person) took up their positions near winch M1 and winch M2, respectively. From this position the AB did not have a direct line of sight of the two OS's when they worked close to the winches.

Figure 5: View of the mooring deck from the port side winch controls

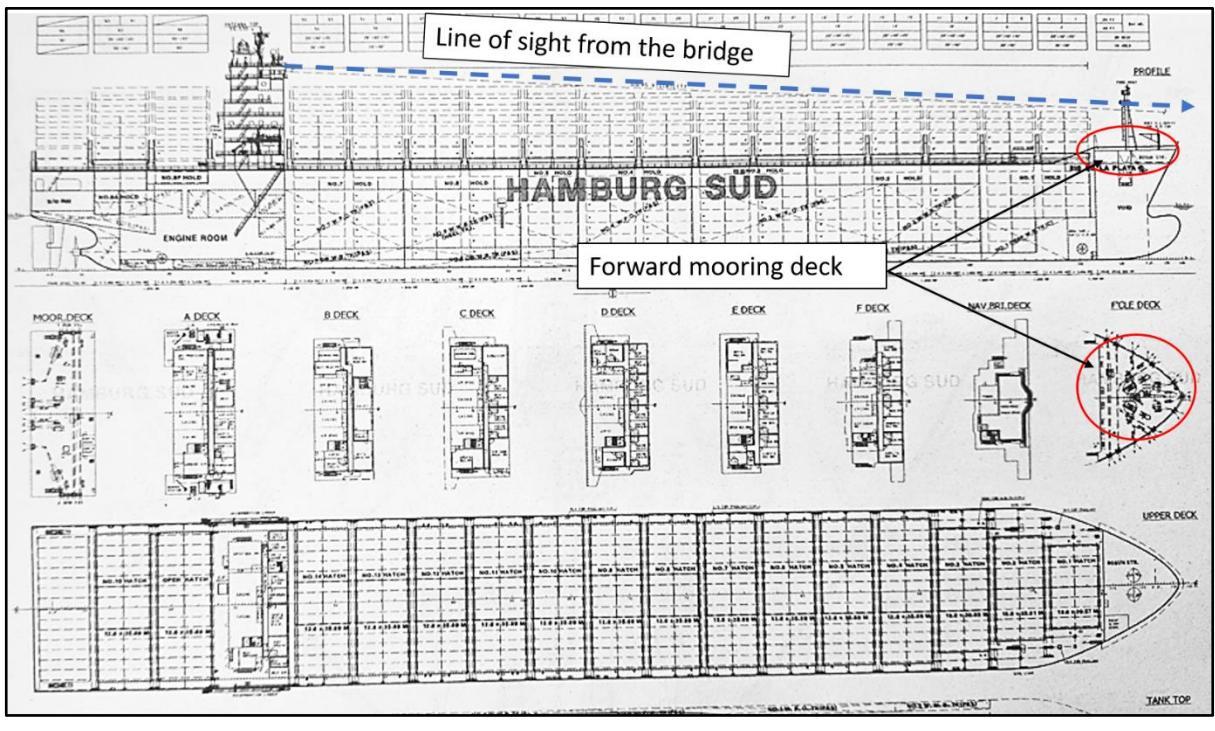
2.34 The bridge, by virtue of the vessel's design, had no view of the forward mooring deck as shown in figure 6.

Figure 6: Longitudinal view showing line of sight from the bridge

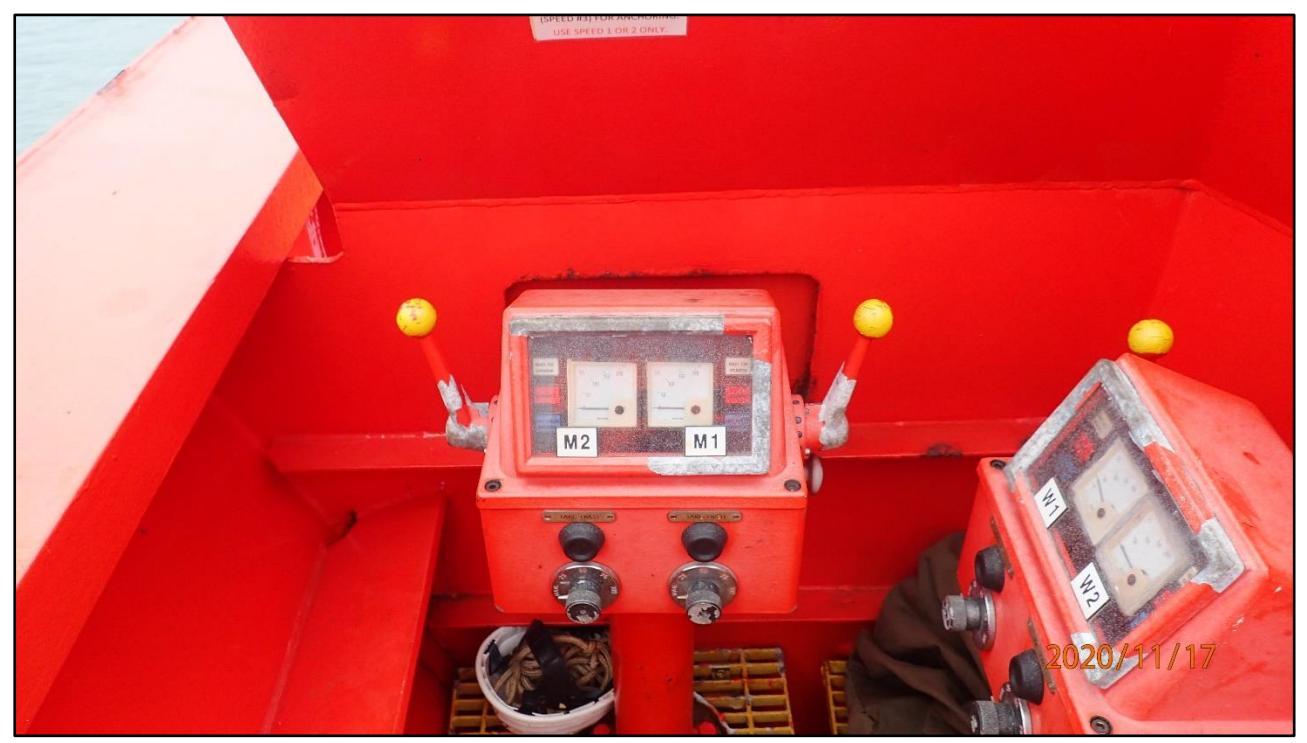
Figure 7: Port side control station

2.36 At the time of the accident, the AB operating the winch was positioned at the port control station. From this position, there was no direct line of sight between the AB and the two OS's working and handling the ropes forward of winch M1 and winch M2 (see figure 4 and figure 5). The forward mooring team therefore relied on verbal and/or hand signals to communicate. This issue is further discussed in the analysis section of the report.

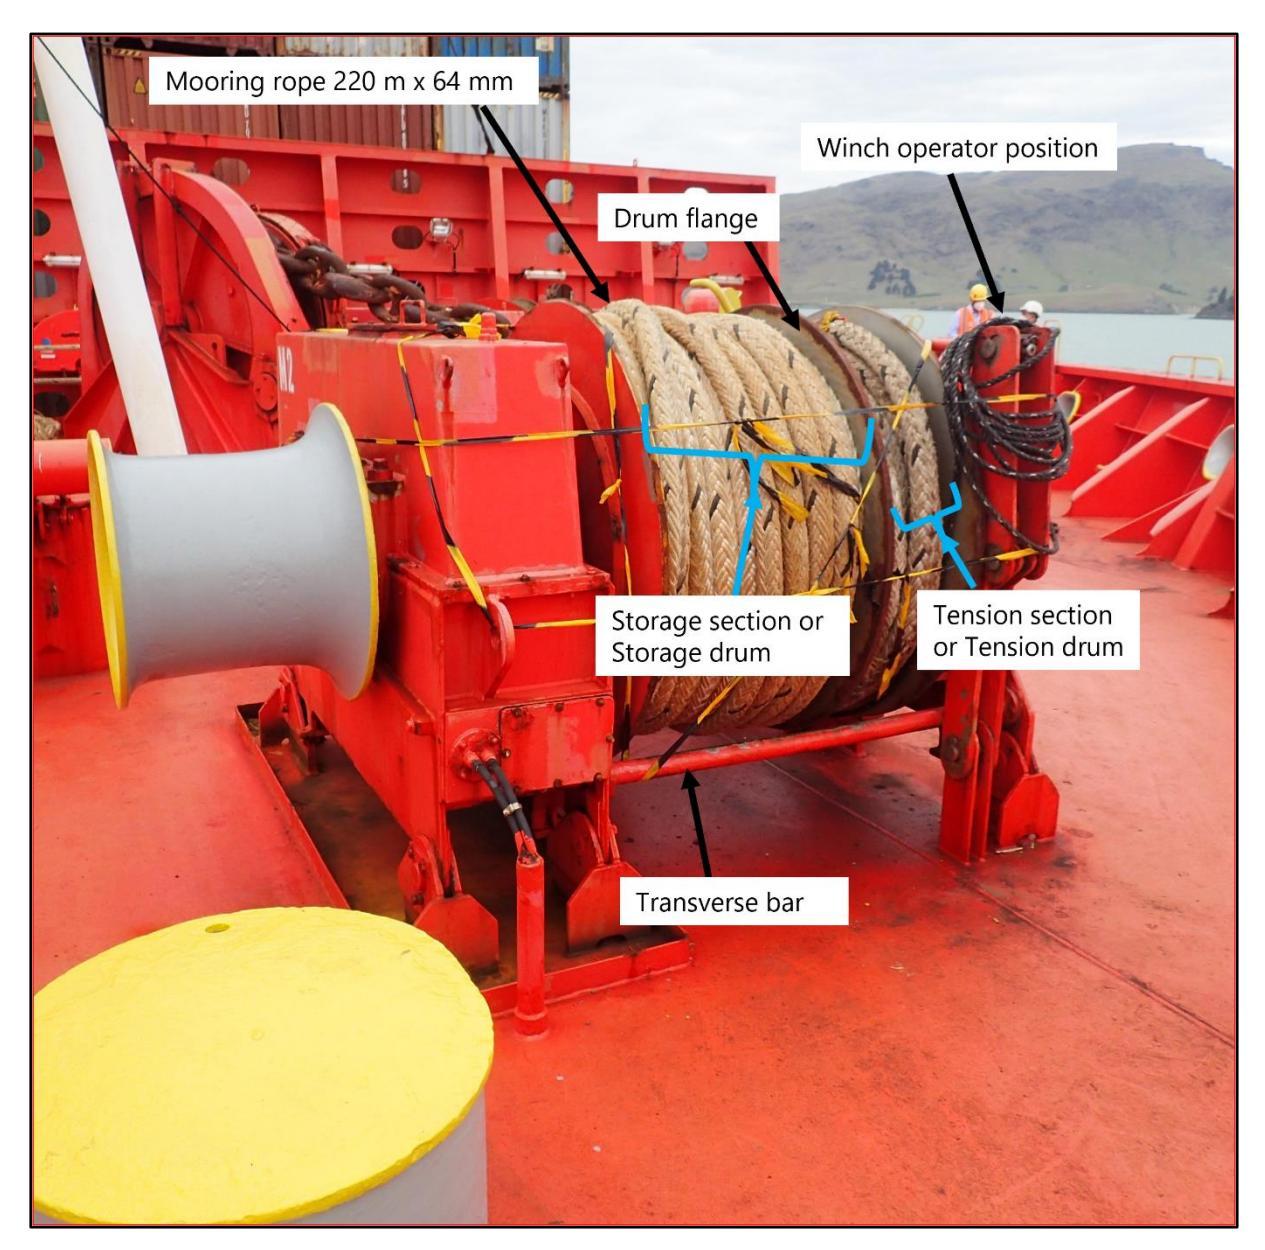
Figure 8: M2 winch

- 2.37 The split drum mooring winches fitted on the forward mooring deck of the *Rio De La Plata* were manufactured by Hatlapa Uetersener Maschnenfarik Ltd. The company has since been taken over by MacGregor Germany GmbH & Co. KG.
- 2.38 The mooring winch design included two transverse bars running across the winch, one in the front and the other at the back. At the time of the accident OS2 was adjusting the rope on the storage drum to prevent it getting jammed between the drum and the transverse bar. Figure 8 shows a photo of the M2 mooring winch identifying the various sections of the drum and the location of the transverse bars.

- 3.10 The mooring winch has two sections, a tension section (tension drum) and a storage section (storage drum). The storage section is designed to accommodate 158 metres of mooring rope in six layers and the remaining 42 metres is designed to be stowed on the tension section.

- 3.11 The two transverse bars that run across the winch were very likely there since the winches were installed on the *Rio De La Plata* in 2008. The manufacturer stated that these transverse bars were installed as a support for the transport and alignment of the winch during installation.

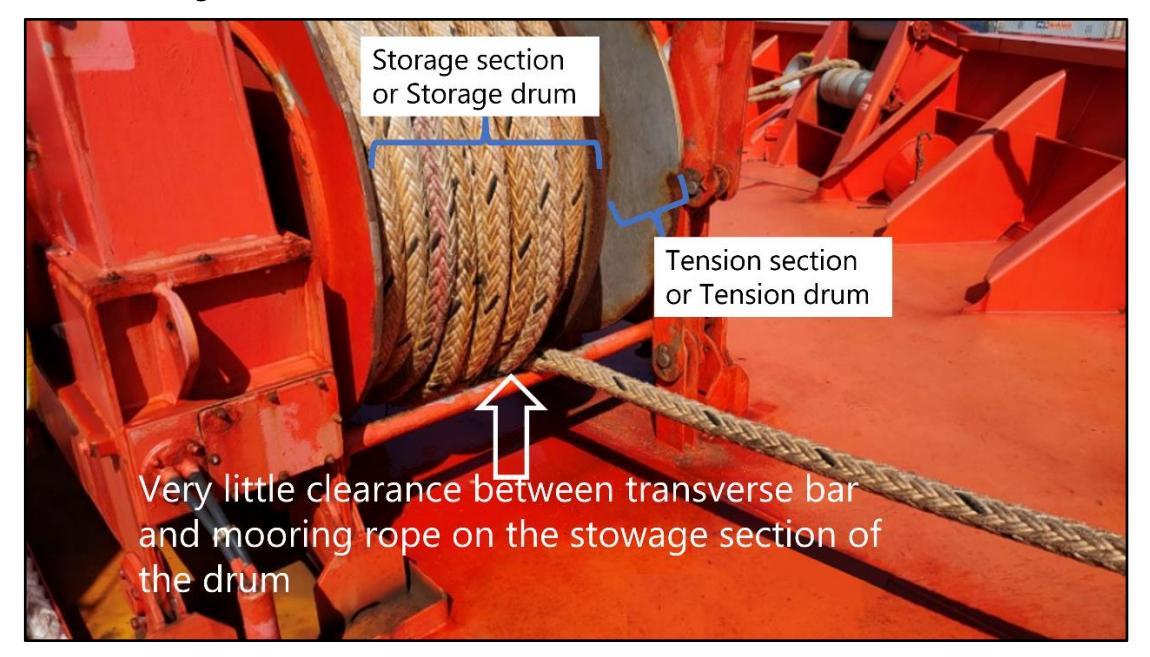
Figure 9: The rope on the storage section on the winch drum at the time of the accident

3.12 Immediately prior to the accident, 200 metres of the 220 metre rope was stowed on the storage drum, about 42 metres more than the design limit. This significantly reduced the clearance between the transverse bar and the rope and very likely increased the risk of the mooring rope getting caught at the bar (see figure 9). The transverse bars are required during installation of the winch but serve no safety or operational function thereafter. Removing the transverse bars significantly increases the available clearance and improves the overall safety of the mooring operation as seen in figure 10.

- 3.13 During the operation of mooring, as the rope is being retrieved, it can be difficult to always ensure that the rope is stored precisely and correctly as it should be on the drum, so there needs to be a margin for error. The additional 20 metres of rope and the presence of the transverse bar together reduced this margin of error by significantly reducing the clearance.

- 3.16 It is very likely that the transverse bar (not required) and the rope too long and incorrectly stowed on the drum created an unsafe working environment where OS1 and OS2 had to physically adjust the rope to ensure it would stow correctly, and this increased the risk of them getting trapped in the process and sustaining serious injury.

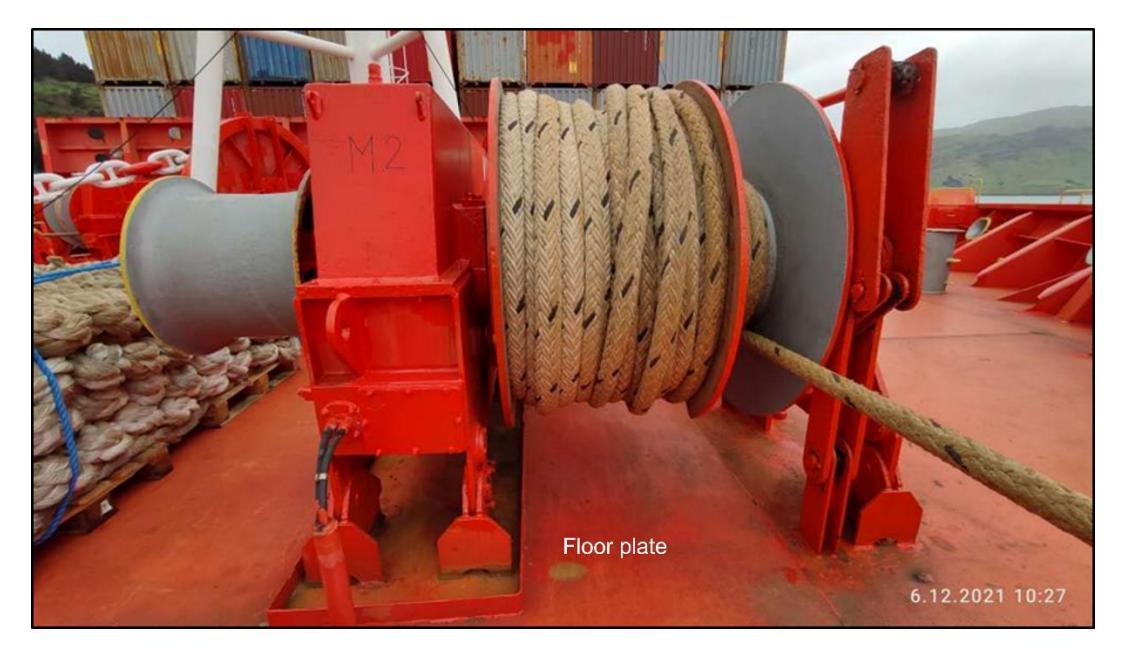
Figure 10: Winch with transverse bar removed (Credit: Photograph shared by Maersk)

- 3.14 The Commission has made a recommendation to the manufacturer of the mooring winch to ensure that other operators using the same type of winch are aware of the risks associated with leaving the transverse bar in place after the winch has been installed.

6.4 On 27 April 2022, the Commission recommended that MacGregor Germany GmbH & Co., the manufacturer of the mooring winch, ensure that other operators using the same type of winch are aware that the transverse bar should be removed after the winch has been installed on the vessel to increase the safe operation of the mooring winch. (007/22)
