Final report Tuhinga whakamutunga

Marine inquiry MO-2021-201 Jet boat KJet 8 Loss of control Shotover River, Queenstown 21 March 2021

May 2022

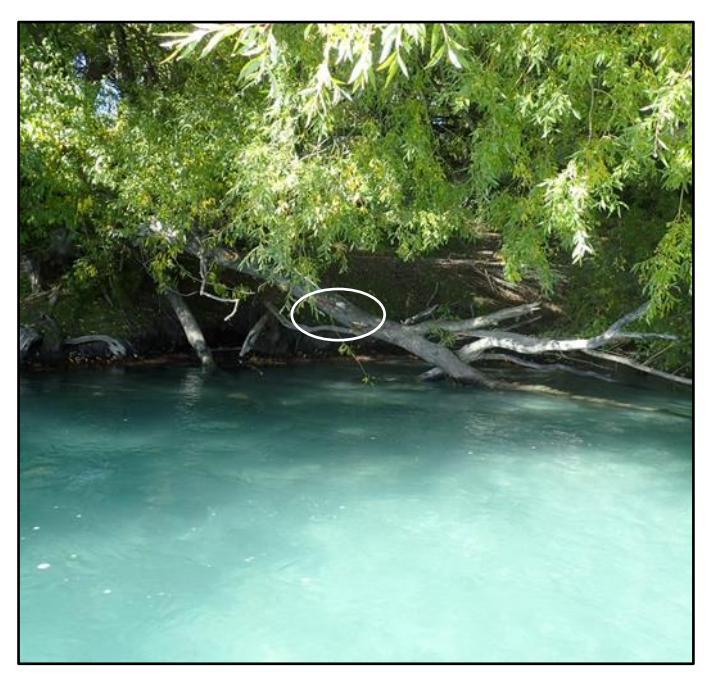
Figure 5: Point of impact with trees lining the riverbank

2.25 The accident occurred on the return leg of the journey, travelling downstream approaching a right-hand bend. Figure 5 shows the point of impact with the tree branch situated on the left-hand bank. The jet boat suffered minor structural damage.

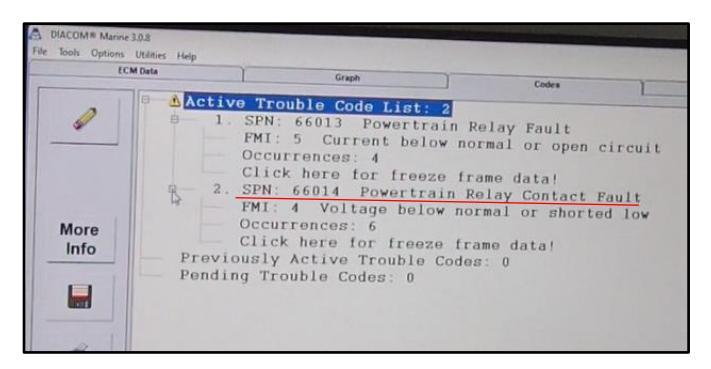
Figure 7: Diagnostic read out from the main engine

2.35 The information from the diagnostic read out provided engineers and investigators with a focal point from which to systematically try to identify the cause of engine failure. During examination of the engine, its components and the powertrain, it was found that deliberate movement of the wiring loom connected to the main engine fuse box (figure 8) caused the powertrain relay to activate.

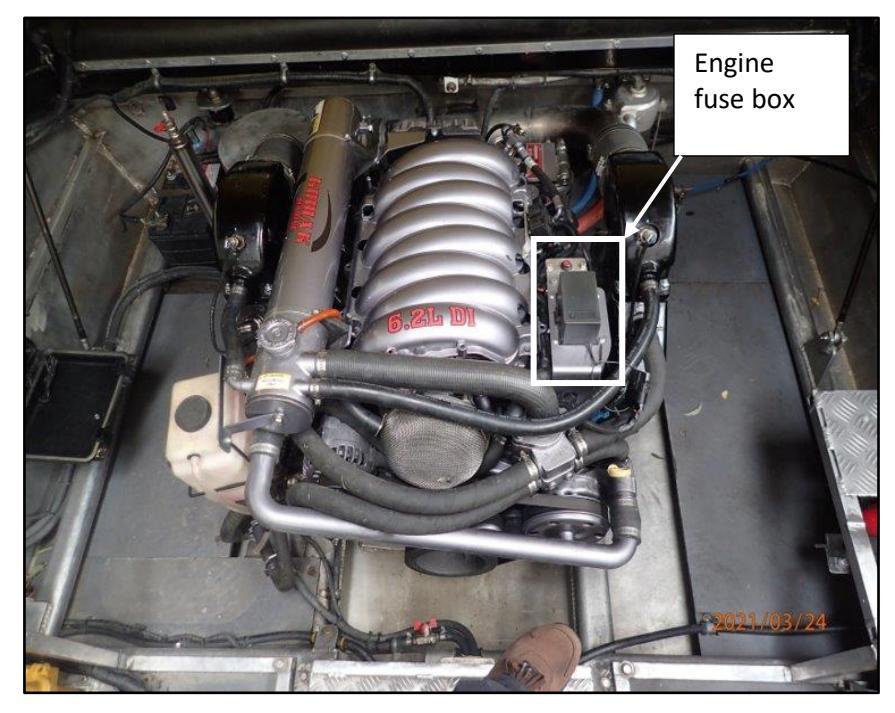
Figure 8: Location of fuse box

2.36 Closer inspection of the fuse box found that a 20 ampere fuse protecting the engine powertrain relays had failed. The fuse and the connections into the main fuse box were replaced, the engine was retested and it operated successfully.

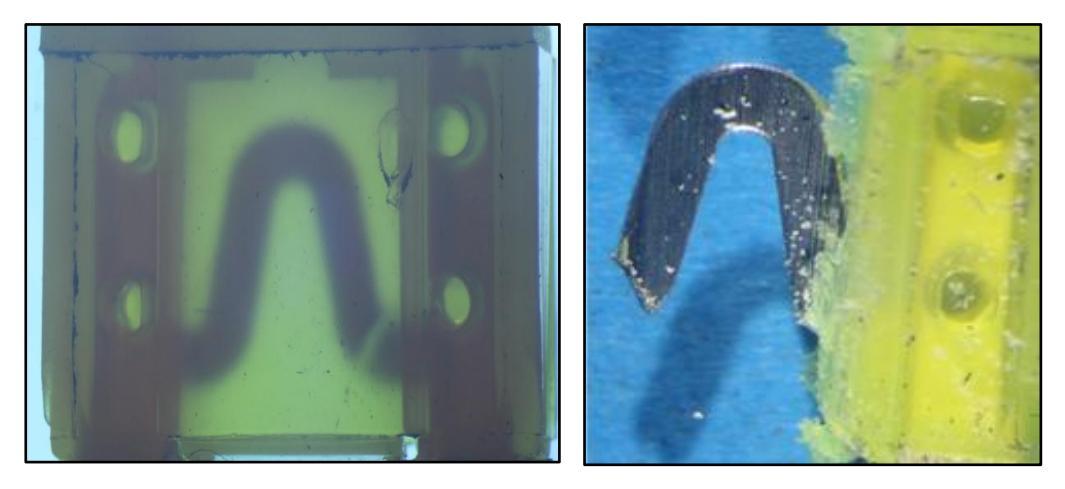
Figure 9: Condition of the failed fuse removed from KJet 8

- 2.39 There was significant evidence to show that the fuse did not fail as a result of electrical overload as shown in figure 10. Extensive melting did not occur, the fuse section was not distorted, and failure did not occur in the normal mid-point position of the fuse (figure 9).

- 2.40 It was considered **very likely** that the fuse failed primarily because of bending fatigue due to flexing caused by an unsupported connecting wire. Evidence to support this hypothesis included: lack of gross distortion, a flat fracture face, failure occurring at the end of the radius where there was a stress concentration, the design of the fuse box, and stiff connecting wires allowing a rotation of about 10 degrees.

- 2.41 The fuse was made from zinc, which provided reasonable corrosion resistance, low melting point, good electrical conductivity and relatively low cost. Zinc is not a good structural material. It is hard and brittle and will be highly prone to fatigue failures at room temperature. It is therefore important that the wires connecting to a fuse box should not be able to transfer cyclic loading to the fuse, which would lead to fatigue.

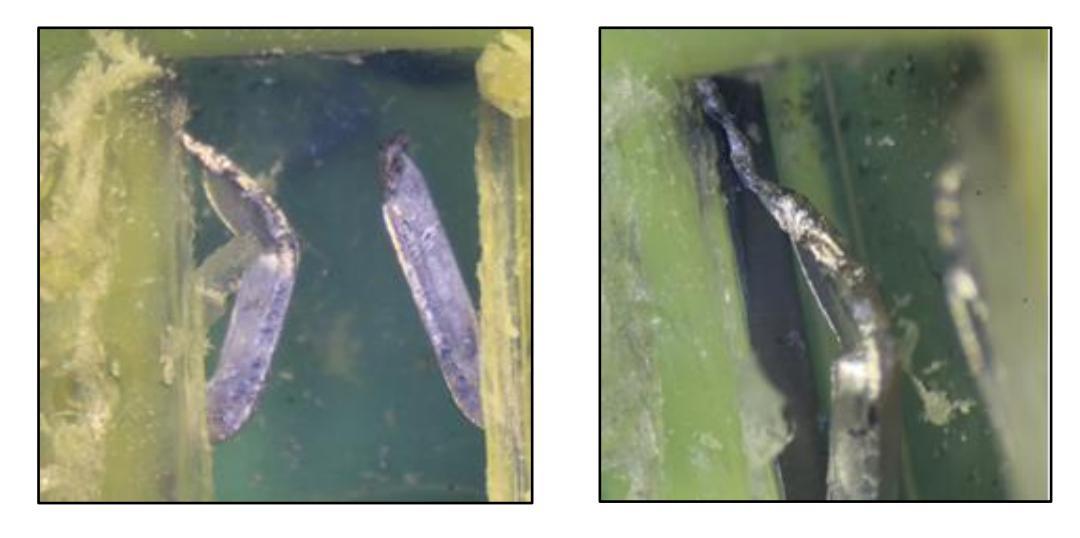
Figure 10: Example of the condition of a similar fuse deliberately failed through electrical overload

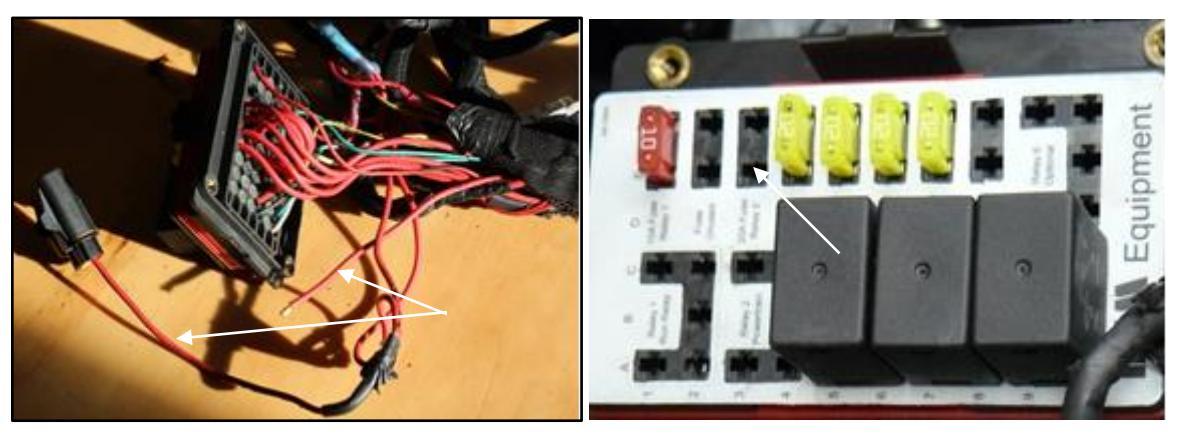
- 2.42 The fuse box fitted to *KJet 8* was of a design commonly used in the automotive industry where wiring looms are generally secured to prevent significant vibration occurring on the wiring. When *KJet 8*'s engine was marinised the fuse box was installed on a bracket bolted to the engine without any vibration dampening. Without vibration

dampening the fuse box was subject to vibrations from the engine, which could lead to fatigue loading on the fuse box assembly. Wires were bent into place after they were fitted into the fuse box.

Figure 11: Left – wiring loom at the rear of the fuse box from *KJet 8* showing the two wires that had been attached to the failed fuse. Right – fuse box where the failed fuse had been located

2.43 If the resonant frequency⁵ of a wire assembly is close to one of the engine's vibrational frequencies, resonance will occur that could result in significant vibrational movement and increased risk of failure of the weak points, such as a fuse. In this case it is considered **probable** that the wire to the failed fuse had a longer unsupported length than the other wires (figure 11), which likely resulted in excessive vibration contributing to the mechanical failure of the fuse.

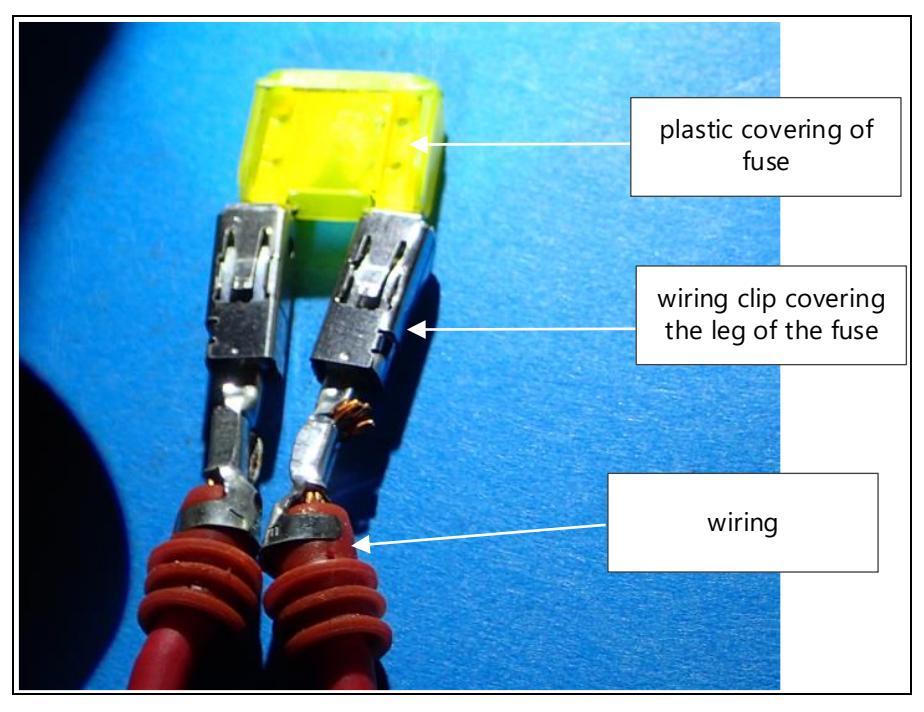
Figure 13: Image of fuse with wiring attached

- 3.12 The mechanical failure of the fuse was **very likely** a result of a load being imparted onto the leg of the fuse from the wire of the engine wiring loom as shown in figure 13. That load was cyclic because it was also subject to engine vibrations.

- 4.5 Mechanical failure was **very likely** caused by a load being imparted onto the leg of the fuse by unsupported wiring, which was susceptible to resonating with engine vibrations back and forwards.

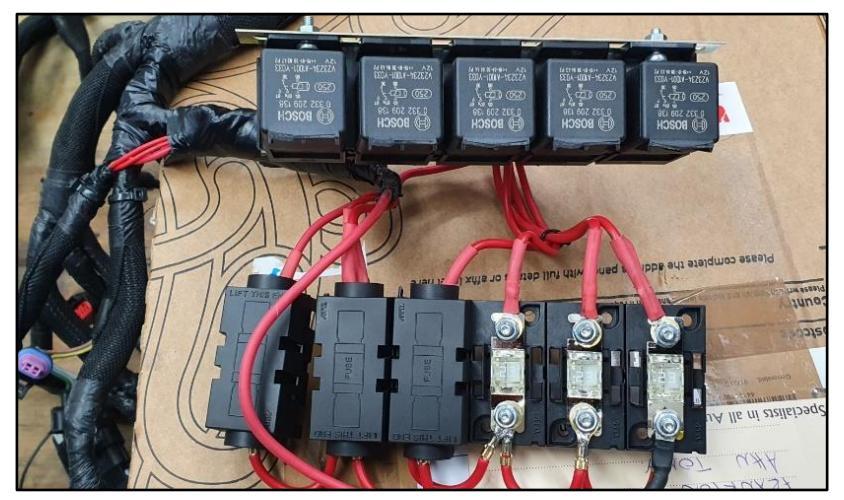
Figure 14: KJet's new arrangement for fuse installation

- 3.17 A recommendation would have been made to KJet to ensure the safety of the fuse arrangement in their vessels. However, the Commission is satisfied that the safety action taken to date by the company has addressed the safety factors identified during the investigation (see section 5).
