Final report Tuhinga whakamutunga

Maritime inquiry MO-2024-203 Fishing vessel, Chokyu Maru No.68 Grounding The Noises, Hauraki Gulf 16 April 2024

June 2025

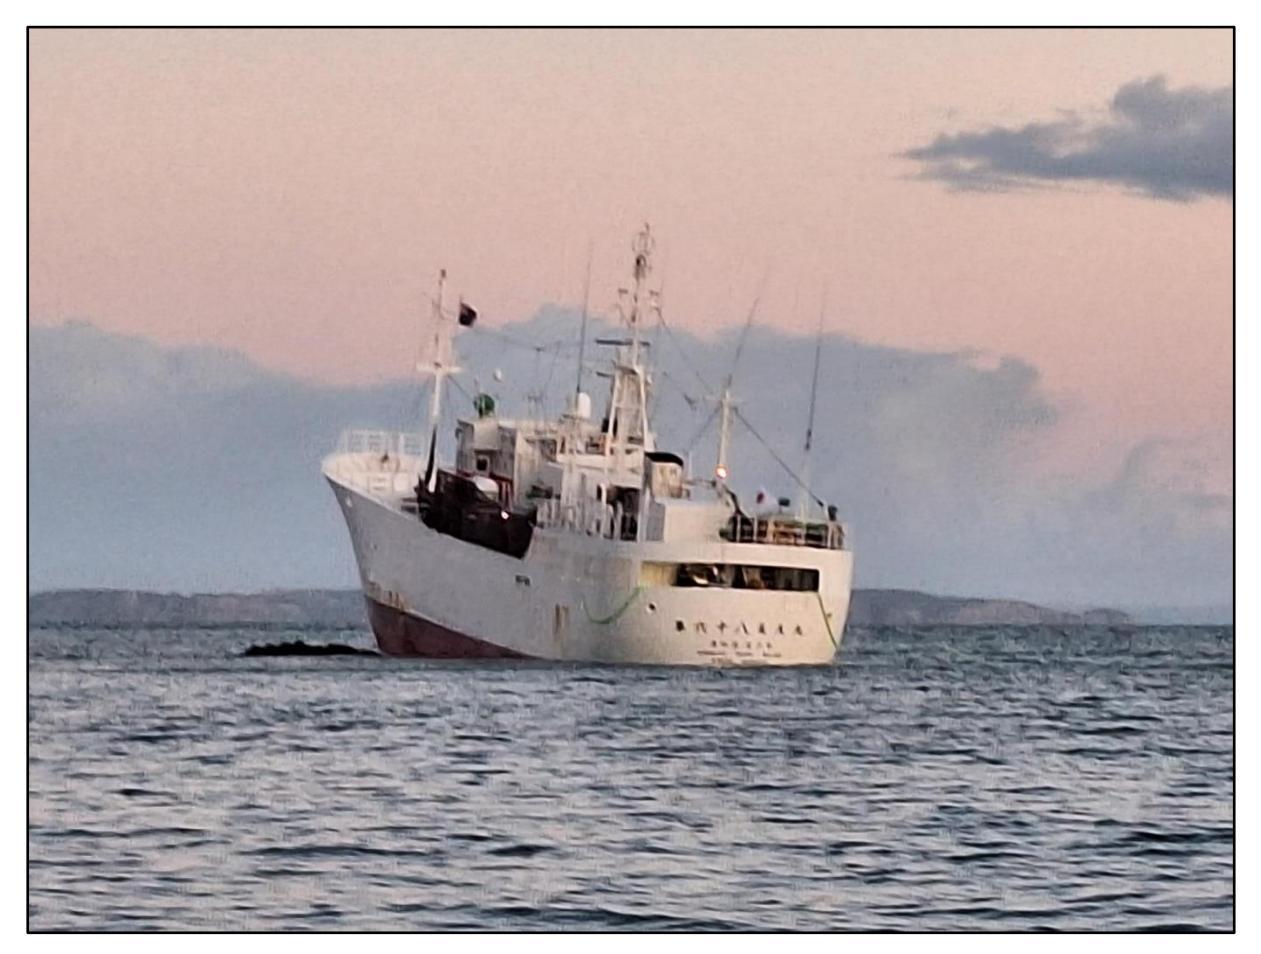
Figure 1: Fishing vessel, *Chokyu Maru No.68* after grounding (Credit: Auckland harbourmaster)

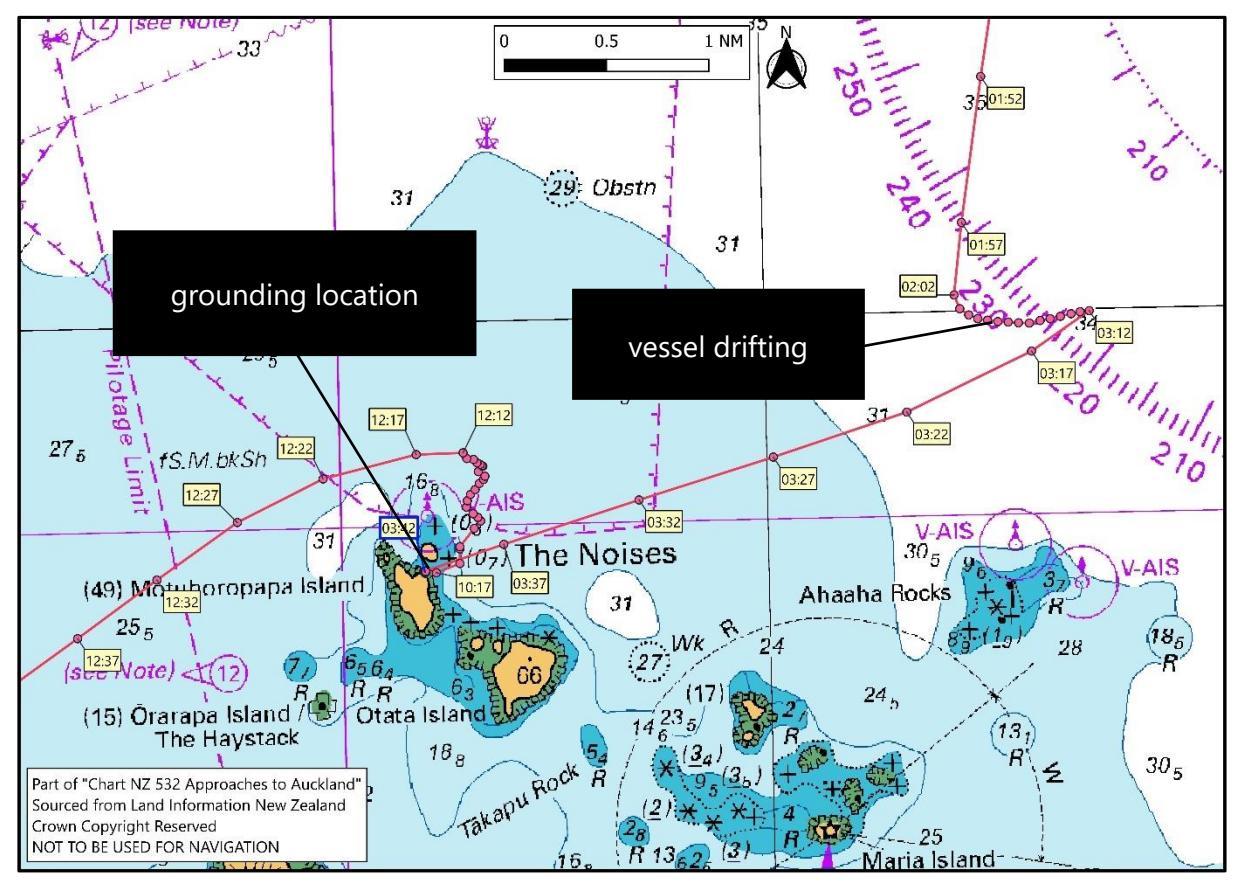
2.5. At approximately 0342, while travelling at a speed of around 8 knots, the *Chokyu Maru No.68* ran aground on rocks near Motuhoropapa Island. The vessel was hard

Figure 4: Track of *Chokyu Maru No.68* (indicated by red line) before grounding and after refloating (times indicated in yellow)

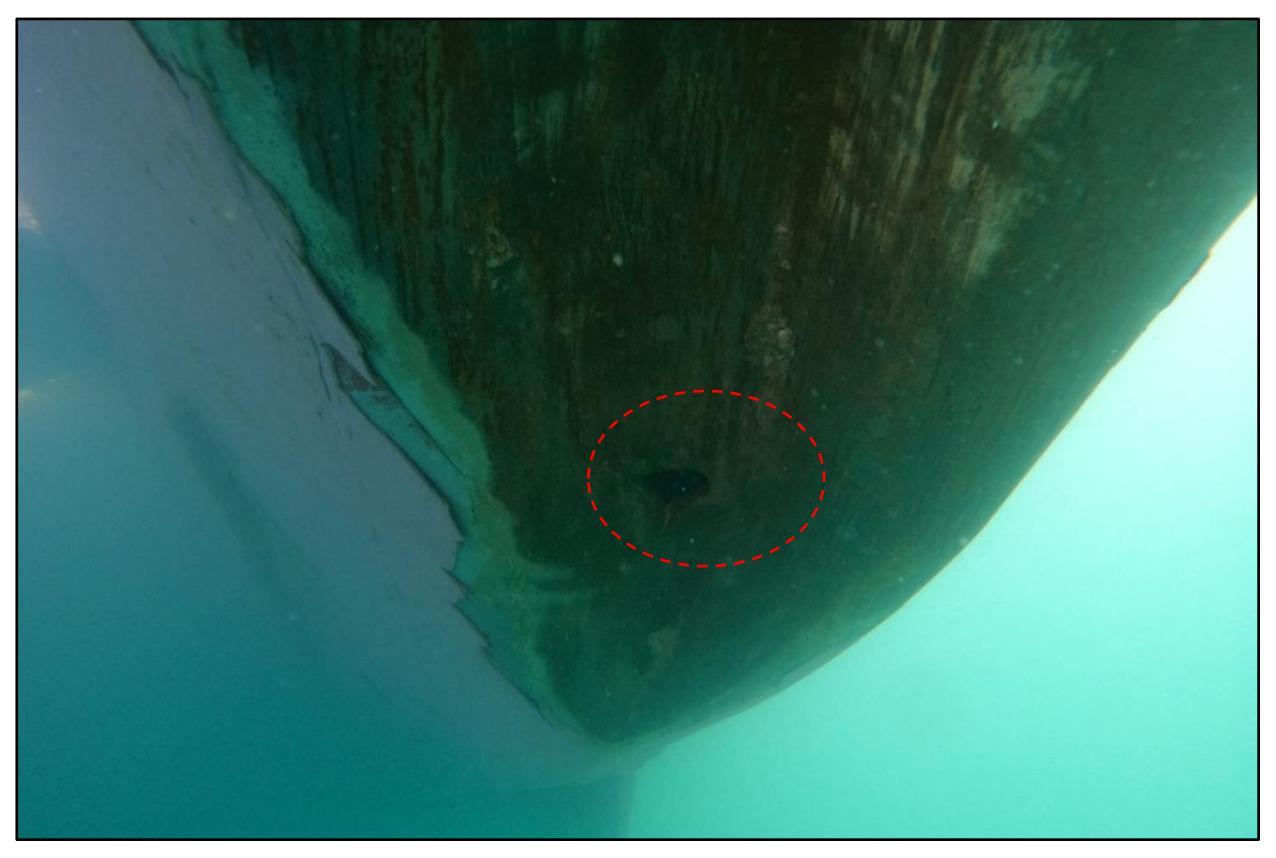
aground with the tide ebbing, so at low water⁶ the bow was high and dry⁷. Initial inspections made by the crew and the harbourmaster's staff determined that the damage was limited to scraped hull paint and a hole in the forepeak tank. This was later confirmed by a diver's inspection of the outside of the hull. The diver also observed a small dent in a propeller blade.

Figure 5: Bow of *Chokyu Maru No.68* showing hole (circled) and paint damage (Credit: Salt Services 2018 Limited)

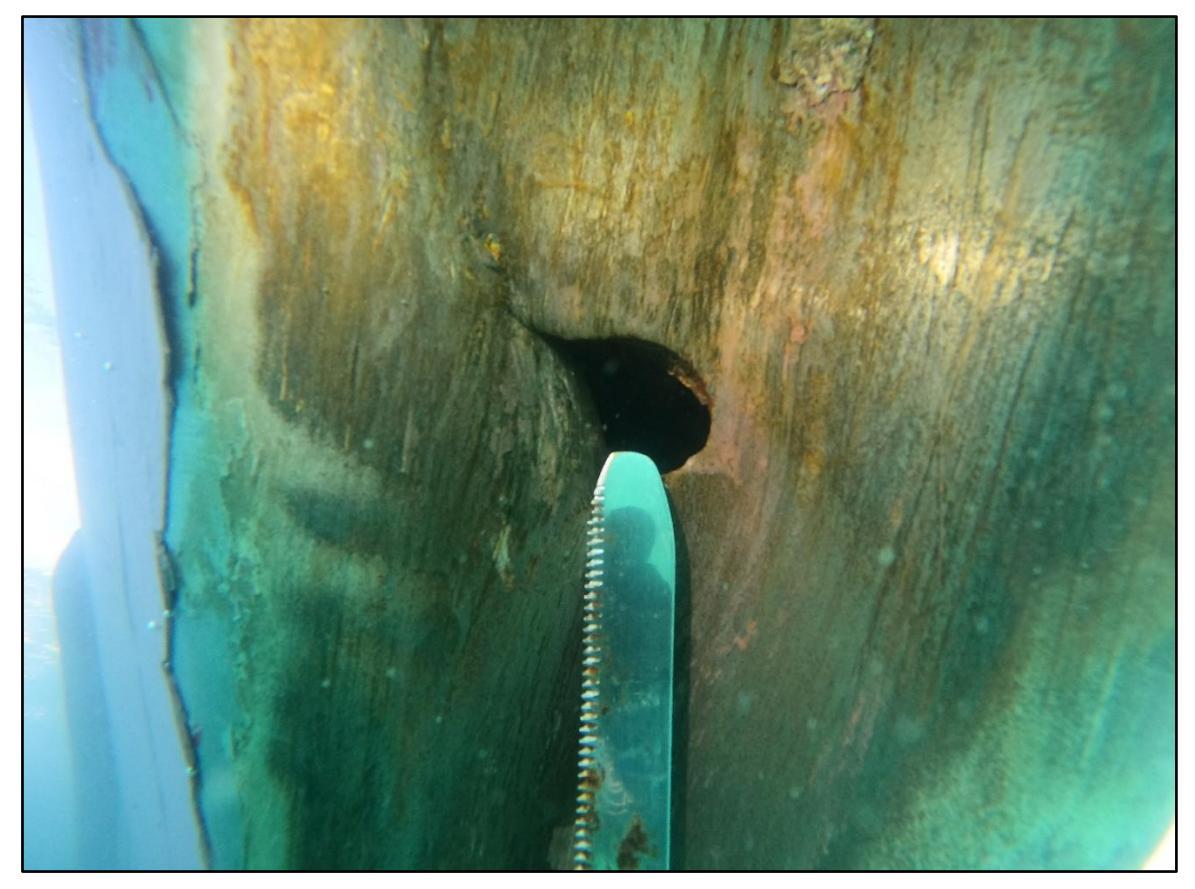
Figure 6: Close-up of the hole in the bow (Credit: Salt Services 2018 Limited)

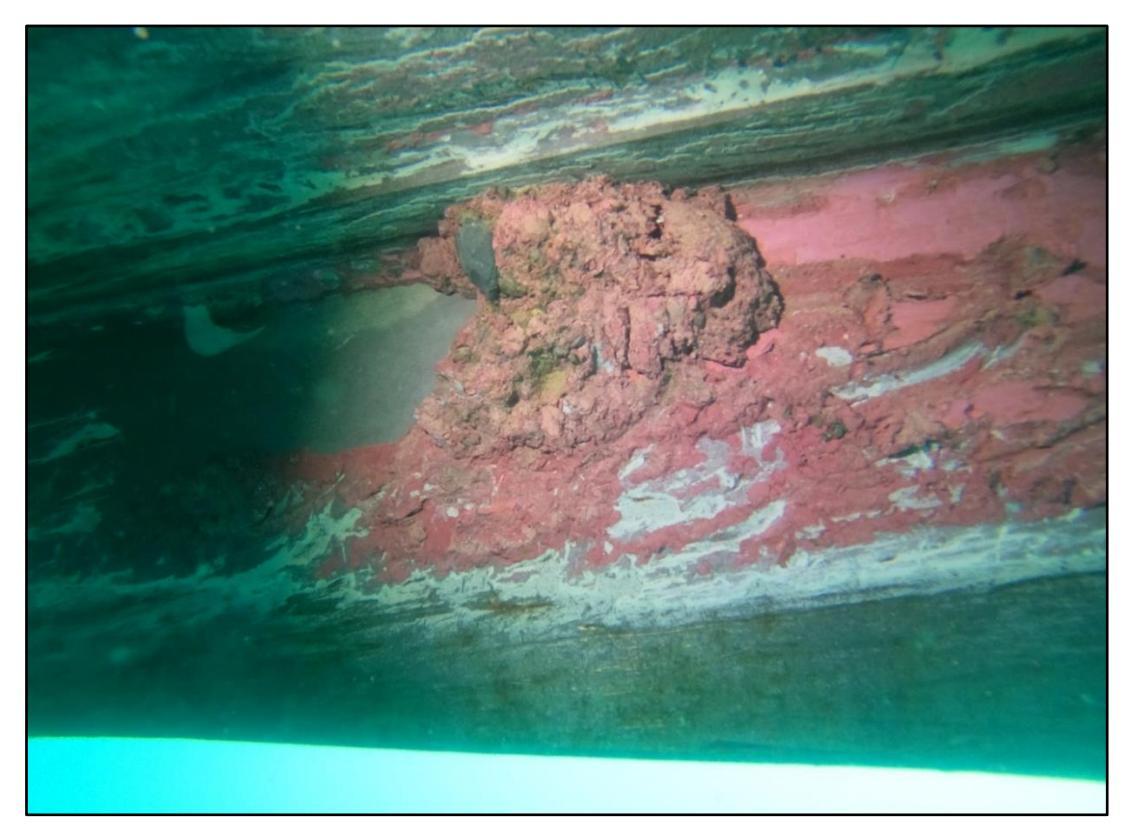
Figure 7: Paint abrasion and rock remnants on the hull (Credit: Salt Services 2018 Limited)

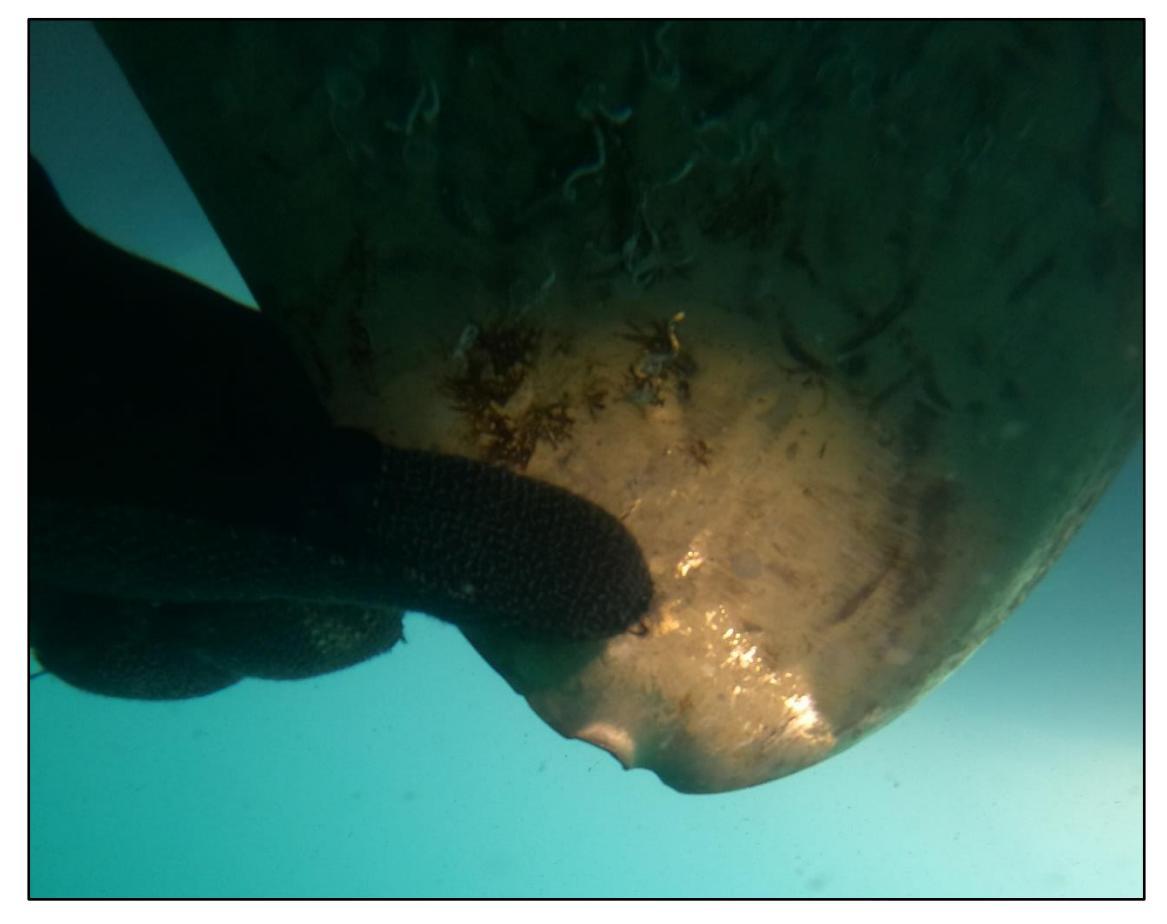
Figure 8: Minor damage to the propeller (Credit: Salt Services 2018 Limited)

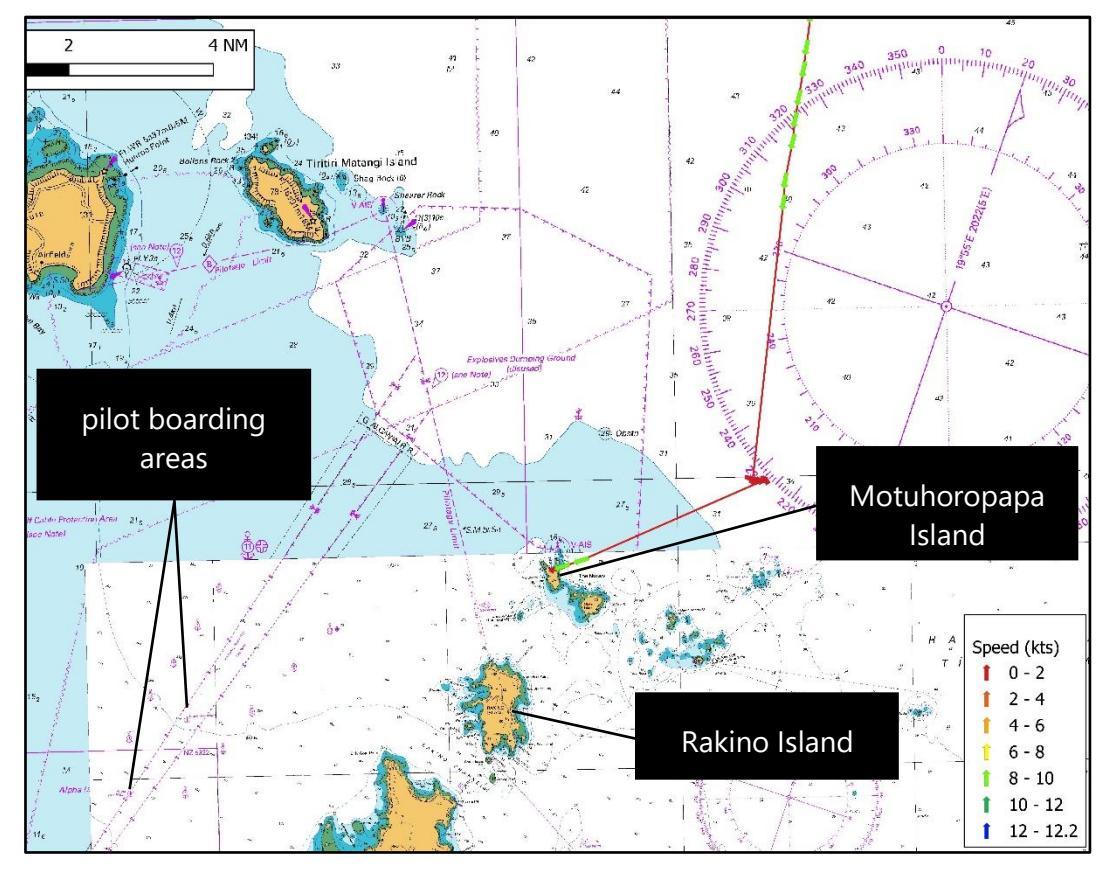
officer realised that the vessel was heading towards Motuhoropapa Island and its outlying rocks (*see* Figure 9).

Figure 9: Track of Chokyu Maru No.68 and location of pilot boarding areas (Credit: Land Information New Zealand Toitū Te Whenua, data and labels added by the Transport Accident Investigation Commission)

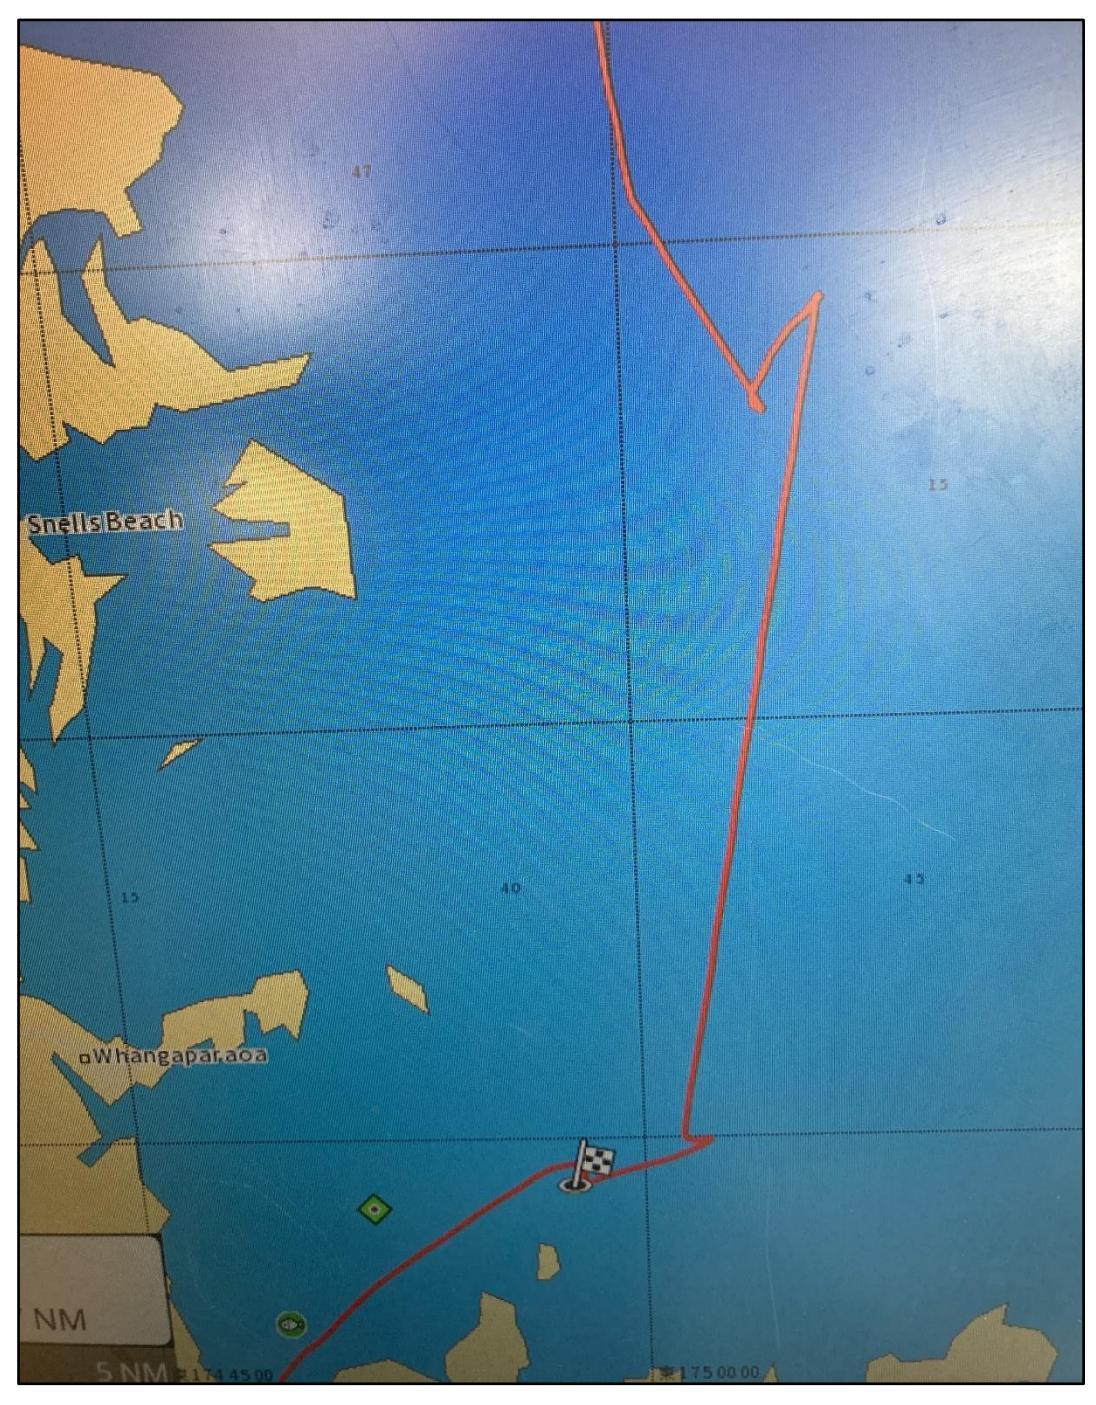
3.12. The chart plotter on *Chokyu Maru No.68* did not have the electronic charts for New Zealand installed and therefore did not display the small islands of the Hauraki Gulf (*see* Figure 10 and Figure 11). The differences in detail between the vessel's installed electronic charts for Japan and those for New Zealand are shown in Figure 12.

Figure 10: Chart plotter display on Chokyu Maru No.68

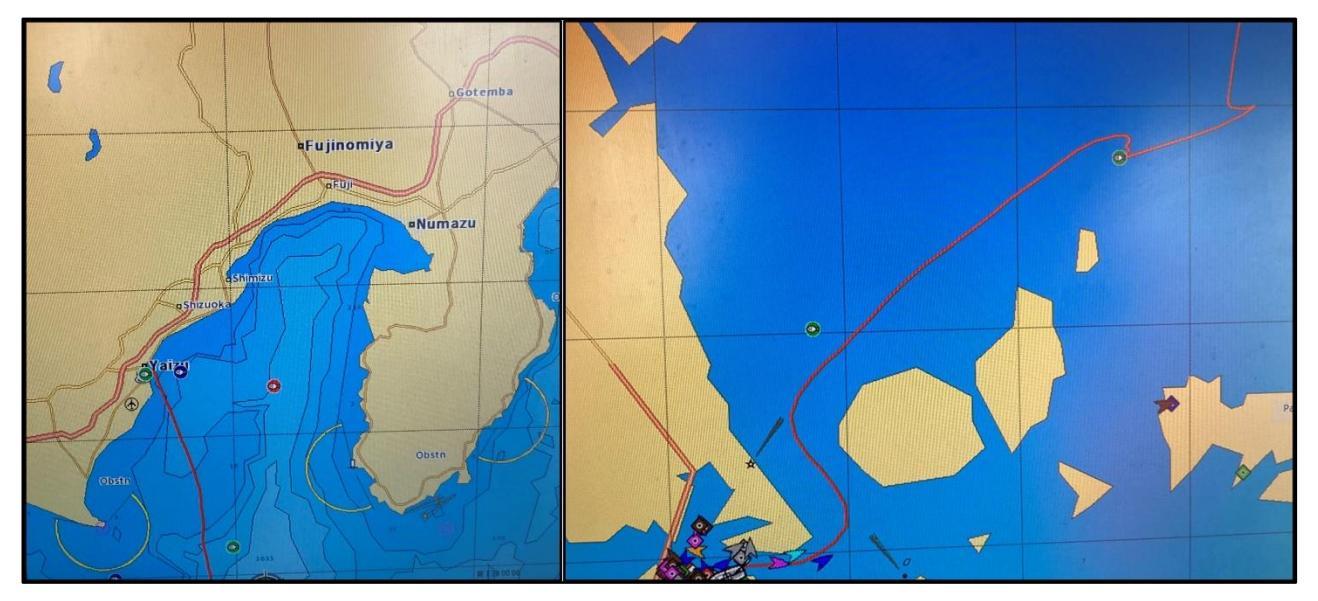
Figure 12: Comparison of chart plotter details. Left, Japanese coastal water; right, New Zealand coastal waters
