Final report RO-2017-106: Mainline locomotives, Wrong-routing and collision with work vehicle, Invercargill, 16 November 2017

Rail inquiry RO-2017-106

Mainline locomotives Wrong-routing and collision with work vehicle Invercargill 16 November 2017

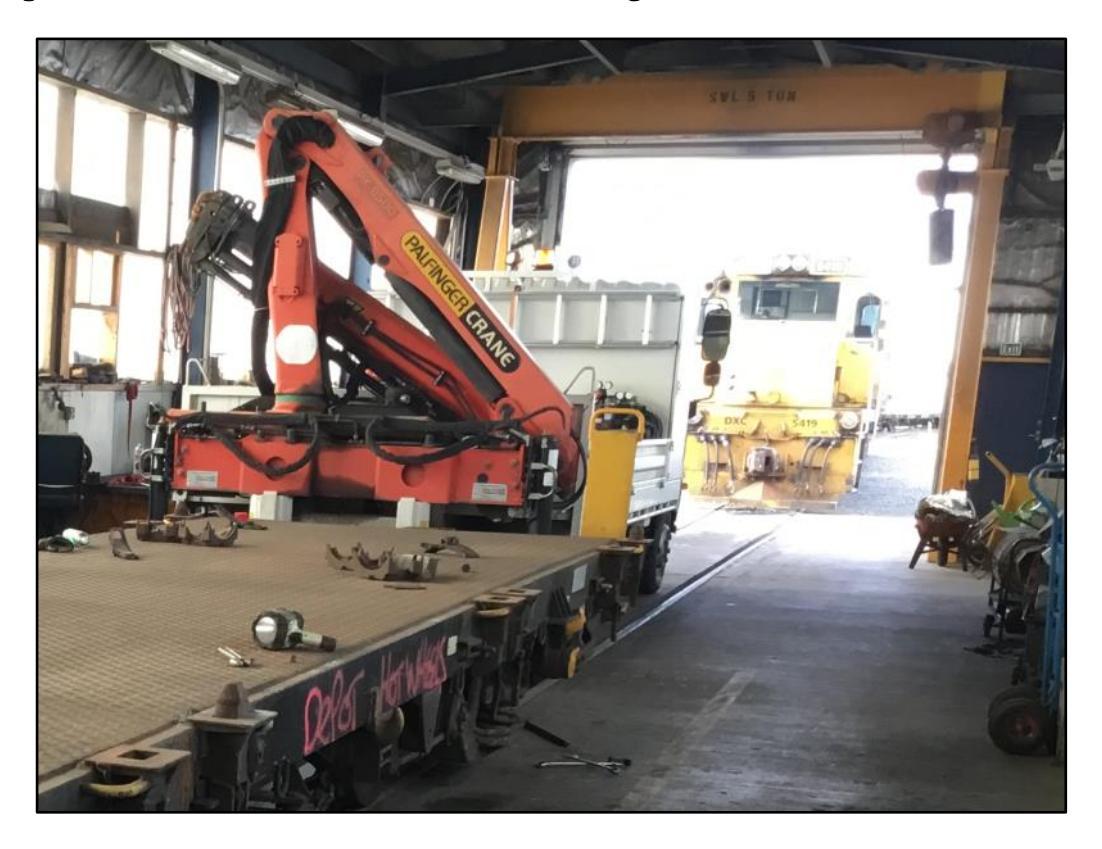
Figure 1 Final position of the lead locomotive, the maintenance truck and the freight wagon

- 1.2. The locomotives collided with a truck that was parked outside the maintenance depot, propelling it into a freight wagon that was parked inside the depot for repair work. Both ends of the truck were damaged, but nobody was injured.

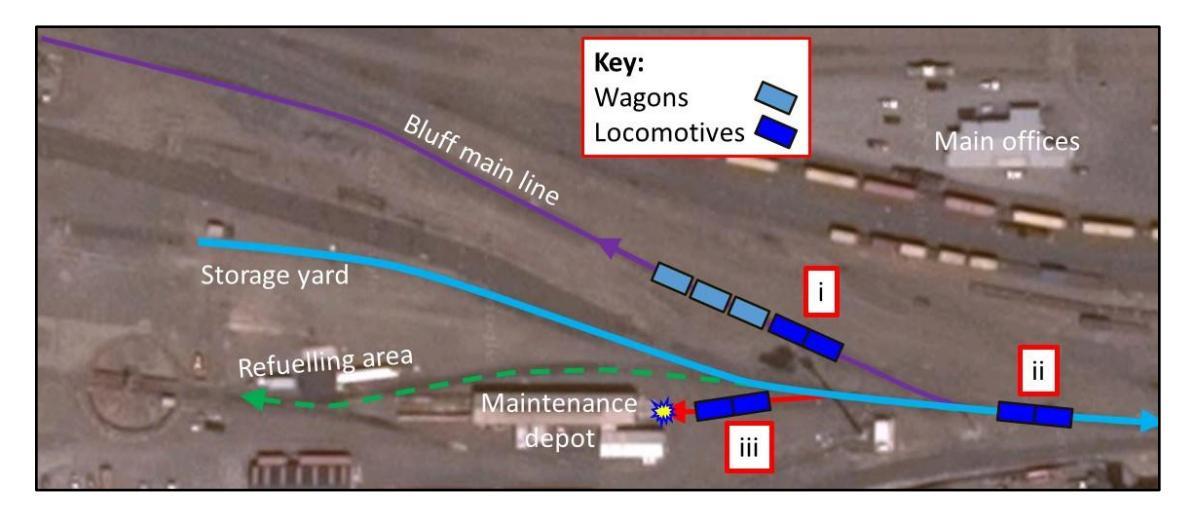
Figure 2 Schematic of train movements

- 3.1.2. The train then setback onto the Bluff main line, where the pilot disconnected the wagons from the locomotives (position i in Figure 2). The pilot then told the driver to contact Train Control and request a signal to move the locomotives forward past a set of points that would give the locomotives access to the siding⁶ that branched into the storage yard, the refuelling area and the maintenance depot. The intention was to move the locomotives into the refuelling area. When the correct signal was obtained the driver moved the locomotives forward and stopped beyond the points (position ii in Figure 2).

- 3.1.3. With the locomotives clear of the points to the Bluff Main Line (position ii in Figure 2), the pilot was able to set the points and authorise the locomotives to setback to enter the siding for the refuelling area. Once in the siding the locomotives had to pass through two more sets of points in order to reach the refuelling area. The first set of points could direct trains to the maintenance depot and the second set could direct trains to either the storage yard or the refuelling area.

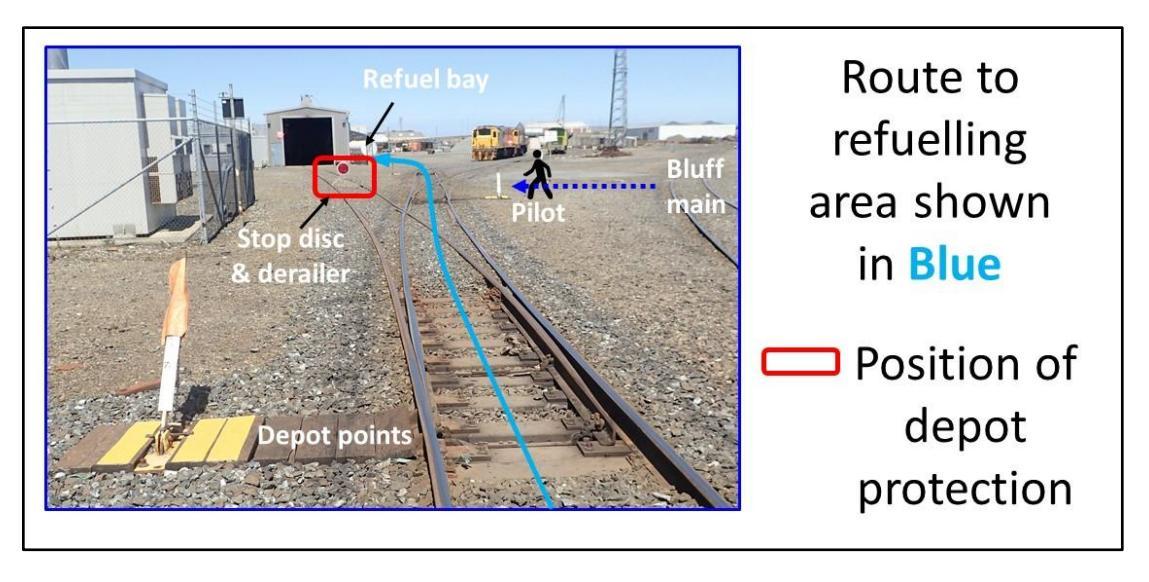
Figure 3 Points for maintenance depot correctly set away from depot

- 3.1.4. The pilot walked from the Bluff main line, where the wagons had been disconnected, directly to the second set of points to set them for the locomotives to enter the refuelling area (see Figure 3). The pilot observed that on the adjacent maintenance depot line a derailer⁷ and stop-disc⁸ were in place, protecting the maintenance depot. In the pilot's previous experience the presence of the depot protection meant that the first set of points was not directing rail vehicles to the maintenance depot, so did not visually check the setting of the points.

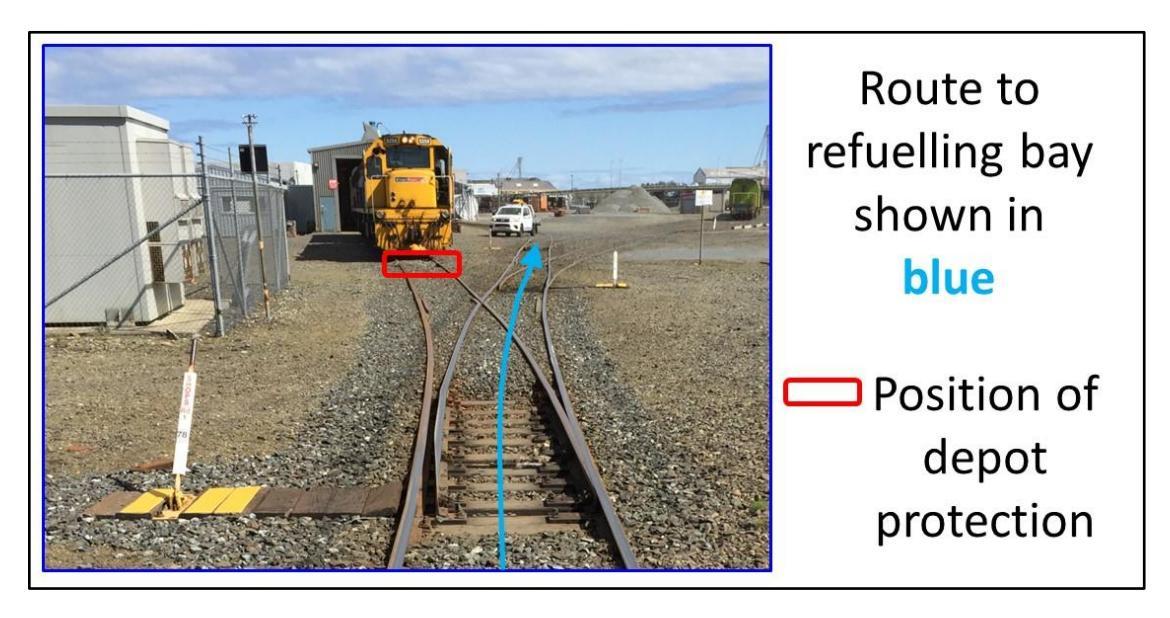
Figure 4 Manually operated points¹⁰ for maintenance depot, refuelling bay and storage yard

3.1.5. The pilot advised the driver that the points were set and authorised the driver to setback towards the refuelling area. However, the first set of points were set for rail vehicles to enter the maintenance depot (see Figure 4). The driver was positioned in the trail locomotive⁹ so could not see ahead in the direction of travel, but proceeded to reverse the locomotives at about 15km/h under the instruction of the pilot. As the locomotives setback, the pilot used a road vehicle to drive approximately 150 metres to the refuelling area to meet the locomotives and call a halt to the movement.

3.1.6. As the locomotives reversed the driver noticed they had diverted and were heading towards the maintenance depot instead of the refuelling area (position iii in Figure 2). The lead locomotive¹¹ overcame the maintenance depot protection by knocking the stop-disc flat and

4.3.6. Subsequent to this incident the use of the derailer has been discontinued and the points leading to the maintenance depot siding are now set away from the depot and padlocked in this position. The maintainer now controls the use of the padlock key and the system now complies with Rule 909.

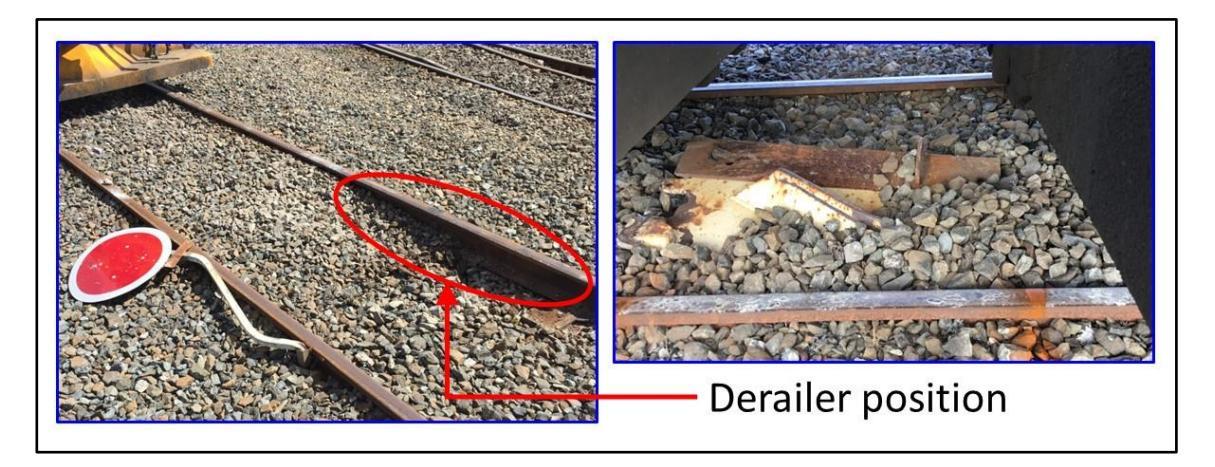
- 1.3. A protective derailing device had been placed onto the rail outside the maintenance depot. The device was designed to derail any rail vehicle inadvertently entering the track that led to the depot. However, the cowcatcher on the front of the lead locomotive dislodged the derailer and prevented it derailing the locomotive.

dislodging the derailer, which instead of derailing the locomotive as it was designed to, became dislodged from the rail and dragged along the ballast (see Figure 5).

Figure 5 Left – damaged stop-disc Right – dislodged derailer in ballast under locomotive

- 7.7. The protection of the Invercargill maintenance depot building was changed, with the use of the derailer discontinued and replaced by padlocking the points to the depot building siding. The depot mechanical staff have sole control of the padlock key. The Joint Operation Plan has been updated to document the new depot protection regime.

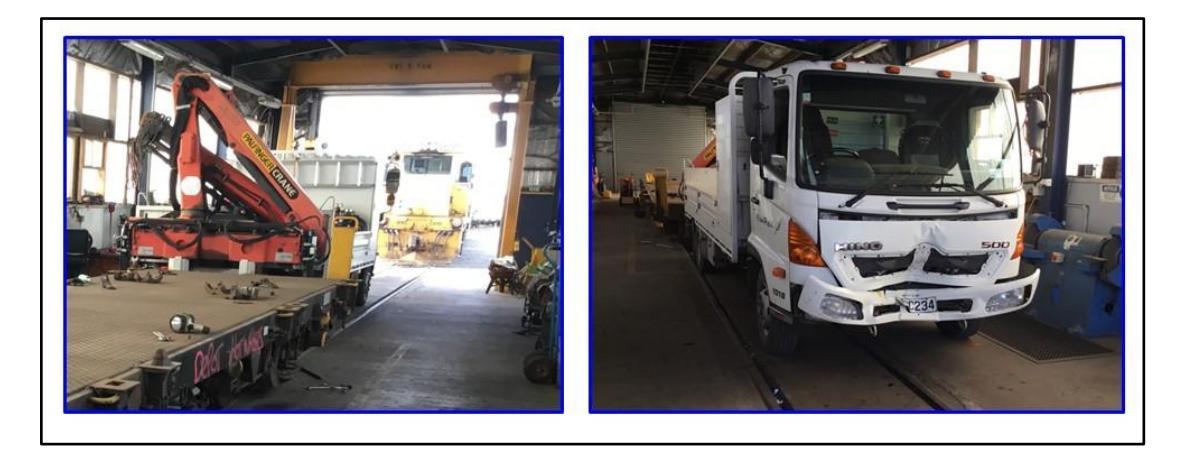
- 3.1.7. The driver applied the locomotive brakes and brought them to a stop, but not before the lead locomotive had collided with a maintenance truck parked on the track outside the depot.
- 3.1.8. The maintenance truck had been parked in neutral over the track leading to the maintenance depot, with the handbrake lightly applied. The coupler¹² at the rear of the locomotives struck the maintenance truck.
- 3.1.9. The truck was propelled¹³ back approximately 15 metres and collided with the coupler of a freight wagon that was chocked¹⁴ inside the maintenance facility (see Figure 6). The maintainer was in another room in the depot when the collision occurred. The front and rear of the truck suffered moderate impact damage.

Figure 6 Final position of locomotives and maintenance truck, and frontal damage to truck

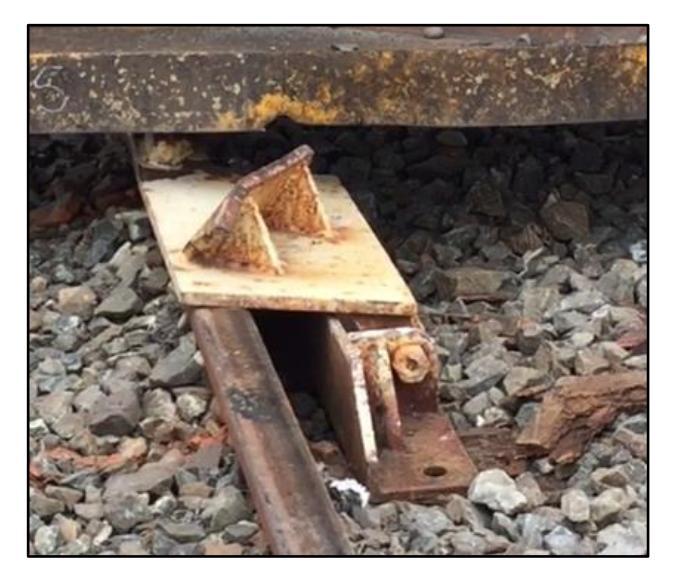
Figure 8 Derailer (pictured during post-incident re-enactment)

- 4.2.11. A post-incident re-enactment revealed that the derailer protruded sufficiently above the rail to make contact with the cowcatcher¹⁵ of the leading locomotive. The design specification of the derailer permitted it to have a height of up to 120 millimetres above the top of the rail, while the cowcatcher was permitted to have a height above the rail as low as 100 millimetres. As a result the cowcatcher tore the derailer off its mounts before it could perform its purpose of derailing the locomotives (see Figure 8). KiwiRail is undertaking a review of the suitability of its derailers for its current rolling stock.

- had the incompatibility between the designs of the derailer and the cowcatcher on the lead locomotive been identified, it would have been known that without a redesign the derailer would not have performed its function and derailed the lead locomotive before it reached the maintenance depot.
