# **Final Report**

Rail inquiry RO-2019-101 Safe-working occurrence, Westfield yard, Ōtāhuhu, Auckland 24 March 2019

April 2020

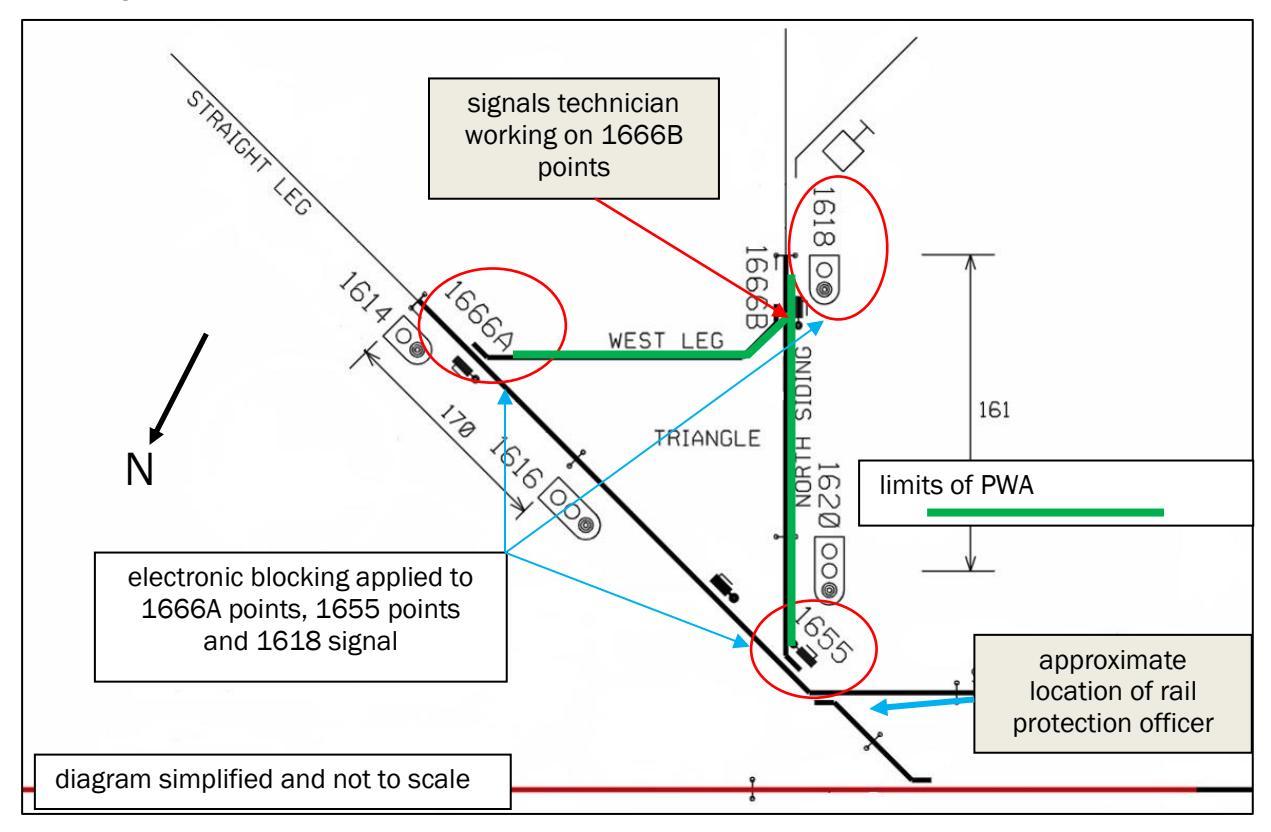
#### Figure 2: Schematic diagram of Ōtāhuhu triangle

- 2.3. The repair work was planned to be completed by 1800 on 24 March, but due to delays it was extended by a further hour until 1900.
- 2.4. The PWA was being managed by a rail protection officer (RPO), who was responsible for ensuring that all personnel within the worksite were protected from rail movements. This was in accordance with KiwiRail's Rail Operating Rules and Procedures.
- 2.5. The RPO was located near 1655 points<sup>2</sup>, in a safe area outside the PWA, so that they could be approached by visitors requiring access to the worksite (Figure 2).
- 2.6. A signals technician had also been requested to attend the worksite after a work vehicle had reportedly crossed the track within the PWA, and in doing so had possibly caused damage to 1666B points.

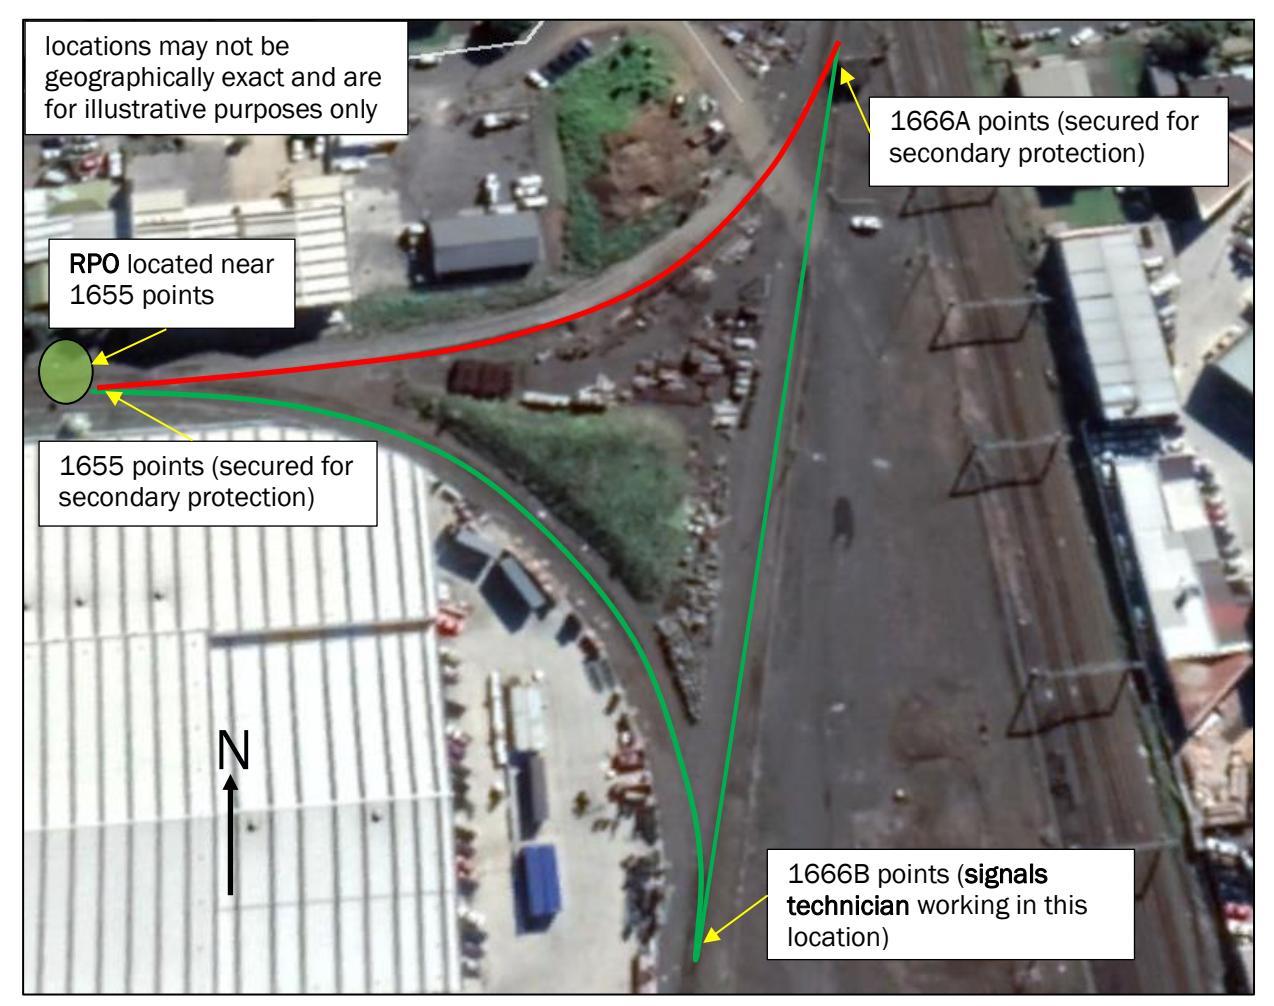
#### Figure 3: Satellite view of Ōtāhuhu triangle (Credit: Google Earth modified by the Transport Accident Investigation Commission) Site protection

- 2.17. The site was located at the southern end of the Westfield yard. Three tracks consisting of "the straight leg, north siding and the west leg" formed a triangle around a large area of land used for industrial storage (Figure 3).
- 2.18. There was no direct line of sight between the RPO and the signals technician due to the curvature of the track.
