Final Report

Rail inquiry RO-2019-102 Clinton derailment 29 March 2019

February 2020

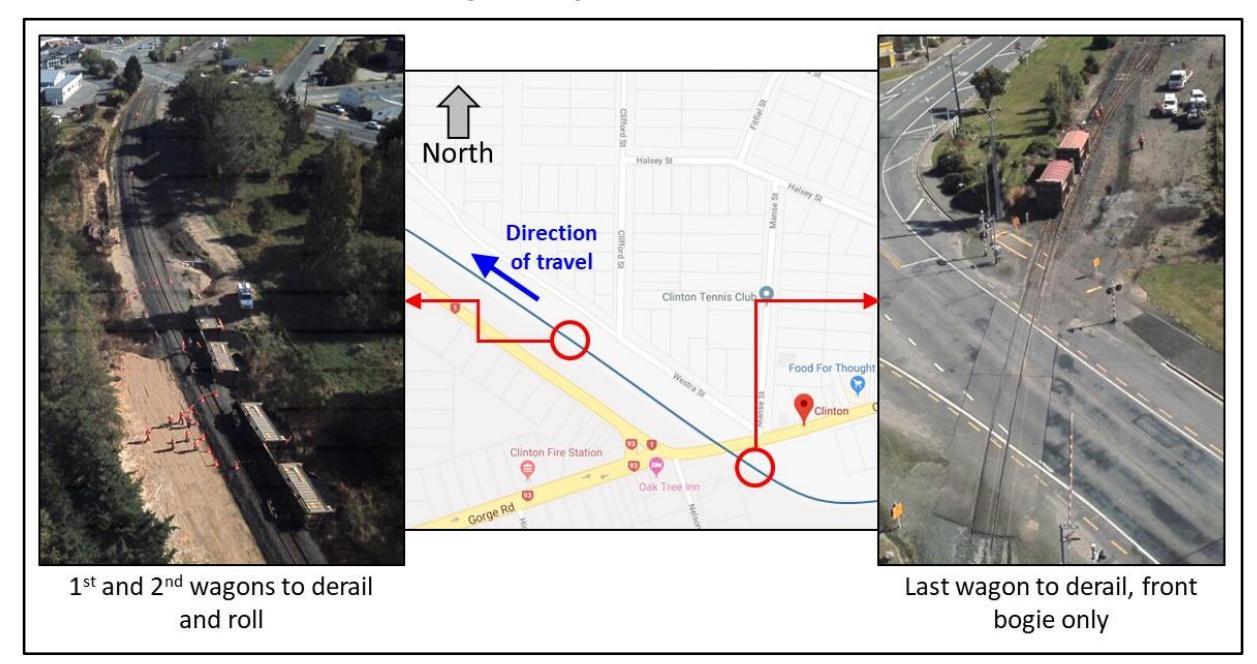
Figure 3: Location of derailed wagons at Clinton (map source: Google)

- 2.7. As the driver approached the rear of the train, it became evident that the last three wagons had derailed. The third and second last wagons had derailed before the level crossing, but had remained attached to the train until they overturned onto their left sides about 300 metres after passing over the level crossing.
- 2.8. The front bogie of the last wagon had derailed but the wagon was upright and had not passed over the level crossing (see Figure 3).

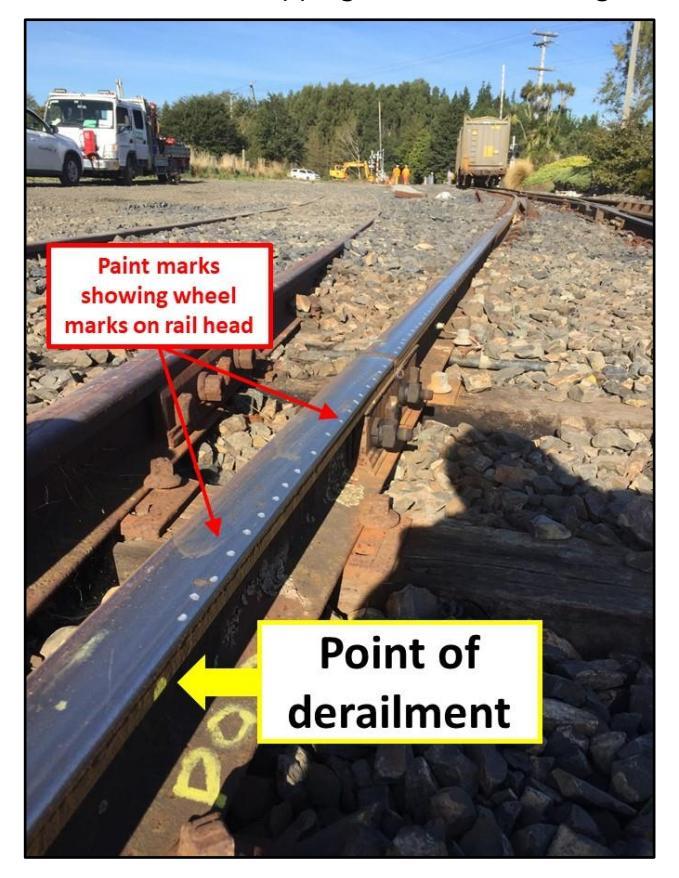
Figure 5: Point of derailment

2.13. Witness marks⁷ on the rail indicated that, when facing the direction of travel, a left-side wheel on a right-hand bend had climbed and then ridden along the rail head⁸ for approximately five metres before dropping off the outside edge of the rail (see Figure 5).

3.22. The wheel then continued to travel along the top of the rail for approximately five metres. The wheel flange created witness marks on the rail head before it dropped off the outside edge of the rail. The subsequent effect was that a further two wagons derailed until the last wagon parted from the train, severing the air supply and automatically applying the train brakes.

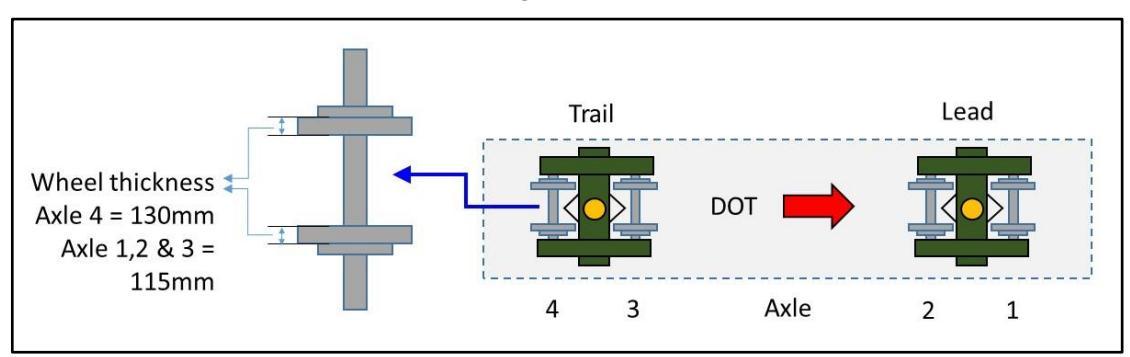
Figure 6: Wagon and bogie layout

2.16. One anomaly was found during the inspection: one wheelset⁹ out of the four was fitted with wheels that were thicker than the other three (see Figure 6). The wheels on axle four, the rear axle, were 130 millimetres (mm) thick compared with 115 mm for the other axles. The thinner wheels are an older design.

- 2.17. The fitting of different-thickness wheels on an axle to make a wheelset is not allowed. Wheelsets with different-thickness wheels on an individual bogie are allowed in the specification but discouraged and considered undesirable.
- 2.18. It is likely that this bogie had previously been damaged and had been repaired with the replacement of a single wheelset at a remote depot. It should be noted that each individual wheelset did have matching-thickness wheels at each end. The anomaly across the four axles was not considered contributory to the derailment.

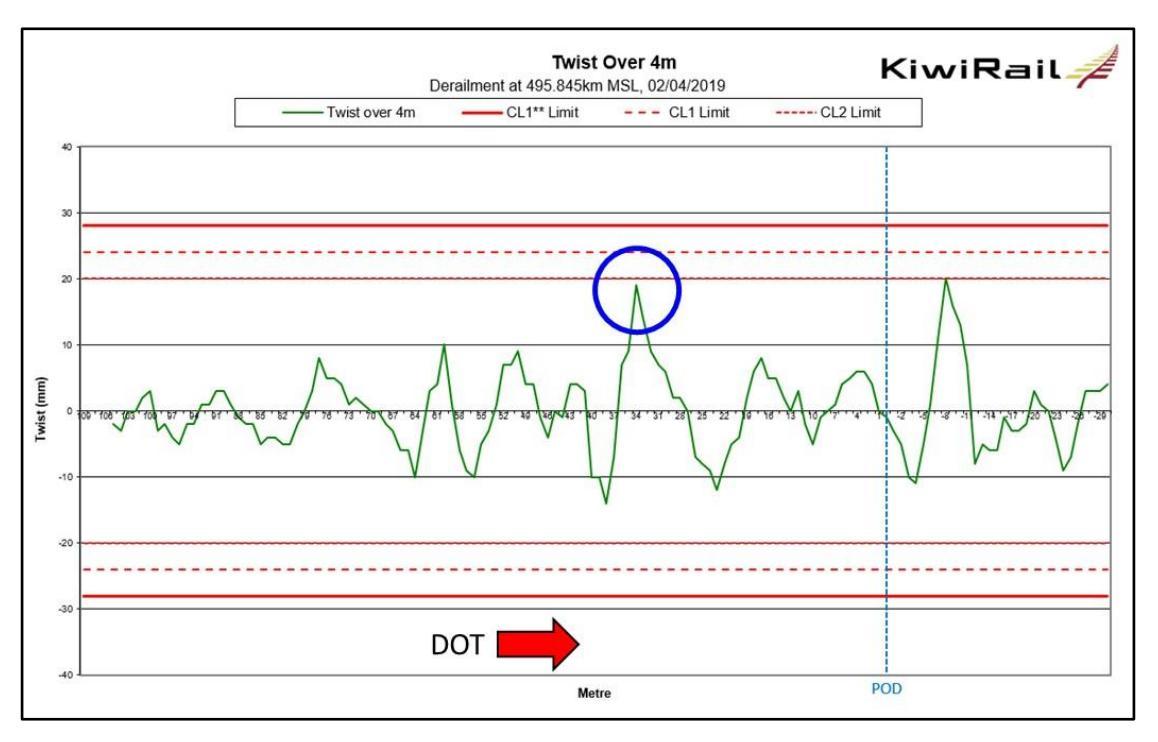
Figure 7: Track twist graph

- 2.21. After the derailment, a manual measurement of the track geometry either side of the point of derailment showed a track twist¹⁰, which was just within the acceptable maintenance tolerance limit (see Figure 7). This level of track twist required no action to be taken; however, once it deteriorated to the tolerance, maintenance would be planned to bring the track geometry back within limits.

- 3.14. It can be seen from Figure 6 that the manual measurement of track geometry postaccident identified a track twist just before the point of derailment. The twist was just within KiwiRail's tolerance limits and was not considered severe enough to have caused the derailment directly.
- 3.15. The effect of a track twist in relation to derailment is for the twist to start a rocking motion, of the wagons particularly. When the cause of derailment is considered in terms of dynamic interaction, it is very likely that a rocking motion on the wagons created by the track twist was a contributory factor but was not sufficient in itself to have caused the derailment.

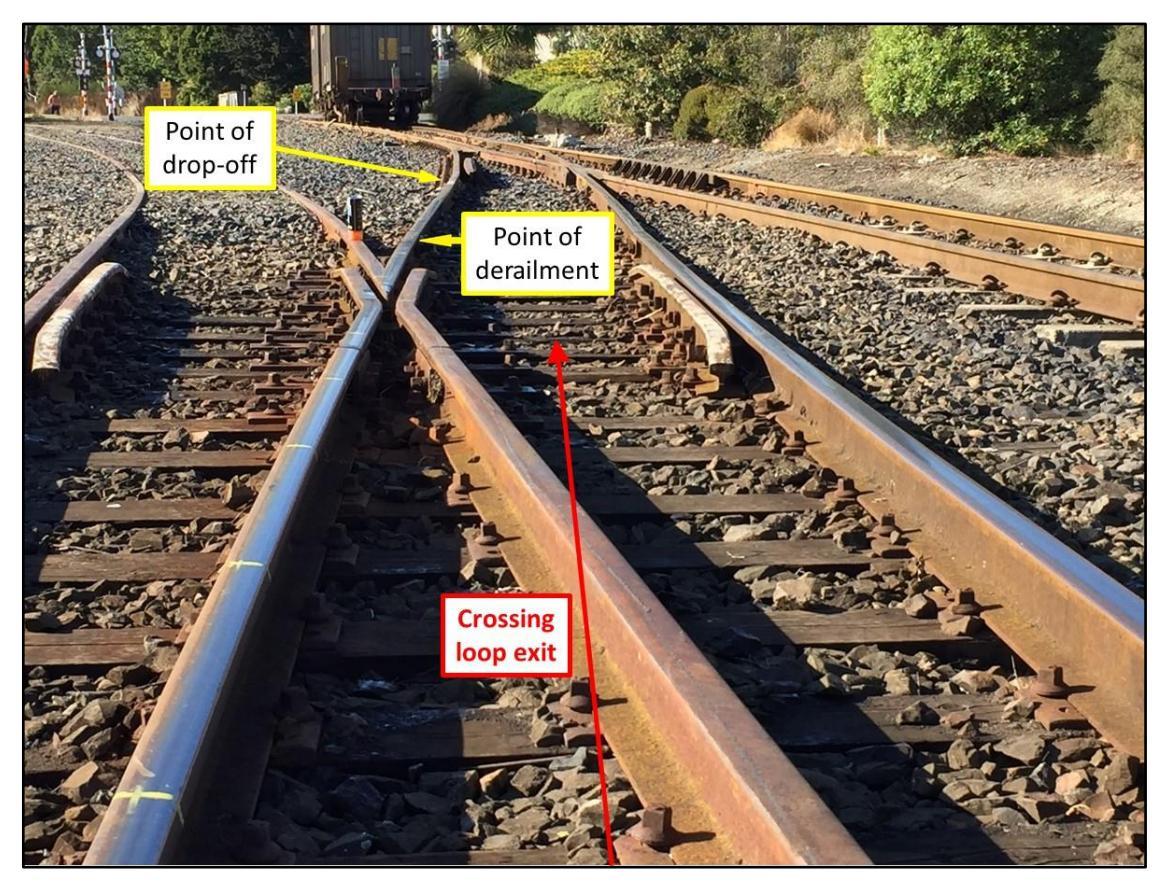
Figure 8: Point of derailment

3.13. Witness marks confirmed that the point of derailment (see Figure 5) was on the left-hand rail in the direction of travel, between 7B and 7A points (see Figure 2), a section of track that was still within the crossing loop (see Figure 8).

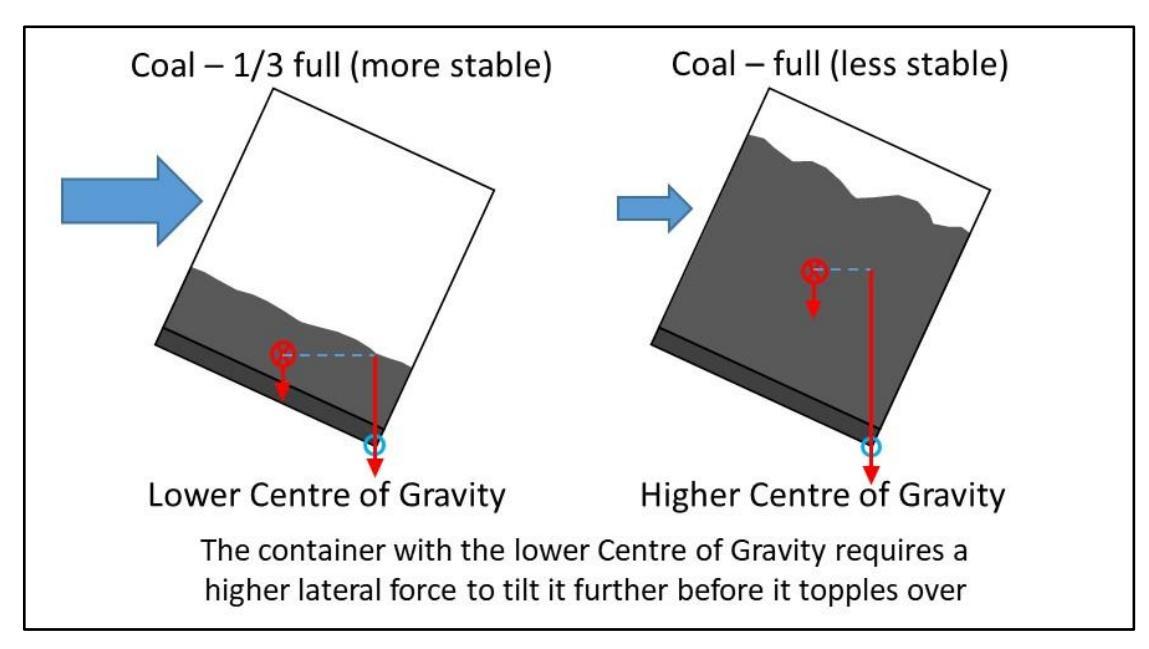
Figure 9: Effect of centre of gravity on stability

3.16. The higher the centre of gravity of a loaded coal wagon, the greater the destabilising effect of any lateral force acting on the wagon, such as centripetal force, created when a wagon is following a curve in a track. In a worst-case scenario the lateral force may cause the centre of gravity to move beyond the pivot point (see Figure 9) and become unstable. A part-filled coal wagon, with a much lower centre of gravity than a full coal wagon, will require a greater lateral force to move the centre of gravity beyond the pivot point for it to become unstable.

- 3.17. By design, the coal wagons that were involved in the accident had, at maximum capacity, a centre of gravity of 1,849 mm above rail level. The maximum permissible centre of gravity is 2,000 mm above rail level. The loading of the coal wagons involved in this derailment was below the maximum permissible and therefore within tolerance.

- 3.18. The relatively high centre of gravity of the loaded coal wagons was within permissible limits and is not considered to have caused the derailment by itself. When considering the effect of a lateral force being applied to the centre of gravity of a loaded wagon, such as centripetal force generated by travelling around a curve or a rolling motion force generated by a track twist, the overall effect will be to destabilise the wagon.
