Final Report

Rail inquiry RO-2020-103 Collision between bus and locomotive Clevely Line level crossing Bunnythorpe 16 September 2020

December 2021

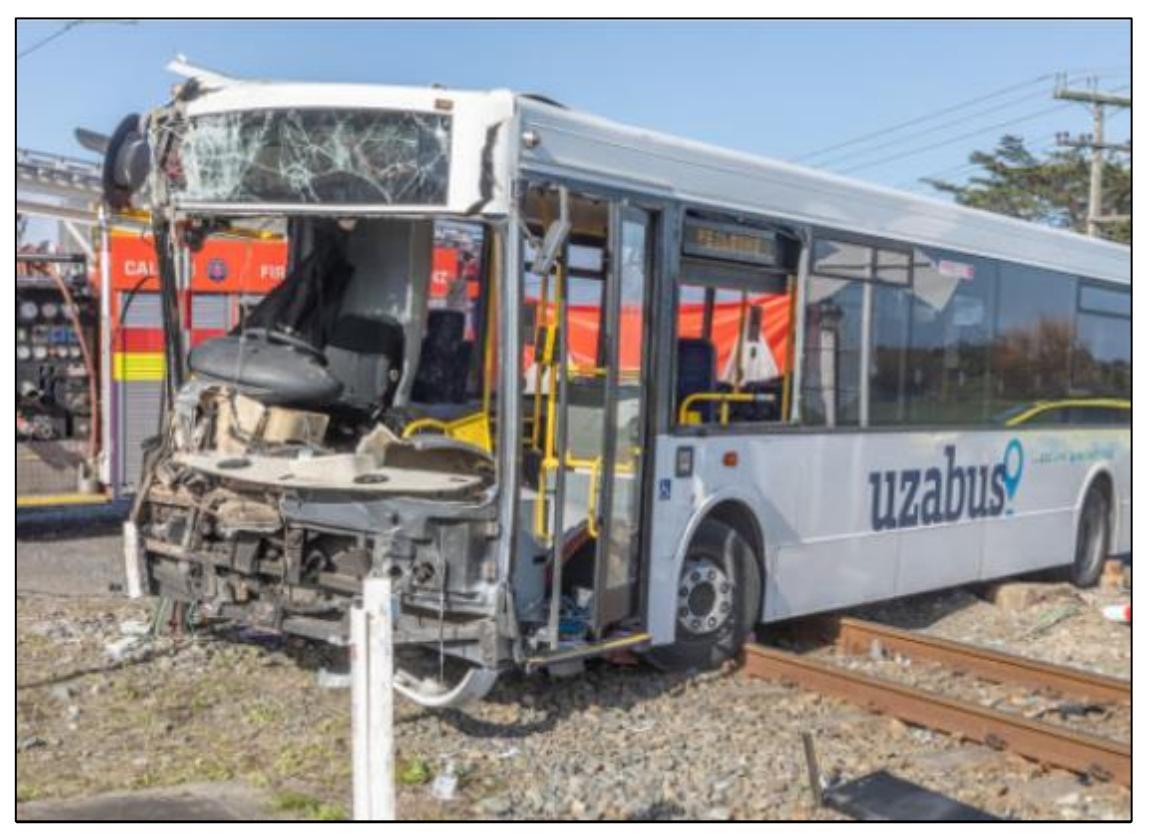
Figure 1: Uzabus KEW458 (Credit: New Zealand Police)

- 1.9 The bus completed its right-hand turn onto Clevely Line and, for reasons unable to be determined, did not stop before the level crossing.
- 1.10 The bus drove onto the level crossing at the same time as the locomotive was passing over it. The front of the bus connected with the rear left-hand quarter of the locomotive, causing the windscreen of the bus to be torn off along with most of the front fairing structure.

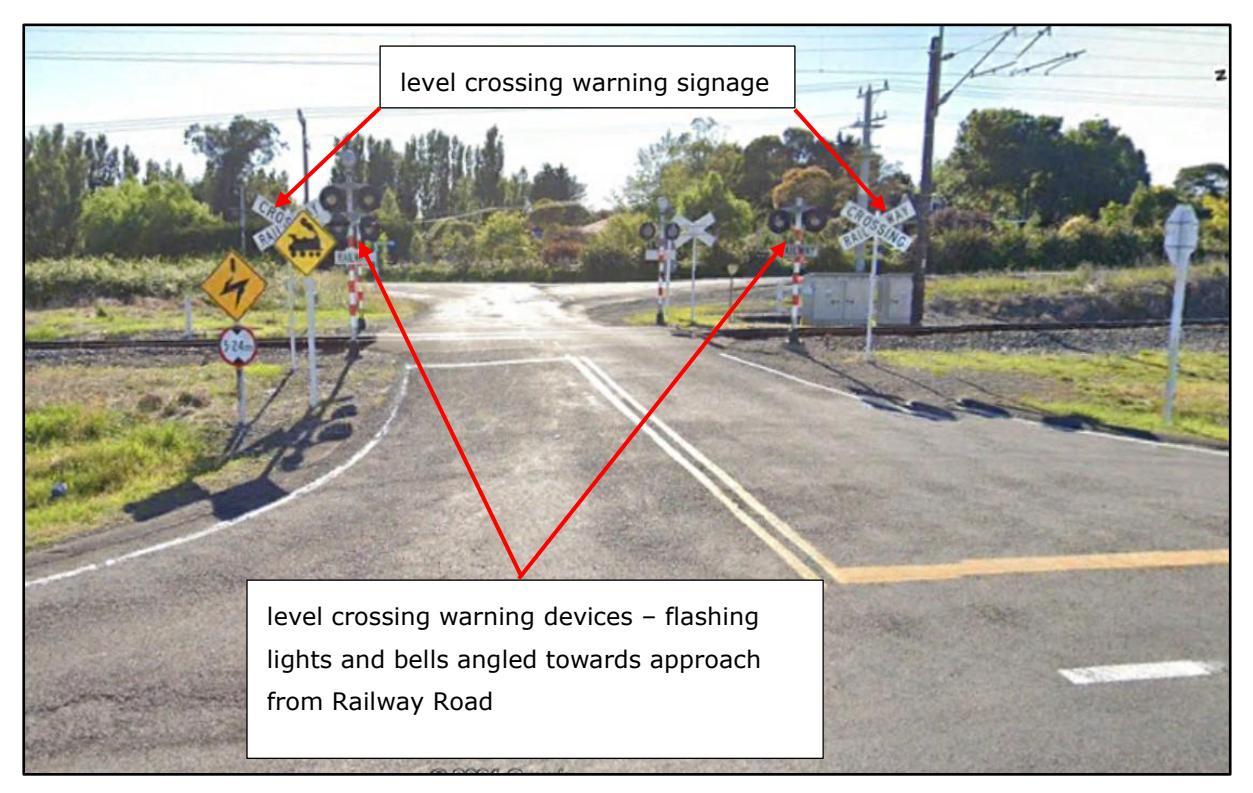
3.9 The physical defences in place to mitigate the risk of collision at the crossing included warning signs and alternately flashing red lights and bells (see Figures 3 and 4).

Figure 3: Clevely Line level crossing from Railway Road (Credit: Google Earth, modified by Transport Accident Investigation Commission)

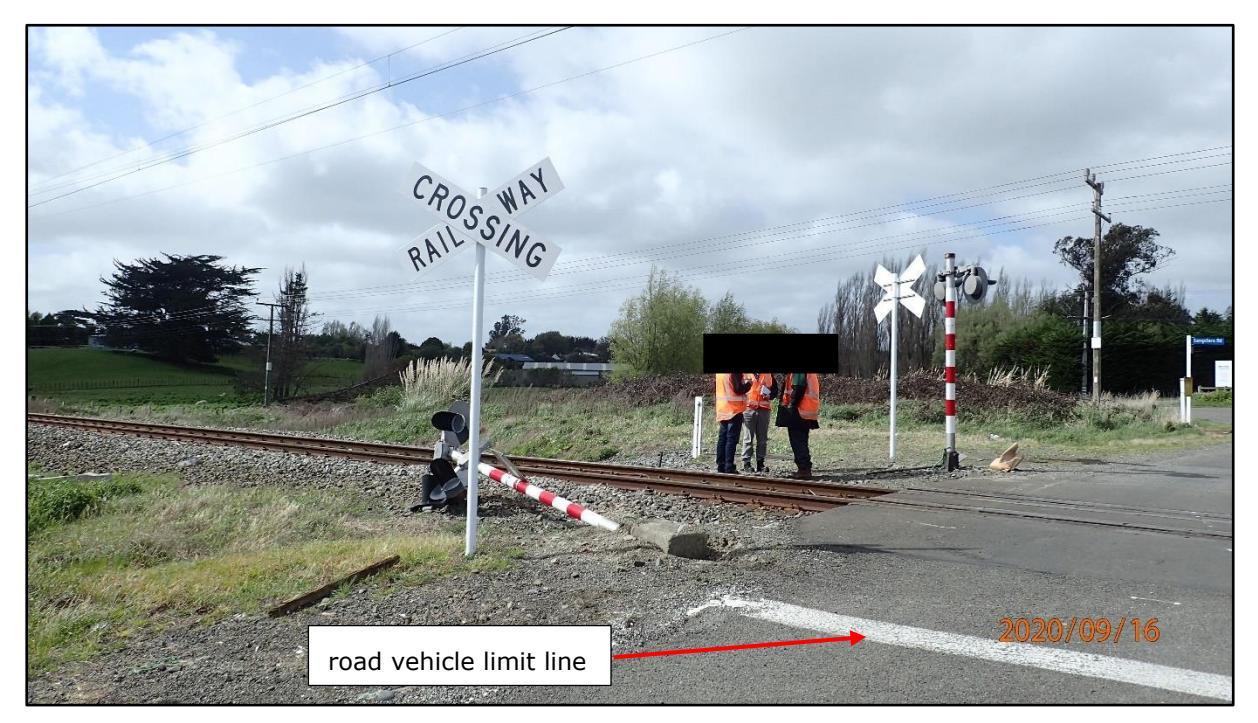
Figure 4: Level crossing warning device damaged in collision (Source: Transport Accident Investigation Commission)
