Final report Tuhinga whakamutunga

Rail inquiry RO-2023-104 Passenger train (Te Huia) signal passed at danger and potential conflict Penrose, Auckland 17 June 2023

November 2024

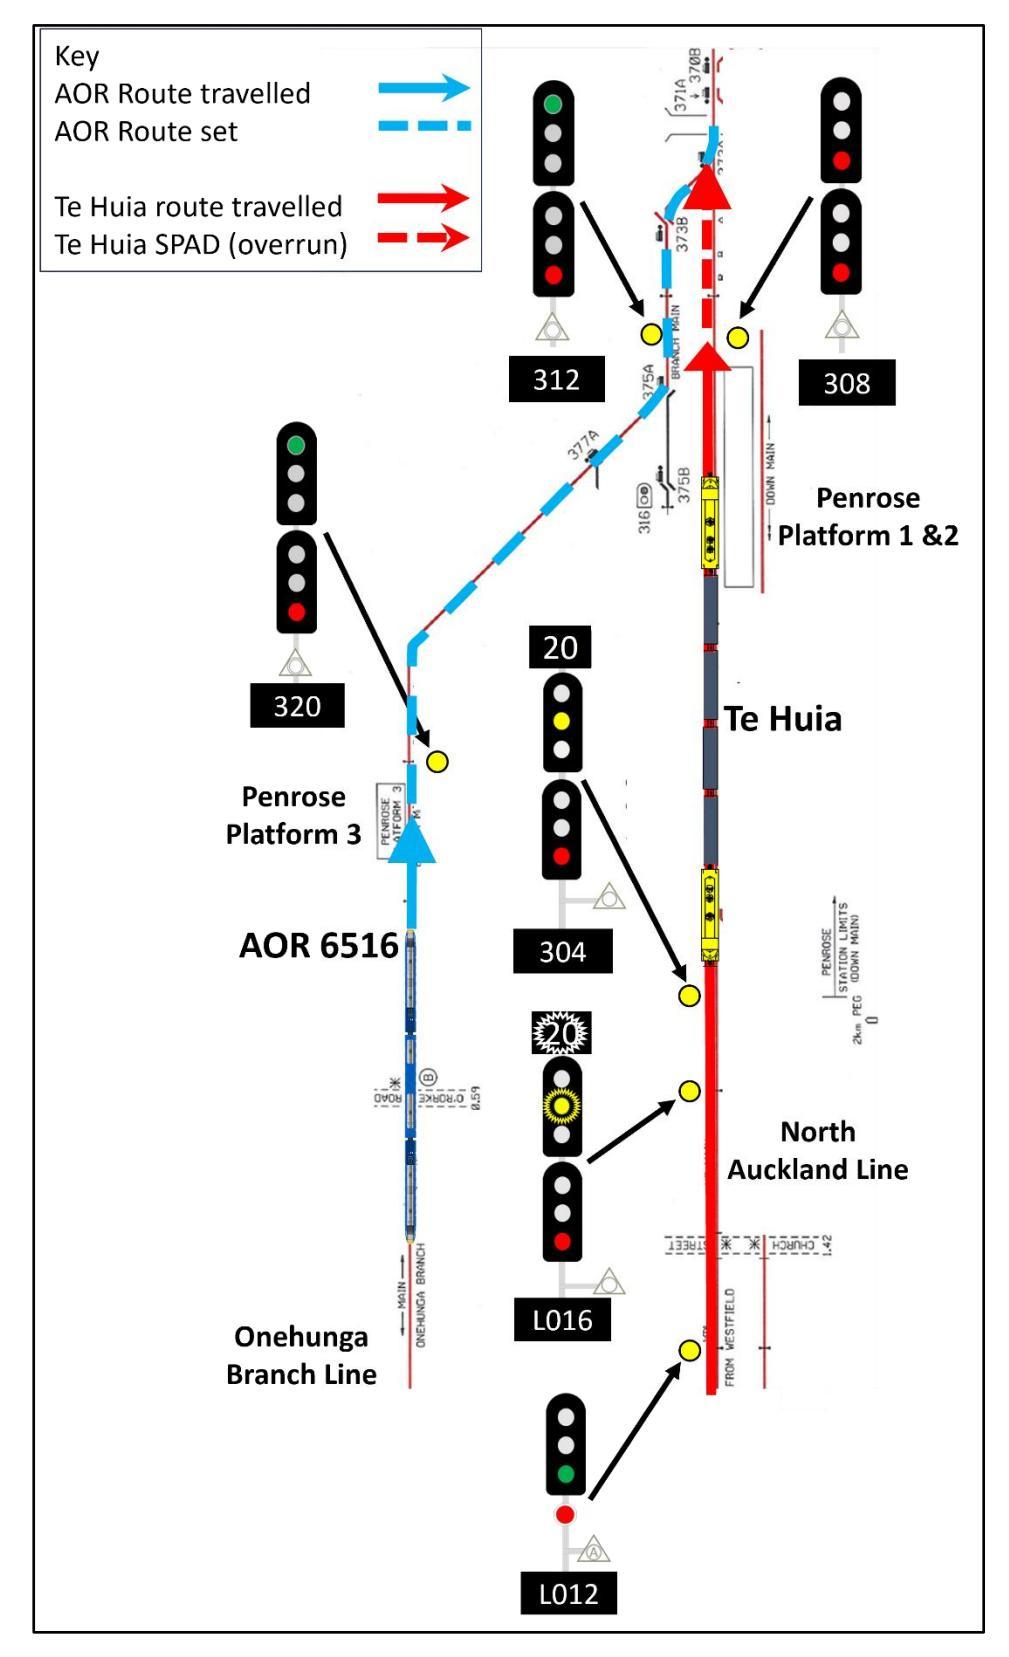
Figure 4: Signals and train movements approaching Penrose Station

2.7. At about 0950 Te Huia approached Penrose, where the sequence of signals indicated that a stop at Penrose Station had been planned by the Train Controller (*see* Figure 4).

2.8. Signal L012 was displaying a green aspect⁸, authorising movement in the track section between Westfield and Penrose. The signal was a single unit equipped with a marker disk as the lower light and an 'A' light (*see* Figure 5).

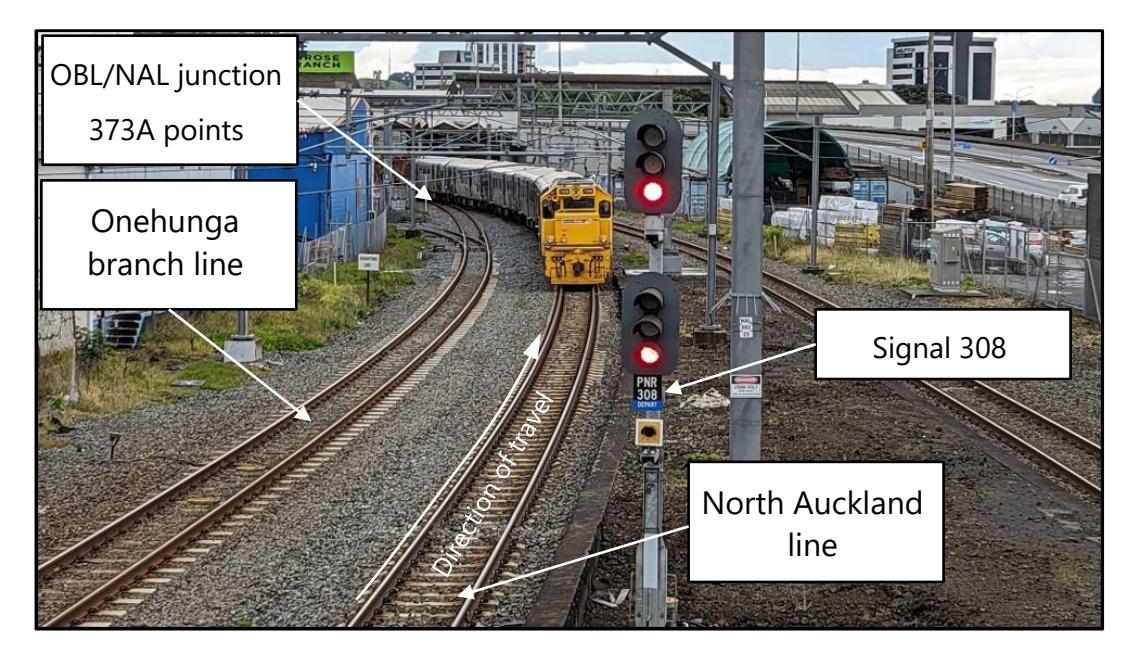
Figure 10: Location and aspect of signal 308 with Te Huia stopped and obstructing 373A points (Credit: nzrailphotos.co.nz)

- 2.15. As Te Huia continued past the station, the LE saw the red aspect of signal 308 in their peripheral vision. They realised that they had identified the incorrect signal for the route, and responded by applying the train's brake handle into a 'handle off' position¹³. The LE thought they had applied the train brake handle to the emergency position¹⁴.
- 2.16. Te Huia continued past signal 308 and travelled a further 195.2 metres before coming to a stop. The train could not be stopped and ran through¹⁵ and damaged the 373A points at the OBL junction (*see* Figure 10).

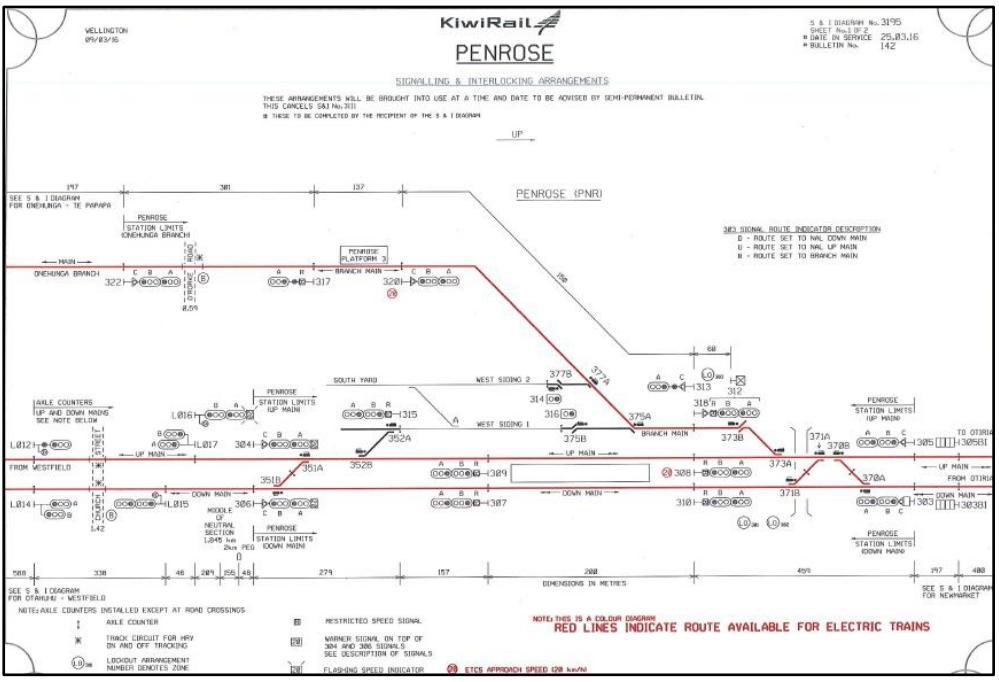
Figure 12: Signalling and interlocking arrangements diagram for Penrose Station

2.34. The signalling layout on approach to Penrose was contained in the *Signalling and Interlocking Arrangements*²¹ diagram 3195, dated 25 March 2016 (*see* Figure 12).

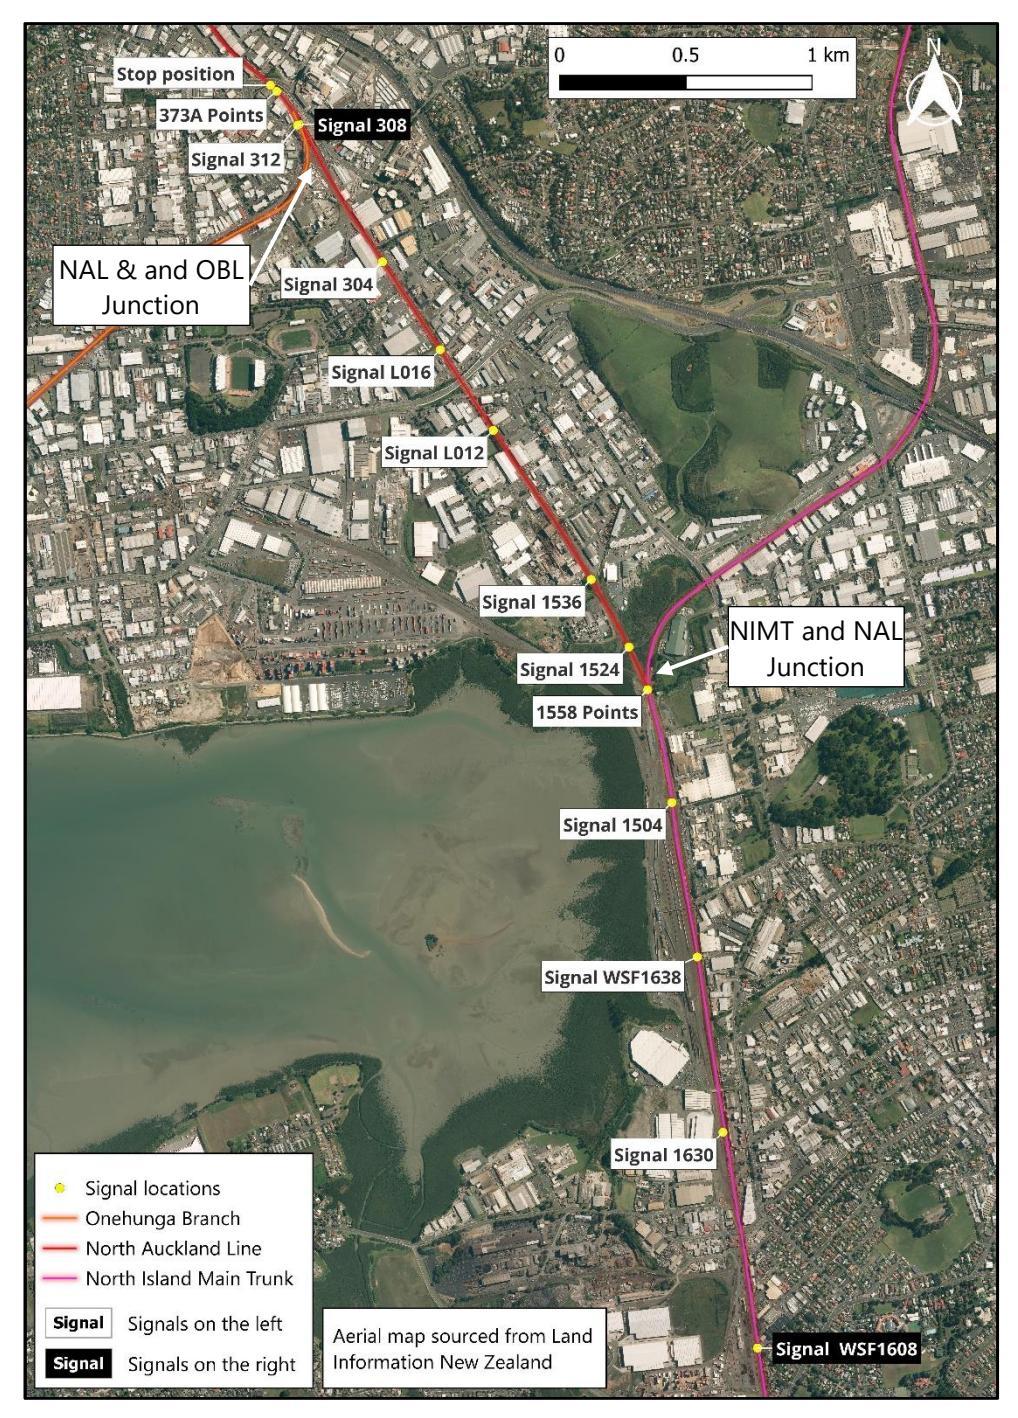
Figure 14: Signal positions and junctions Westfield to Penrose (Credit: Toitū Te Whenua, LINZ)

- 3.6. The Commission's investigators conducted and recorded in-cab observations of the signalled route from Otahuhu Station to Westfield on the NIMT, and then on the NAL from Westfield to Penrose Station. Further in-cab observations were made from the Penrose Station to Newmarket Station limits, the sections of track beyond where the incident took place. The observations followed the route on which Te Huia had operated and were conducted in a similar locomotive. The recordings showed that of the 10 signals applicable to Te Huia's direction of travel between Otahuhu and Penrose Stations, eight were located to the left of the track and two were to the right (*see* Figure 14).
- 3.7. Of the two signals to the right, one was on a signal gantry³¹ (signal WSF1608) and was clear of obstructions, with signal 308 at Penrose the only pole-mounted signal on the right.

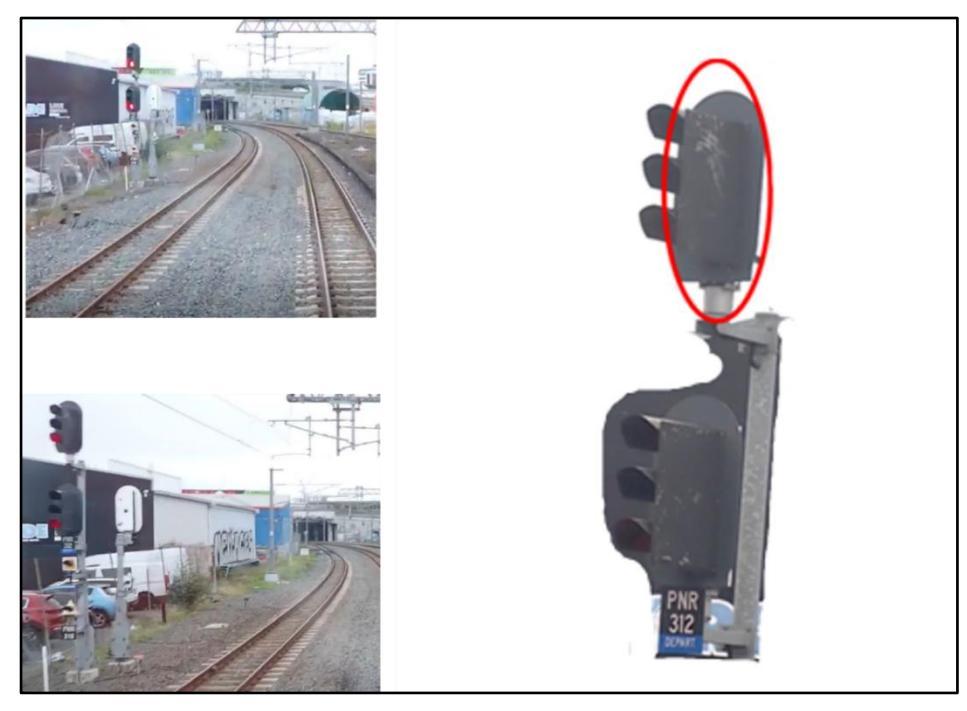
Figure 15: Signal 312 viewed from the locomotive cab in the left photographs. The right photograph shows the shields (circled in red) as viewed from the station platform

3.11. Signal 312 was located adjacent to signal 308 and had retrofitted shields mounted to the right side of the shroud³². The purpose of the shields was to prevent the possibility of the LE misreading a signal, known as making a 'read across error'³³ (*see* Figure 15).

- 3.12. The shields had been fitted following a SPAD incident in 2014. The observations by the Commission's investigators when visiting the site were that signal 312 was still clearly visible on approach, and the shields were largely ineffective.

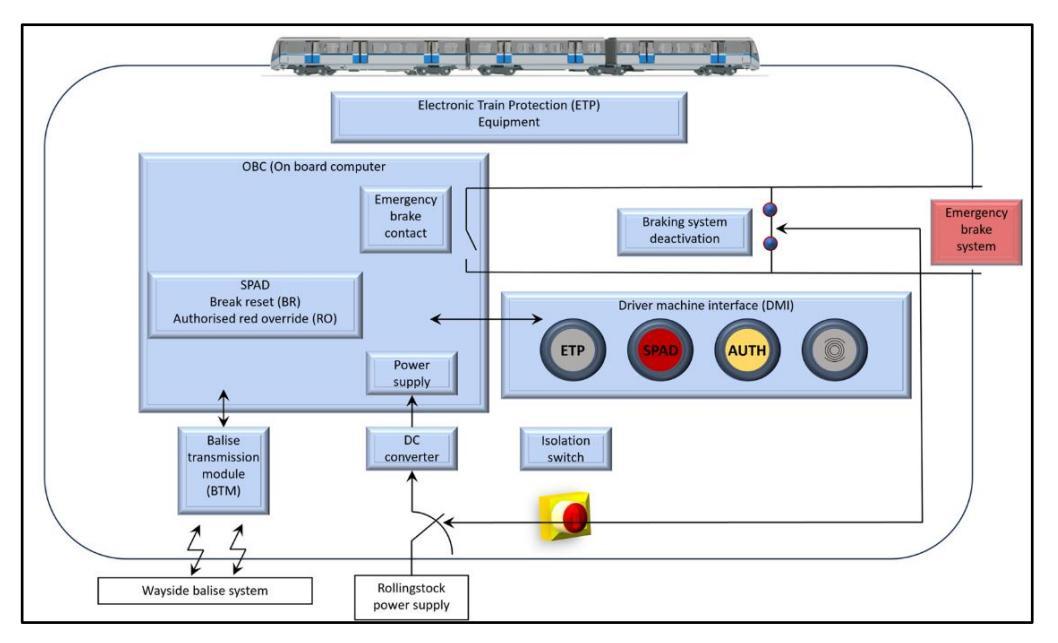
Figure 17: ETP system schematic

- 3.43. When a signal is at stop, the ETP system reads a 'signal at stop' message from the ETCS balise and applies the emergency brakes. The system relies on positive transmission between the balise and the train receiver. Since the train's system does not know where to expect a balise message, it will never know if the transmission is disrupted. For this reason, ETP cannot be considered fail-safe. The information on the ETP system's status could be observed by the LE through the driver machine interface (*see* Figure 17).

- 3.45. For the ETP system to be effective and stop the train before it entered the fouling zone, Te Huia had to be travelling at or below the speed shown on the speed indicator. In this instance a speed any greater than 20 kilometres per hour reduced the effectiveness of the ETP in preventing entry into the fouling zone because of the trains increased stopping distance at higher speeds.
