**Report 96-116**

**Train B02**

**loss of gangway**

## Rail Incident Report 96-116

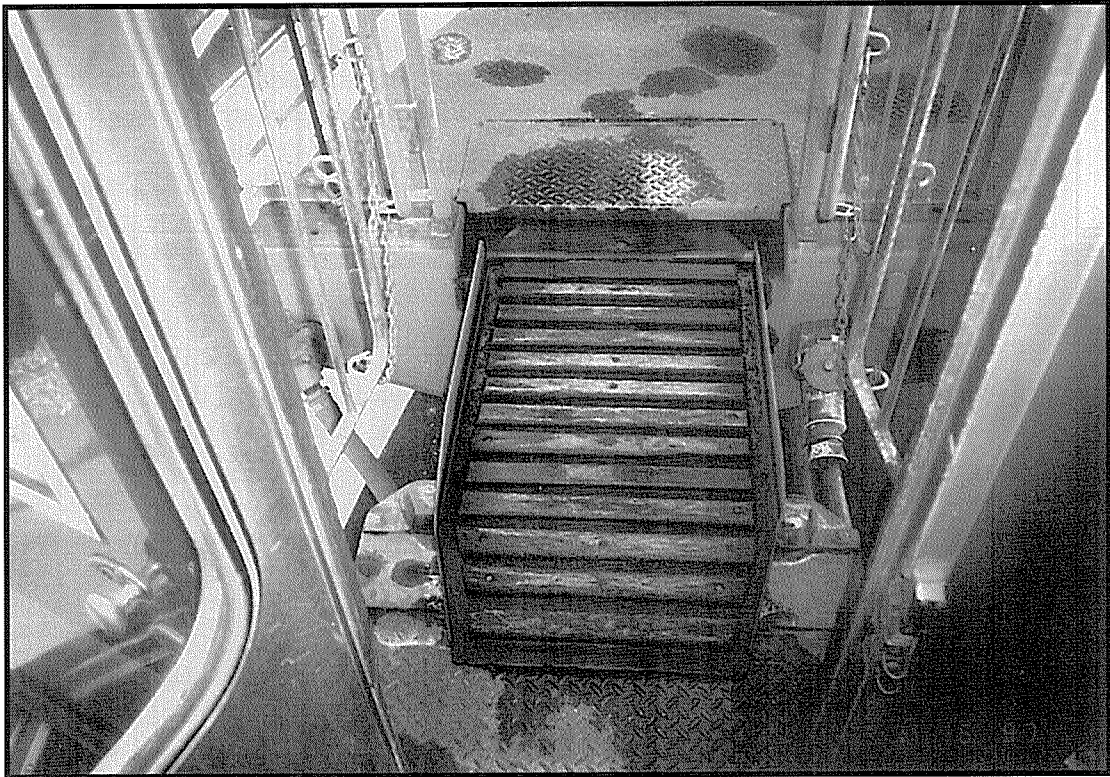
**Figure 1**

Typical installation of an alignment bar used by Tranz Rail when connecting power cars to Wellington fleet carriages

<sup>1</sup> The function of an alignment bar is to limit the lateral movement of the unpinned end of a gangway. (See Figure 1)

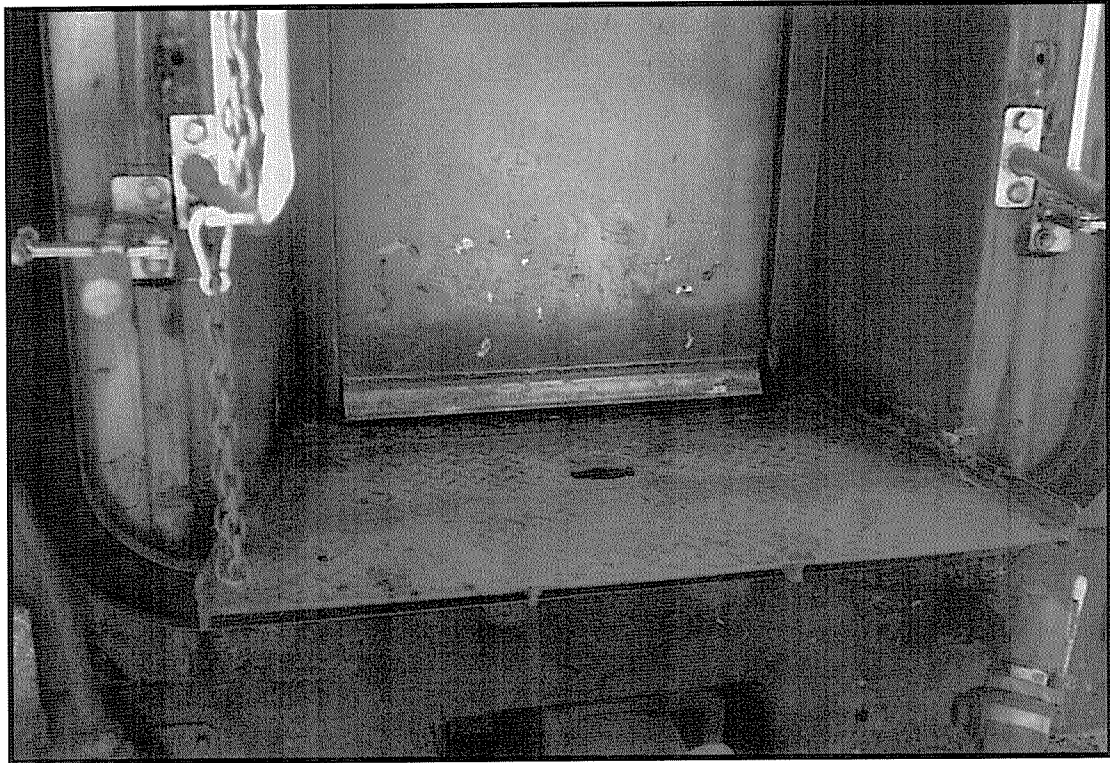
**Figure 2**  
Carriage A. Note lack of drilled holes for scissored type gangway (and alignment bar) location and scuff marks on door/upstand area, right side

- 1.4.3 Witness reports indicated that the gangway originally jammed on carriage A on the right side in the direction of travel. Examination of the carriage at Auckland showed evidence of gangway scuffing on the inside of the door recess and on the 50 mm upstand on the side of the extended gangway plate on this side (see Figure 2).

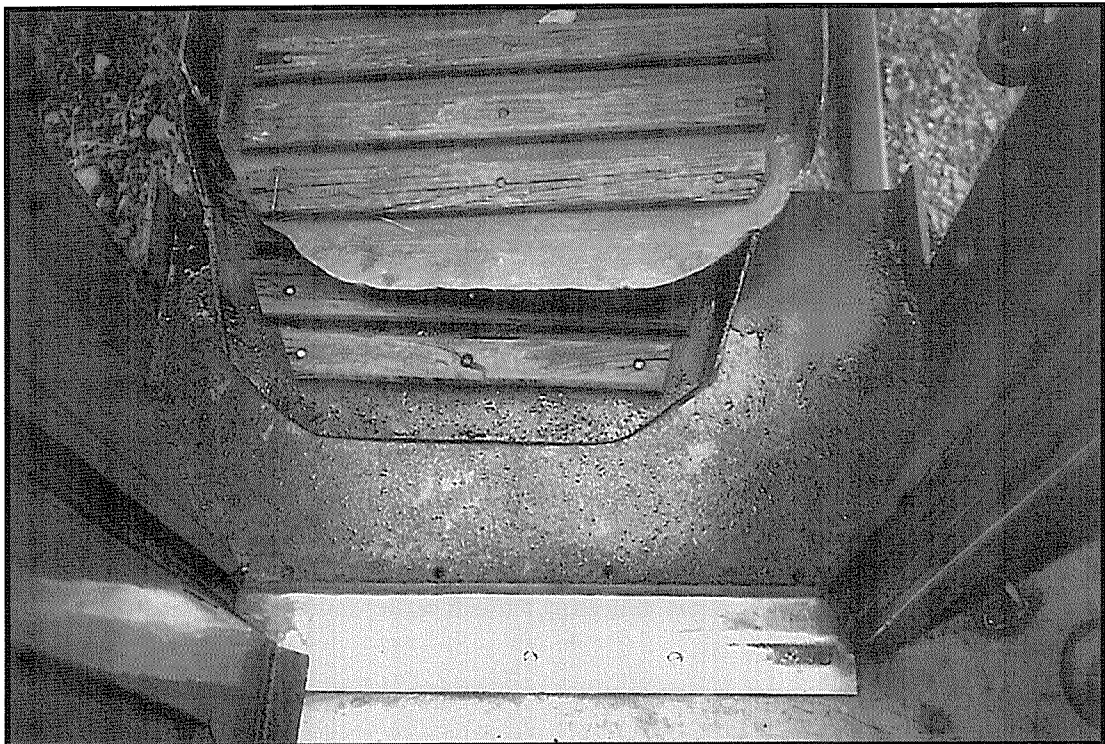
**Figure 3**  
The gangway used on 25 October 1996 laid on top of a type "X" gangway (with a common datum) to illustrate length and profile differences

- 1.4.5 The recovered gangway had a rounded end. The end was asymmetrical and worn where it rested on the support carriage, as distinct from the squarer and symmetrical profile of an unworn gangway (see Figure 3). The lug on the locating pin had sheared (the piece missing was that found below the hole on carriage B) and the weld holding the pin to the gangway had failed.

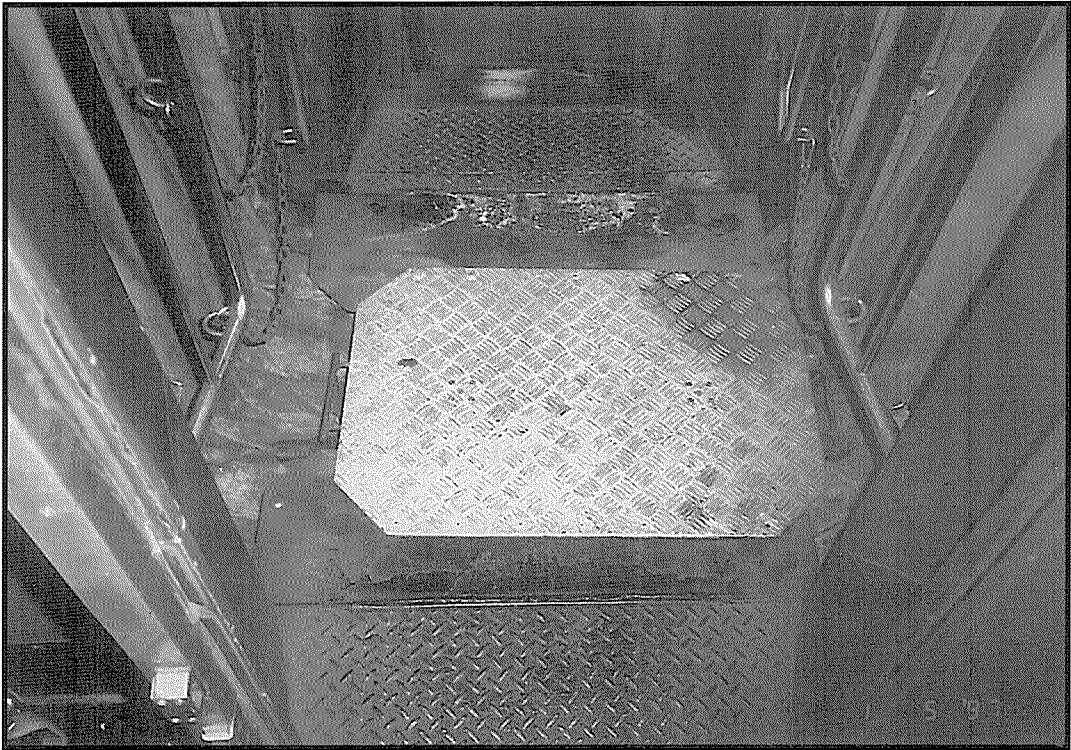
**Figure 4**

Standard Tranz Rail scissors-type gangway used with Wellington-based carriages.  
(Note one of four locating pins at bottom left. These pinholes were also used to locate the alignment bars when coupled to a power car)

- 1.5.2 At the time of the incident all Wellington-based carriages had been modified with extended platforms to incorporate scissors-type gangways (see Figure 4) which superseded the drawbridge type gangways. The holes in the platform required to locate these gangways were also used to locate the alignment bar when using a type “X” gangway to connect a carriage to a power car. No other gangway types were required or held in Wellington.
