Transport Accident
Investigation
Commission

Watchlist

Safety for pedestrians and vehicles using level crossings

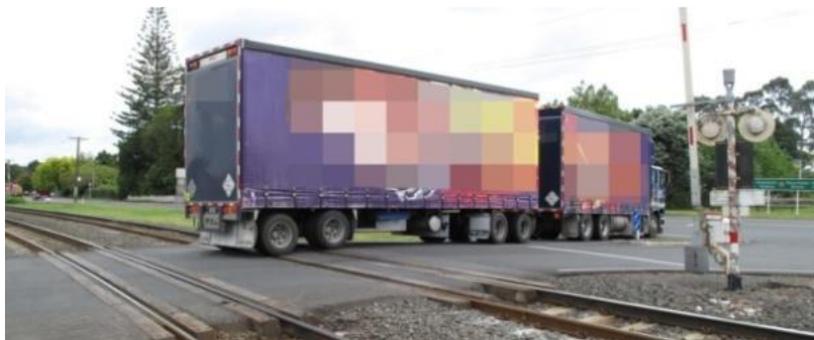
The Commission has investigated several accidents where road-legal vehicles have become stuck on rail level crossings, or have been too long to clear a rail level crossing and then stop, as required, at an adjacent road intersection. There is no routine procedure for measuring the profile or vertical alignment of the road at rail level crossings. There could be other level crossings in New Zealand on which low-slung, but nevertheless road-legal vehicles, could become stuck.

A total of 362 level crossings with short stacking distances are rated as high risk.² At level crossings with a short stacking distance, a long vehicle, even though it complies with road regulations, is unable to clear the level crossing when

stopping at an adjacent road intersection. Similarly, the profile (the rate of change in gradient) of level crossings may not be compatible with vehicles that have low, albeit legal, ground clearance. A train colliding with a heavy vehicle is a serious safety issue.
