Report 00-105

Lyttelton shunting service

derailment

27 April 2000

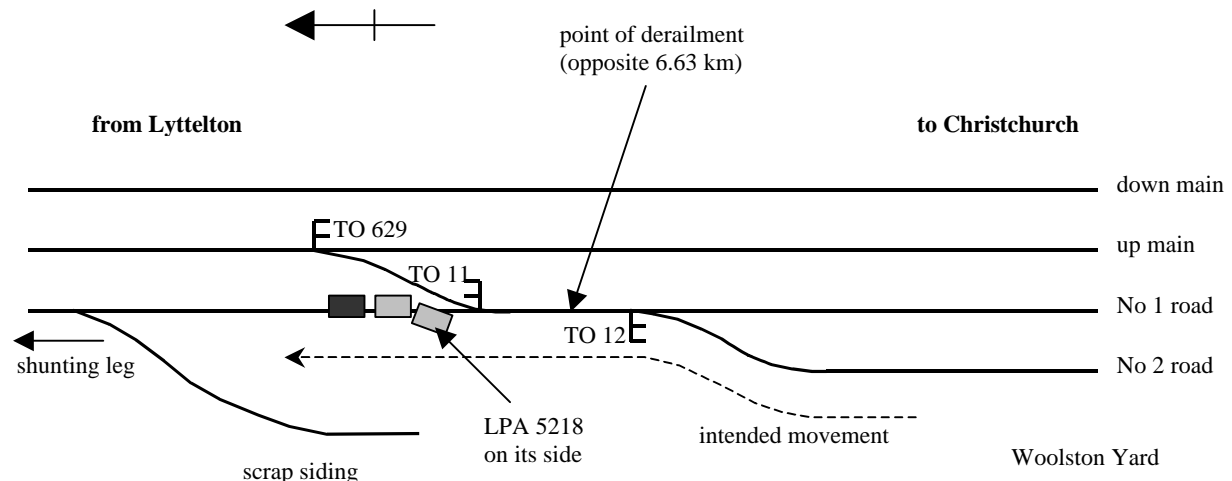
Figure 1
Site plan
(not to scale)

1.1.2 At about 1100 the shunt was required to place 2 wagons carrying scrap metal to different sidings. Figure 1 is a site plan of the area concerned.

- 1.4.4 The acting Line Inspector advised that the turnouts in Woolston yard had been rationalised and renumbered in late 1999, and that the entry in August 1999 referred to the curved track between TO 629 and what is now TO 11 (see Figure 1). He advised this inspection did not detect any problem with the straight between TO 11 and TO 12. None of the work detailed in this diary entry had been carried out prior to the derailment.

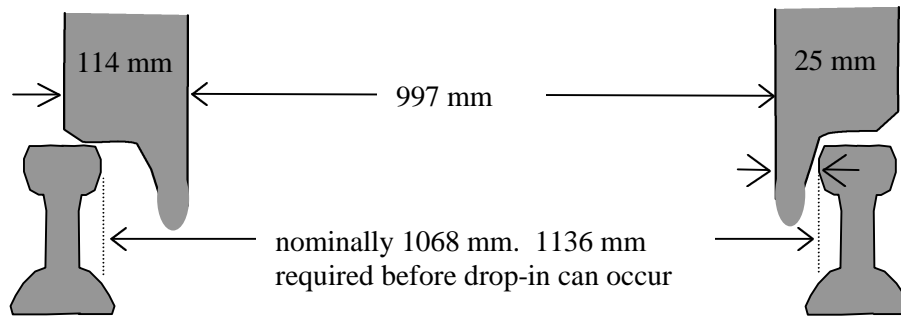
Figure 4
Conditions for a spread gauge derailment
(not to scale)

- 1.2.6 An inspection of wagon LPA 5218 following the derailment found it was to Tranz Rail's standards and there were no unusual features which could have contributed to the incident. The back-to-back wheel measurement on wheelset 1 was 997 mm and the leading right-hand wheel flange had a reading of 18, indicating a 25 mm flange thickness. The leading left-hand wheel had an overall width of 114 mm. The significance of these dimensions to derailment due to spread gauge is shown in Figure 4.
