**Report 00-202**

**Restricted limits passenger vessel *Sweet Georgia***

**engine room fire and grounding**

**10 March 2000**

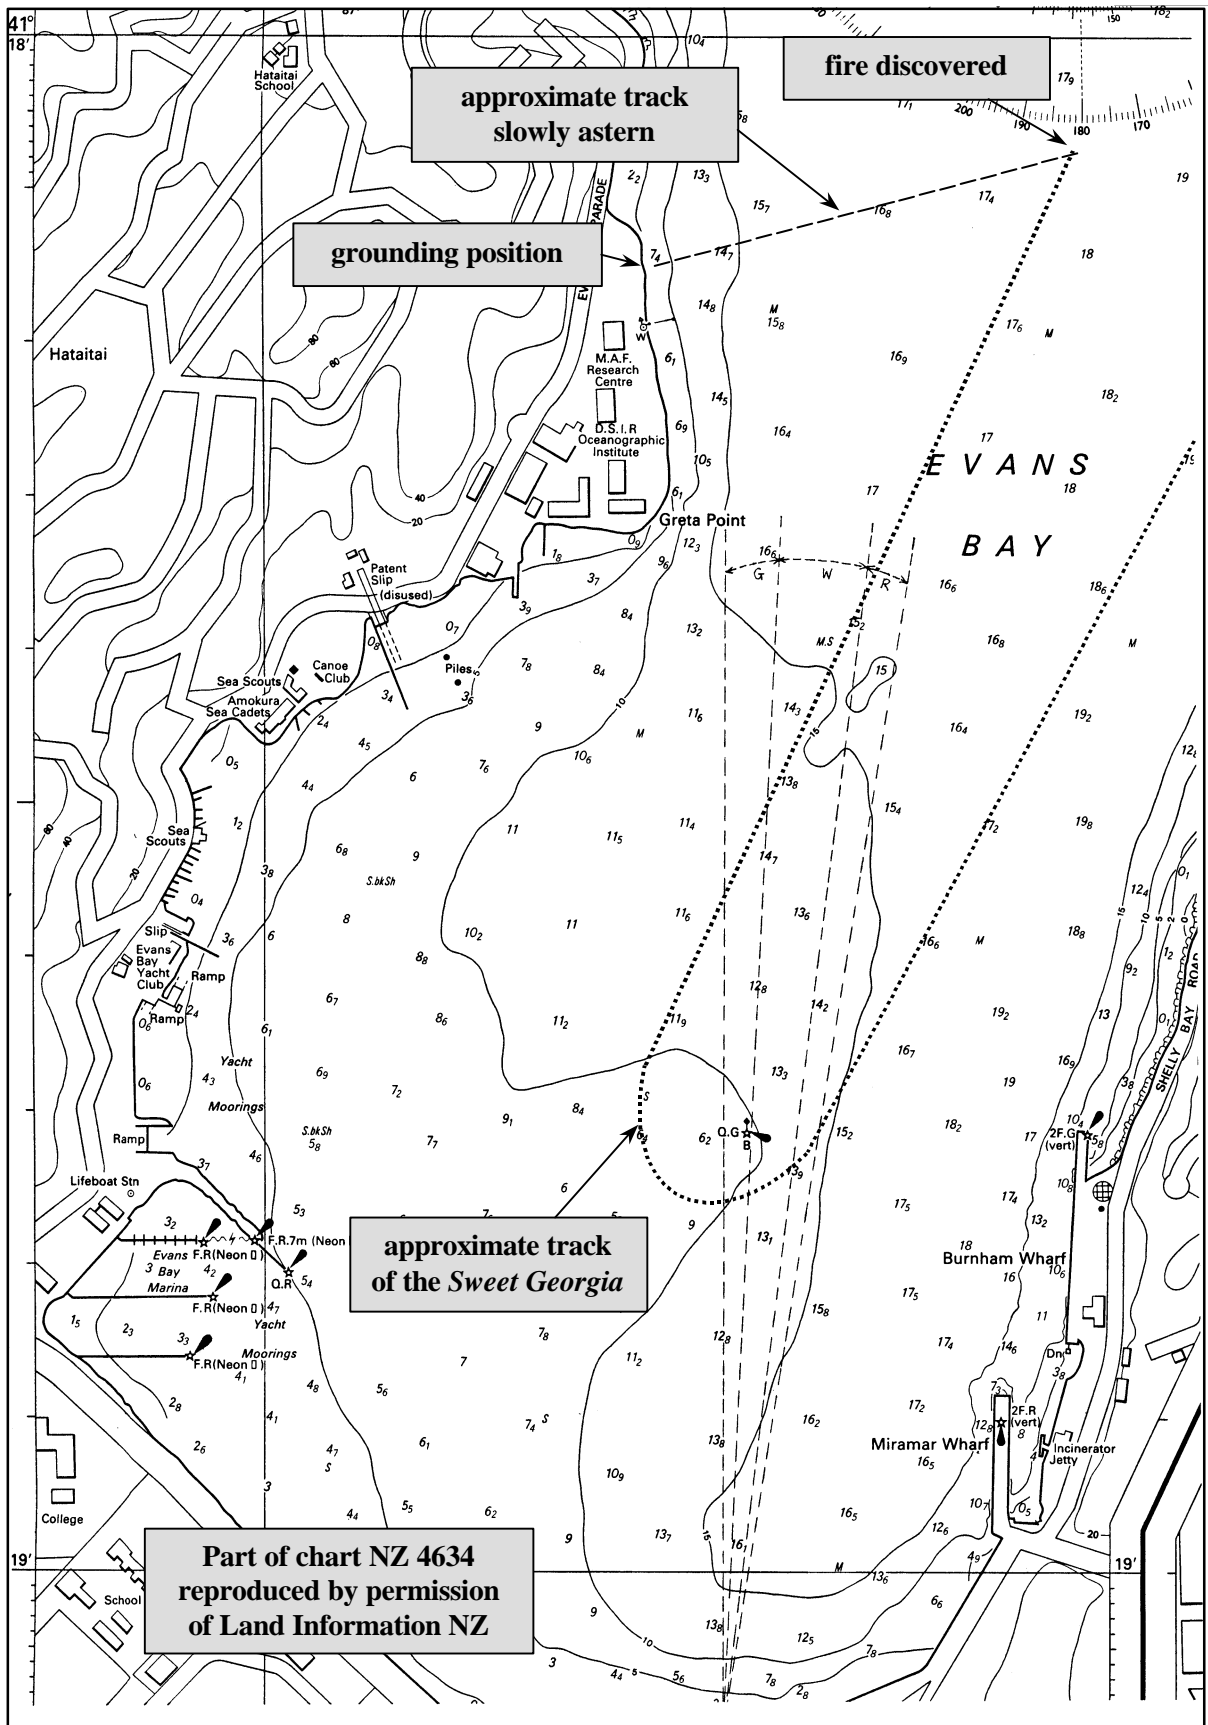
**Figure 1**  
**Part of chart NZ 4634 showing approximate track of Sweet Georgia**

- 1.1.10 The *Sweet Georgia* proceeded down the harbour to Falcon Shoal beacon. The skipper increased the engine revolutions to about 1450 rpm for a brief period before reducing them back to about 1250 rpm. He then turned the vessel and headed passed Kau Bay and into Evans Bay at about 1940. (See Figure 1)

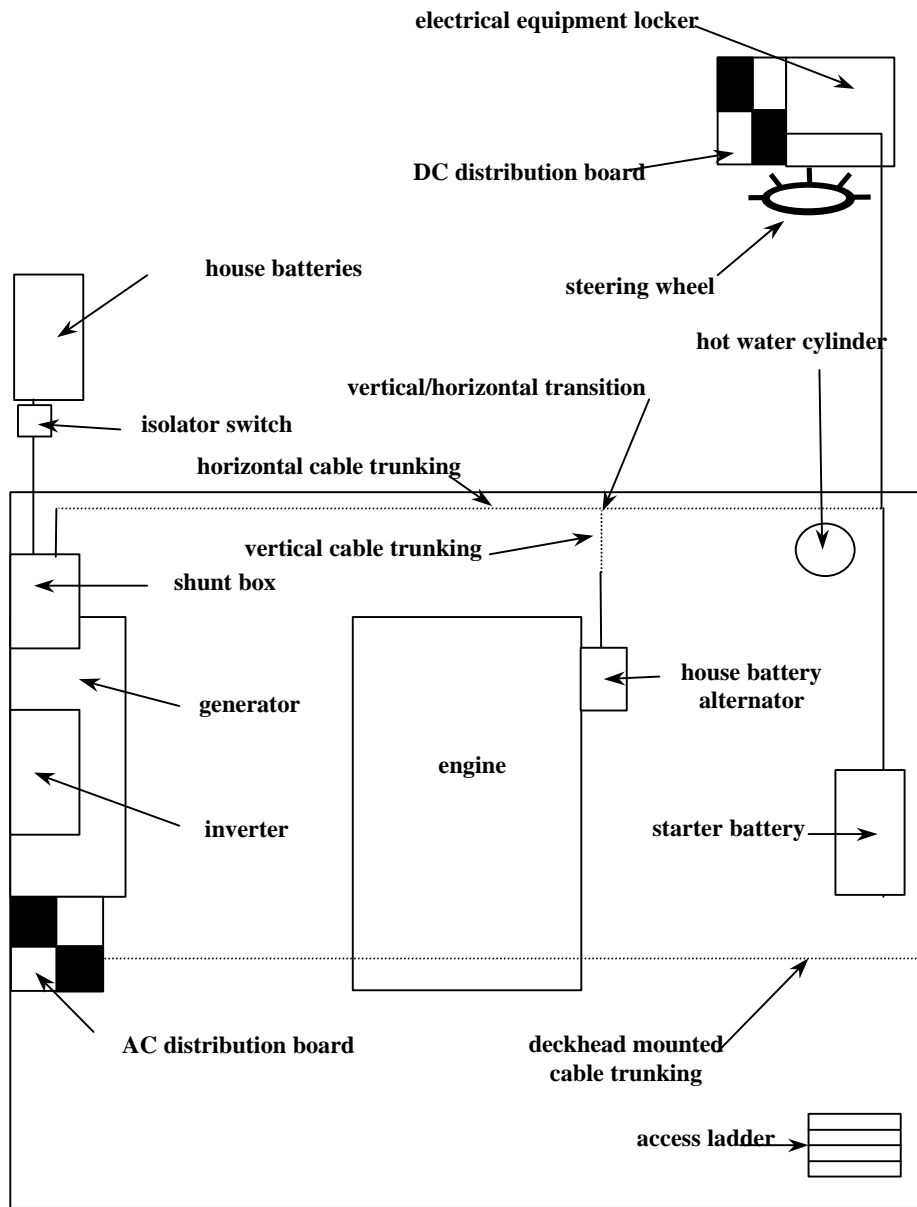
**Figure 2**  
**Plan view of engine room**

1.3.4 Access to the engine room was through a hatch in the deck of the galley area. The engine room was about 4 m square and as well as the propulsion machinery it contained the bulk of the electrical system. On the port and starboard side were the fuel tanks. The space was totally enclosed, with ventilation provided via air intakes on each side of the radar and antenna arch. Fire dampers for these ventilators were operated from either side of the main deck. (See Figure 2)
