## **Report 00-211**

### **harbour tug *Waka Kume***

### **loss of control**

**19 November 2000**

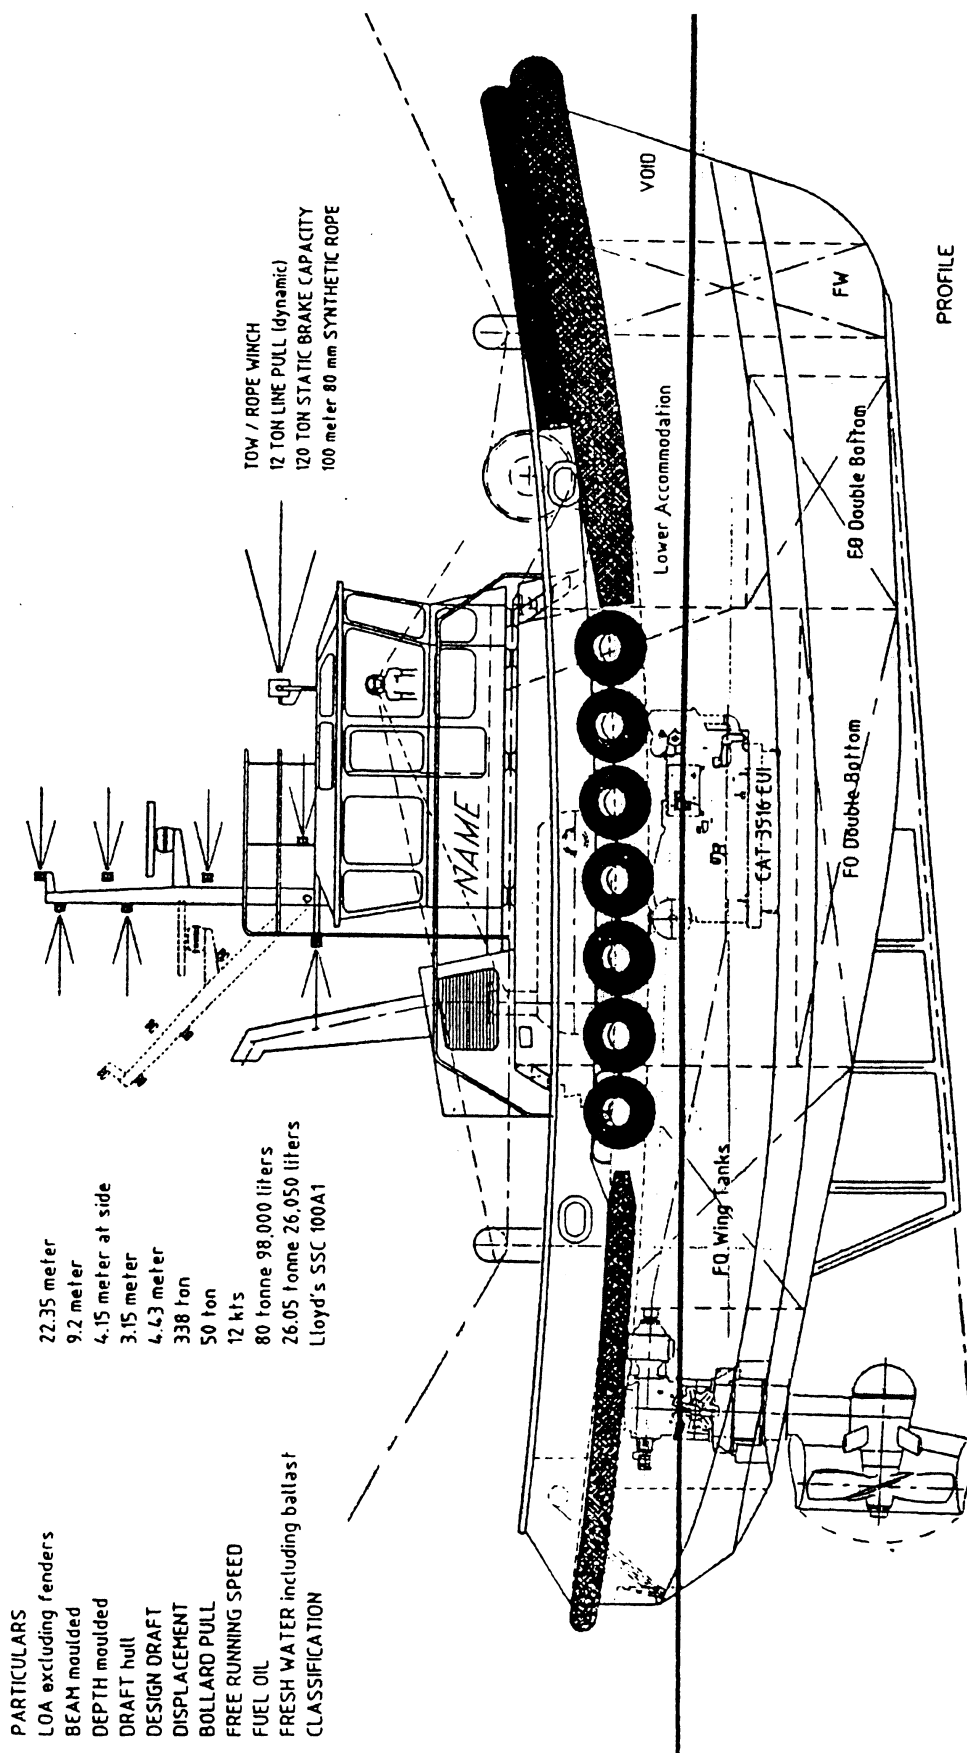
Figure 4  
Drawing of Waka Kume

- 1.3.2 The tugs had 2 azimuth drive units at the stern and were known as reverse tractor tugs. This type of tug usually operates with the towing point towards the assisted ship and the propulsion units away from the assisted ship. This configuration made them highly manoeuvrable. They were capable of travelling sideways at about 5 knots (see Figure 4).

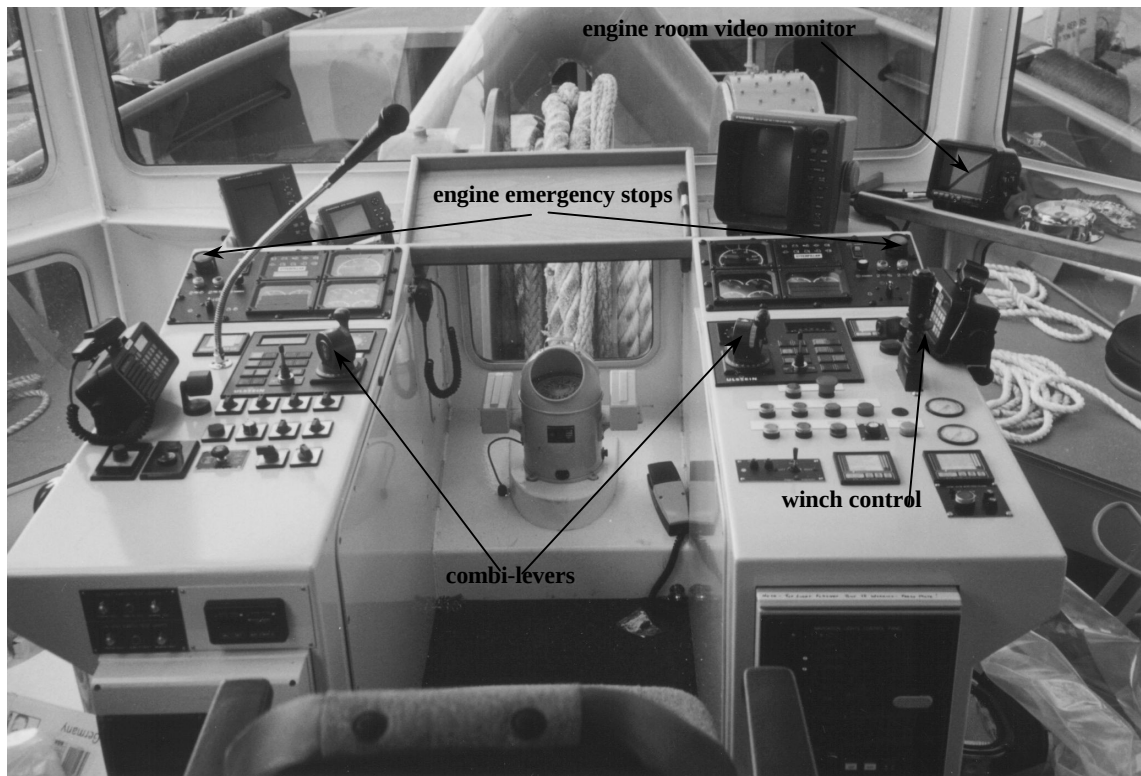
**Figure 5**  
**Wheelhouse console**

- 1.3.4 The wheelhouse had close to 360-degree visibility. There were also windows in the deckhead above and to each side of the driving position.
- 1.3.5 The wheelhouse control console was split to allow the operator to stand or sit between the controls. Each side of the console housed a combi-lever and the associated engine controls, gauges and emergency stops for that unit. The very high frequency (VHF) radio could be activated by a foot pedal (see Figure 5).

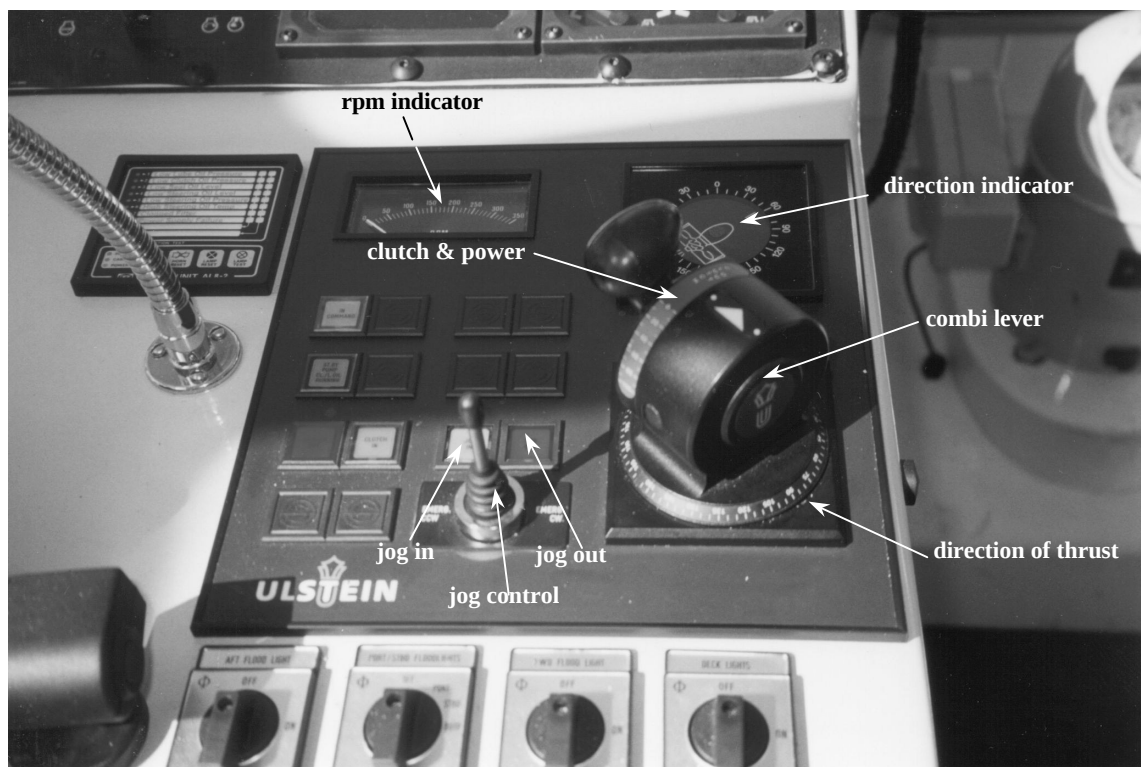
**Figure 6**  
**Port combi-lever and associated controls**

- 1.4.1 The operator controlled each azimuth unit with a combi-lever that controlled the clutch, thrust direction and rpm of each azimuth unit. The combi-lever consisted of a rotating base that controlled the direction of thrust and a lever that controlled the clutch and propeller rpm. The handle of the lever was ovoid with the sharper end indicating the direction of thrust (see Figure 6).

- 1.4.2 When the engine was clutched out the lever was at an angle of about 25 degrees away from the direction of thrust, when clutched in it was vertical. To increase the rpm the lever was pushed towards the direction of thrust, obtaining maximum rpm when the lever was horizontal.
- 1.4.3 There was an auxiliary steering control known as the jog control. This consisted of a joystick, mounted close outboard of each combi-lever. The jog control was engaged by pushing a jog in button and disengaged by pushing a jog out button. When engaged the joystick rotated the azimuth unit clockwise if pushed right and anticlockwise if pushed left.
