## **Report 01-205**

***Spirit of Enterprise***

**sheer and contact with channel side**

**Otago Harbour**

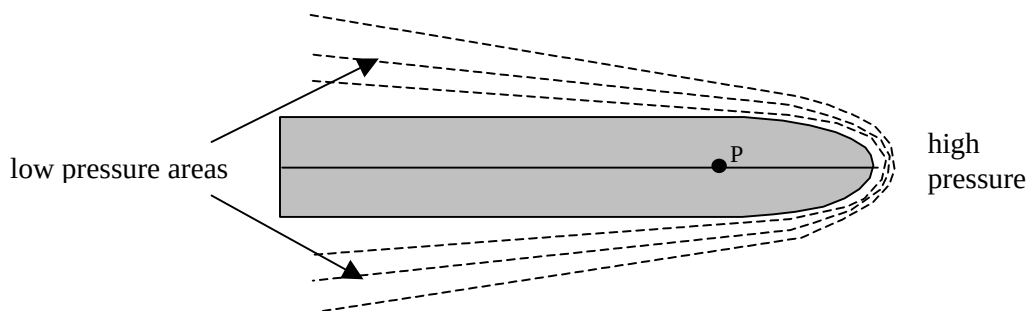
**Figure 5**  
**Simplified diagram of pressure areas**

- 1.2.1 When a ship is making headway, a positive pressure builds up forward of the pivot point and the flow of water down the sides of the ship creates a low pressure area which extends out from the ship (see Figure 5). When the ship is in deep open water the pressure areas are not a problem. However, when the ship is in confined or shallow water, the pressure areas cause interaction between the ship and the seabed or sides of a channel.

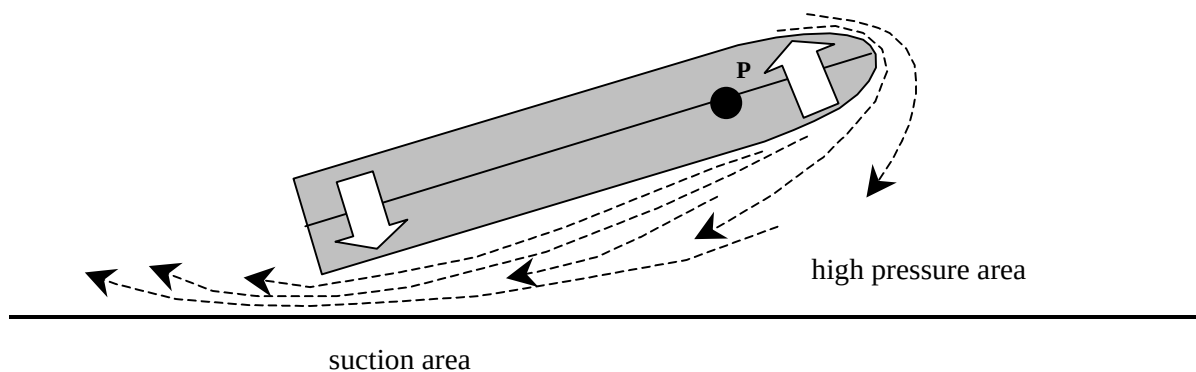
**Figure 6**  
**Bank effect**

- 1.2.2 As a ship starts to close with a vertical obstruction, such as a shoal or channel side, the areas of high and low pressure become restricted and the ship is influenced by the resultant forces and suffers what is known as bank effect. The positive pressure at the bow builds up and cushions the bow away from the obstruction, while the low pressure area at the stern creates a suction towards the obstruction. The suction effect is greater than the cushion effect due to the longer distance from the pivot point. The combined forces can be very strong. Under such conditions constant corrective rudder, sometimes as much as hard over, is required to control the heading. If left uncorrected, the ship is liable to sheer away from the side of the channel, sometimes violently. The higher the speed of the ship, the more pronounced the effects of interaction will be (see Figure 6).

- 1.2.3 When a ship transits the centre of a channel, the interaction forces are present on both sides of the ship and counteract each other. If the ship moves closer to one side of the channel then it will be influenced by bank effect on that side, and may need considerable corrective helm.
